### ASBESTOS SURVEY REPORT FOR HETTON LE HOLE NURSERY SCHOOL, SUNDERLAND

**HETTON LE HOLE NURSERY SCHOOL**

**UPRN: - J259890**

**Date: 29 January 2026**

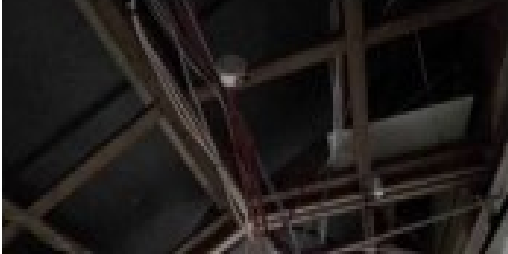
4.	OQ000481	Ceiling forming roof – flat panels	Hallway/Passageway G/003	Very Low Risk
<b>Photo 1: Wide Angle</b>		<b>Photo 2: Close</b>

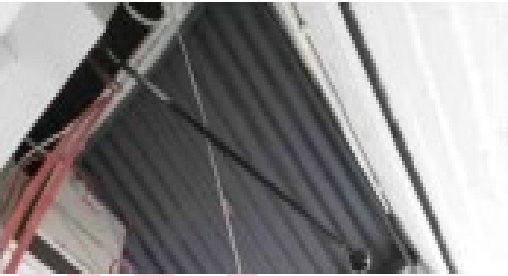
5.	As OQ000481	Ceiling forming roof – corrugates panels	Hallway/Passageway G/003	Very Low Risk
<b>Photo 1: Wide Angle</b>		<b>Photo 2: Close</b>

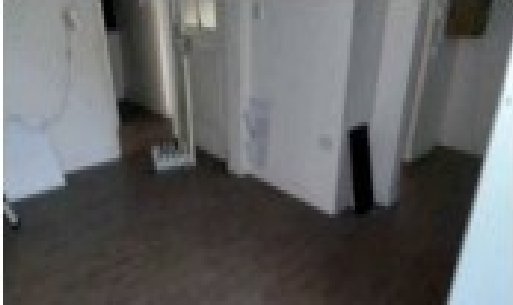
6.	As OQ000485	Floor adhesive remnants under flooring	Room G/004	Very Low Risk
<b>Photo 1: Wide Angle</b>		<b>Photo 2: Close</b>

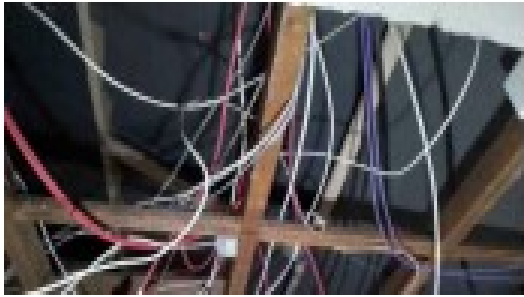
7.	As OQ000481	Ceiling forming roof – flat panels	Room G/004	Very Low Risk
<b>Photo 1: Wide Angle</b>		<b>Photo 2: Close</b>

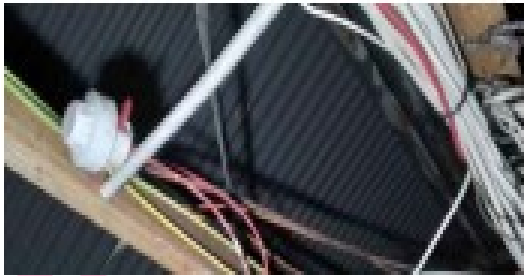
8.	OQ000482	Ceiling forming roof – corrugates panels	Room G/004	Very Low Risk
<b>Photo 1: Wide Angle</b>		<b>Photo 2: Close</b>

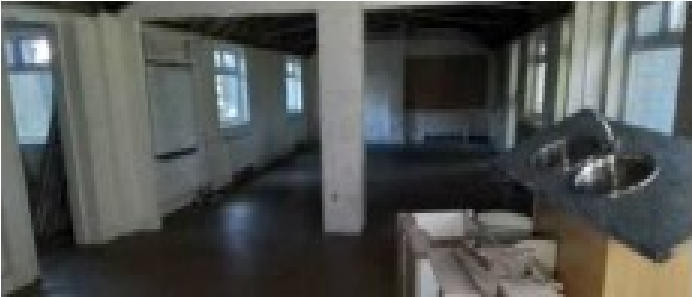
9.	As OQ000485	Floor adhesive remnants under flooring	Main Hall G/007	Very Low Risk
<b>Photo 1: Wide Angle</b>		<b>Photo 2: Close</b>

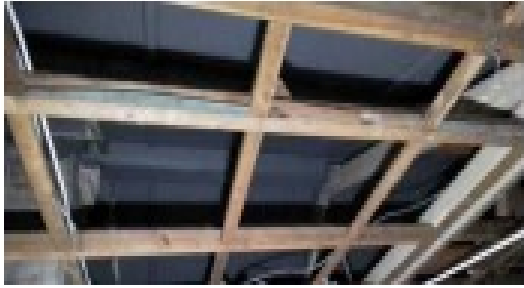
10.	As OQ000481	Ceiling forming roof – flat panels	Main Hall G/007	Very Low Risk
<b>Photo 1: Wide Angle</b>		<b>Photo 2: Close</b>

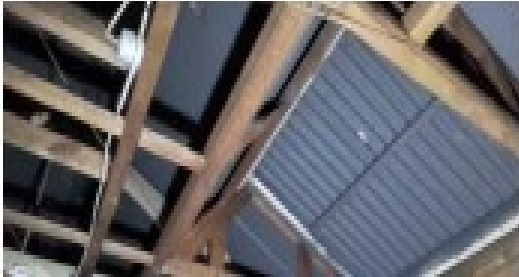
11.	As OQ000482	Ceiling forming roof – corrugates panels	Main Hall G/007	Very Low Risk
<b>Photo 1: Wide Angle</b>		<b>Photo 2: Close</b>

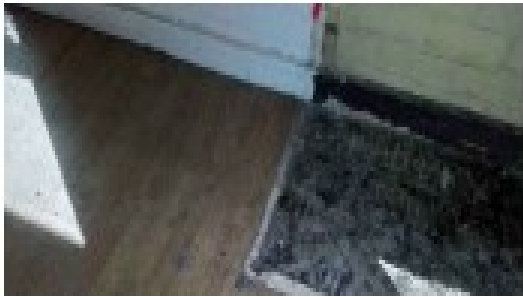
12.	OQ000483	Floor – covering beneath top layer, remnants	Main Hall G/007	Very Low Risk
<b>Photo 1: Wide Angle</b>		<b>Photo 2: Close</b>

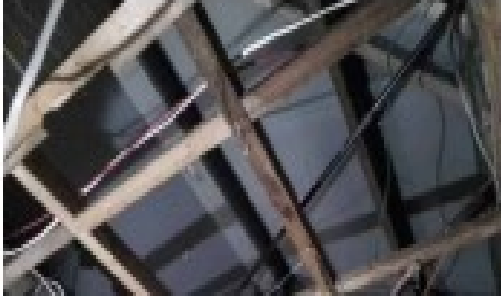
19.	As OQ000481	Ceiling forming roof – flat panels	Store Room G/009	Very Low Risk
<b>Photo 1: Wide Angle</b>		<b>Photo 2: Clo</b>

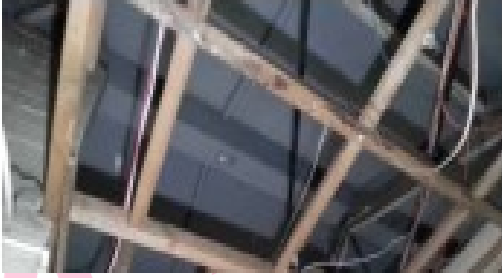
20.	OQ000487	Beam Cladding – protection to apex beams	Store Room G/009	Very Low Risk
<b>Photo 1: Wide Angle</b>		<b>Photo 2: Clos</b>

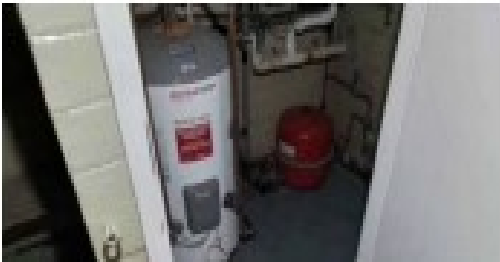
21.	OQ000485	Floor adhesive remnants under flooring	Boiler Room G/010	Very Low Risk
<b>Photo 1: Wide Angle</b>		<b>Photo 2: Close</b>

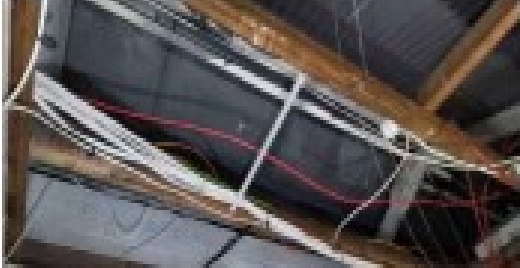
37.	As OQ000481	Ceiling forming roof – flat panels	Kitchen G/027	Very Low Risk
<b>Photo 1: Wide Angle</b>		<b>Photo 2: Clos</b>

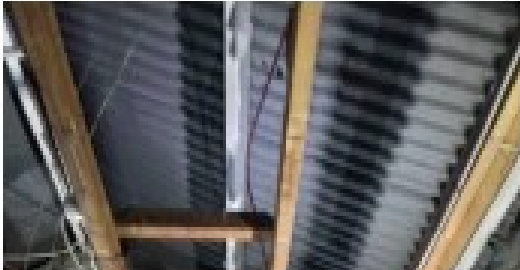
38.	As OQ000482	Ceiling forming roof – corrugates panels	Kitchen G/027	Very Low Risk
<b>Photo 1: Wide Angle</b>		<b>Photo 2: Clos</b>

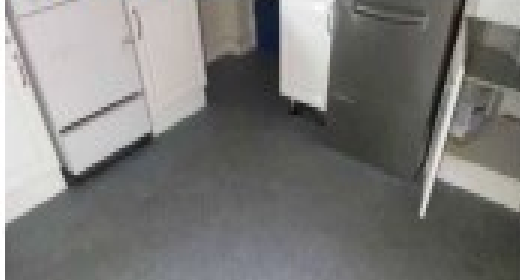
39.	As OQ000485	Floor adhesive remnants under flooring	Kitchen G/027	Very Low Risk
<b>Photo 1: Wide Angle</b>		<b>Photo 2: Clos</b>
