ASBESTOS SURVEY REPORT FOR RYHOPE CA, SUNDERLAND

Asbestos Register for

RYHOPE COMMUNITY ASSOCIATION, SUNDERLAND

Date: 07 July 2025

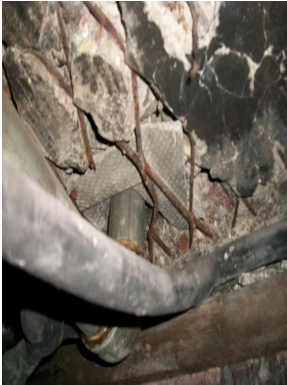
Item 2 - Ref: Sample 10

The packing to pipework in boiler room contains asbestos. Any change in its appearance should be recorded and passed to Property Services.

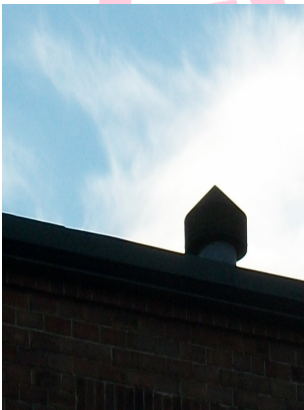
Item 3 - Ref: Presumed

The external roof cowl to the roof is presumed to contain asbestos. Any change in its appearance should be recorded and passed to Property Services.

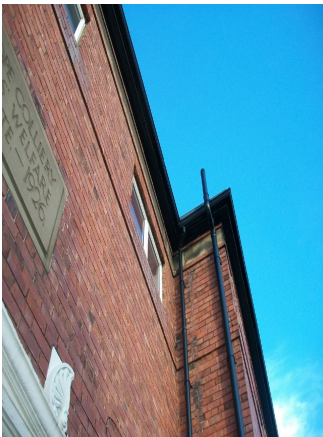
Item 5 - Ref: Presumed

The soffit to the external is presumed to contain asbestos. Any change in its appearance should be recorded and passed to Property Services.

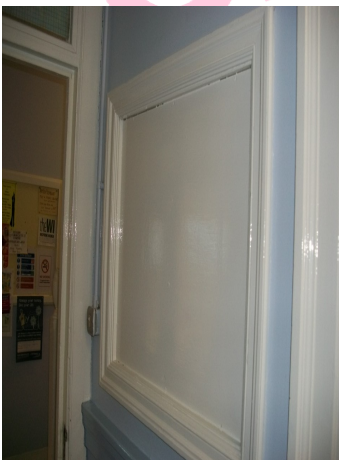
Items 6 & 10- Ref: Sample 2

The wall panel outside the male wc (Rm 004) does not contain asbestos.

Similar wall panel is located outside female wc.

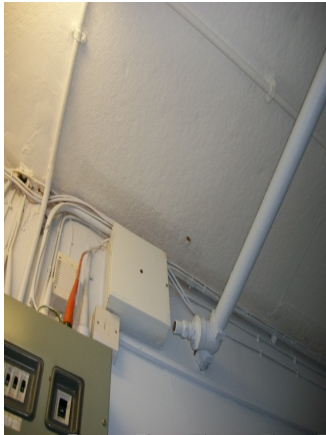
Item 7 - Ref: Sample 03

The ceiling board to room 004 does not contain asbestos.

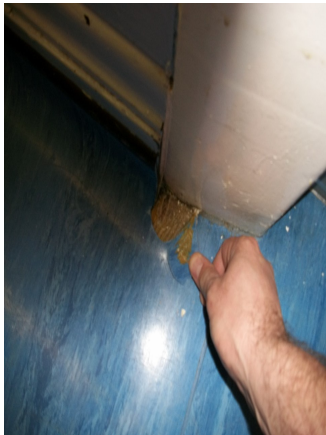
Item 8 & 11 - Ref: Sample 04

The floor covering under the lino in the entrance and corridor (Area 004) does not contain asbestos.

Similar floor covering is located in area 007.

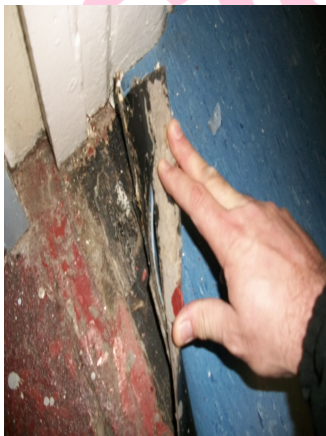
Item 9 - Ref: Sample 01

The vinyl floor tiles to the corridor (Area 005) do not contain asbestos.

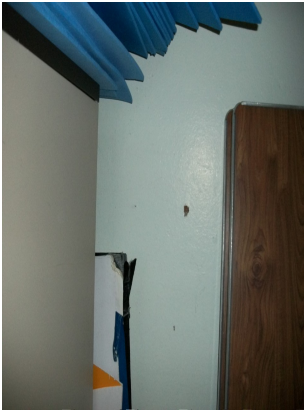
Item 12 - Ref: Sample 05

The board to the rear wall in the cupboard (Area 011) does not contain asbestos.

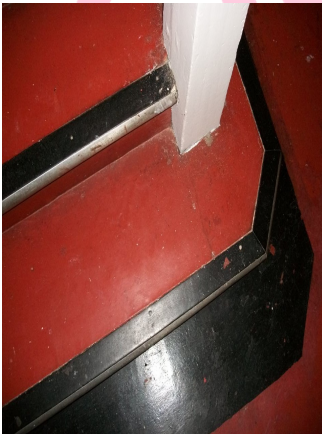
Item 14 - Ref: Sample 07

The stair nosing to the stairs (Area 012) does not contain asbestos.

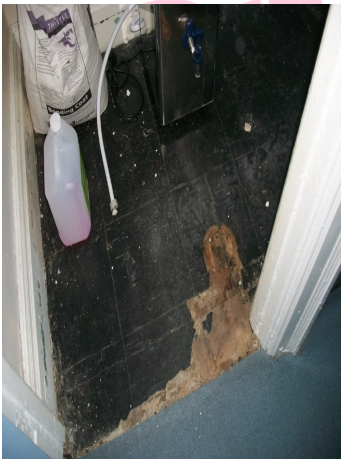
Item 17 - Ref: Sample 13

The floor tiles to the cupboard in the kitchen (Room 004) do not contain asbestos.

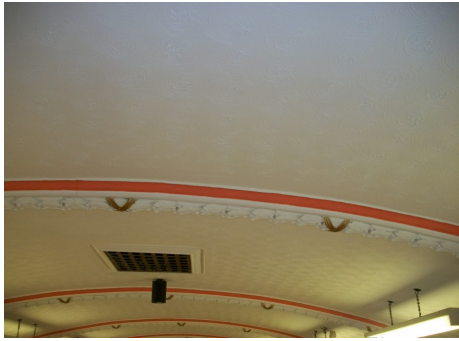
Item 18 - Ref: Sample 14

The dance hall ceiling (Area 005) does not contain asbestos.

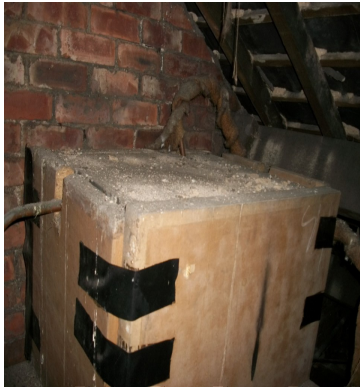
Item 21 - Ref: Sample 15

The water tank insulation in the loft space above the kitchen (Area 009) does not contain asbestos.

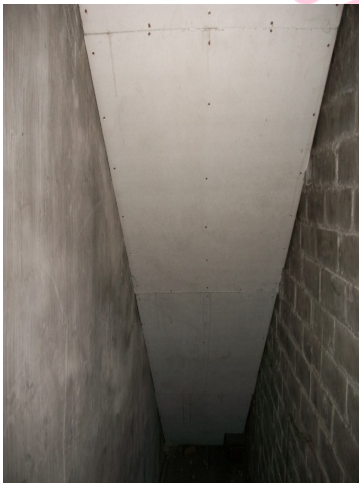
Item 22 - Ref: Sample 11

The board above the stairs in the boiler room (Area 001) does not contain asbestos.

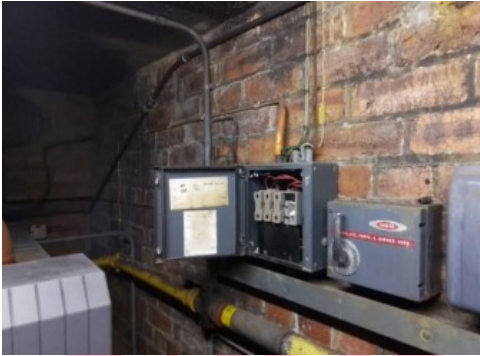
Item 27 Ref: PZ000693

The fuses/flashguards in the Boiler Room (Z1/001) contain asbestos.

Removed 22/11/2023
