### ASBESTOS SURVEY REPORT FOR RYHOPE CA, SUNDERLAND

**Asbestos Register for**

**RYHOPE COMMUNITY ASSOCIATION, SUNDERLAND**

**Date: 03 February 2026**

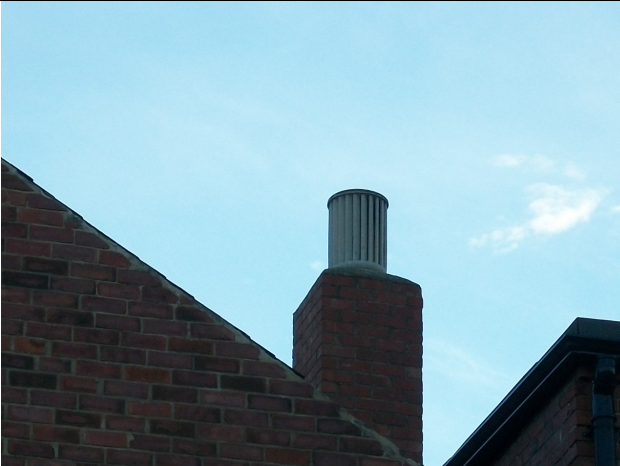
4	Presumed	Cowl	External	Very Low Risk – to be checked on a 12 monthly basis

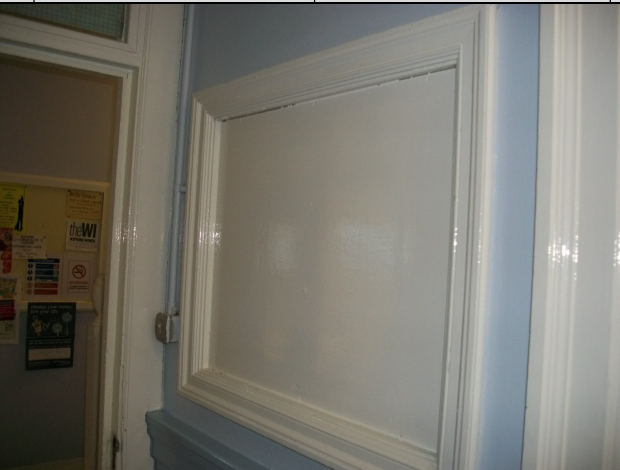
6	Sample 02	Wall panel	Ground Floor/004 Entrance and corridor	No Risk

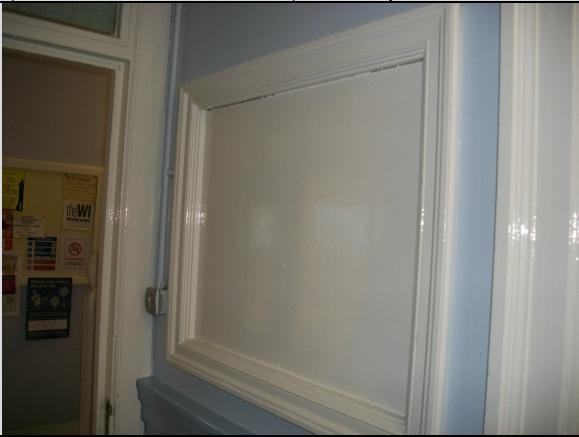
10	As Sample 02	Wall panel	Ground Floor/007 Male and female wc and cupboard	No Risk

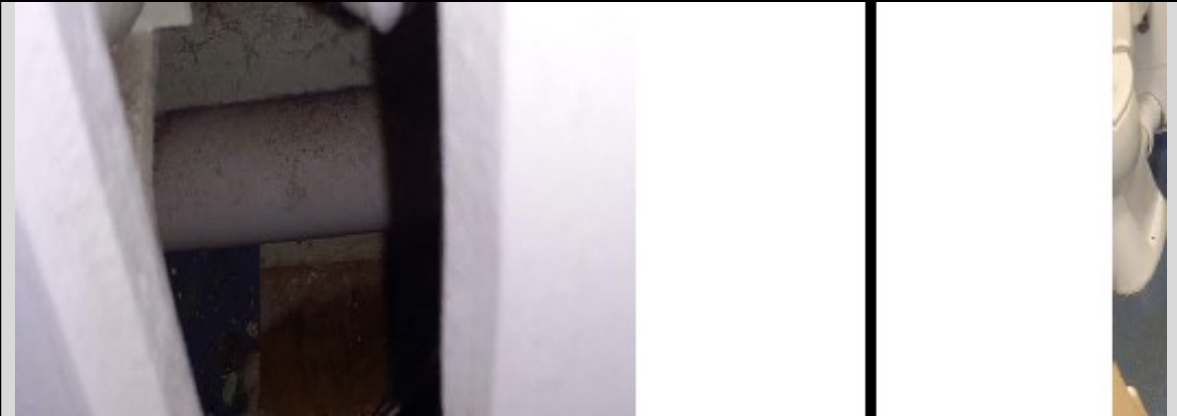
11	As PK003190	Beige floor tiles - Floor below modern lino	WC 0/07 G/10	No Risk

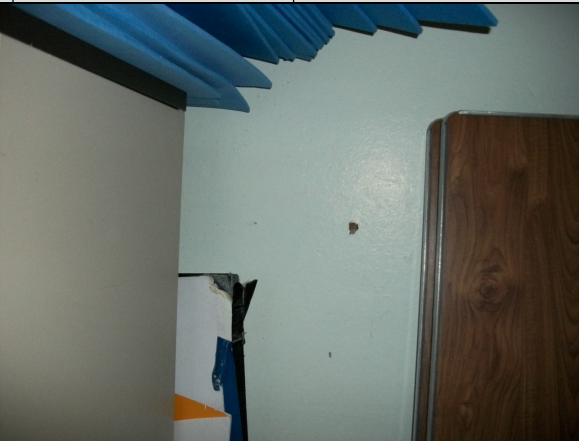
12	Sample 05	Wall board	Ground Floor/011 Hall/ cupboards and kitchen	No Risk

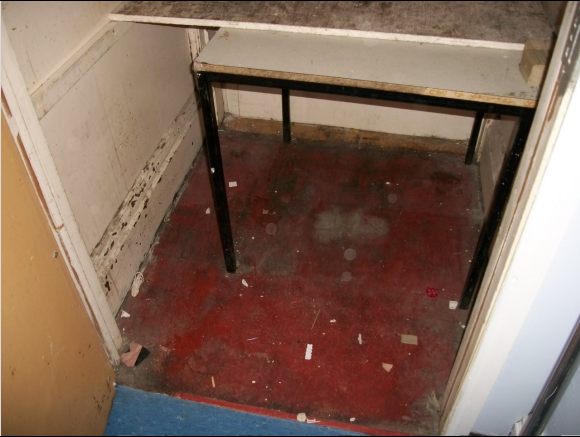
16	Sample 12	Floor covering	First Floor/003 Landing, WC and cupboard	No Risk

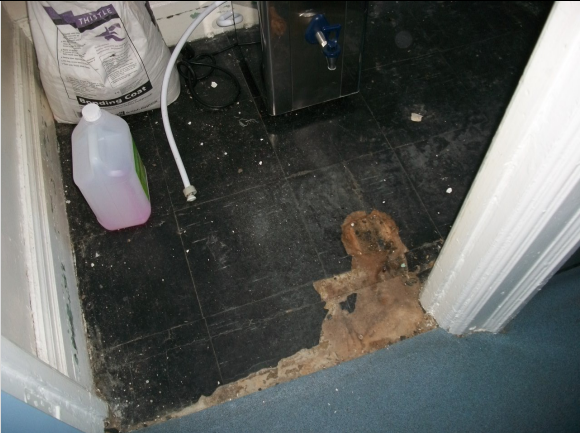
17	Sample 13	Floor tiles	First Floor/004 Kitchen and cupboard	No Risk

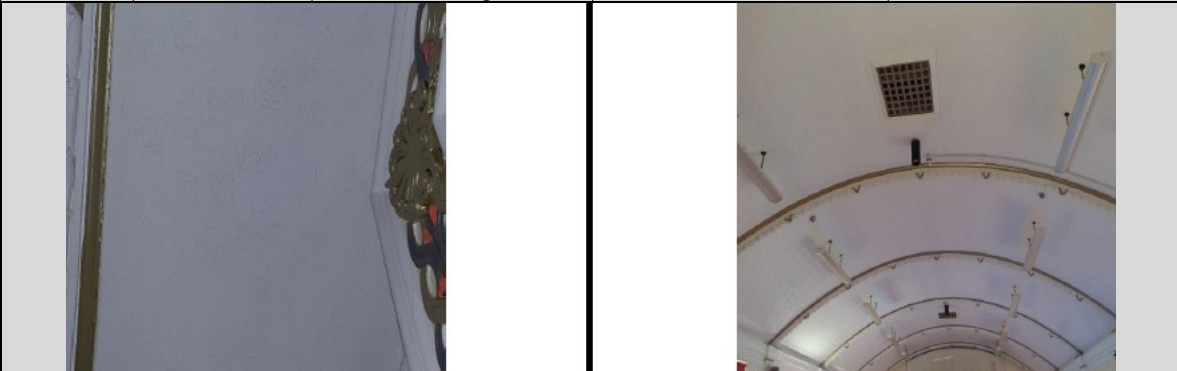
18	PK003194	Textured coating - Curved ceiling	Dance Hall 1/05 1/02	No Risk

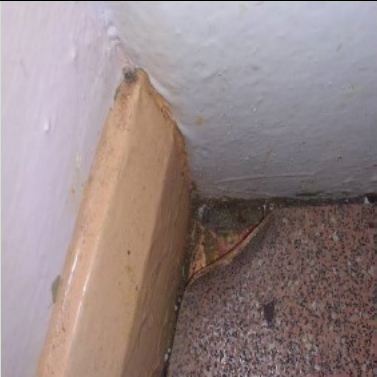
19	PK003196	Red floor covering - Floor below modern lino	WC 1/06 1/03	No Risk

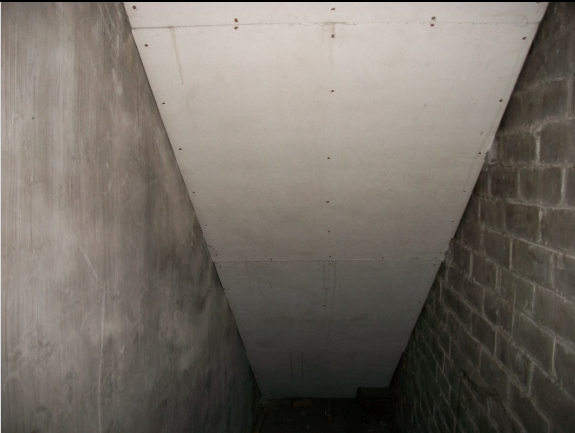
22	Sample 11	Ceiling board	First Basement Level/001 Boiler room	No Risk

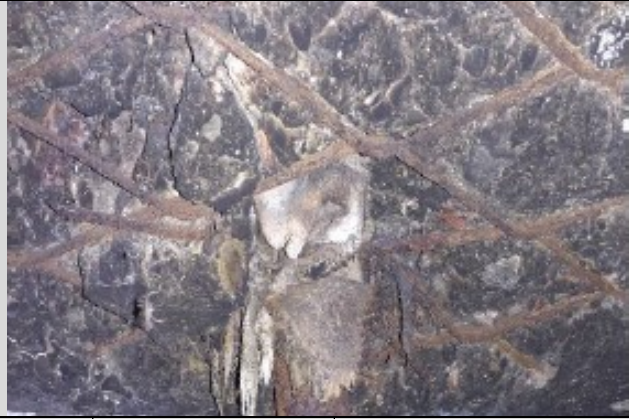
23	PK003199	Rope insulation - Pipework to ceiling penetration	Boiler Room Z1/02	No Risk

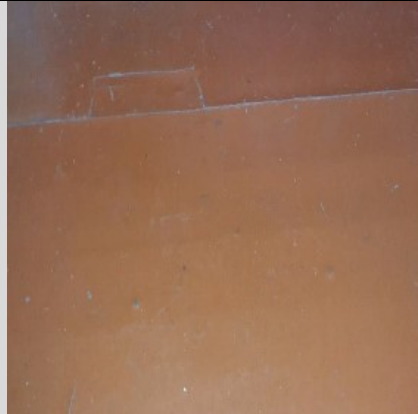
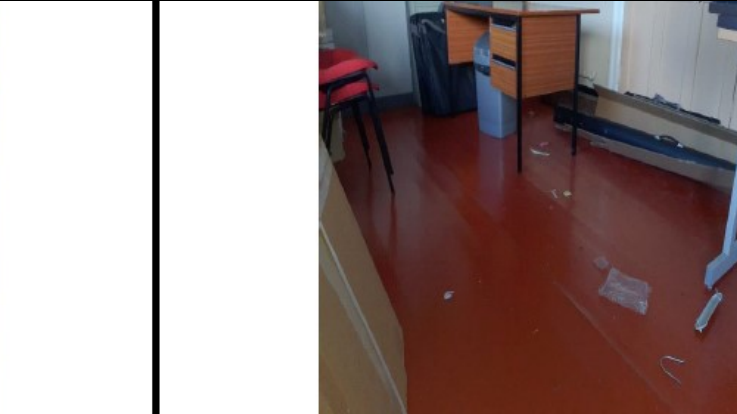
24	As PK003197	Floor covering - Floor	Store 2/01 2/01	No Risk

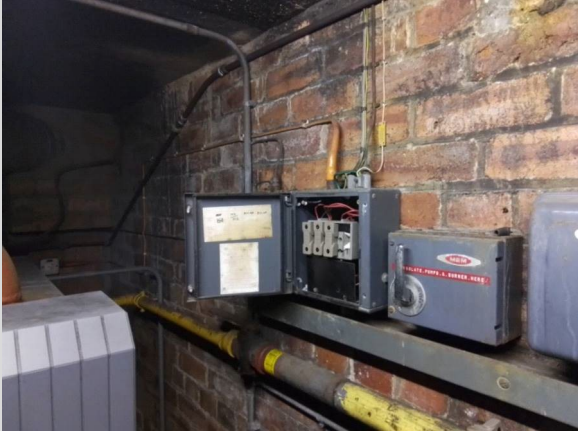
25	222608-1	Coving	Reception lobby	No Risk
<b>No Image Provided</b>				
26	222608-2	Coving	Reception lobby	No Risk
<b>No Image Provided</b>				
27	PZ000693	Electrical services fuses/flashguards	Boiler Room Z1/001	Removed 22.11.23
