ASBESTOS SURVEY REPORT FOR 56a HIGH STREET, SUNDERLAND, SR1 3DP

Asbestos Register for

56a High Street, Sunderland, SR1 3DP

Date: 29 January 2026

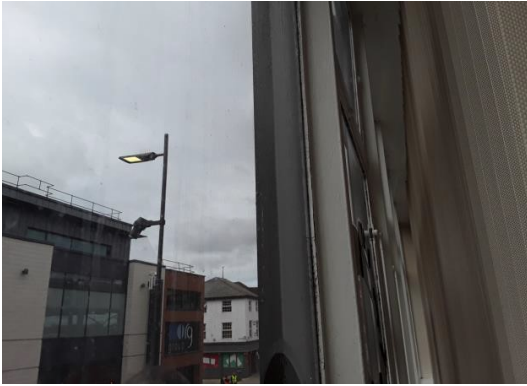
Item 1 Ref: 21-35341-1

The window mastic (Floor 1 Room 3) does not contain asbestos.

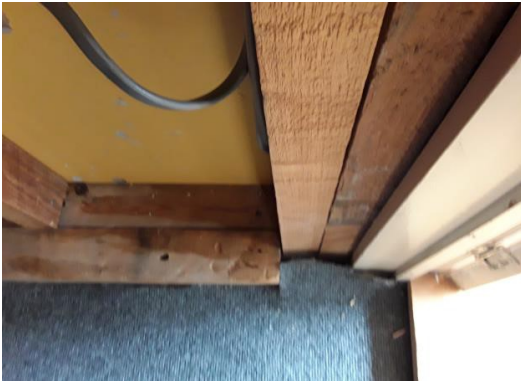
Item 2 Ref: 21-35341-2

The vinyl floor (Floor 1 Room 4) does not contain asbestos.

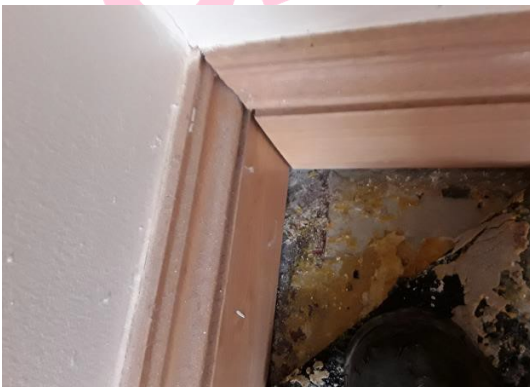
Item 3 Ref: 21-35341-2

The vinyl floor (Floor 1 Room 5) does not contain asbestos.

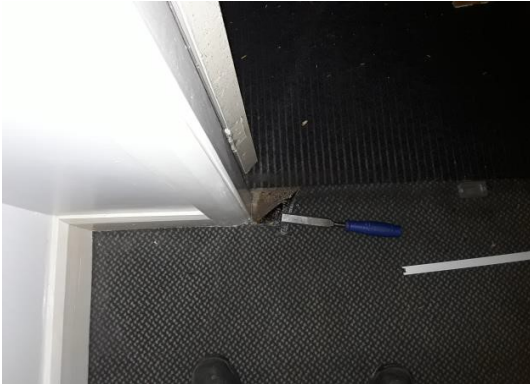
Item 4 Ref: 21-35341-2

The vinyl floor (Floor 1 Room 6) does not contain asbestos.

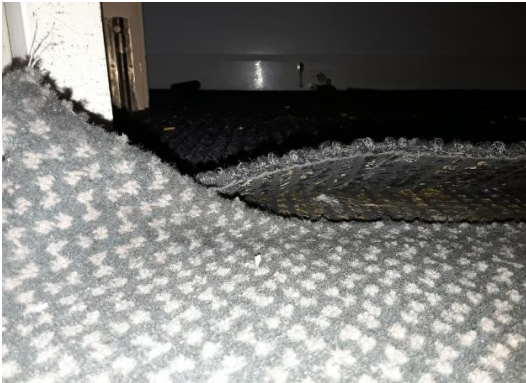
Item 5 Ref: 21-35341-2

The vinyl floor (Floor 1 Room 7) does not contain asbestos.

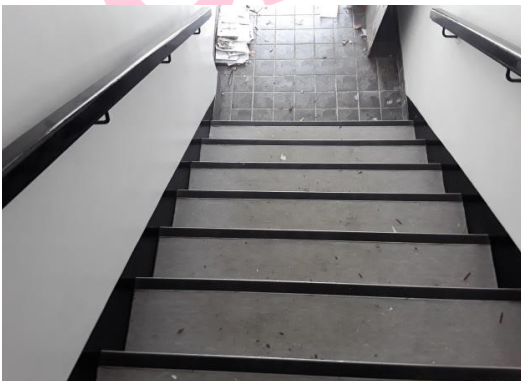
Item 6 Ref: 21-35341-3

The stair nosings (Floor G/1 Room 9) does not contain asbestos.

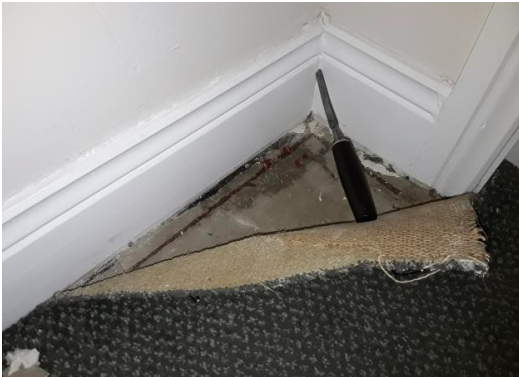
Item 7 Ref: 21-35341-2

The vinyl floor (Floor 1 Room 10) does not contain asbestos.

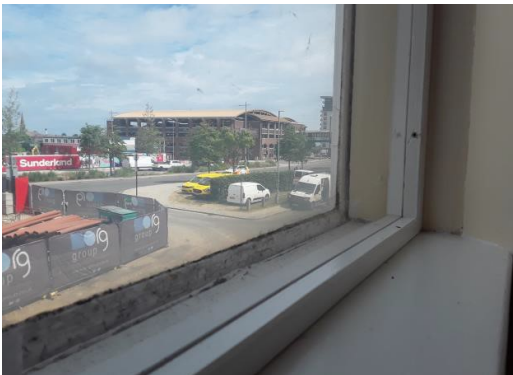
Item 8 Ref: 21-35341-1

The window mastic (Floor 1 Room 16) does not contain asbestos.

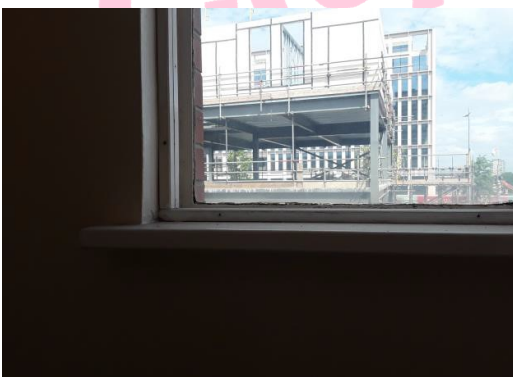
Item 9 Ref: 21-35341-1

The window mastic (Floor 1 Room 17) does not contain asbestos.

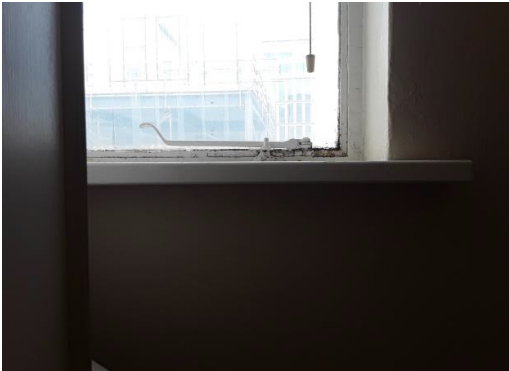
Item 10 Ref: 21-35341-1

The window mastic (Floor 1 Room 18) does not contain asbestos.

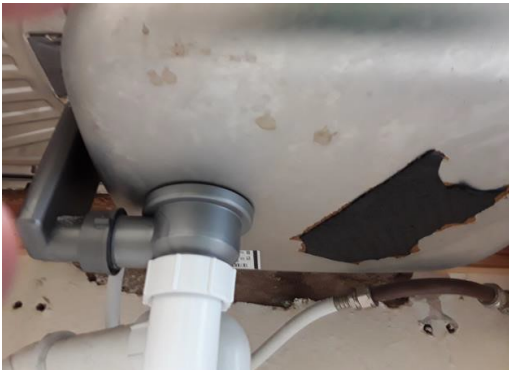
Item 11 Ref: 21-35341-4

The sink pad (Floor 1 Room 18) does not contain asbestos.

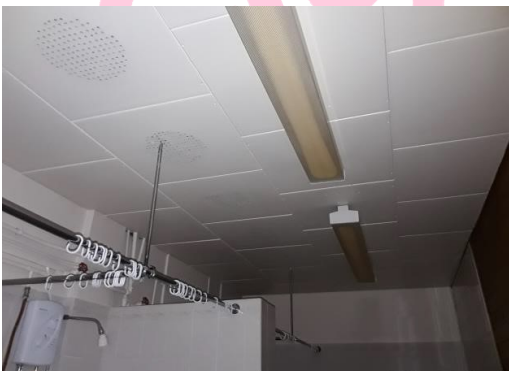
Item 12 Ref: 21-35341-5

The suspended ceiling tiles (Floor 1 Room 19) does not contain asbestos.

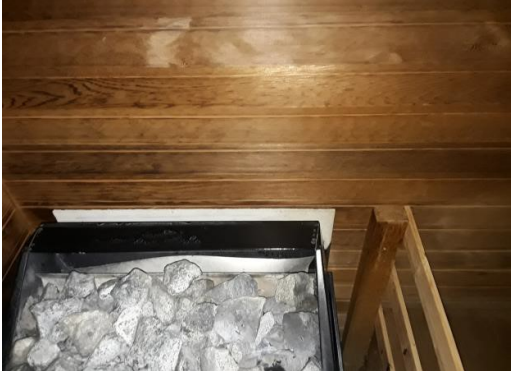
Item 13 Ref: 21-35341-6

- (Item 13) Ref: 21-35341-6 – Board to wall behind hot coals (Floor 1 Room 20) – Low Risk
- (Item 14) Ref: 21-35341-7 – Ceiling (Floor 1 Room 21) – No Risk

The board to wall behind hot coals (Floor 1 Room 20) contains asbestos.

Item 13	Board to wall behind hot coals (Floor 1 Room 20)	Low Risk	6 monthly	27/07/2026
<i>Item 14</i>	<i>No asbestos</i>	<i>Is present</i>		
<i>Item 15</i>	<i>No asbestos</i>	<i>Is present</i>		
<i>Item 16</i>	<i>No asbestos</i>	<i>Is present</i>		
<i>Item 17</i>	<i>No asbestos</i>	<i>Is present</i>

Any change in its appearance should be recorded and passed to Property Services.

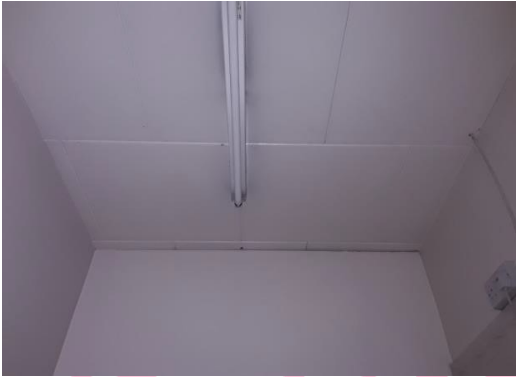
Item 14 Ref: 21-35341-7

The ceiling (Floor 1 Room 21) does not contain asbestos.

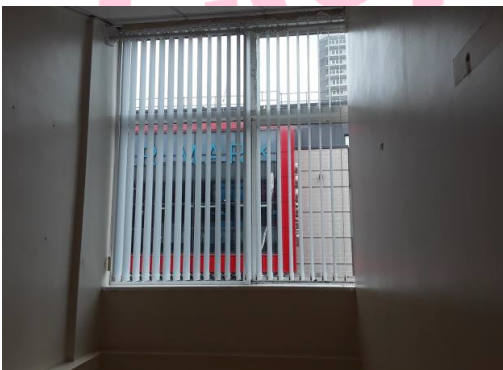
Item 15 Ref: 21-35341-1

The window mastic (Floor 1 Room 25) does not contain asbestos.

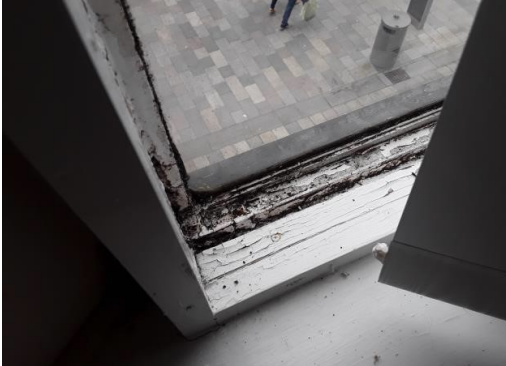
Item 16 Ref: 21-35341-1

The window mastic (Floor 1 Room 26) does not contain asbestos.

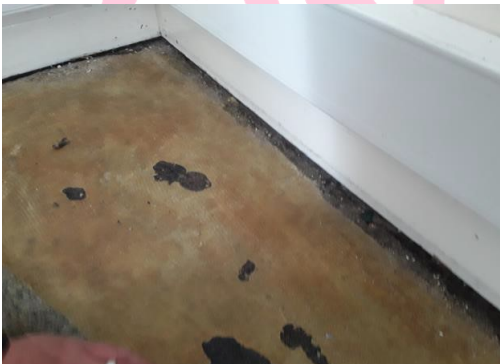
Item 18 Ref: 21-35341-8

- (Item 18) Ref: 21-35341-8 – Residual adhesive to floor (Floor 2 Room 28) – Very Low Risk
- (Item 19) Ref: 21-35341-1 – Window mastic (Floor 2 Room 30) – No Risk

The residual adhesive to floor (Floor 2 Room 28) contains asbestos.

Item 18	Residual adhesive to floor (Floor 2 Room 28)	Very Low Risk	12 monthly	27/7/2026
<i>Item 19</i>	<i>No asbestos</i>	<i>Is present</i>		
Item 20	Floor (Floor 2 Room 30)	Very Low Risk	12 monthly	27/7/2026
<i>Item 21</i>	<i>No asbestos</i>	<i>Is present</i>		
<i>Item 22</i>	<i>No asbestos</i>	<i>Is present</i>

Any change in its appearance should be recorded and passed to Property Services.

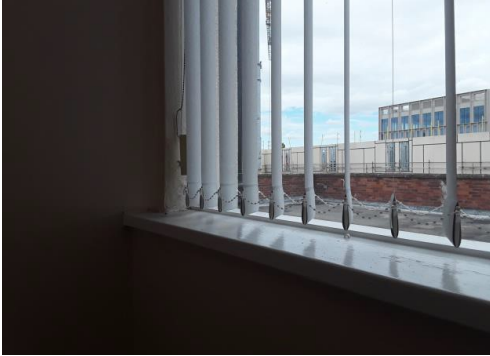
Item 19 Ref: 21-35341-1

The window mastic (Floor 2 Room 30) does not contain asbestos.

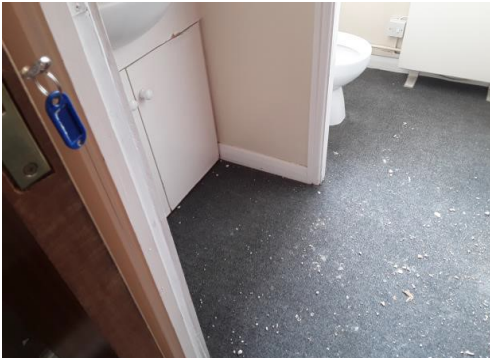
Item 20 Ref: 21-35341-8

- (Item 20) Ref: 21-35341-8 – Floor (Floor 2 Room 30) – Very Low Risk
- (Item 21) Ref: 21-35341-10 – Felt to rear walkway on roof (External) – No Risk
- (Item 22) Ref: 21-35341-11 – Downpipes (External) – No Risk

The floor (Floor 2 Room 30) contains asbestos.

Any change in its appearance should be recorded and passed to Property Services.

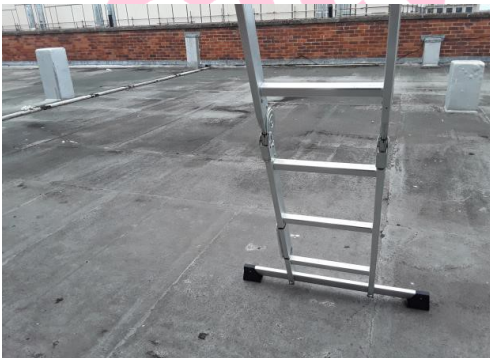
Item 21 Ref: 21-35341-10

The felt to rear walkway on roof (External) does not contain asbestos.

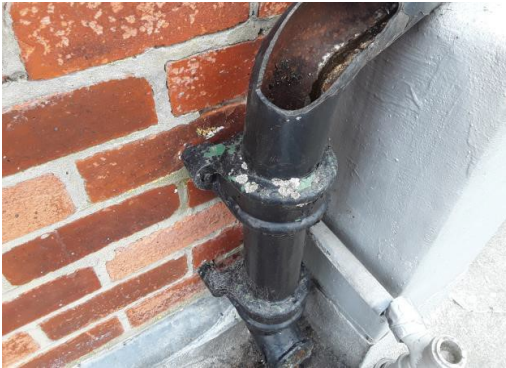
Item 22 Ref: 21-35341-11

The downpipes (External) do not contain asbestos.

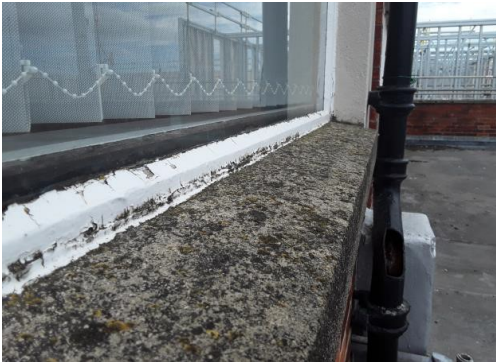
Item 23 Ref: 21-35341-12

- (Item 23) Ref: 21-35341-12 – Window frame sealant (External) – Very Low Risk
- (Item 24) Ref: 21-35341-13 – Flashing to roof floor (External) – No Risk

The window frame sealant (External) contains asbestos.

Item 23	Window frame sealant (External)	Very Low Risk	12 monthly	27/7/2026
<i>Item 24</i>	<i>No asbestos</i>	<i>Is present</i>		
<i>Item 25</i>	<i>No asbestos</i>	<i>Is present</i>		
<i>Item 26</i>	<i>No asbestos</i>	<i>Is present</i>

Any change in its appearance should be recorded and passed to Property Services.

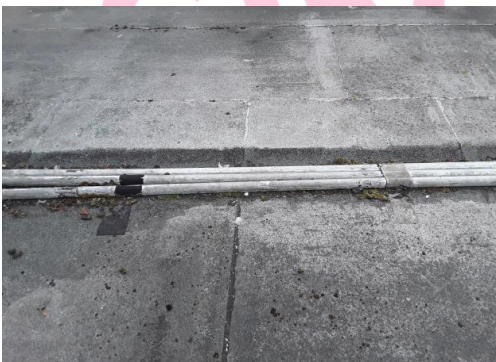
Item 24 Ref: 21-35341-13

The flashing to roof floor (External) does not contain asbestos.

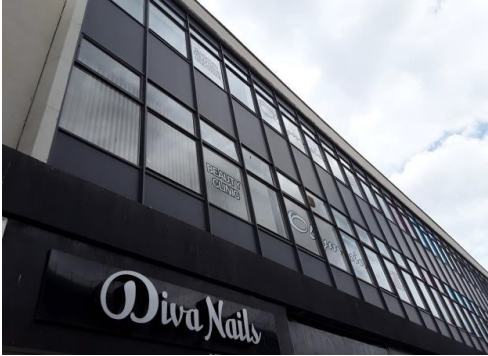
Item 24 Ref: 21-35341-14

The infill panel (External) does not contain asbestos.

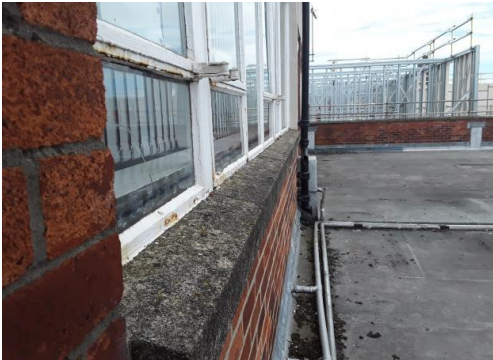
Item 25 Ref: 21-35341-9

The window putty (External) does not contain asbestos.
