ASBESTOS SURVEY REPORT FOR BISHOPWEARMOUTH CEMETERY LODGES, SUNDERLAND

Asbestos Register for Bishopwearmouth Cemetery Lodges

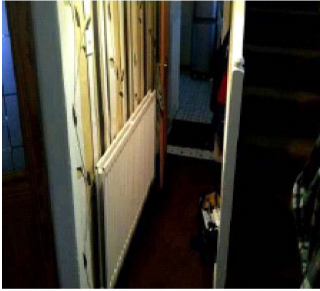
Item 1: Ref: EA003486

The floor screed to the hall (Room 1) does not contain asbestos.

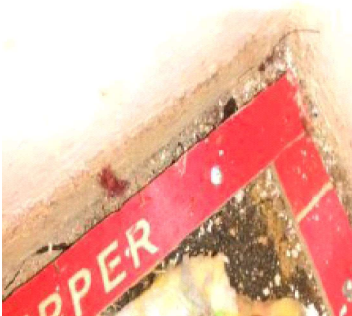
Item 2: As EA003486

The floor screed to the lounge (Room 2) does not contain asbestos.

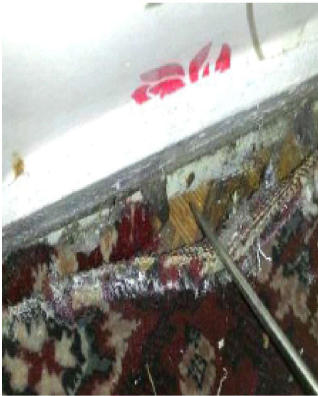
Item 3 – As EA003486

The floor screed to the dining room (Room 6) does not contain asbestos.

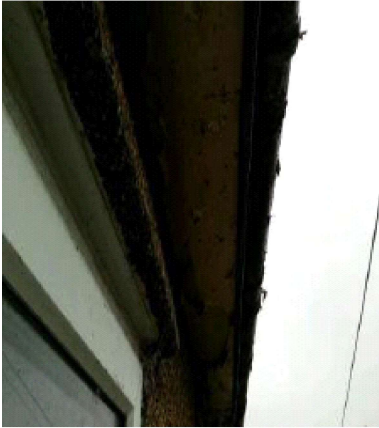
Item 4 – Presumed

The soffits to the external were presumed to contain asbestos.

These were removed in October 2015.

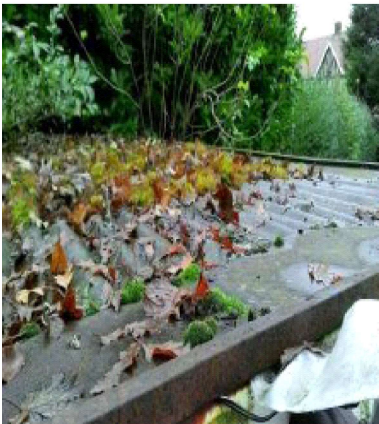
Item 5 Ref: EA003487

The garage roof sheets to the external garage contain asbestos.

Any change in its appearance should be noted and passed to Property Services.

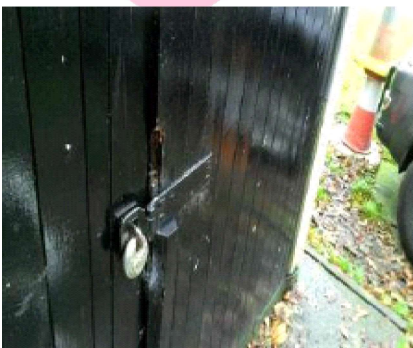
There was no access to the garage as it was locked. Therefore further investigation may be required.

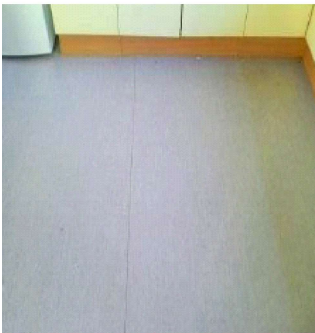
Item 6 Ref: EY000576

The lino to the kitchen (Room 2) does not contain asbestos.

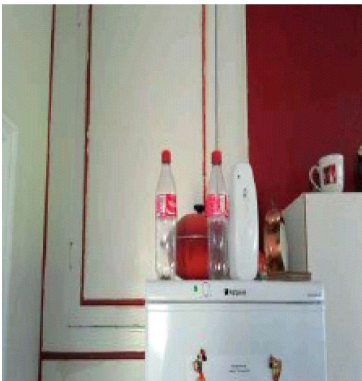
There was no access into the cupboards in the kitchen (Room 2) due to the fridge. Therefore further investigation may be required.

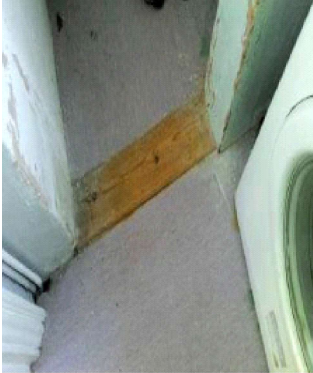
Item 7 As:EY000576

The lino to the kitchen cupboard (Room 3) does not contain asbestos.

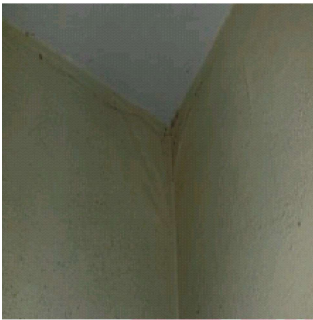
Item 8 – Ref: EY000577

The textured coating to the walls and ceiling in the store room (Room 4) does not contain asbestos.

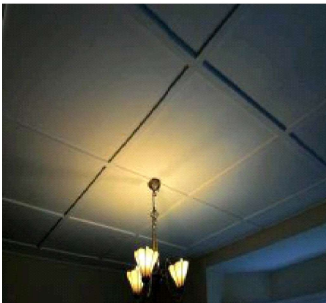
Item 9 – Ref: EY000578

The ceiling to the lounge (Room 5) does not contain asbestos.

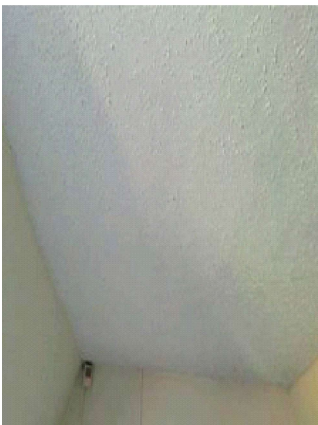
Item 10 – Ref: EY000575

The textured coating to the ceiling in bedroom 2 (Room 2) on the first floor does not contain asbestos.

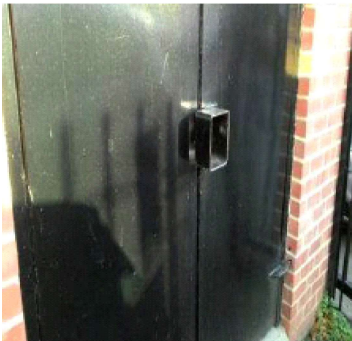
There was no access to the side store. Therefore further investigation may be required.

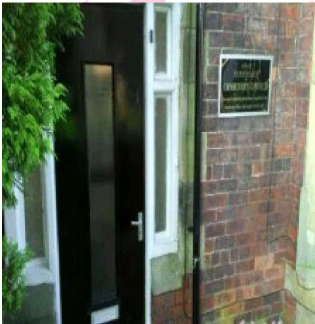
There was no access to the side cemetery office. Therefore further investigation may be required.

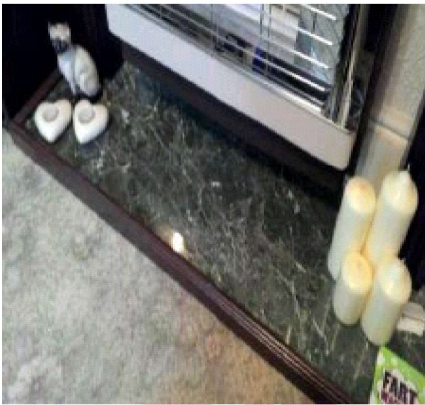
Item 11 – Ref: EA003478

The panel to the underside of the fireplace hearth in the lounge (Room 2) does not contain asbestos.

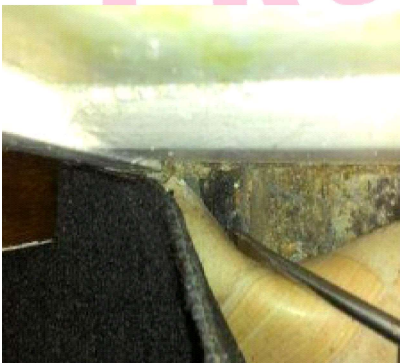
Item 12 – Ref: EA003479

The blue floor tiles to the bathroom (Room 6) contain asbestos.

Item 11	No asbestos	Is present		
Item 12	Floor tiles – Room 6	Very Low	12 monthly	03.01.27
Item 13	Adhesive to floor tiles - Room 6	Very Low	12 monthly	03.01.27

Any change in its appearance should be noted and passed to Property Services.

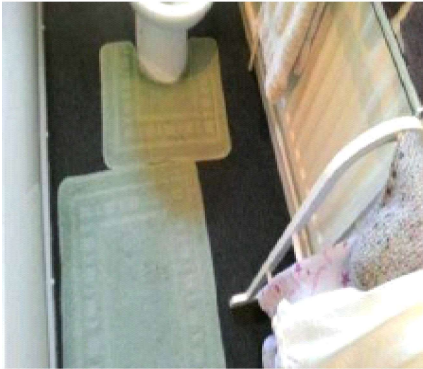
Item 13 – Ref: EA003480

The bitumen adhesive beneath the floor tiles in the bathroom (Room 6) contains asbestos.

Any change in its appearance should be noted and passed to Property Services.

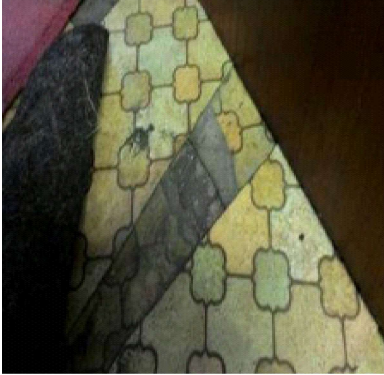
Item 14 As EA003479

The blue floor tiles in the kitchen (Room 9) contain asbestos.

Item 14	Floor tiles - Room 9	Very Low	12 monthly	03.01.27
Item 15	Adhesive to floor tiles – Room 9	Very Low	12 monthly	03.01.27
Item 16	No asbestos	Is present

Any change in its appearance should be noted and passed to Property Services.

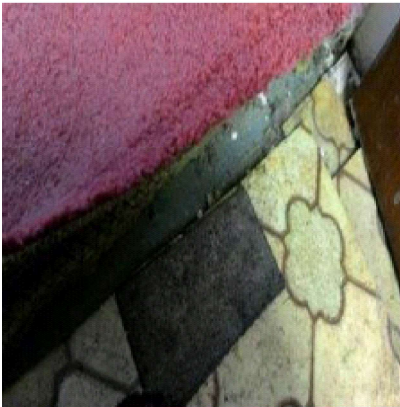
Item 15 As EA003480

The bitumen adhesive beneath the floor tiles in the kitchen (Room 9) contains asbestos.

Any change in its appearance should be noted and passed to Property Services.

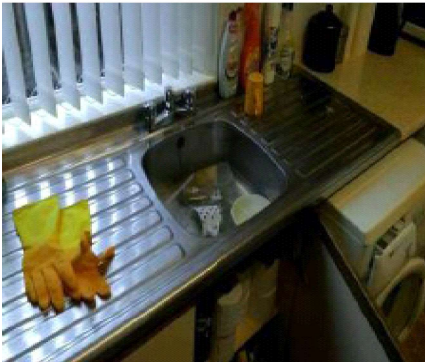
Item 16 Ref: EA003481

The sink pads to the drainer in the kitchen (Room 9) do not contain asbestos.

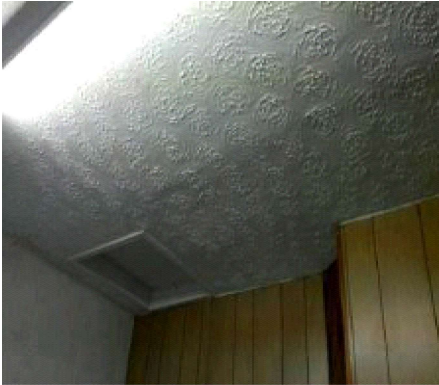
Item 17 Ref: EA003482

The textured coating to the ceiling in the kitchen (Room 9) contains asbestos.

Item 17	Textured coating to ceiling - Room 9	Low	6 monthly	03.07.26
Item 18	No asbestos	Is present		
Item 19	No asbestos	Is present		
Item 20	No asbestos	Is present

Any change in its appearance should be noted and passed to Property Services.

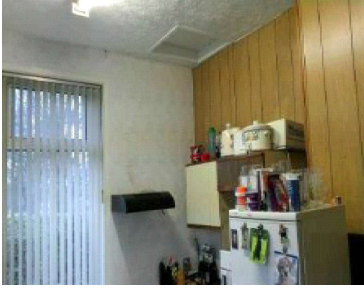
The roof void (Room 1) was inaccessible due to the hatch being above cupboards and cooker hood.

Therefore further investigation may be required.

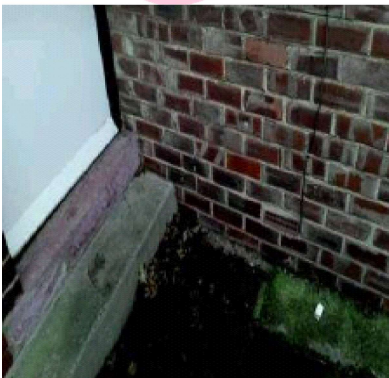
Item 18 Ref: EA003483

The damp proof course to the extension (external) does not contain asbestos.

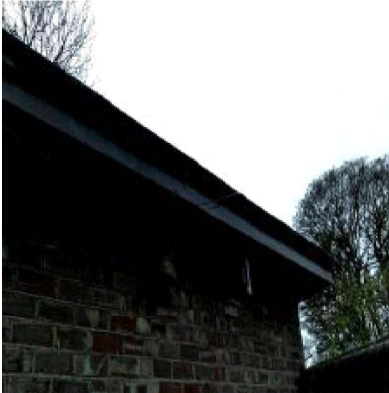
Item 19 Ref: EA003484

The bitumen to the flat roof (external) does not contain asbestos.

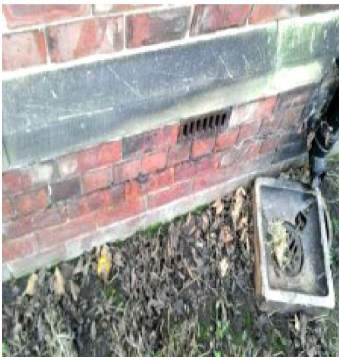
Item 20 Ref: EA003485

The damp proof course (external) to the main building does not contain asbestos.

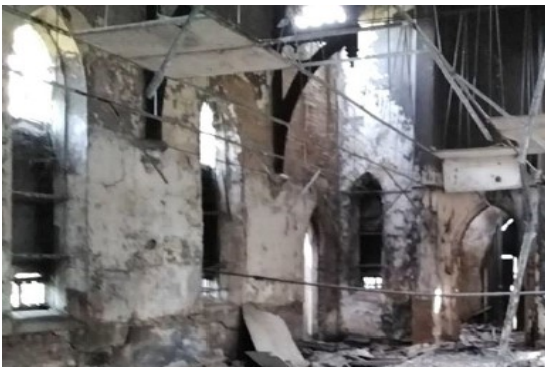
Item 21 Ref: SC005440

The ceiling tile, solid debris to floor and some still suspended in the chapel does not contain asbestos.

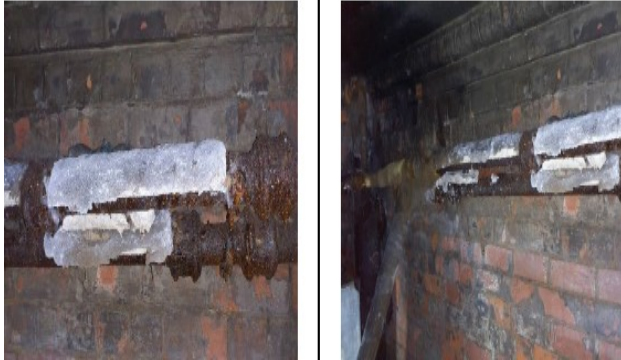
Item 23 Ref: PK003725

The lagging pipework in the basement (Z1/01) does contain asbestos.

South Chapel				
<i>Item 21</i>	<i>No asbestos</i>	<i>Is present</i>		
Item 23	Lagging pipework (Basement Z1/01)	Low Risk	6 monthly	Poor condition remove asap
Item 24	Lagging debris to floor (Basement Z1/01)	Low Risk	6 monthly	Poor condition remove asap
Item 25	Residue to rear wall (Basement Z1/01)	Low Risk	6 monthly	Poor condition remove asap
<i>Item 26</i>	<i>No asbestos</i>	<i>Is present</i>		
<i>Item 27</i>	<i>No asbestos</i>	<i>Is present</i>		
<i>Item 28</i>	<i>No asbestos</i>	<i>Is present</i>		
<i>Item 29</i>	<i>No asbestos</i>	<i>Is present</i>		
<i>Item 30</i>	<i>No asbestos</i>	<i>Is present</i>		
North Chapel				
<i>Item 21</i>	<i>No asbestos</i>	<i>Is present</i>

Any change in appearance should be reported to Property Services.

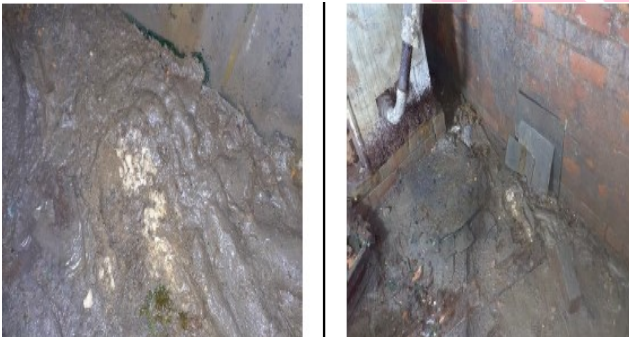
Item 24 Ref: PK003726

The lagging debris to the floor in the basement (Z1/01) does contain asbestos.

Any change in appearance should be reported to Property Services.

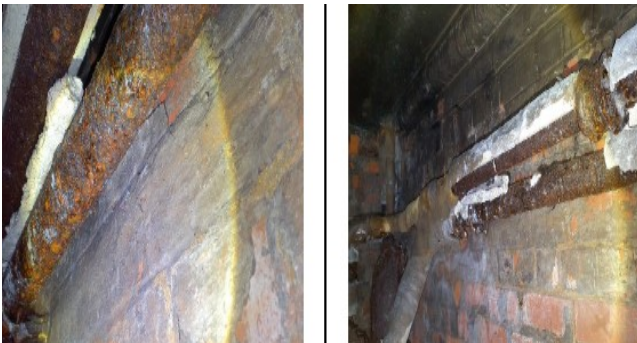
Item 25 Ref: PK003727

The residue to the rear wall in the basement (Z1/01) does contain asbestos.

Any change in appearance should be reported to Property Services.

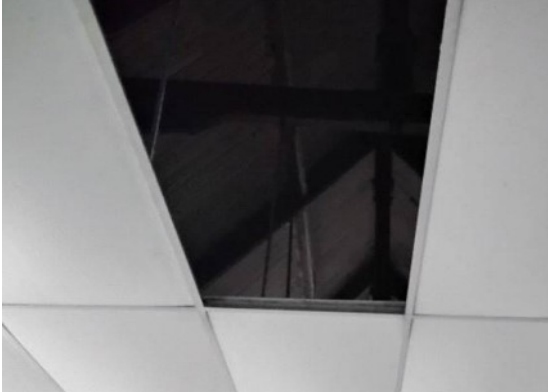
Item 22 Ref: DC003178

The ceiling tile, solid debris to floor and some still suspended in the chapel does not contain asbestos.
