ASBESTOS SURVEY REPORT FOR 19 VILLIERS STREET, SUNDERLAND
SR1 1EJ

Asbestos Register for

19 Villiers Street, Sunderland SR1 1EJ

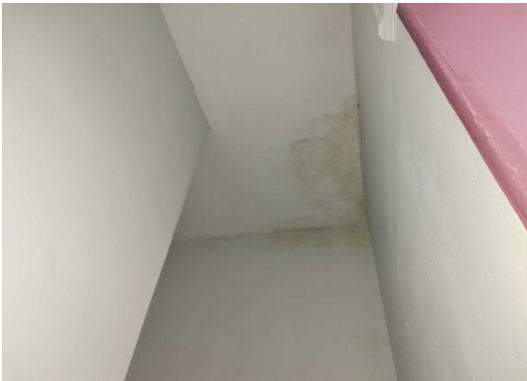
Item 1 Ref: Presumed

The ceiling (Textured Coating), Area: 1 (Landing and Stairs) is presumed to contain asbestos.

Any change in its appearance should be recorded and passed to Property Services.

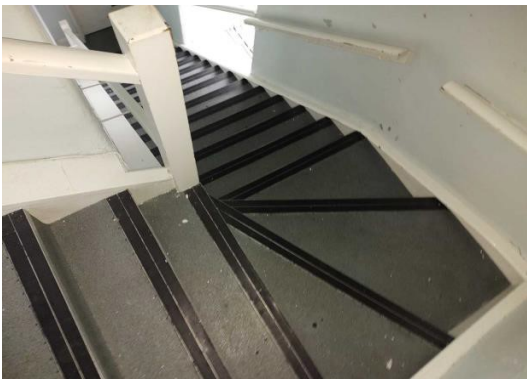
Item 2 Ref: 22-55202-2

The floor – stair nosing, Area: 1 (Landing and Stairs) does not contain asbestos.

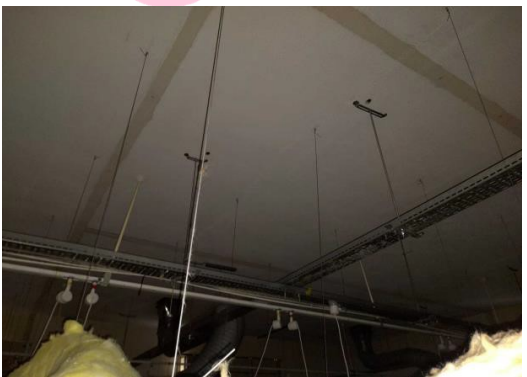
Item 3 Ref: Presumed

The ceiling (Textured Coating), Area: 2 (Common ceiling void) is presumed to contain asbestos.

Any change in its appearance should be recorded and passed to Property Services.

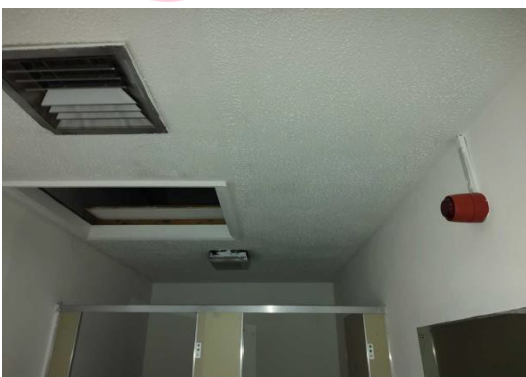
Item 6 Ref: 22-55202-6

The ceiling (Textured Coating), Area: 8 (Female wc & lobby) does not contain asbestos.

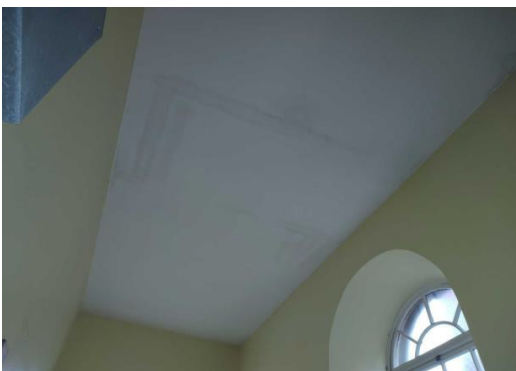
Item 9 Ref: 22-55202-6

The ceiling (Textured Coating), Area: 16 (Fire exit stairwell) does not contain asbestos.

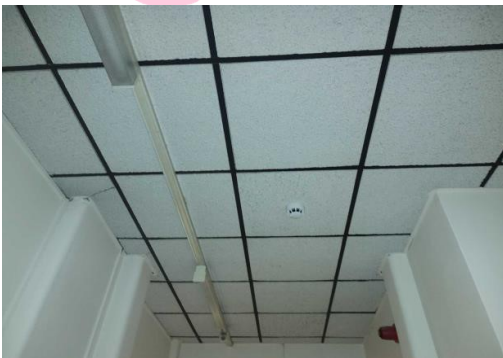
Item 12 Ref: 22-55202-9

The ceiling - suspended ceiling tiles, Area: 19 (Corridor) do not contain asbestos.

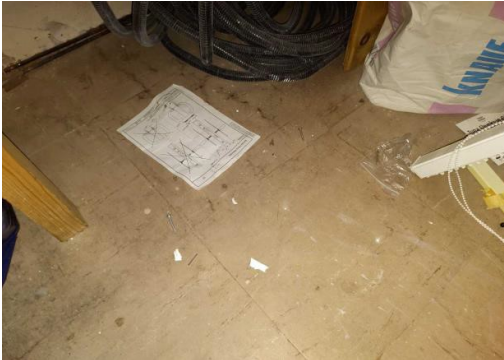
Item 13 Ref: 22-55202-10

The floor (Tiles & Adhesive), Area: 21 (Cupboard - Understairs) does not contain asbestos.

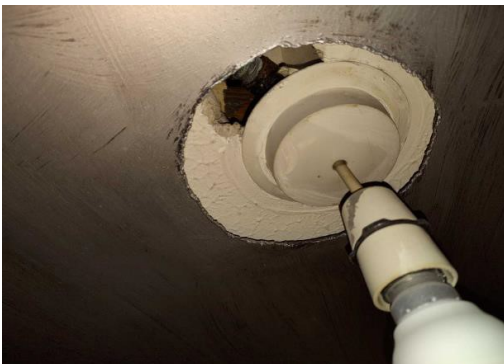
Item 14 Ref: 22-55202-8

The ceiling (Textured Coating), Area: 21 (Cupboard - Understairs) does not contain asbestos.

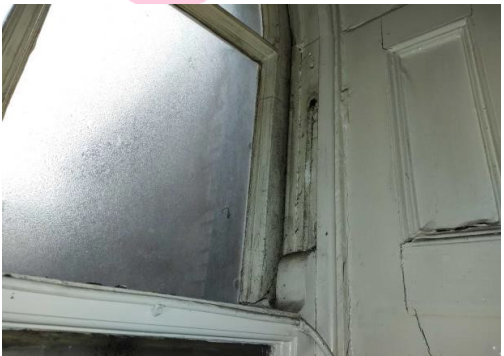
Item 15 Ref: 22-55202-11

The window - sash window cords, Area: 23 (Side lobby) does not contain asbestos.

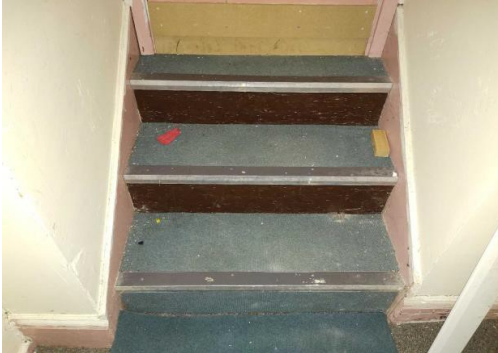
Item 16 Ref: 22-55202-12

The floor - stair nosing strips, Area: 23 (Side lobby) does not contain asbestos.

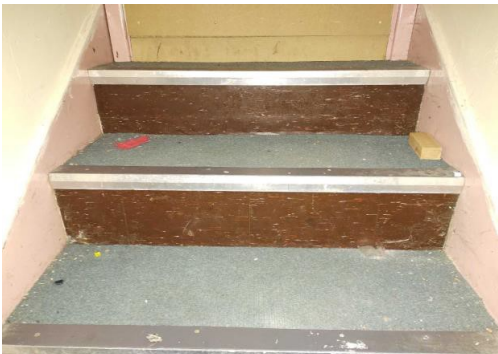
Item 17 Ref: 22-55202-13

The floor to stairs (Tiles & Adhesive), Area: 23 (Side lobby) does not contain asbestos.

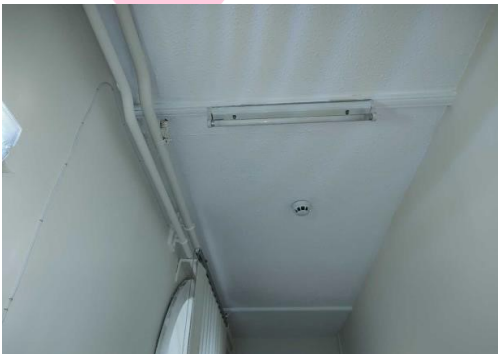
Item 18 Ref: 22-55202-8

The ceiling (Textured Coating), Area: 23 (Side lobby) does not contain asbestos.

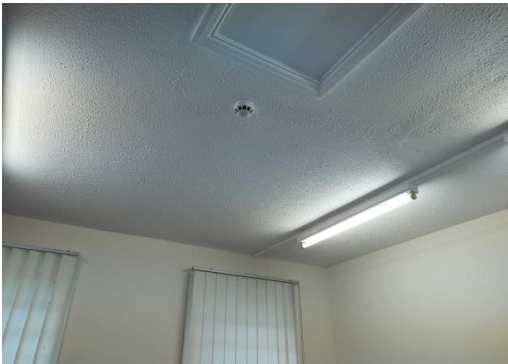
Item 20 Ref: 22-55202-8

The ceiling (Textured Coating), Area: 25 (Music office) does not contain asbestos.

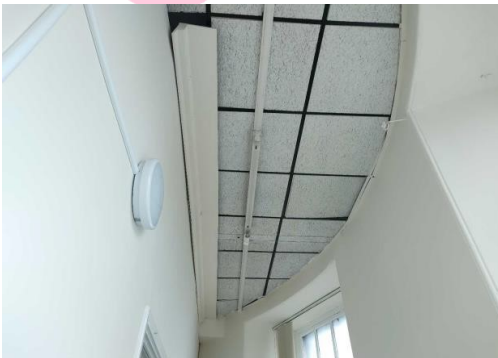
Item 21 Ref: 22-55202-9

The ceiling - suspended ceiling tiles, Area: 27 (Storage area) does not contain asbestos.

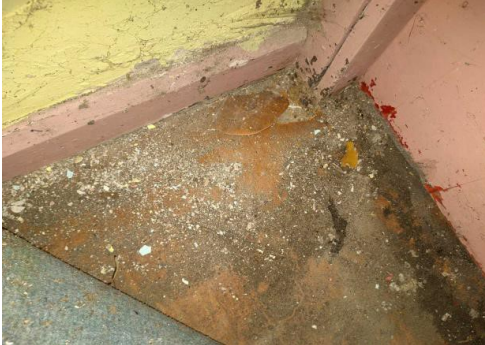
Item 22 Ref: 22-55202-14

The floor (Vinyl), Area: 28 (Rear corridor) does not contain asbestos.

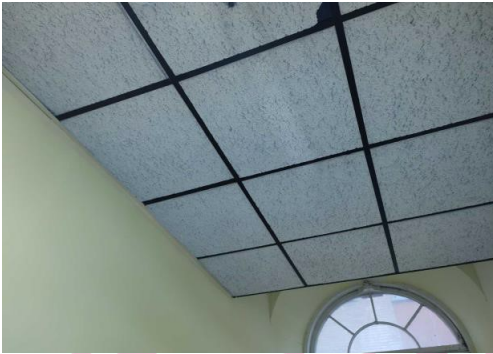
Item 23 Ref: 22-55202-9

The ceiling - suspended ceiling tiles, Area: 28 (Rear corridor) does not contain asbestos.

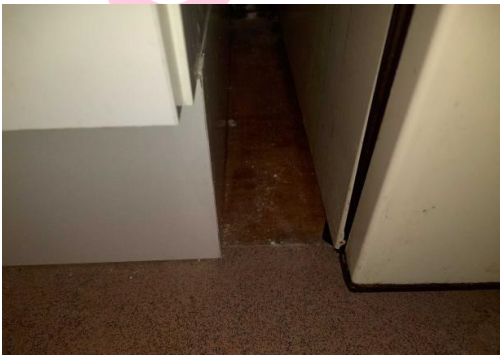
Item 24 Ref: 22-55202-14

The floor - beneath modern vinyl, Area: 29 (Kitchen) does not contain asbestos.

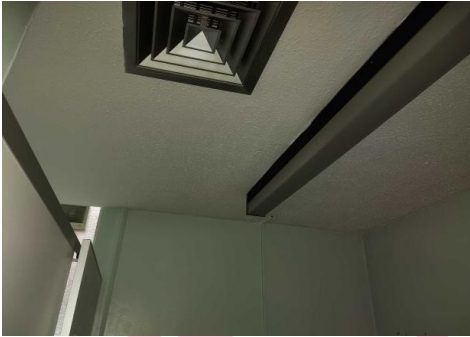
Item 26 Ref: 22-55202-15

The ceiling (Textured Coating), Area: 30 (Female wc/ baby change & lobby) does not contain asbestos.

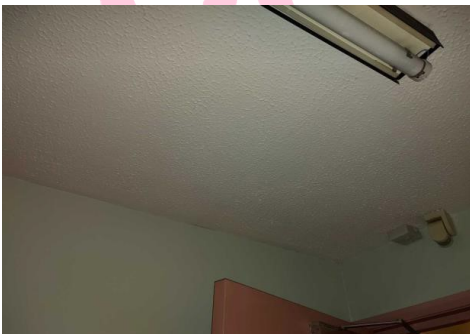
Item 27 Ref: 22-55202-15

The ceiling (Textured Coating), Area: 31 (Male wc & lobby) does not contain asbestos.

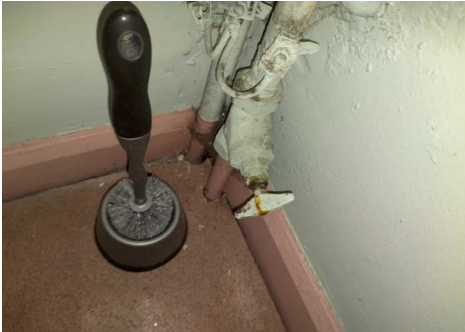
Item 28 Ref: 22-55202-5

The pipes - gasket to stop tap, Area: 31 (Male wc & lobby) does not contain asbestos.

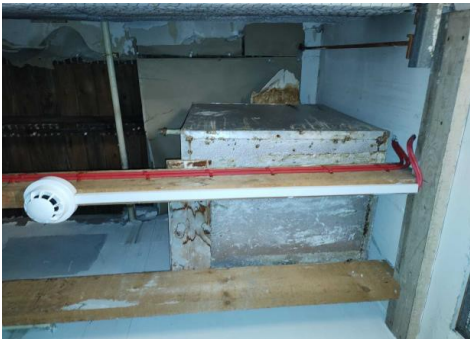
Item 29 Ref: Presumed

The Vessels - Gasket to redundant tank flange, Area: 33 (Boiler cupboard) are presumed to contain asbestos.

Any change in its appearance should be recorded and passed to Property Services.

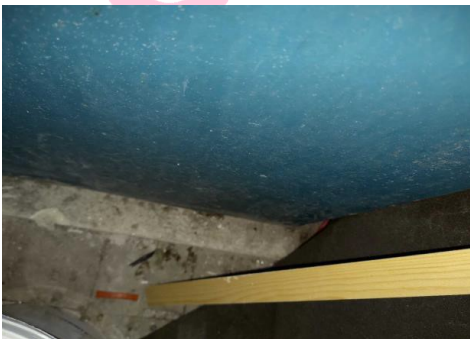
Item 30 Ref: 22-55202-17

The floor - boiler plinth, Area: 33 (Boiler cupboard) does not contain asbestos.

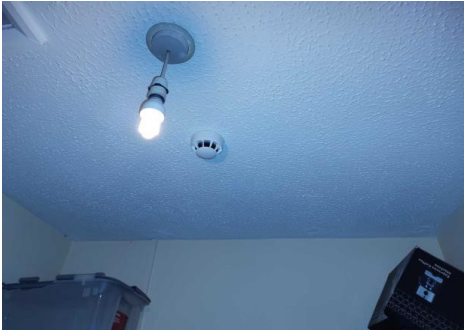
Item 31 Ref: 22-55202-15

The ceiling (Textured Coating), Area: 34 (Store cupboard) does not contain asbestos.

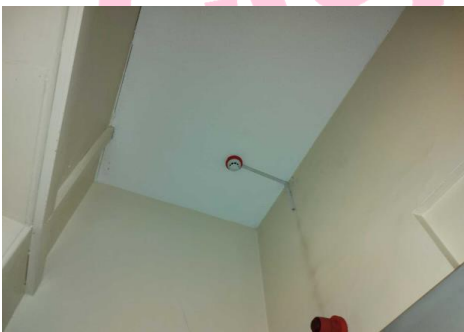
Item 33 Ref: 22-55202-15

The ceiling (Textured Coating), Area: 37 (Front Lobby) does not contain asbestos.

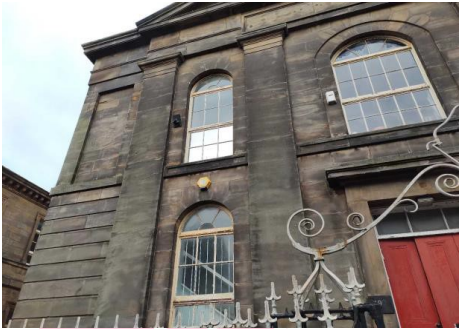
Item 35 Ref: 22-55202-19

The window - putty to glazing, Area: 38 (External) does not contain asbestos.

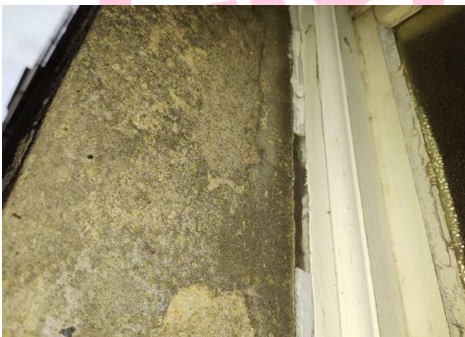
Item 36 Ref: 22-55202-20

The Windows - Sealant to frames, Area: 38 (External) contains asbestos.

Any change in its appearance should be recorded and passed to Property Services.
