ASBESTOS SURVEY REPORT FOR BARNWELL ACADEMY CARETAKERS HOUSE, PENSHAW

**BARNWELL ACADEMY - CARETAKERS HOUSE,
PENSHAW**

UPRN: - 138049

Date: 02 April 2026

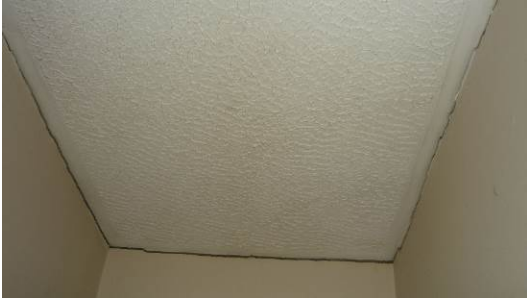
Item 1 Ref: ME1467/10

The textured coating to the ceiling in the porch (Rm 0/01) contains asbestos.

Any change in its appearance should be recorded, and passed to Property Services.

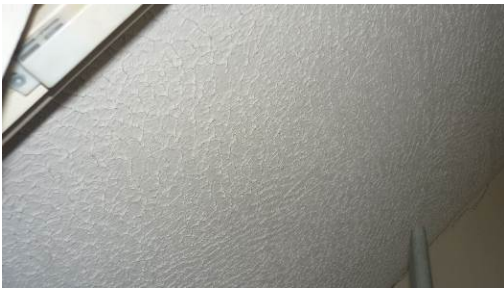
Item 2 – As ME1467/10

The textured coating to the ceiling in the cupboard under the stairs (Rm 0/02) contains asbestos.

Any change in its appearance should be recorded, and passed to Property Services.

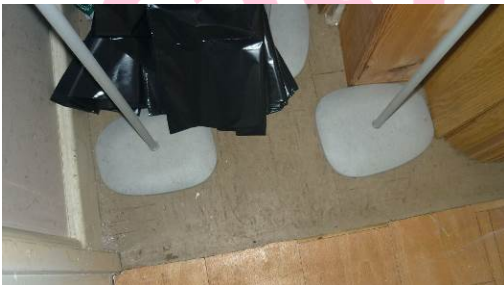
Various - Ref: ME1468/10

The floor tiles to the cupboard under the stairs (Rm 0/02) do not contain asbestos.

Similar floor tiles are located in room 0/03 and 1/06.

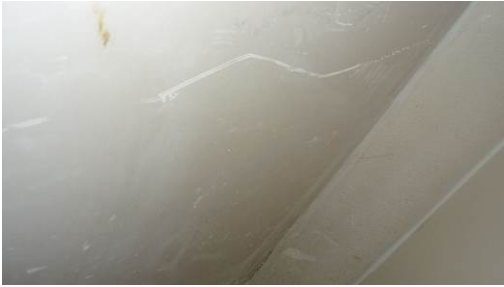
Item 4 - Ref: ME1469/10

The ceiling to the heating cupboard (Rm 0/03) does not contain asbestos.

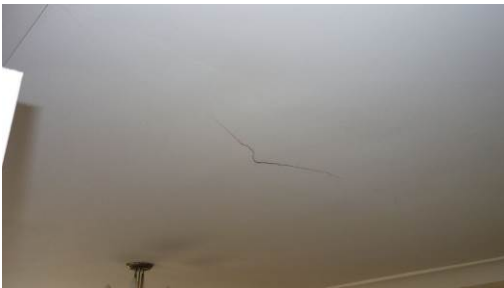
Item 6 - Ref: Presumed

The ceiling coating above the plaster skim in the living room (Rm 0/04) does not contain asbestos.

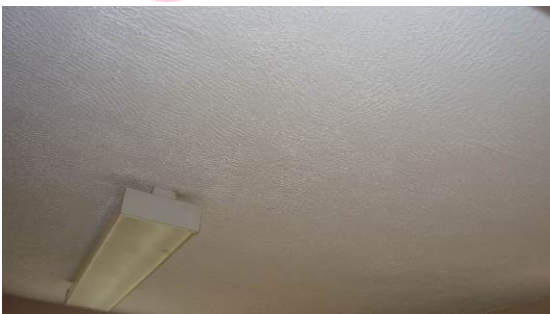
Item 7 – As ME1467/10

The textured coating to the ceiling in the kitchen contains asbestos.

Any change in its appearance should be recorded, and passed to Property Services.

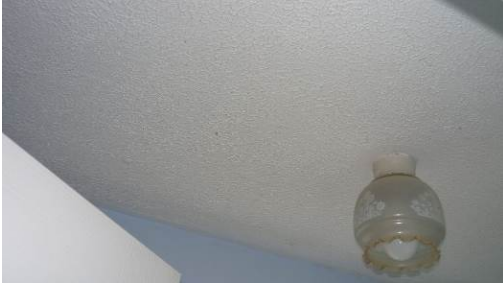
Item 8 – As ME1467/10

The textured coating to the ceiling in the toilet (Rm 0/06) contains asbestos.

Any change in its appearance should be recorded, and passed to Property Services.

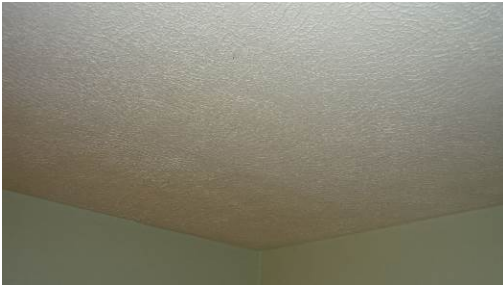
Item 9 – As ME1467/10

The coating to the ceiling in the stairs/landing/hallway (Rm 1/01) contains asbestos.

Any change in its appearance should be recorded, and passed to Property Services.

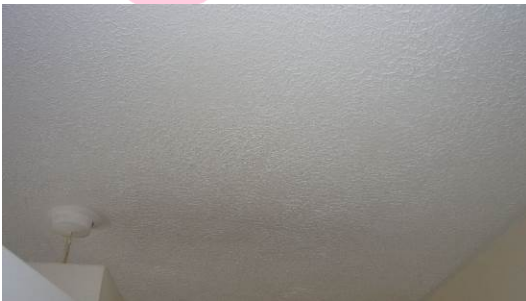
Item 10 – As ME1467/10

The coating to the ceiling in Bedroom 1 (Rm 1/02) contains asbestos.

Any change in its appearance should be recorded, and passed to Property Services.

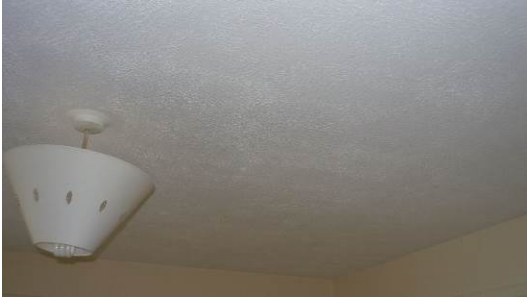
Item 11 – As ME1467/10

The coating to the ceiling in Bedroom 2 (Rm 1/03) contains asbestos.

Any change in its appearance should be recorded, and passed to Property Services.

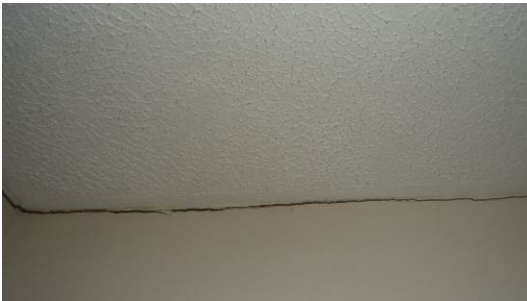
Item 12 – As ME1470/10

The coating to the ceiling in the cupboard to the landing (Rm 1/05) contains asbestos.

Any change in its appearance should be recorded, and passed to Property Services.

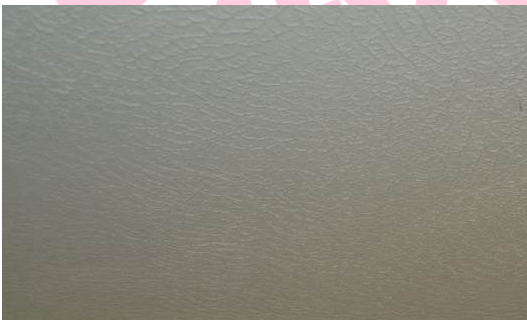
Item 13 – As ME1470/10

The coating to the ceiling in the cupboard to bedroom 3 (Rm 1/06) contains asbestos.

Any change in its appearance should be recorded, and passed to Property Services.

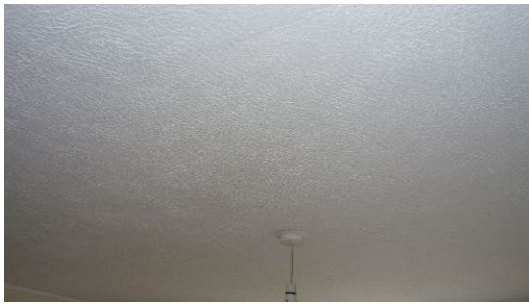
Item 15 – Ref: ME1470/10

The coating to the ceiling in Bedroom 3 (Rm 1/07) contains asbestos.

Any change in its appearance should be recorded, and passed to Property Services.

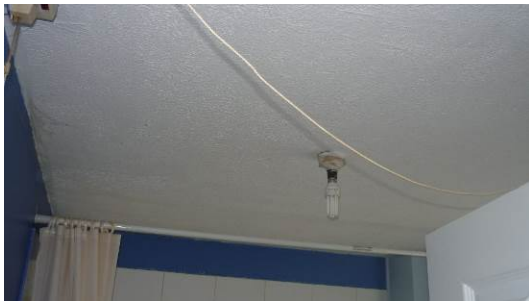
Item 16 – As ME1470/10

The coating to the ceiling in the bathroom (Rm 1/08) contains asbestos.

Any change in its appearance should be recorded, and passed to Property Services.

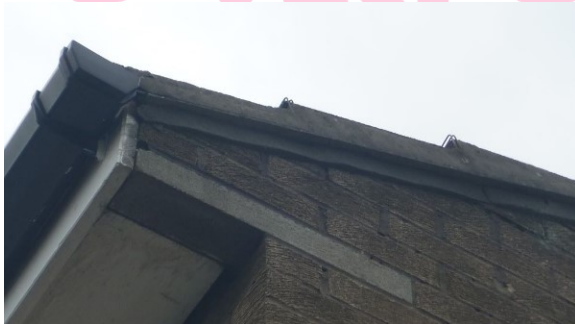
Item 17 – Presumed

The main roof undercloaking to the external of the building is presumed to contain asbestos.

Any change in its appearance should be recorded, and passed to Property Services.

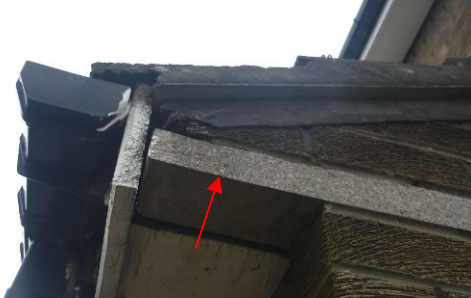
Item 18 – Ref: ME1466/10

The low level undercloaking to the external of the building contains asbestos.

Any change in its appearance should be recorded, and passed to Property Services.
