ASBESTOS SURVEY REPORT FOR ASHLEY PRIMARY ACADEMY, TEMPLE PARK ROAD, SOUTH SHIELDS, NE33 0QA

Asbestos Register for

ASHLEY PRIMARY ACADEMY, TEMPLE PARK ROAD

Date: 13 March 2026

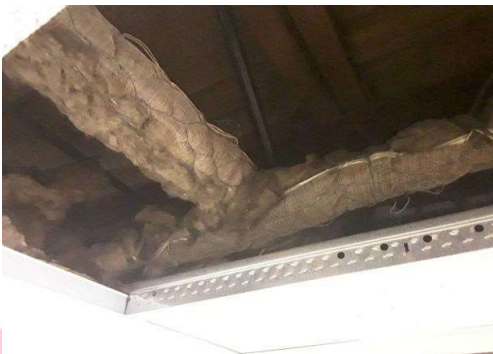
Item 2 Ref: 22-53098-1

The pipes – string to mmmf lagged metal pipes - Ground Floor, Room 1, Entrance Hall - do not contain asbestos

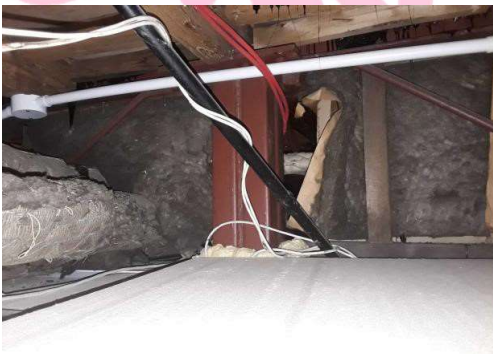
Item 3 Ref: Presumed

The walls – lining inside clasp columns - Ground Floor, Room 1, Entrance Hall - are presumed to contain asbestos.

Any change in its appearance should be recorded and passed to Property Services.

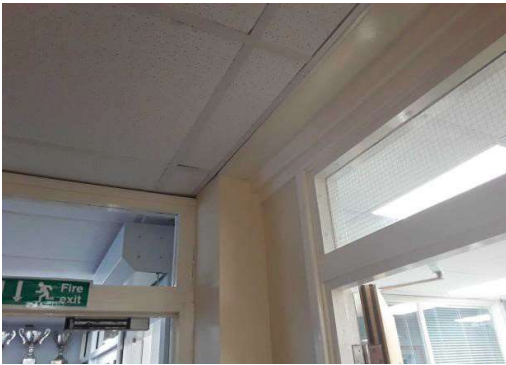
Item 4 Ref: Presumed

The walls – lining inside clasp columns - Ground Floor, Room 2, Corridor - are presumed to contain asbestos.

Any change in its appearance should be recorded and passed to Property Services.

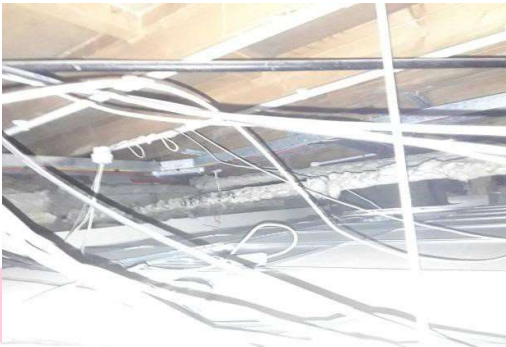
Item 5 Ref: 22-53098-1

The pipes – string to mmmf lagged metal pipes - Ground Floor, Room 3, Staff Room - do not contain asbestos

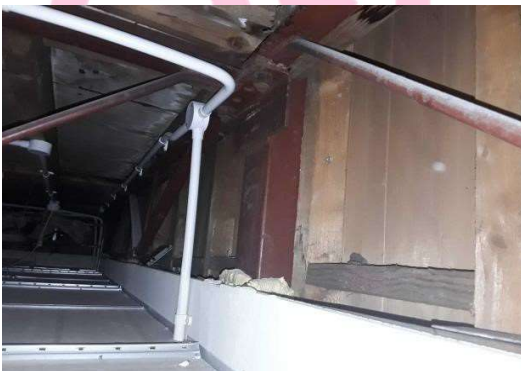
Item 6 Ref: Presumed

The walls – lining inside clasp columns - Ground Floor, Room 3, Staff Room - are presumed to contain asbestos.

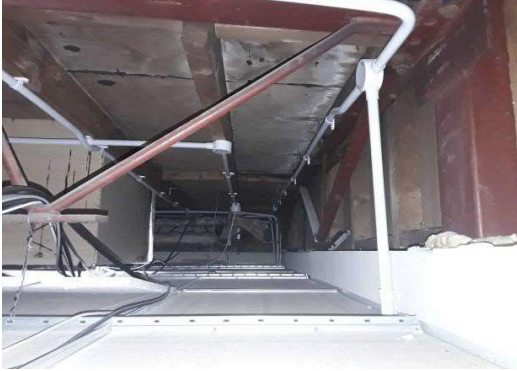
Item 7 Ref: 22-53098-1

The pipes – string to mmmf lagged metal pipes - Ground Floor, Room 4, Reception - do not contain asbestos

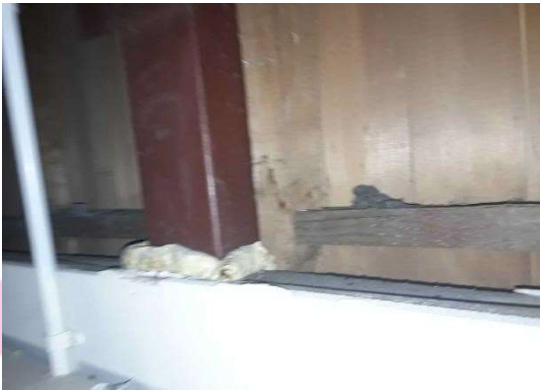
Item 8 Ref: Presumed

The walls – lining inside clasp columns - Ground Floor, Room 4, Reception - are presumed to contain asbestos.

Any change in its appearance should be recorded and passed to Property Services.

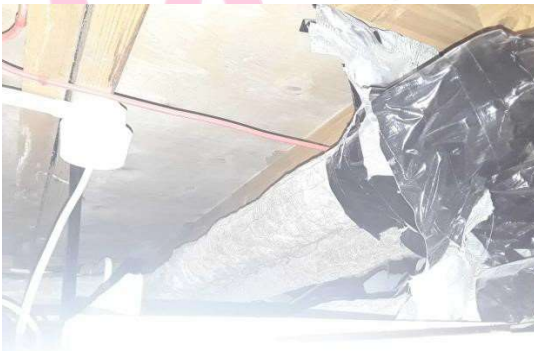
Item 9 Ref: 22-53098-1

The pipes – string to mmmf lagged metal pipes - Ground Floor, Room 5, Ladies Toilets - do not contain asbestos

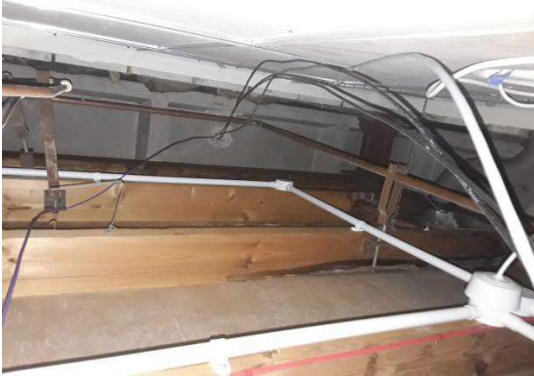
Item 10 Ref: Presumed

The walls – lining inside clasp columns - Ground Floor, Room 5, Ladies Toilets - are presumed to contain asbestos.

Any change in its appearance should be recorded and passed to Property Services.

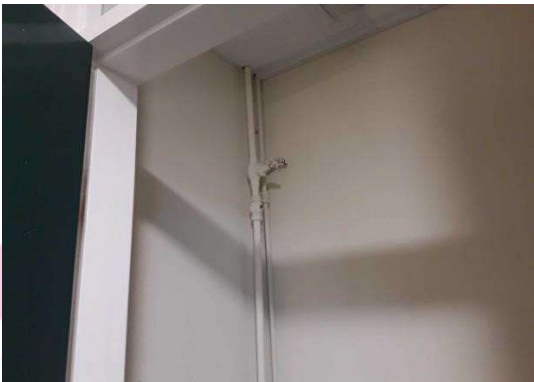
Item 11 Ref: Presumed

The pipes – stop taps (Gaskets) - Ground Floor, Room 5, Ladies Toilets - are presumed to contain asbestos.

Any change in its appearance should be recorded and passed to Property Services.

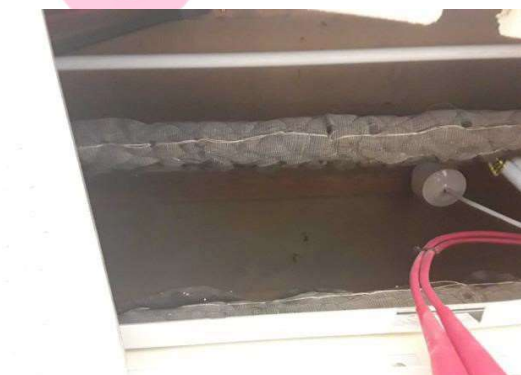
Item 12 Ref: 22-53098-1

The pipes – string to mmmf lagged metal pipes - Ground Floor, Room 6, Disabled Toilets - do not contain asbestos

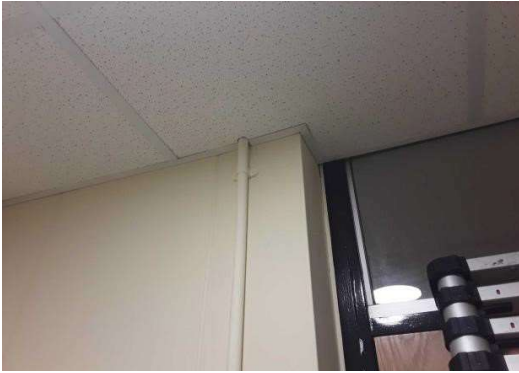
Item 13 Ref: Presumed

The walls – lining inside clasp columns - Ground Floor, Room 6, Disabled Toilets - are presumed to contain asbestos.

Any change in its appearance should be recorded and passed to Property Services.

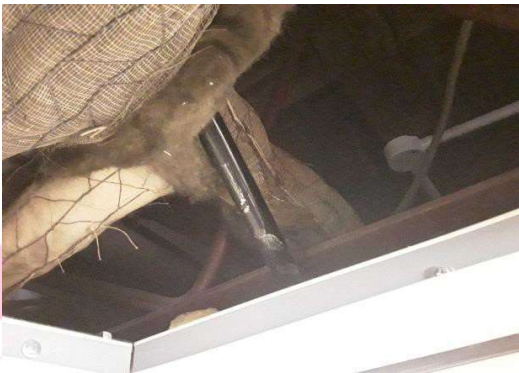
Item 14 Ref: 22-53098-1

The pipes – string to mmmf lagged metal pipes - Ground Floor, Room 7, Head teachers office - do not contain asbestos

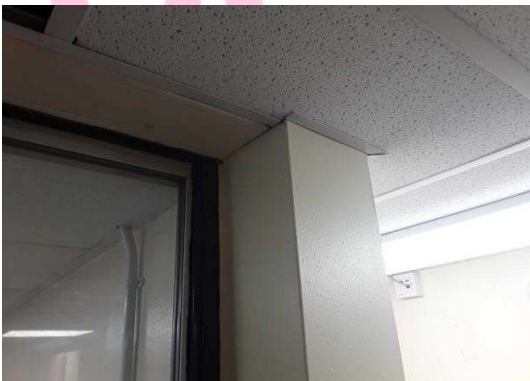
Item 15 Ref: Presumed

The walls – lining inside clasp columns - Ground Floor, Room 7, Head teachers office - are presumed to contain asbestos.

Any change in its appearance should be recorded and passed to Property Services.

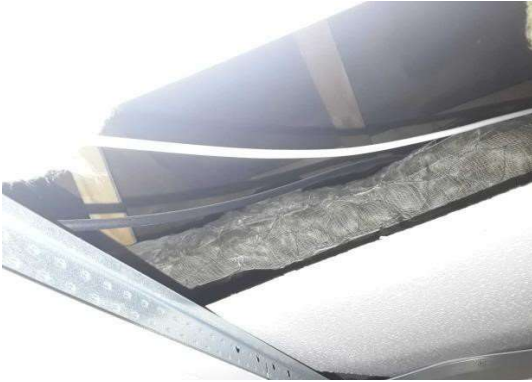
Item 16 Ref: 22-53098-1

The pipes – string to mmmf lagged metal pipes - Ground Floor, Room 8, Hallway - do not contain asbestos

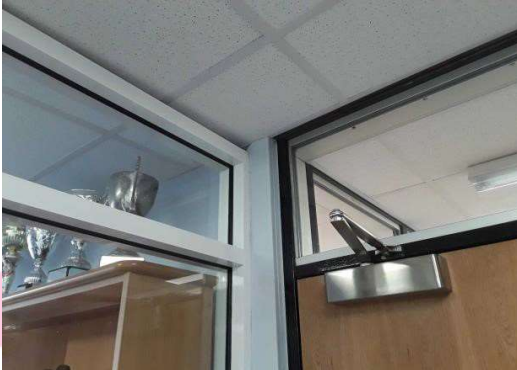
Item 17 Ref: Presumed

The walls – lining inside clasp columns - Ground Floor, Room 8, Hallway - are presumed to contain asbestos.

Any change in its appearance should be recorded and passed to Property Services.

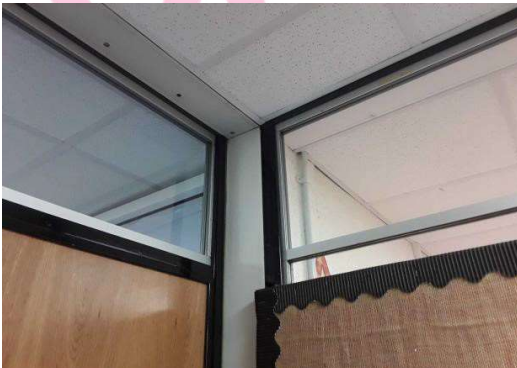
Item 18 Ref: Presumed

The walls – lining inside clasp columns - Ground Floor, Room 9, Corridor - are presumed to contain asbestos.

Any change in its appearance should be recorded and passed to Property Services.

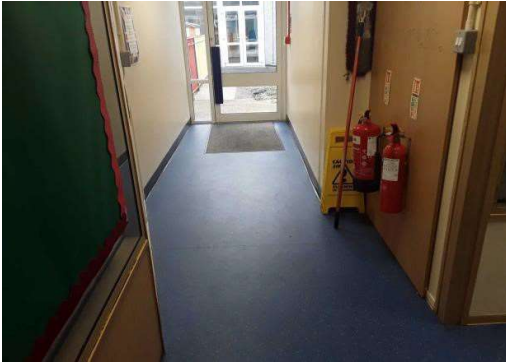
Item 19 Ref: 22-53098-3

The floor – residual adhesive beneath floor screed - Ground Floor, Room 9, Corridor contains asbestos.

Any change in its appearance should be recorded and passed to Property Services.

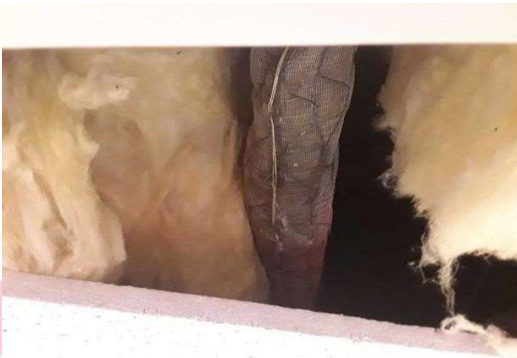
Item 20 Ref: 22-53098-1

The pipes – string to mmmf lagged metal pipes - Ground Floor, Room 10, Classroom - do not contain asbestos

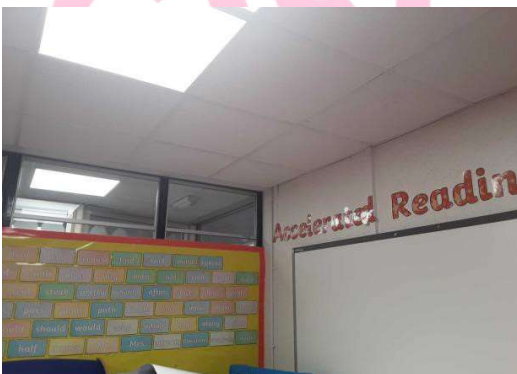
Item 21 Ref: Presumed

The walls – lining inside clasp columns - Ground Floor, Room 10, Classroom - are presumed to contain asbestos.

Any change in its appearance should be recorded and passed to Property Services.

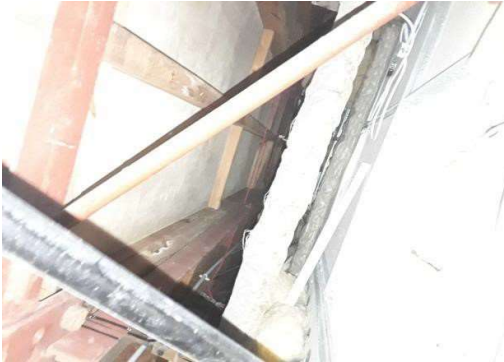
Item 22 Ref: 22-53098-1

The pipes – string to mmmf lagged metal pipes - Ground Floor, Room 11, Classroom - do not contain asbestos

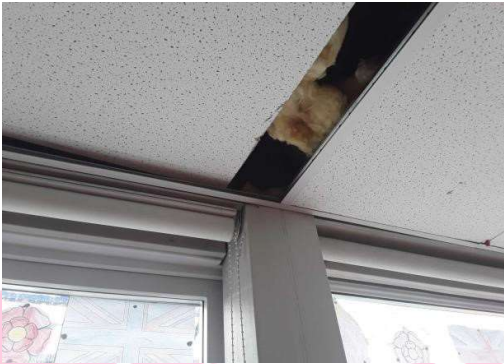
Item 23 Ref: Presumed

The walls – lining inside clasp columns - Ground Floor, Room 11, Classroom - are presumed to contain asbestos.

Any change in its appearance should be recorded and passed to Property Services.

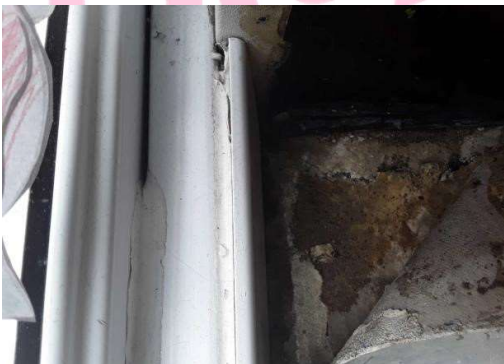
Item 24 Ref: 22-53098-3

The floor – residual adhesive beneath floor screed - Ground Floor, Room 11, Classroom - contains asbestos.

Any change in its appearance should be recorded and passed to Property Services.

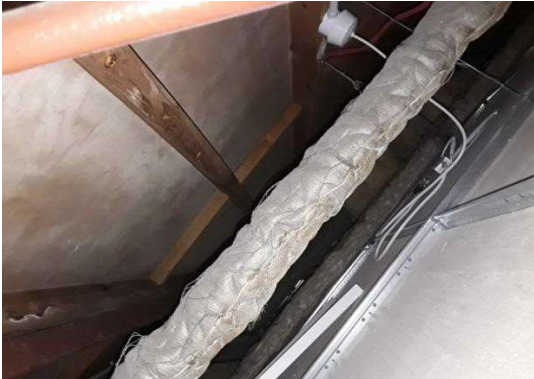
Item 25 Ref: 22-53098-1

The pipes – string to mmmf lagged metal pipes - Ground Floor, Room 12, Classroom store cupboard - do not contain asbestos

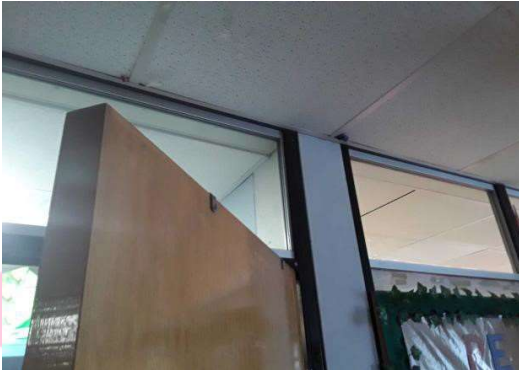
Item 26 Ref: Presumed

The walls – lining inside clasp columns - Ground Floor, Room 12, Classroom store cupboard - are presumed to contain asbestos.

Any change in its appearance should be recorded and passed to Property Services.

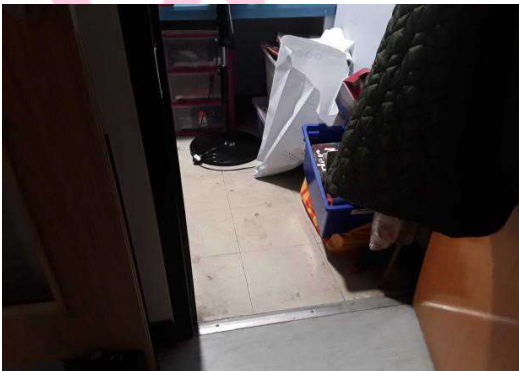
Item 27 Ref: 22-53098-3

The floor – residual adhesive beneath floor screed - Ground Floor, Room 12, Classroom store cupboard - contains asbestos.

Any change in its appearance should be recorded and passed to Property Services.

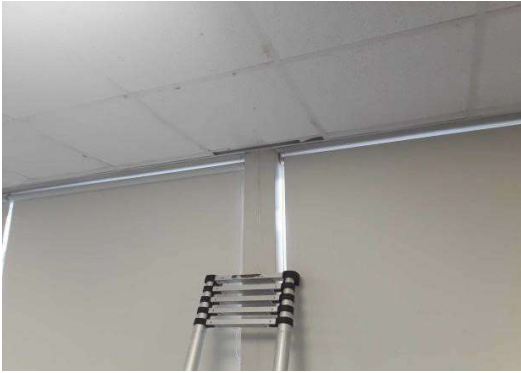
Item 28 Ref: Presumed

The walls – lining inside clasp columns - Ground Floor, Room 13, Classroom – are presumed to contain asbestos.

Any change in its appearance should be recorded and passed to Property Services.

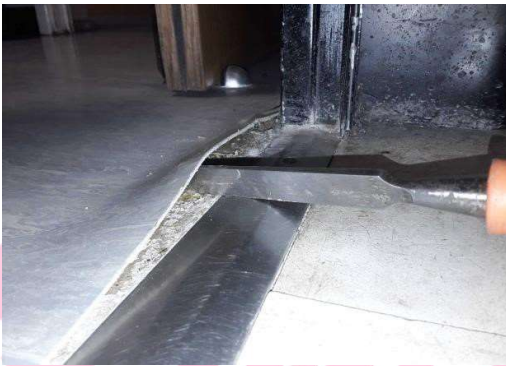
Item 29 Ref: 22-53098-3

The floor – residual adhesive beneath floor screed - Ground Floor, Room 13, Classroom - contains asbestos.

Any change in its appearance should be recorded and passed to Property Services.

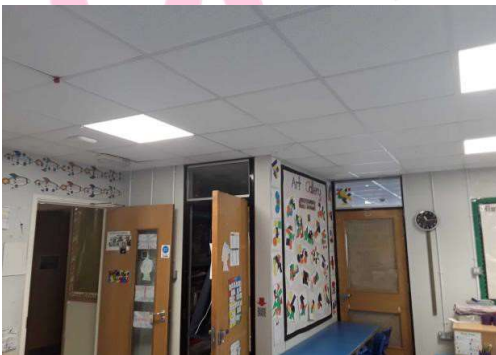
Item 30 Ref: Presumed

The walls – lining inside clasp columns - Ground Floor, Room 14, Classroom – are presumed to contain asbestos.

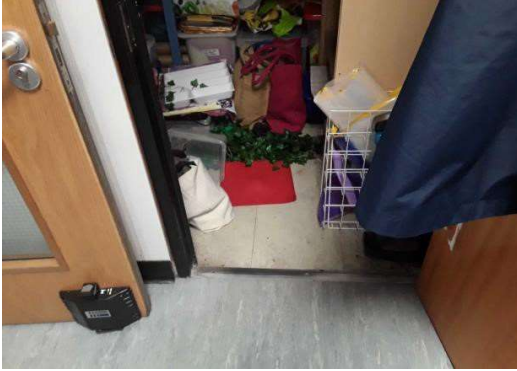
Item 31 Ref: 22-53098-4

The floor – tiles and adhesive – Ground Floor, Room 14, Classroom - contains asbestos.

Any change in its appearance should be recorded and passed to Property Services.

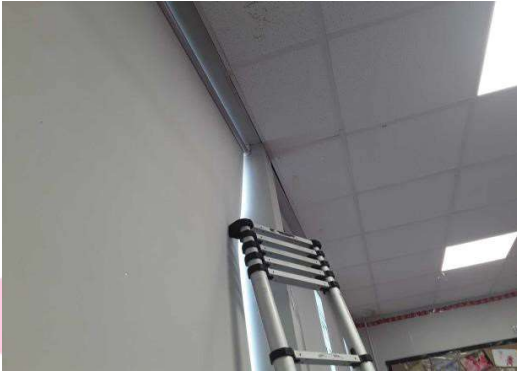
Item 32 Ref: Presumed

The walls – lining inside clasp columns - Ground Floor, Room 15, Classroom – are presumed to contain asbestos.

Any change in its appearance should be recorded and passed to Property Services.

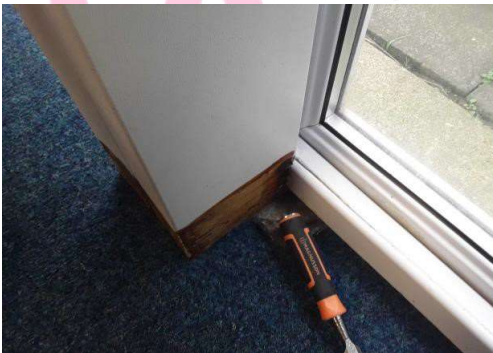
Item 33 Ref: 22-53098-3

The floor – residual adhesive beneath floor screed - Ground Floor, Room 15, Classroom - contains asbestos.

Any change in its appearance should be recorded and passed to Property Services.

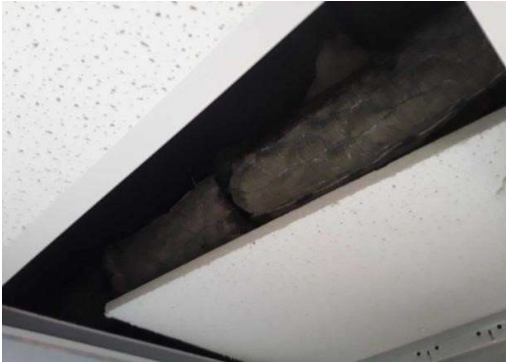
Item 34 Ref: 22-53098-1

The pipes – string to mmmf lagged metal pipes - Ground Floor, Room 12, Classroom store cupboard - do not contain asbestos

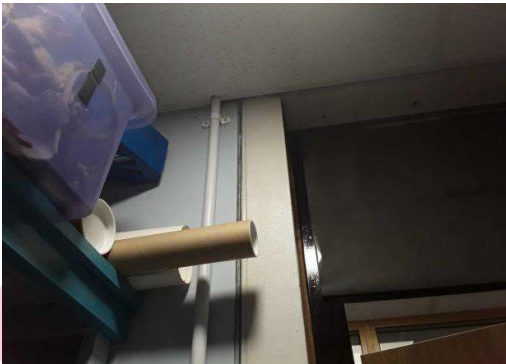
Item 35 Ref: Presumed

The walls – lining inside clasp columns - Ground Floor, Room 16, Corridor Store Cupboard – are presumed to contain asbestos.

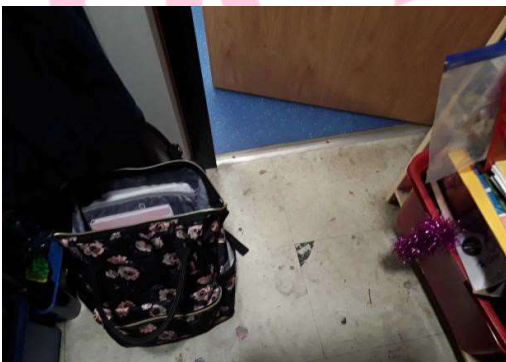
Item 36 Ref: 22-53098-4

The floor – tiles and adhesive - Ground Floor, Room 16, Corridor Store Cupboard - contains asbestos.

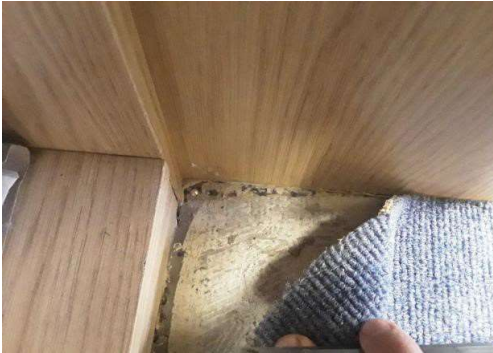
Item 40 Ref: 22-53098-3

The floor – residual adhesive beneath floor screed - Ground Floor, Room 18, Deputy Head teachers office - contains asbestos.

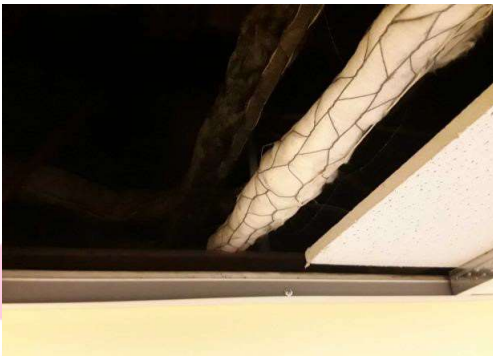
Item 41 Ref: 22-53098-1

The pipes – string to mmmf lagged metal pipes - Ground Floor, Room 19, Fire exit hallway and cloak rooms - do not contain asbestos

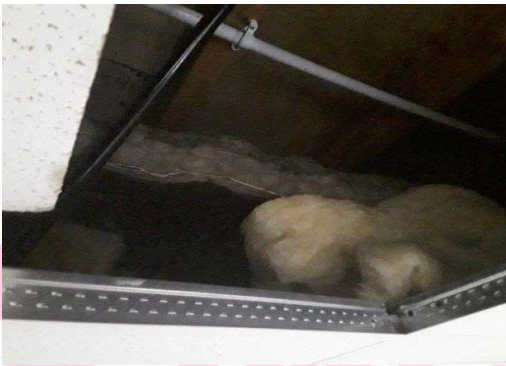
Item 47 Ref: 22-53098-1

The pipes – string to mmmf lagged metal pipes - Ground Floor, Room 21, Girls Toilet - do not contain asbestos

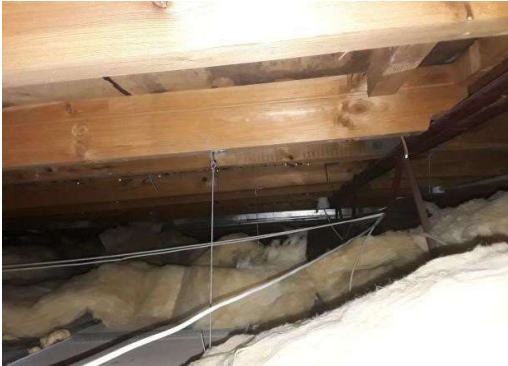
Item 52 Ref: 22-53098-1

The pipes – string to mmmf lagged metal pipes - Ground Floor, Room 22, Classroom - do not contain asbestos

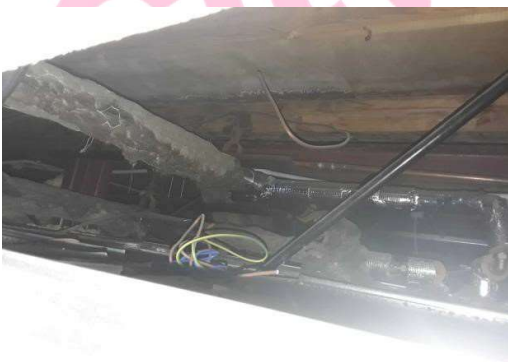
Item 54 Ref: Presumed

The walls – lining inside clasp columns - Ground Floor, Room 25, Classroom store cupboard – are presumed to contain asbestos.

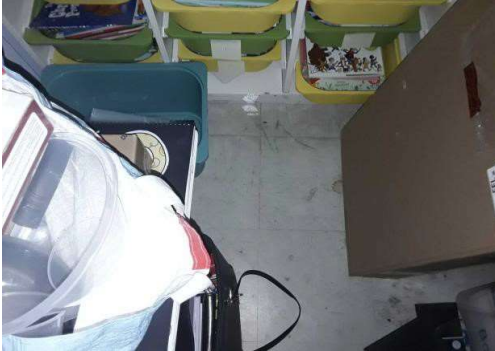
Item 55 Ref: 22-53098-4

The floor – tiles and adhesive
- Ground Floor, Room 25,
Classroom store cupboard -
contains asbestos.

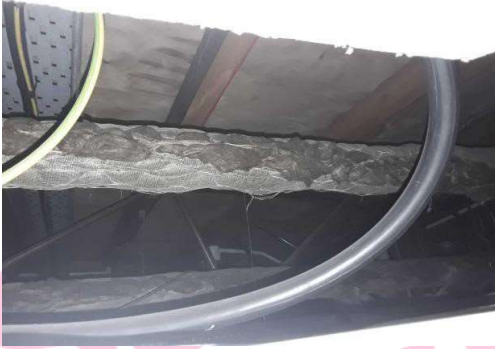
Item 56 Ref: 22-53098-1

The pipes – string to mmmf
lagged metal pipes - Ground
Floor, Room 26, Classroom
store cupboard - do not
contain asbestos

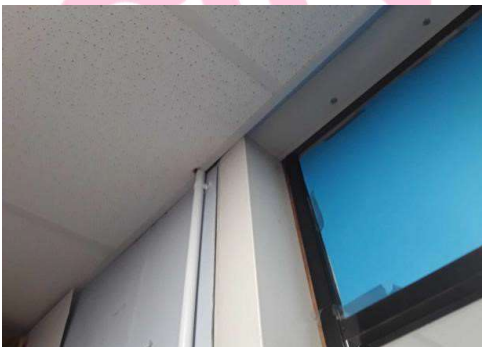
Item 57 Ref: Presumed

The walls – lining inside clasp
columns - Ground Floor,
Room 26, Classroom store
cupboard – are presumed to
contain asbestos.

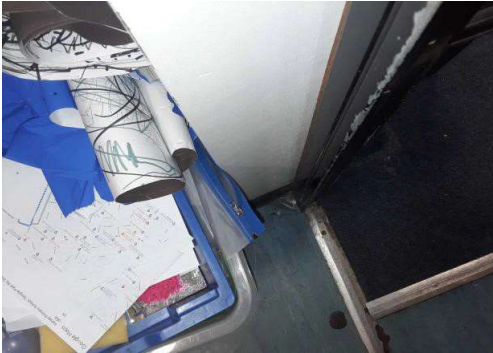
Item 58 Ref: 22-53098-4

The floor – tiles and adhesive
- Ground Floor, Room 26,
Classroom store cupboard -
contains asbestos.

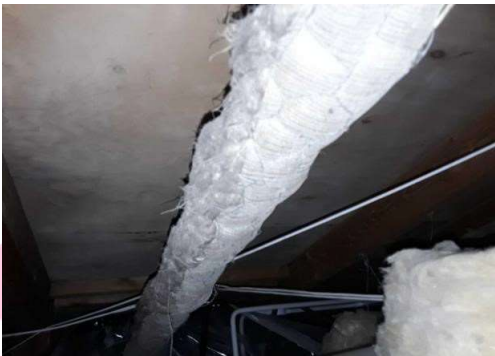
Item 95 Ref: 22-53098-1

The pipes – string to mmmf lagged metal pipes - Ground Floor, Room 42, Classroom Cupboard - do not contain asbestos

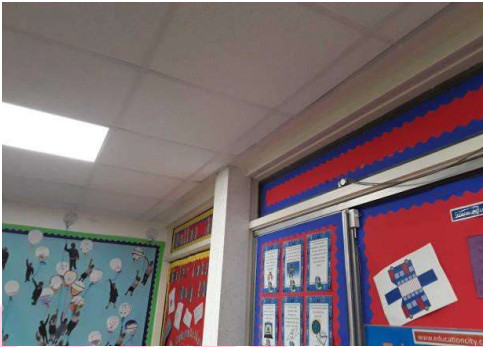
Item 101 Ref: Presumed

The walls – lining inside clasp columns - Ground Floor, Room 45, Classroom – are presumed to contain asbestos.

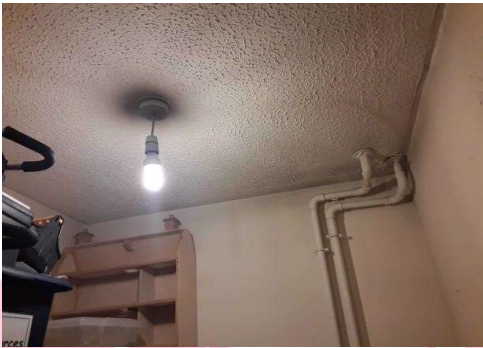
Item 149 Ref: 22-53098-13

The ceiling – textured coating
- Ground Floor, Room 78
Nursery area 2 store cupboard
- contains asbestos.

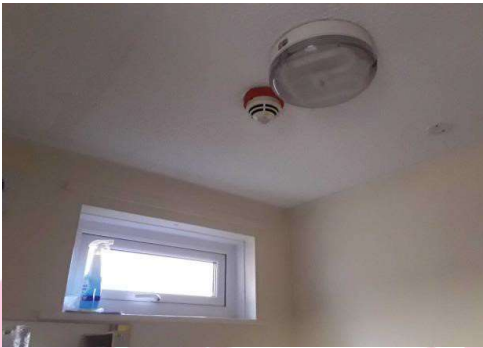
Item 161 Ref: 22-53098-13

The ceiling – textured coating
- Ground Floor, Room 88
Disabled Toilet Nursery -
contains asbestos.

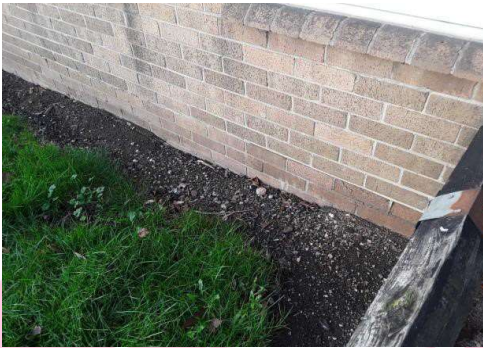
Item 167 Ref: 22-53098-21

The damp proof course -
Room 94, Externals of nursery
- contains asbestos.

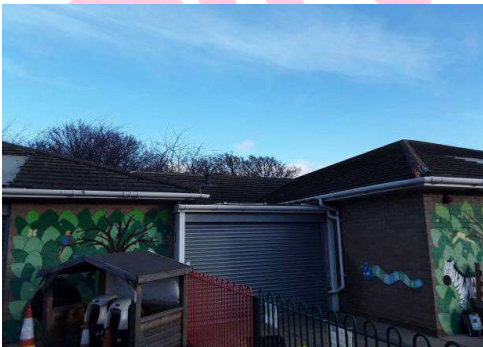
Item 168 Ref: Presumed

The roof – ridge vents - Room
94, Externals of nursery – is
presumed to contain
asbestos.

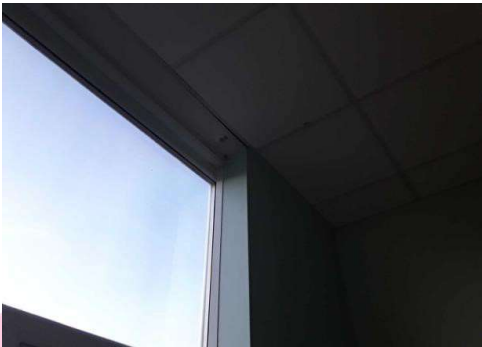
Item 191 Ref: Presumed

The walls – lining inside clasp columns - Ground Floor, Room 109 Kitchen Staff Cloakroom - are presumed to contain asbestos.

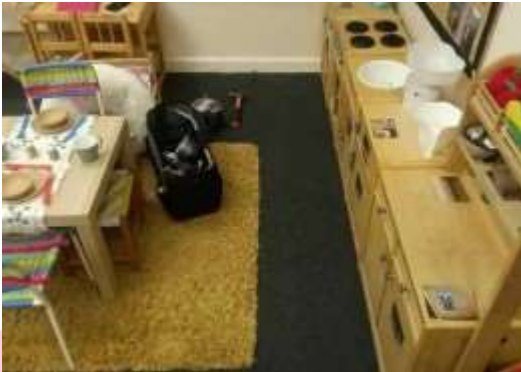
Item 200 Ref: TL000402

The Floor – screed composite sample from opposite ends of room Ground Floor, Rm G/001 Main Nursery Area – does not contain asbestos.

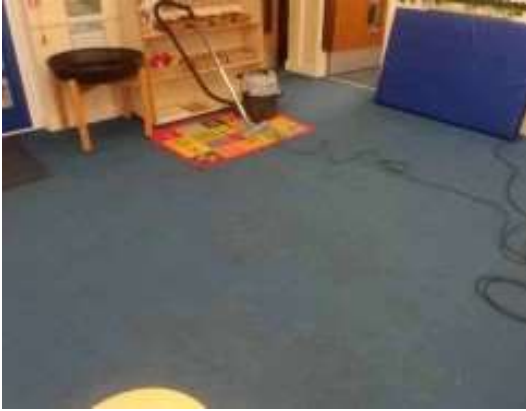
Item 202 Ref: As TL000302

The Floor – screed composite sample from opposite ends of room
Ground Floor, Rm G/002
Main Nursery Area – does not contain asbestos.

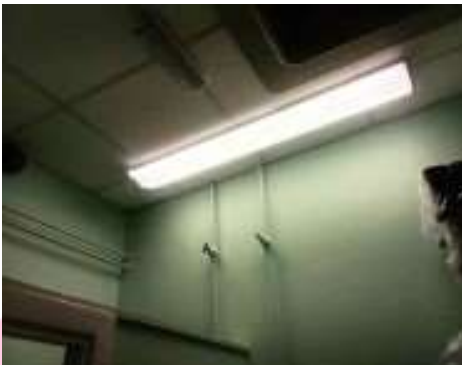
Item 206 Ref: Presumed

The Ceiling Void - Insulating Board, Ground Floor, Rm 109 Toilet(s) is presumed to contain asbestos.

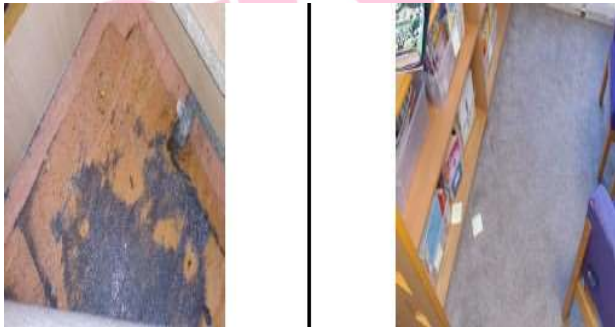
Item 210 Ref: PK003210

The floor covering below carpet in the corridor/reading area (G/01) does not contain asbestos.
