ASBESTOS SURVEY REPORT FOR, CARETAKERS HOUSE, CASTLETOWN PRIMARY, SUNDERLAND

CARETAKERS HOUSE, CASTLETOWN PRIMARY SUNDERLAND

Date: 31 March 2026

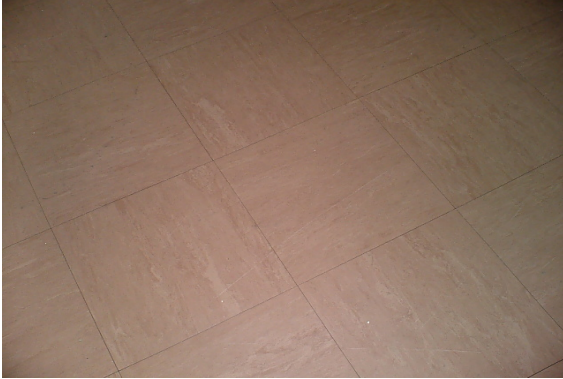
Item 1 Ref: ED19/2

ED19/2 – Vinyl floor tiles (Room 7) (Item 1) - Very Low Risk

The vinyl floor tiles in the storeroom (Room 7) contain asbestos.

Any change in its appearance should be recorded and passed to Property Services.

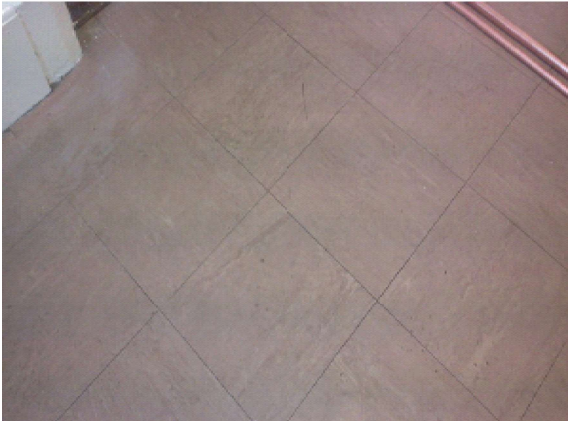
Item 2 Ref:48440-1

The vinyl floor tiles in the kitchen does not contain asbestos.

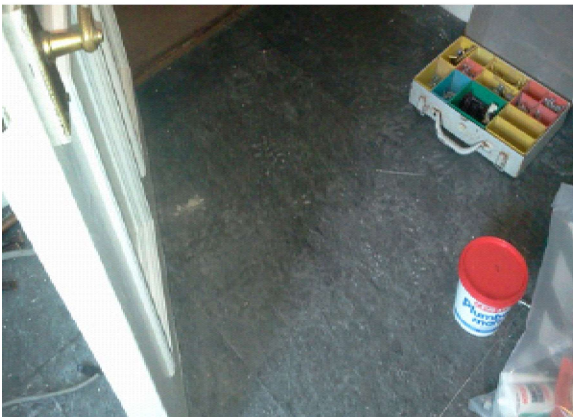
Item 3 Ref:48440-2

The black floor covering to the bathroom does not contain asbestos.

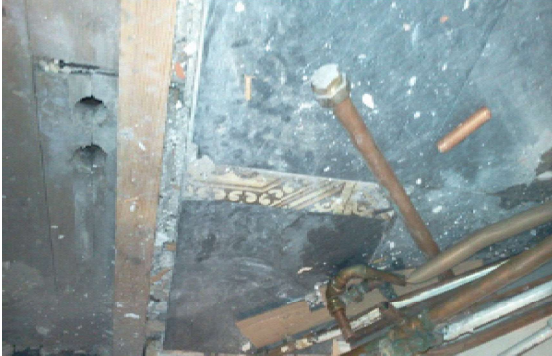
Item 4 Ref:48440-3

The sub floor tile in the bathroom does not contain asbestos.

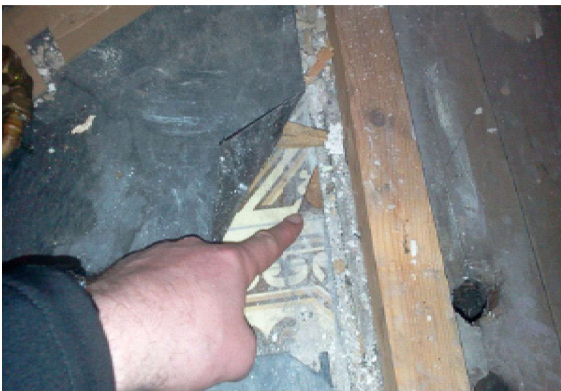
Item 5 Ref:48440-4

The packing to the sub floor in the bathroom does not contain asbestos.

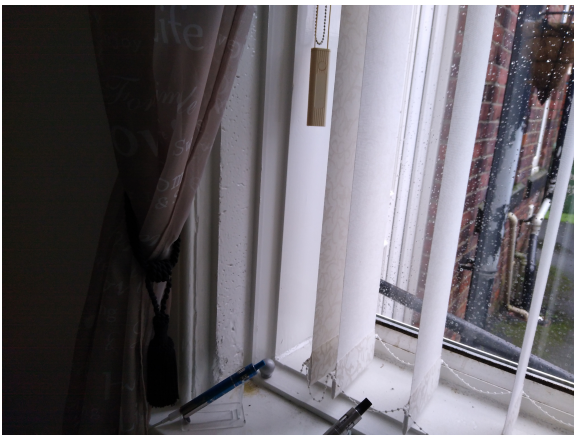
Item 6 Ref:378623-1

The insulation to the wall in the Dining Room (Rm 0/01) does not contain asbestos.

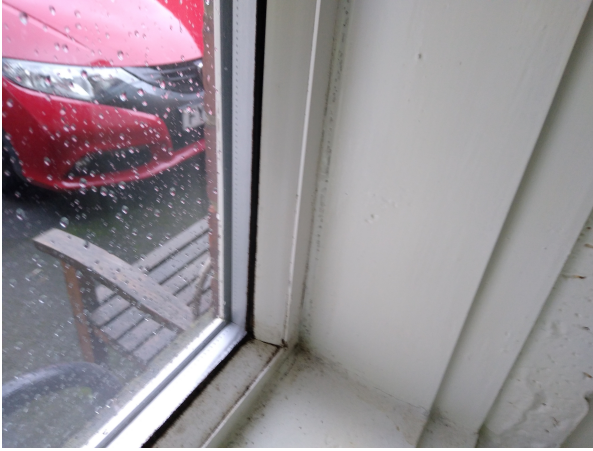
Item 7 Ref: 378623-2

The sealant to window frame in the Dining Room (Rm 0/01) does not contain asbestos.

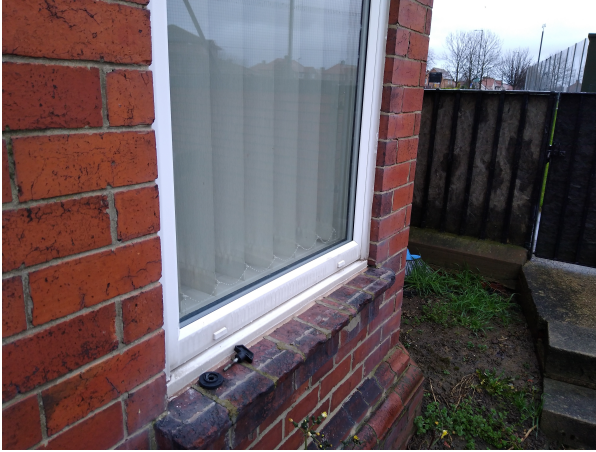
Item 10 Ref: 378623-3

The sealant to window frame (External) does not contain asbestos.
