### **ASBESTOS SURVEY REPORT FOR GRANGE PARK PRIMARY SCHOOL – CARETAKERS HOUSE, SUNDERLAND**

### **Asbestos Register for Grange Park Primary School – Caretakers House**

**Date: 01 May 2025**

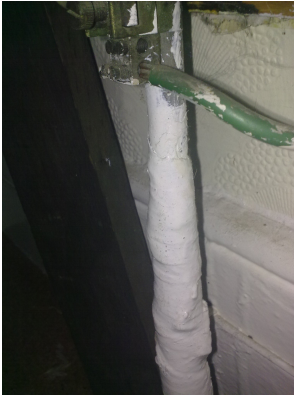
### **Item 1 Ref: DC0735/10**

The electrical services cable braiding to the lobby (Rm 0/01) does not contain asbestos.

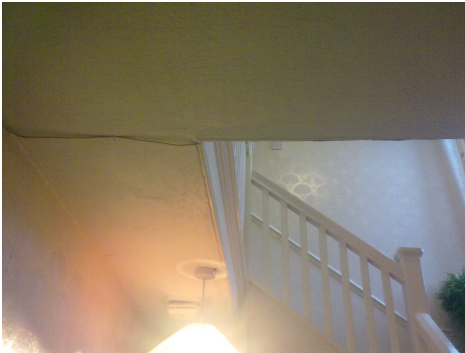
### **Various Ref: DC0736/10**

The textured coating to the ceiling in the hallway (Rm 0/02) does not contain asbestos.

Similar textured coating is located on the staircase and landing.

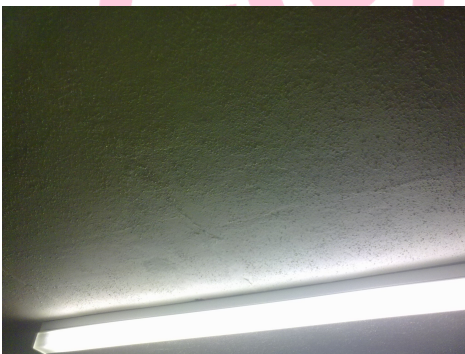
### **Item 3 Ref: DC0737/10**

The textured coating to the ceiling in the kitchen (Rm 0/04) does not contain asbestos.

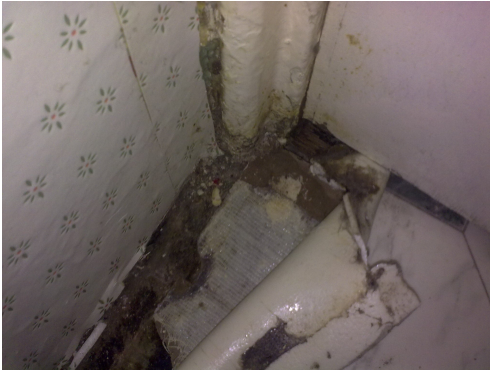
### **Various Ref: DC0739/10**

*DC0739/10 – Floor tiles (Rm 0/04) (Item 4) – These have been screeded over*

*As DC0739/10 – Floor tiles (Rm 0/06) (Item 6) – These have been screeded over*

The floor tiles to the kitchen (Rm 0/04) contain asbestos.

Similar floor tiles are located in room 0/06 (rear lobby).

These have been screeded over.

Any change in its appearance should be recorded and passed to Property Services.

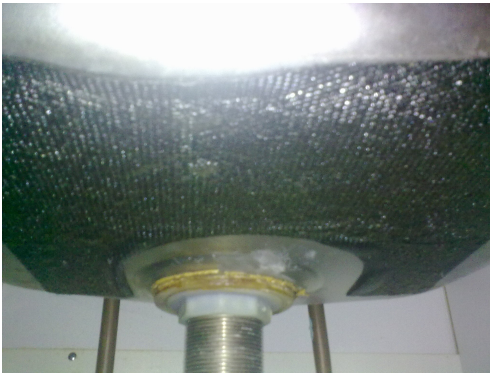
### **Item 5 Ref: DC0738/10**

The sink pad to the kitchen (Rm 0/04) does not contain asbestos.

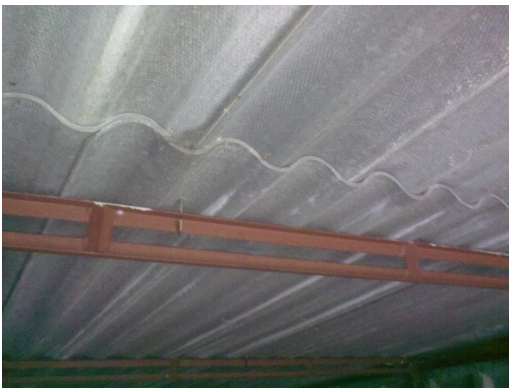
### **Item 7 Ref: DC0740/10**

The ceiling forming the roof in the garage (Rm 0/10) does not contain asbestos.

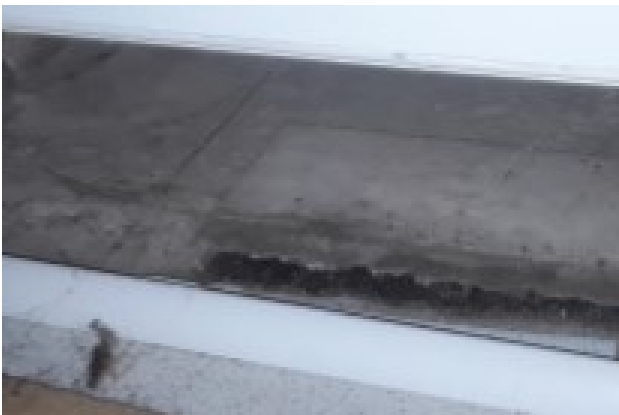
### **Item 10 Ref: 20-26931-3**

**20-26931-3 – Floor behind kickboards tiles and adhesive (Kitchen Rm 0/04) (Item 10) – Removed Dec 2020**

The floor behind kickboards (tiles and adhesive) in the kitchen does contain asbestos.

Removed Dec 2020
