ASBESTOS SURVEY REPORT FOR SPRINGWELL SCHOOL, WILTSHIRE WAY, HARTLEPOOL, TS26 0TB.

Asbestos Register for

Springwell School, Wiltshire Way, Hartlepool

Date: 10 June 2026

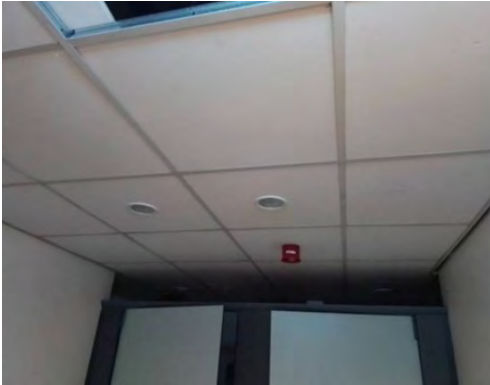
Item 1 Ref: As PZ000002

The old roof lining in the ground floor female toilets (Room 033) does not contain asbestos.

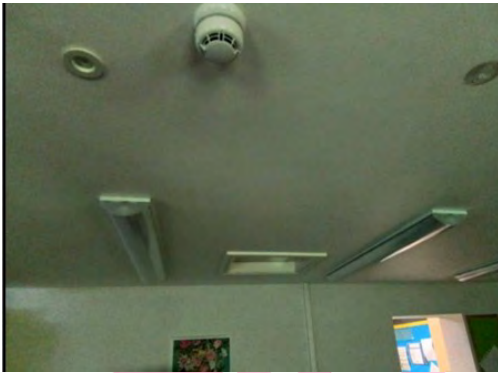
Item 2 Ref: PZ000002

The old roof lining in roof void in the loft space above the library (Room 032a) does not contain asbestos.

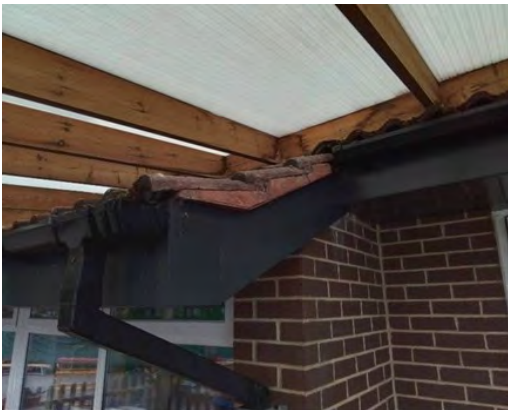
Item 3 Ref: PZ000003

The undercloak (External E1) does not contain asbestos.

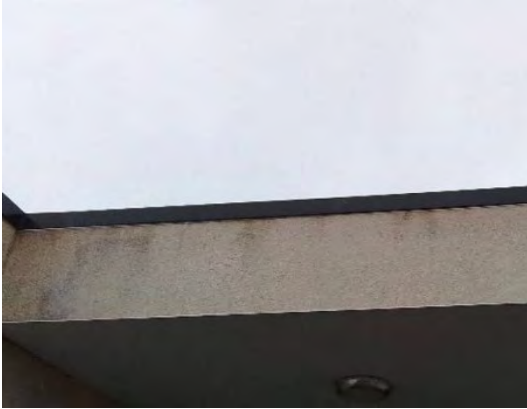
Item 4 Ref: PZ000004

The canopy ceiling (External E1) does not contain asbestos.

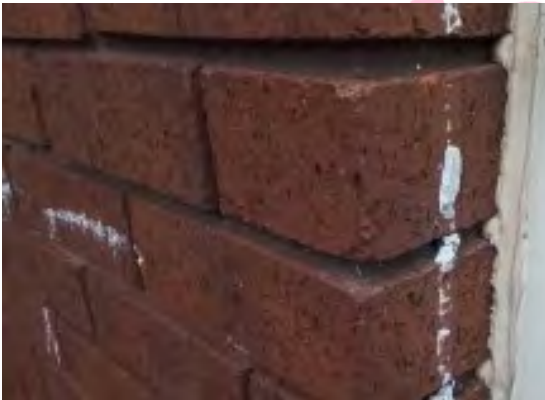
Item 5 Ref: PZ000005

| Item No. | Sample Ref. | Area Sampled | Location Name | Inspection Frequency |
|---|---|---|---|---|
| 5. | PZ000005 | Window putty/seal old mastic around doors and windows outside rooms 058/059 | External E1 | Very Low Risk – To be checked on a 12 monthly basis |

The window putty/seal old mastic around doors and windows and outside rooms (External E1) does contain asbestos.

Any change in its appearance should be recorded and passed to Property Services.

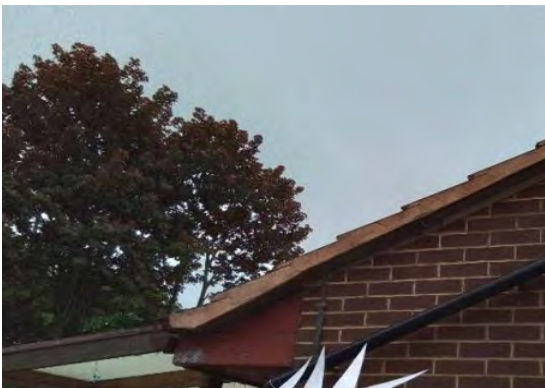
Item 6 Ref: PZ000006

The undercloak outside room 063 (External E1) does not contain asbestos.

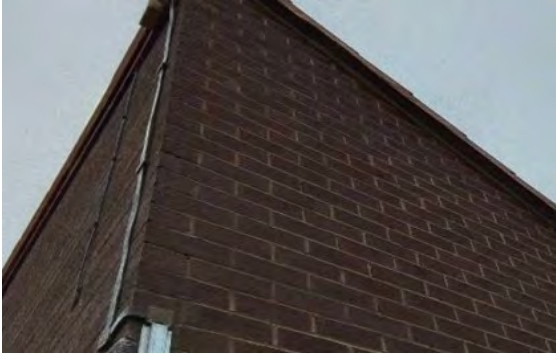
Item 7 Ref: As PZ000006

The undercloak outside room 070a (External E1) does not contain asbestos.

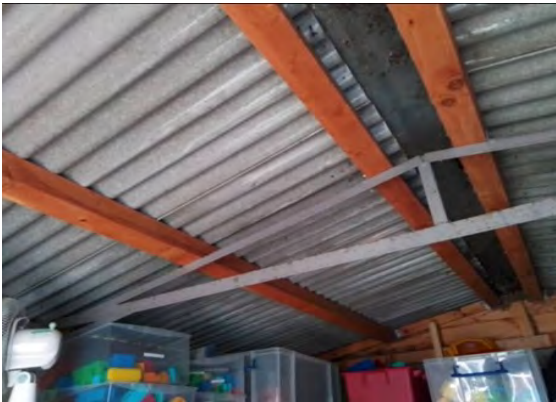
Item 8 Ref: PZ000007

The roof sheet cladding (External E2) does not contain asbestos.

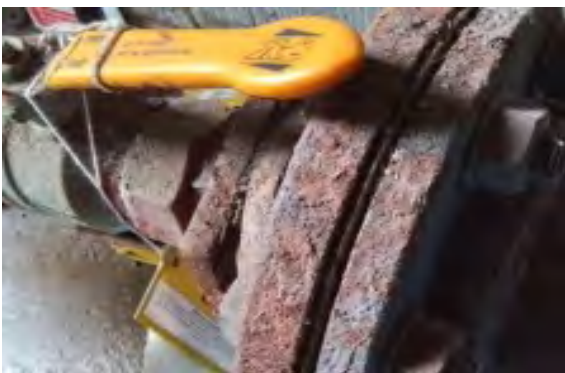
Item 9 Ref: PZ000008

| Item No. | Sample Ref. | Area Sampled | Location Name | Inspection Frequency |
|---|---|---|---|---|
| 9. | PZ000008 | Pipework gaskets | External 089 – Meter Cupboard | Very Low Risk – To be checked on a 12 monthly basis |

The pipework gaskets in the meter cupboard (External 089) does contain asbestos.

Any change in its appearance should be recorded and passed to Property Services.

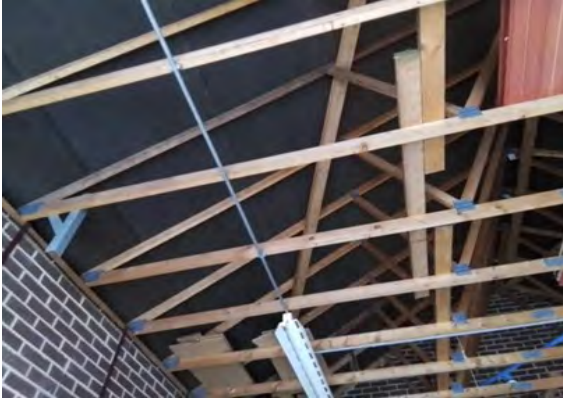
Item 10 Ref: PZ000009

The roof lining to Garage block B (external 090) does not contain asbestos.

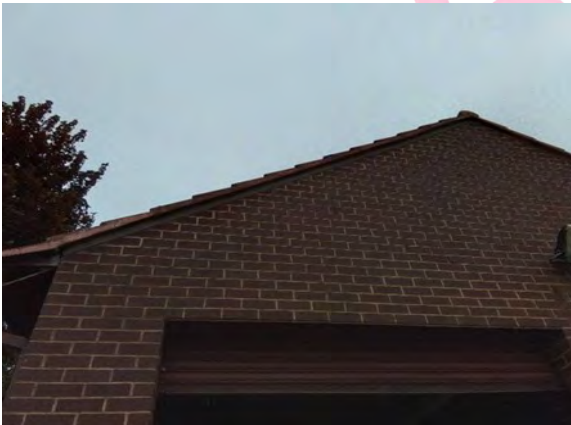
Item 11 Ref: PZ000010

The undercloak to Garage block B (external 090) does not contain asbestos.

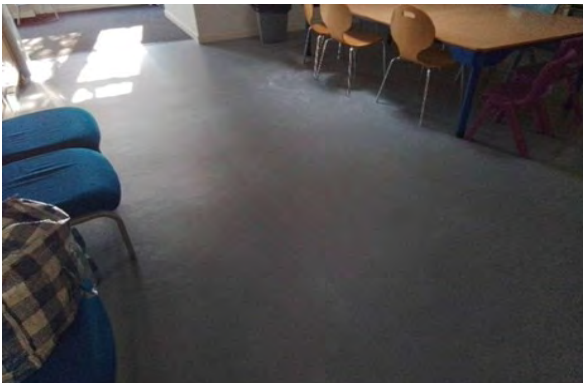
Item 12 Ref: RN000235

The floor adhesive in the Kitchen Cookery Room (G/002) does not contain asbestos.

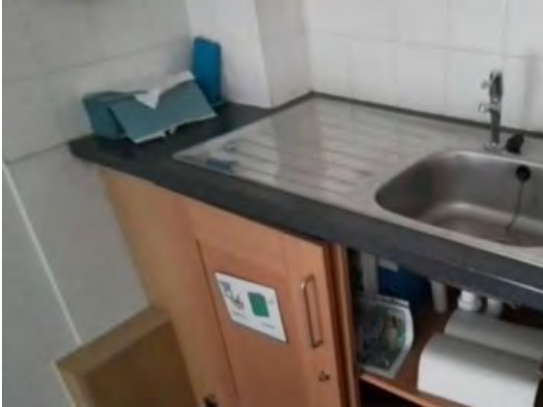
Item 13 Ref: RN000236

The under sink mat in the Kitchen Cookery Room (G/002) does not contain asbestos.

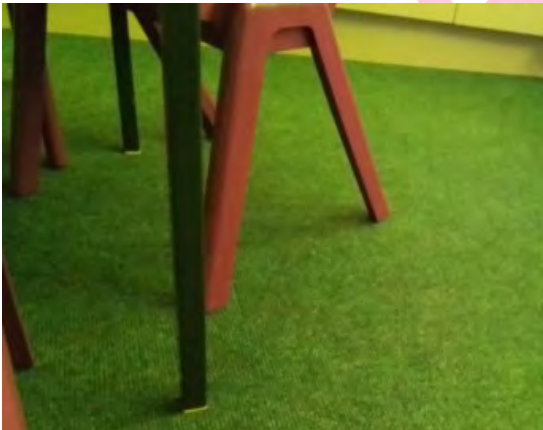
Item 14 Ref: RN000237

The floor adhesive in the Speech and language therapy room (G/003) does not contain asbestos.

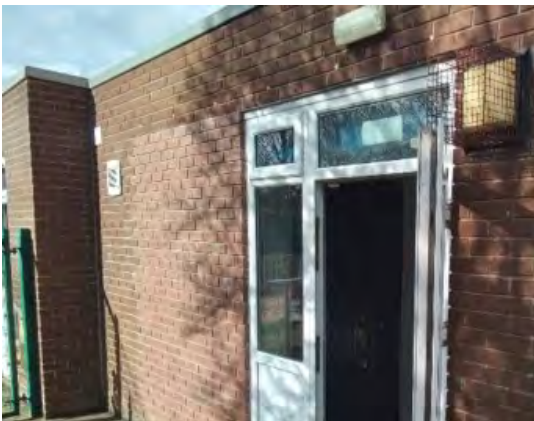
Item 15 Ref: RN000238

The door seal/gasket externally (E/001) does not contain asbestos.

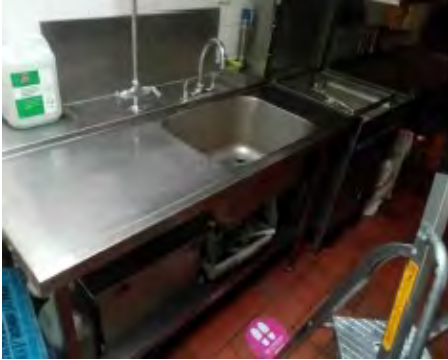
Item 16 Ref: TL001143

The under sink mat in the Kitchen (G/021) does not contain asbestos.

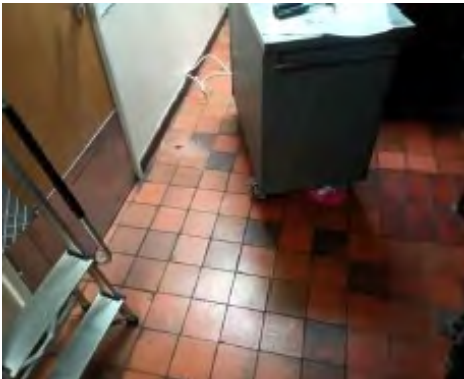
Item 17 Ref: TL001144

The tile joining material to the floor in the Kitchen (G/021) does not contain asbestos.

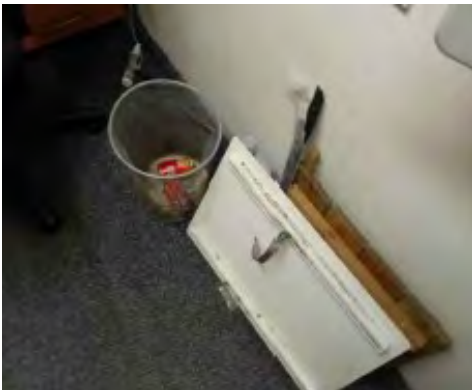
Item 18 Ref: TL001148

The wall skirting in the Caretakers Room G/082) does not contain asbestos.

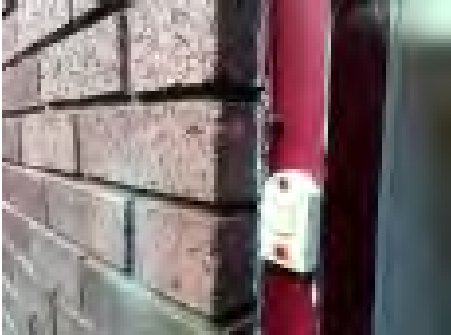
Item 19 Ref: TL001145

| Item No. | Sample Ref. | Area Sampled | Location Name | Inspection Frequency |
|---|---|---|---|---|
| 19. | TL001145 | Door - seal/Gasket door to kitchen | External E/01 | Very Low Risk – To be checked on a 12 monthly basis |

The door seal/gasket door to kitchen (External E/01) does contain asbestos.

Any change in appearance should be reported to Property Services.

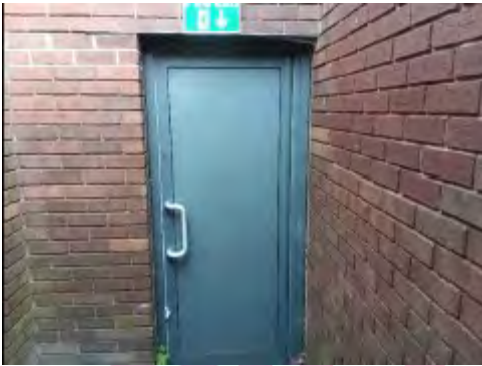
Item 20 Ref: TL001146

The wall remnants around metal door (external E/01) does not contain asbestos.

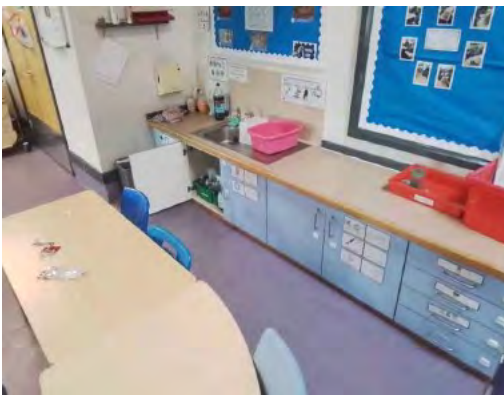
Item 21 Ref: ML000558

The Under Sink Mat (Classroom G/003) does not contain asbestos.

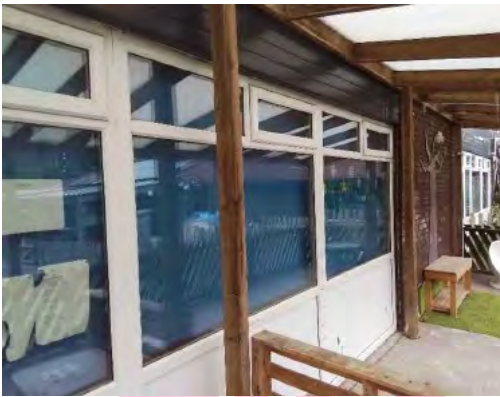
Item 23 Ref: ML000556

The Window Putty/seal to modern frames door and windows (E/001 External Outside classroom G/001) does not contain asbestos.

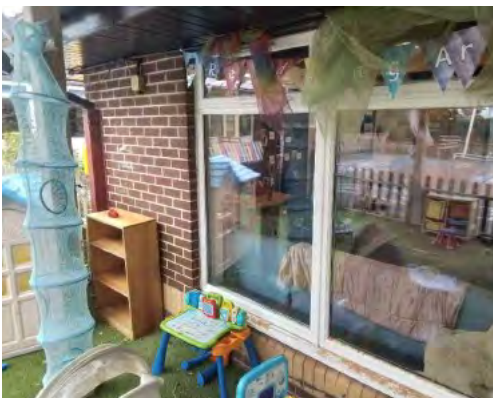
Item 24 Ref: ML000557

The Window Putty/seal to modern frames door and windows (E/002 External Outside classroom G/002) does not contain asbestos.

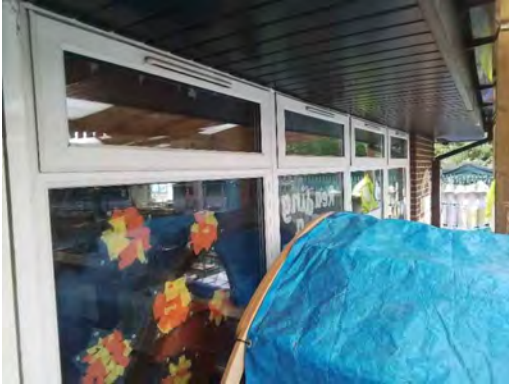
Item 25 Ref: ML000559

The Window Putty/seal to modern frames door and windows (E/003 External Outside classroom G/004) does not contain asbestos.

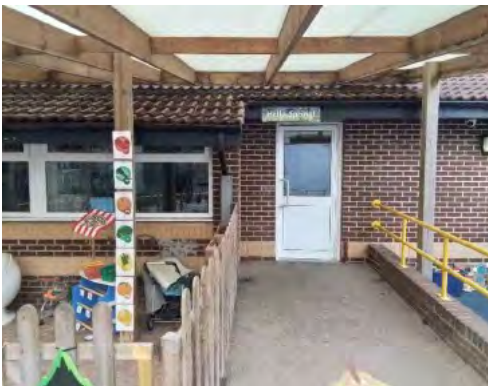
Item 26 Ref: ML000560

The Window Putty/seal to modern frames door and windows (E/004 External Outside classroom G/005) does not contain asbestos.
