ASBESTOS SURVEY REPORT FOR SPRINGWELL SCHOOL, WILTSHIRE WAY, HARTLEPOOL, TS26 0TB.

Asbestos Register for

Springwell School, Wiltshire Way, Hartlepool

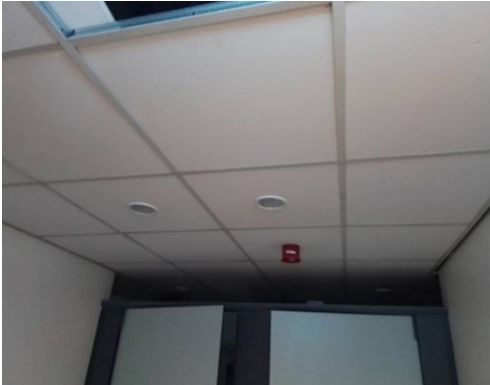
Item 1 Ref: As PZ000002

The old roof lining in the ground floor female toilets (Room 033) does not contain asbestos.

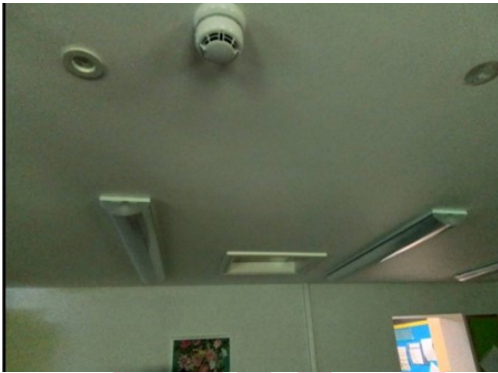
Item 2 Ref: PZ000002

The old roof lining in roof void in the loft space above the library (Room 032a) does not contain asbestos.

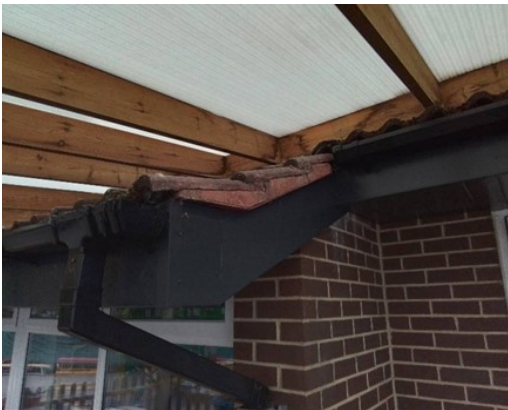
Item 3 Ref: PZ000003

The undercloak (External E1) does not contain asbestos.

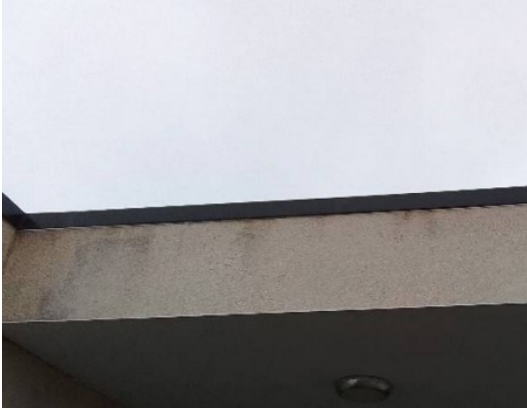
Item 4 Ref: PZ000004

The canopy ceiling (External E1) does not contain asbestos.

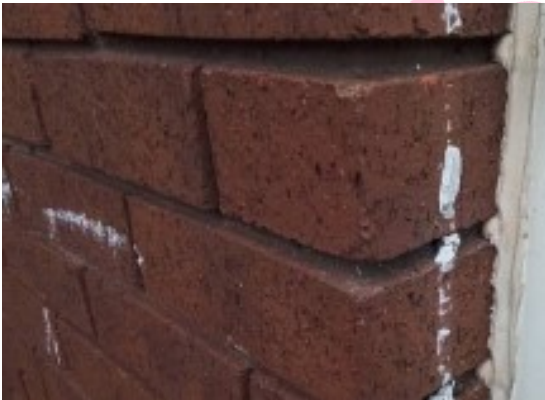
Item 5 Ref: PZ000005

3.	PZ000003	Undercloak	External E1	No Risk
4.	PZ000004	Canopy Ceiling	External E1	No Risk
5.	PZ000005	Window putty/seal old mastic around doors and windows outside rooms 058/059	External E1	Very Low Risk – To be checked on a 12 monthly basis

The window putty/seal old mastic around doors and windows and outside rooms (External E1) does contain asbestos.

Any change in its appearance should be recorded and passed to Property Services.

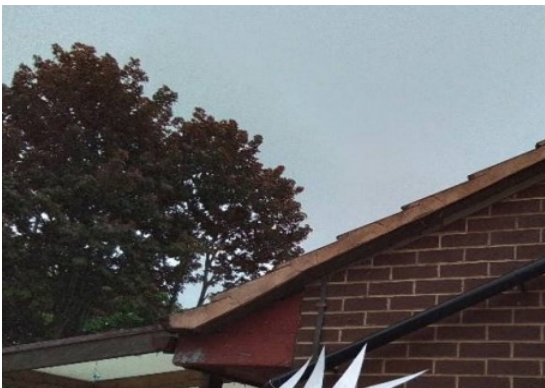
Item 6 Ref: PZ000006

The undercloak outside room 063 (External E1) does not contain asbestos.

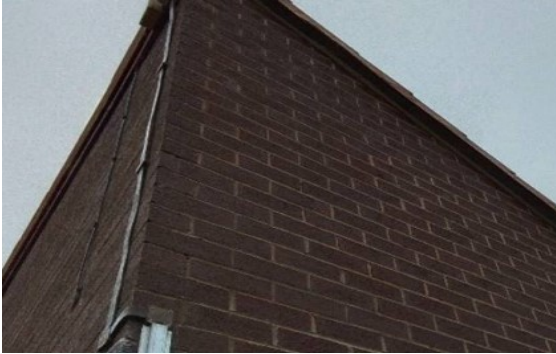
Item 7 Ref: As PZ000006

The undercloak outside room 070a (External E1) does not contain asbestos.

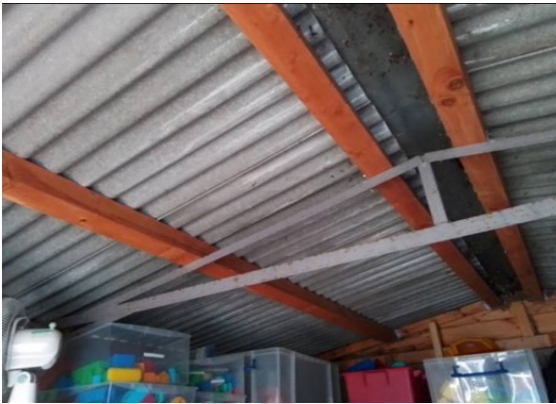
Item 8 Ref: PZ000007

The roof sheet cladding (External E2) does not contain asbestos.

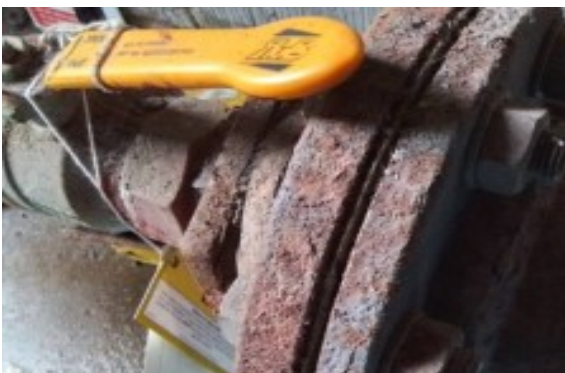
Item 9 Ref: PZ000008

9.	PZ000008	Pipework gaskets	External 089 – Meter Cupboard	Very Low Risk – To be checked on a 12 monthly basis
10.	PZ000009	Roof Lining	External 090 Garage block B	No Risk

The pipework gaskets in the meter cupboard (External 089) does contain asbestos.

Any change in its appearance should be recorded and passed to Property Services.

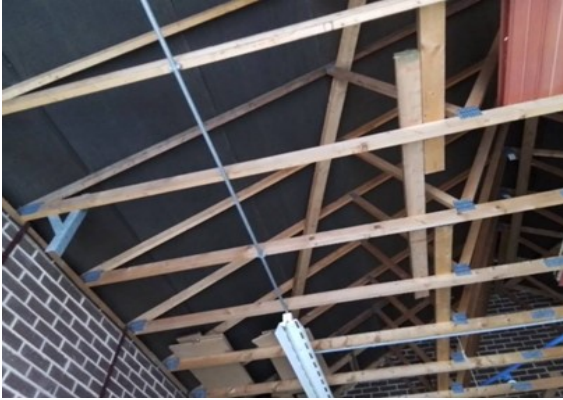
Item 10 Ref: PZ000009

The roof lining to Garage block B (external 090) does not contain asbestos.

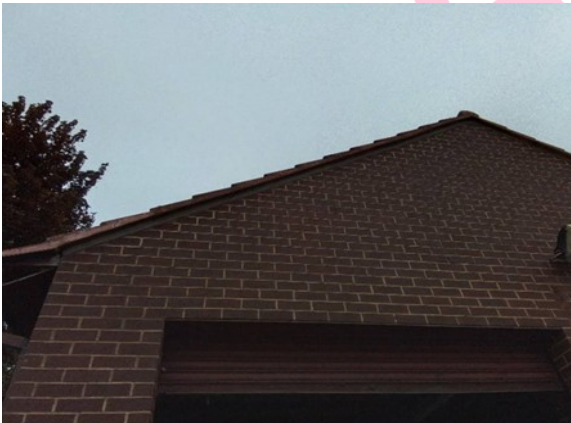
Item 11 Ref: PZ000010

The undercloak to Garage block B (external 090) does not contain asbestos.

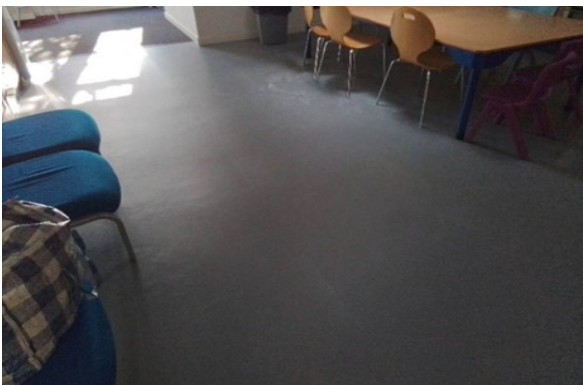
Item 12 Ref: RN000235

The floor adhesive in the Kitchen Cookery Room (G/002) does not contain asbestos.

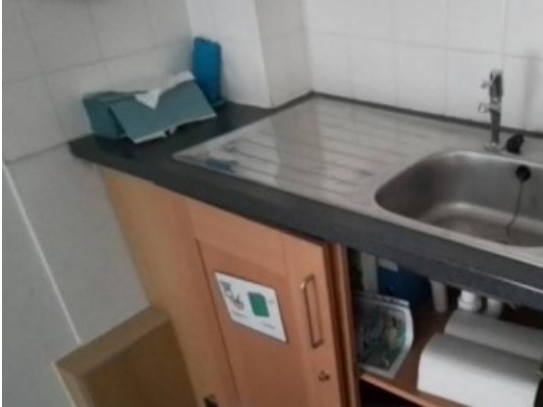
Item 13 Ref: RN000236

The under sink mat in the Kitchen Cookery Room (G/002) does not contain asbestos.

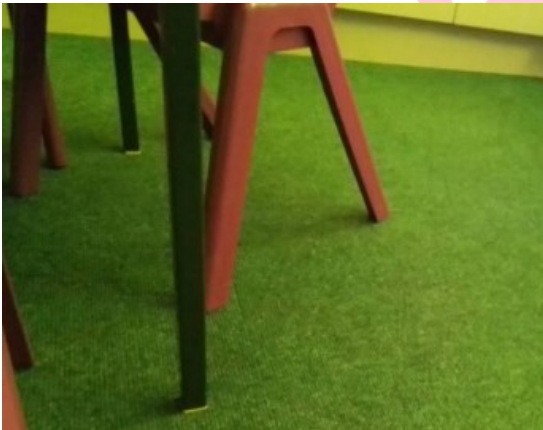
Item 14 Ref: RN000237

The floor adhesive in the Speech and language therapy room (G/003) does not contain asbestos.

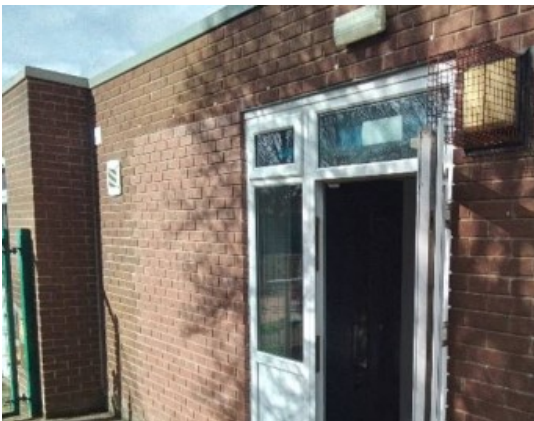
Item 15 Ref: RN000238

The door seal/gasket externally (E/001) does not contain asbestos.

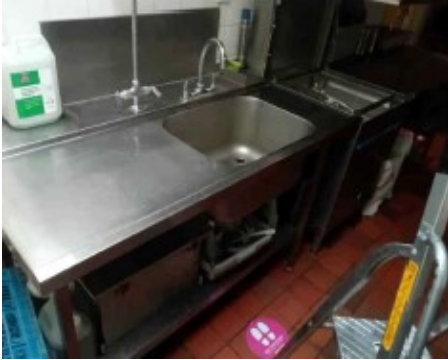
Item 16 Ref: TL001143

The under sink mat in the Kitchen (G/021) does not contain asbestos.

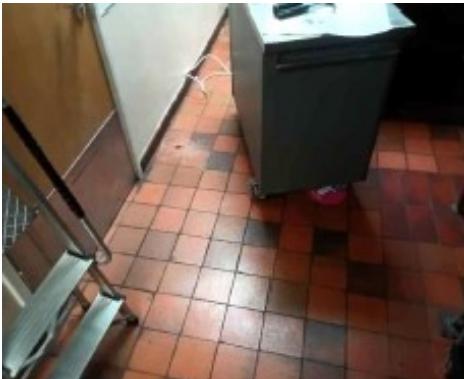
Item 17 Ref: TL001144

The tile joining material to the floor in the Kitchen (G/021) does not contain asbestos.

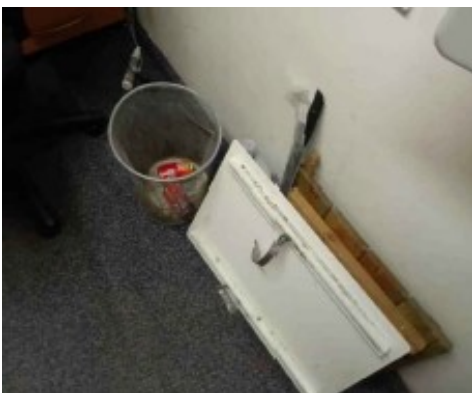
Item 18 Ref: TL001148

The wall skirting in the Caretakers Room G/082) does not contain asbestos.

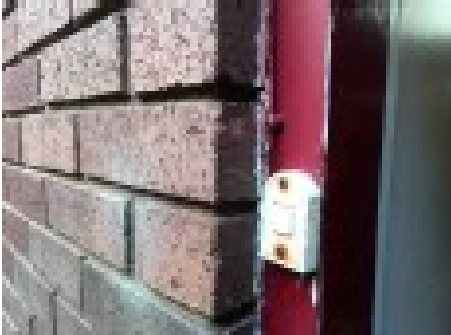
Item 19 Ref: TL001145

17.	TL001144	Floor – tile joining material	Kitchen G/021	No Risk
18.	TL001148	Wall Skirting	Caretakers Room G/082	No Risk
19.	TL001145	Door - seal/Gasket door to kitchen	External E/01	Very Low Risk – To be checked on a 12 monthly basis

The door seal/gasket door to kitchen (External E/01) does contain asbestos.

Any change in appearance should be reported to Property Services.

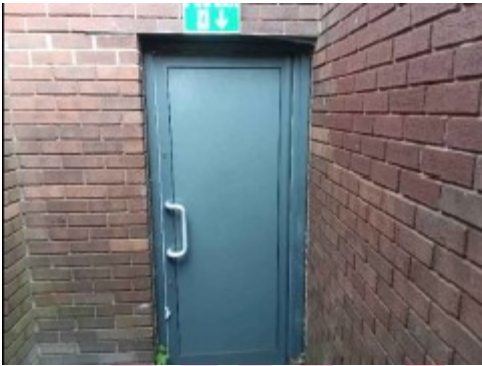
Item 20 Ref: TL001146

The wall remnants around metal door (external E/01) does not contain asbestos.
