ASBESTOS SURVEY REPORT FOR JOPLING HOUSE, JOHN STREET,
SUNDERLAND, SR1 1DP.

Jopling House, John Street, Sunderland

Date: 27 June 2025

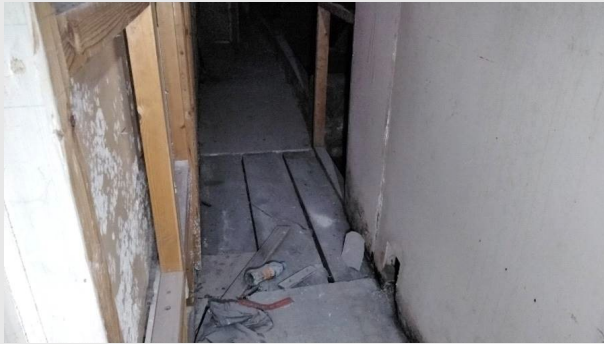
30.	NO000272	Floor tile cream	Z-Sub level 1 Tank Room (Room Z1/018)	Does not contain asbestos.

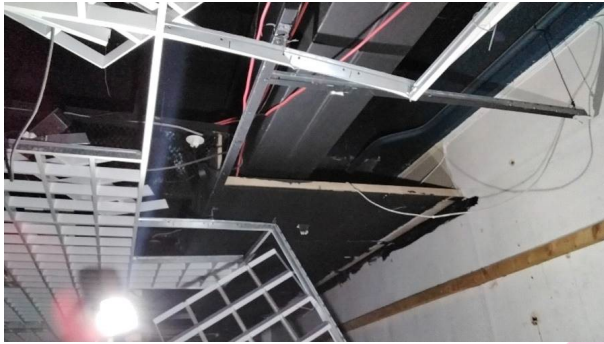
40.	As NO000267	Ductwork joints	Z-Sub level 1 Shop Floor (Room Z1/019)	Presumed to contain asbestos - Any change in its appearance should be recorded and passed to Property Services.

13.	NO000267	Ductwork joints	Z-Sub level 1 Shop Floor (Room Z1/001)	This item is classed as low risk and should be inspected every 6 months
14.	NO000260	Floor tile on shelving	Z-Sub level 1 Store Room (Room Z1/006)	No Risk

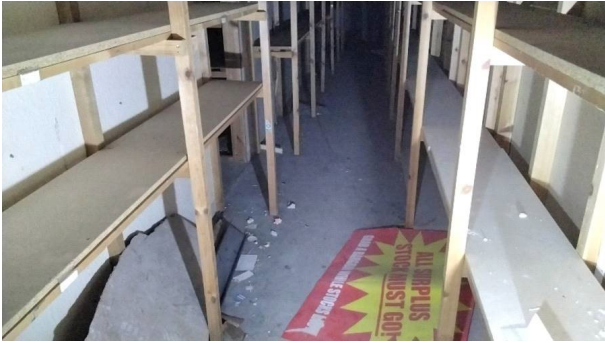
48.	As NO000275	Floor tile grey	Z-Sub level 1 Store Room (Room Z1/027)	Presumed to contain asbestos - Any change in its appearance should be recorded and passed to Property Services.

48.	As NO000275	Floor tile grey	Z-Sub level 1 Store Room (Room Z1/027)	This item is classed as very low risk and should be inspected every 12 months
49.	NO000276	Debris/Residue broken boards	Z-Sub level 1 Store Room (Room Z1/027)	No Risk

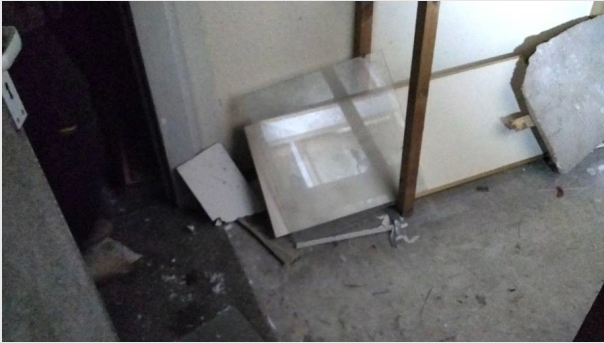
49.	NO000276	Debris/Residue broken boards	Z-Sub level 1 Store Room (Room Z1/027)	Does not contain asbestos.

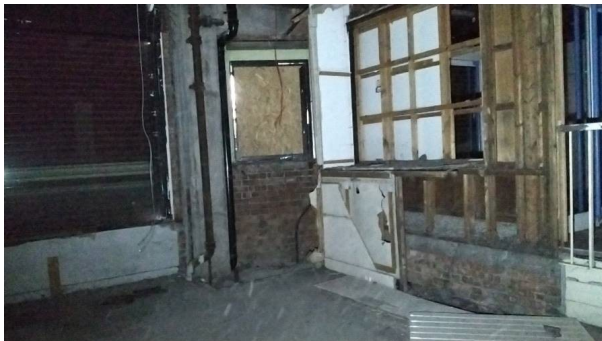
73.	NO000294	Window putty/seal adjacent main entrance damaged and in-situ	Ground Floor Shop Floor Unit 1 (Room G/001)	This item is classed as very low risk and should be inspected every 12 months

73.	NO000294	Window putty/seal adjacent main entrance damaged and in-situ	Ground Floor Shop Floor Unit 1 (Room G/001)	Contains asbestos - Any change in its appearance should be recorded and passed to Property Services.

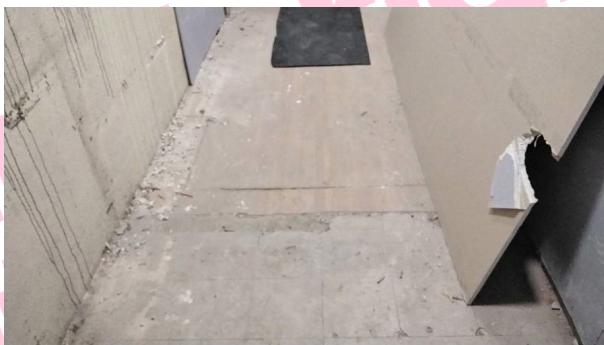
89.	As NO000303	Tile grey/beige beneath modern lino	Ground Floor Hallway/passageway Switch Room (Room G/008)	Presumed to contain asbestos - Any change in its appearance should be recorded and passed to Property Services.

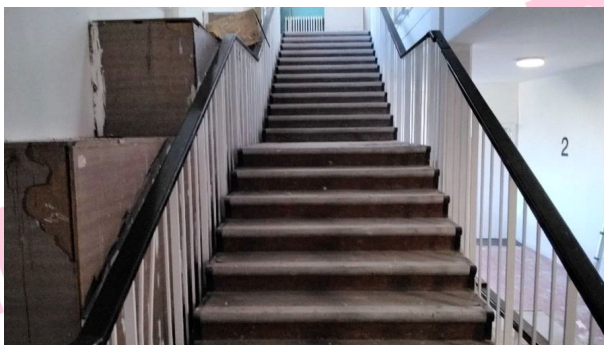
143.	NO000327	Floor nosing to stairs	Second Floor Fire escape (Room 2/015)	Contains asbestos - Any change in its appearance should be recorded and passed to Property Services.

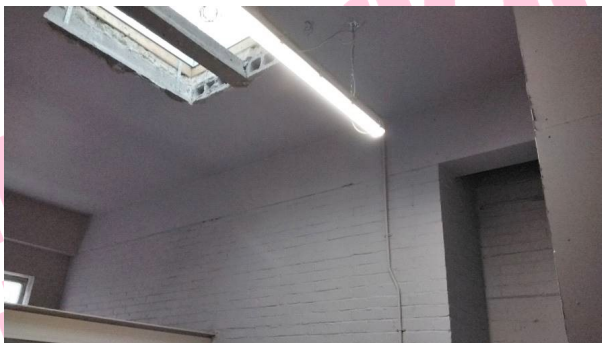
158.	As NO000335	Beam cladding suspected continuation from electric cupboard	Fourth Floor Landing (Room 4/001)	Presumed to contain asbestos - Any change in its appearance should be recorded and passed to Property Services.

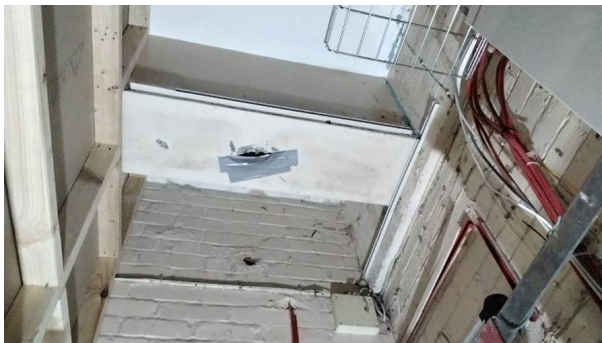
159.	As NO000335	Beam cladding beneath skim, sampled via pre-existing damage to skim	Fourth Floor Electric cupboard (Room 4/002)	Presumed to contain asbestos - Any change in its appearance should be recorded and passed to Property Services.

159.	As NO000335	Beam cladding beneath skim, sampled via pre-existing damage to skim	Fourth Floor Electric cupboard (Room 4/002)	This item should be removed by a licensed contractor asap

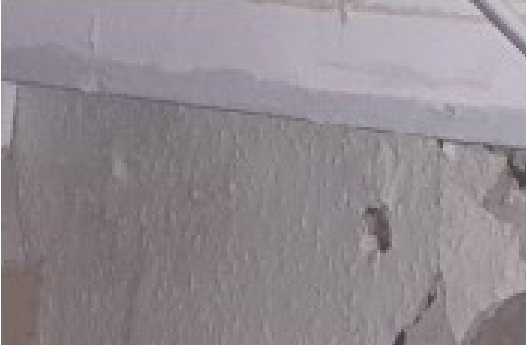
262.	EV005969	Textured coated wall & debris to ceiling loft space where the wall had been damaged to ducting installation	Loft space/Ceiling void (R/01)	Does not contain asbestos.
