ASBESTOS SURVEY REPORT FOR JOPLING HOUSE, JOHN STREET,
SUNDERLAND, SR1 1DP.

Asbestos Register for

Jopling House, John Street, Sunderland

Date: 14 May 2026

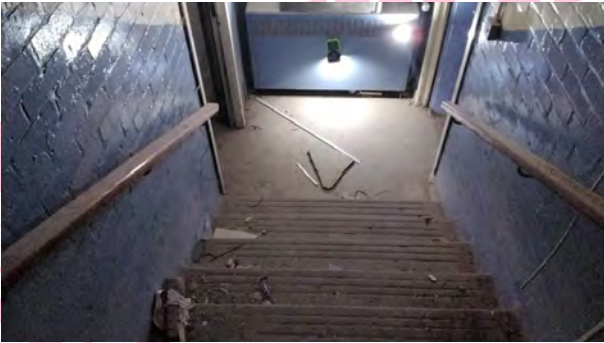
23.	As NO000265	<i>Debris/Residue foot of stairwell and adjacent areas</i>	Z-Sub level 1 Staircase/Stairwell (Room Z1/009)	<i>Removed Sept 2023</i>

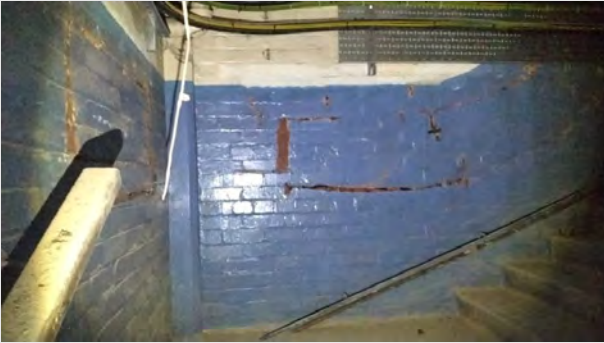
24.	NO000301	Cable braiding insulation remnants to wall	Z-Sub level 1 Staircase/Stairwell (Room Z1/009)	Does not contain asbestos.

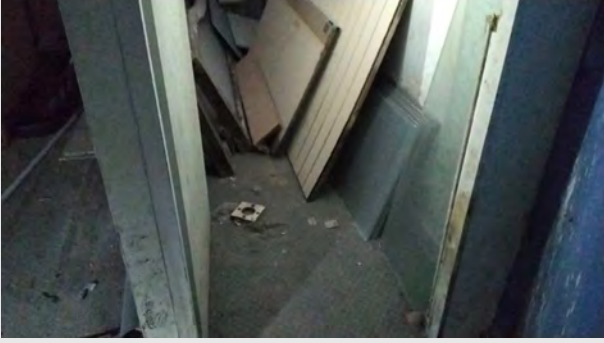
39.	As NO000272	Floor tile cream	Z-Sub level 1 Shop Floor (Room Z1/019)	Does not contain asbestos.

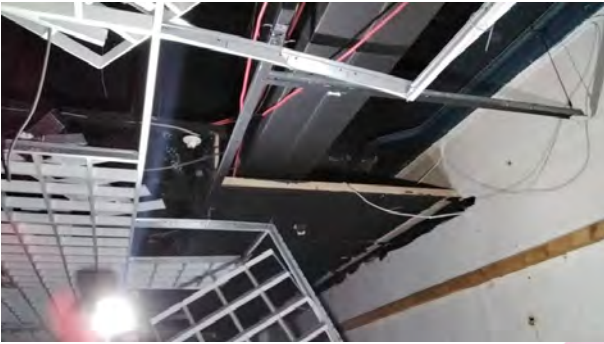
40.	As NO000267	Ductwork joints	Z-Sub level 1 Shop Floor (Room Z1/019)	Presumed to contain asbestos - Any change in its appearance should be recorded and passed to Property Services.

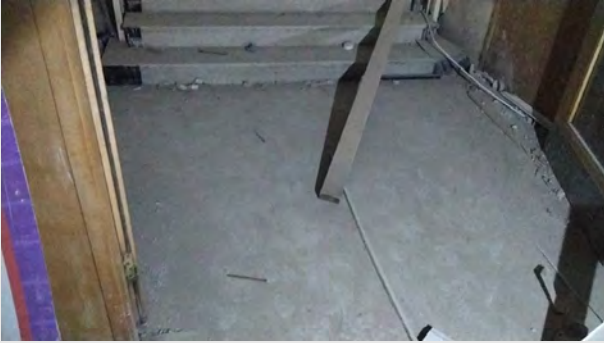
41.	As NO000251	Floor tile pink/grey	Z-Sub level 1 Staircase/Stairwell (Room Z1/020)	Does not contain asbestos.

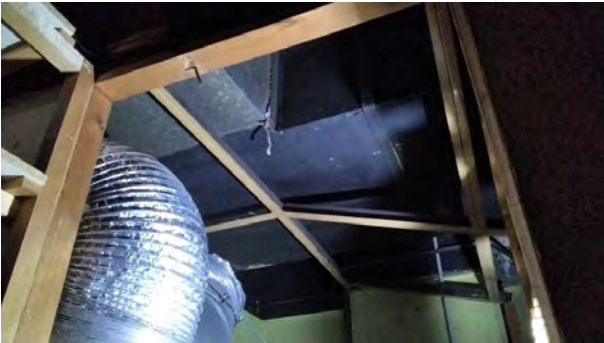
55.	NO000280	Ductwork joints	Z-Sub level 1 Store Room (Room Z1/029)	Contains asbestos - Any change in its appearance should be recorded and passed to Property Services.

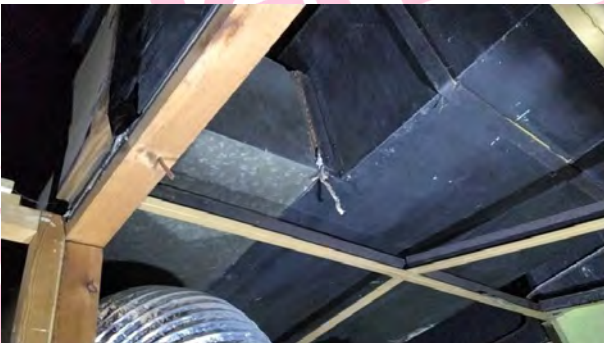
56.	NO000281	Ductwork joints red/brown mastic	Z-Sub level 1 Store Room (Room Z1/029)	Contains asbestos - Any change in its appearance should be recorded and passed to Property Services.

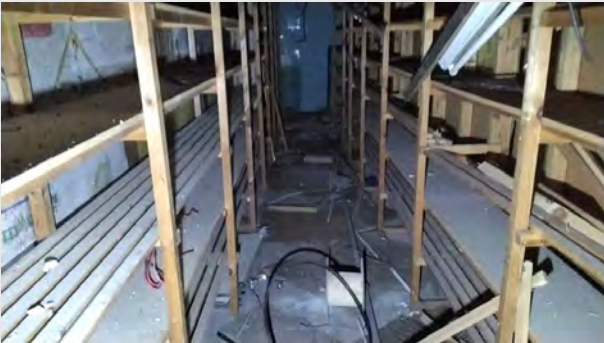
57.	As NO000268	Floor tile	Z-Sub level 1 Store Room (Room Z1/029)	Does not contain asbestos.

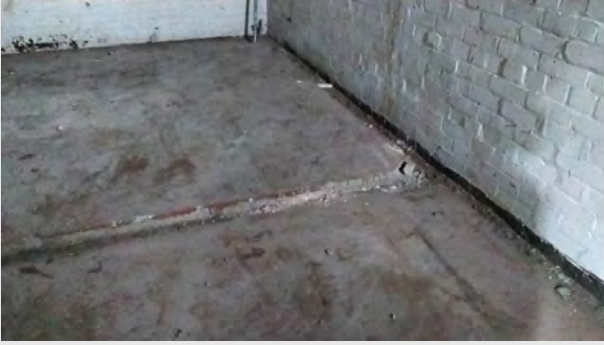
64.	NO000288	Debris/Residue to floor	Z-Sub level 1 Boiler Room (Room Z1/030)	Does not contain asbestos.

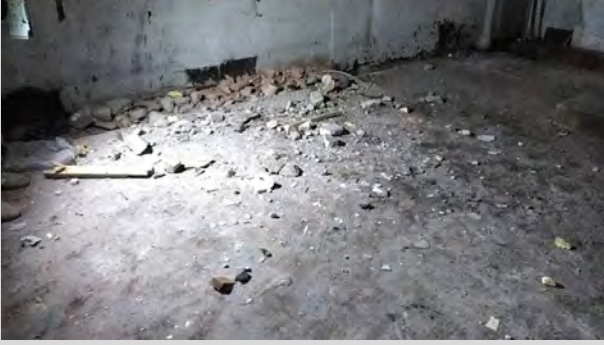
65.	NO000289	Floor tile	Z-Sub level 1 Boiler Room (Room Z1/030)	Removed confirmed on survey J12535

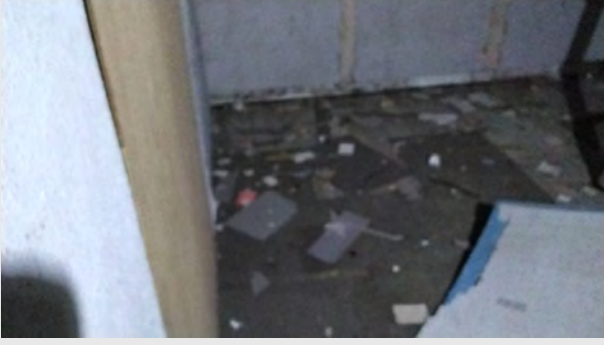
66.	As NO000268	Floor tile	Z-Sub level 1 Store Room (Room Z1/032)	Does not contain asbestos.

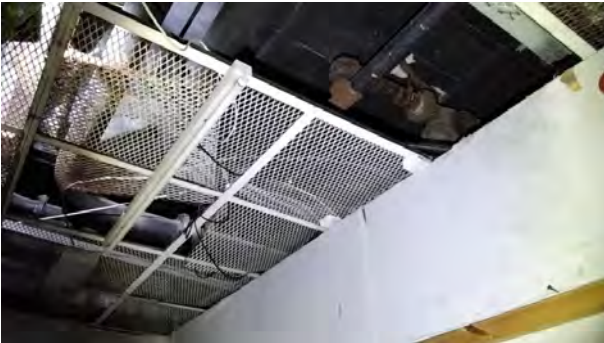
67.	As NO000271	Pipework gasket	Z-Sub level 1 Store Room (Room Z1/032)	Presumed to contain asbestos - Any change in its appearance should be recorded and passed to Property Services.

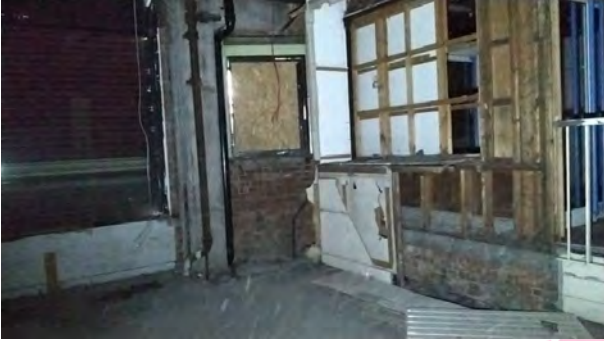
73.	NO000294	Window putty/seal adjacent main entrance damaged and in-situ	Ground Floor Shop Floor Unit 1 (Room G/001)	This item is classed as very low risk and should be inspected every 12 months

73.	NO000294	Window putty/seal adjacent main entrance damaged and in-situ	Ground Floor Shop Floor Unit 1 (Room G/001)	Contains asbestos - Any change in its appearance should be recorded and passed to Property Services.

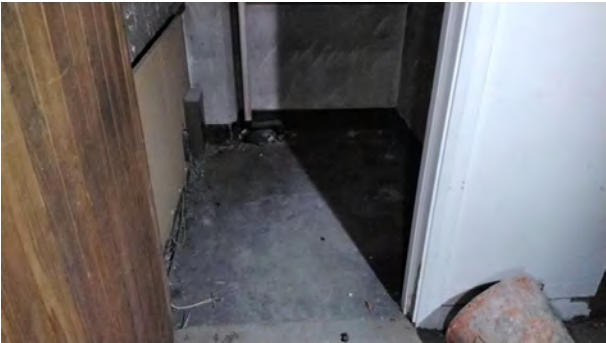
85.	As NO000293	Floor adhesive remnants	Ground Floor Store Room Unit 1 (Room G/004)	Presumed to contain asbestos - Any change in its appearance should be recorded and passed to Property Services.

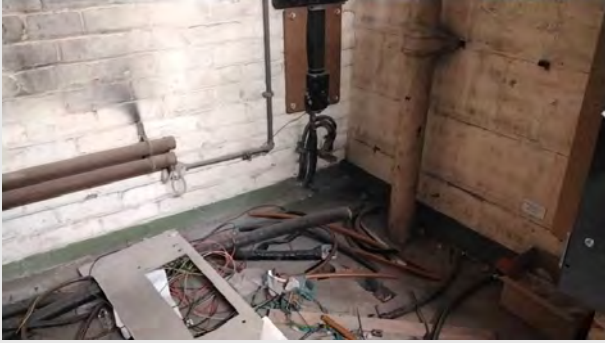
91.	As NO000254	Cable braiding insulation	Ground Floor Switch Room behind lifts (Room G/009)	Does not contain asbestos.

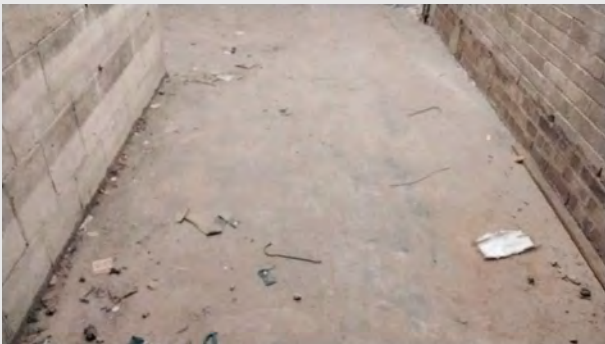
92.	NO000306	Floor jointing compound	Ground Floor Switch Room behind lifts (Room G/009)	Does not contain asbestos.

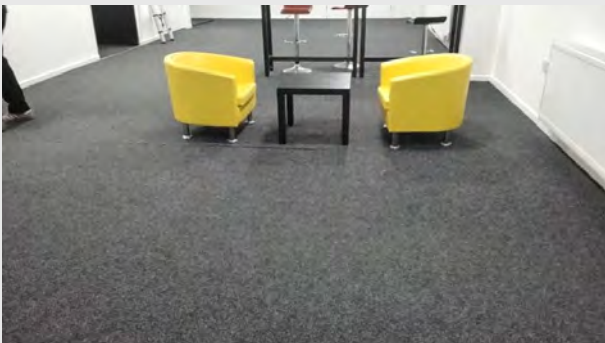
93.	NO000307	Floor adhesive remnants beneath carpet	Ground Floor Hallway/passageway lift lobby (Room G/010)	Does not contain asbestos.

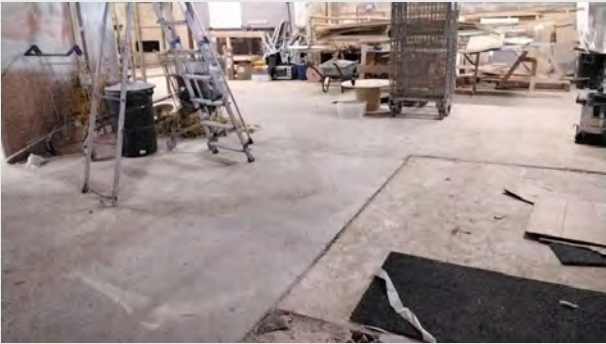
104.	As NO000306	Floor jointing compound	Ground Floor Store Room unit 4 (Room G/018)	Does not contain asbestos.

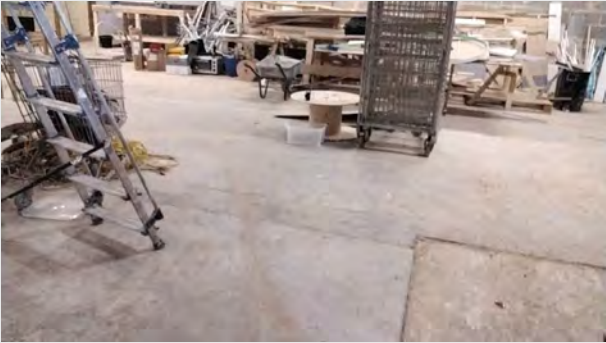
105.	As NO000307	Floor adhesive remnants	Ground Floor Store Room unit 4 (Room G/018)	Does not contain asbestos.

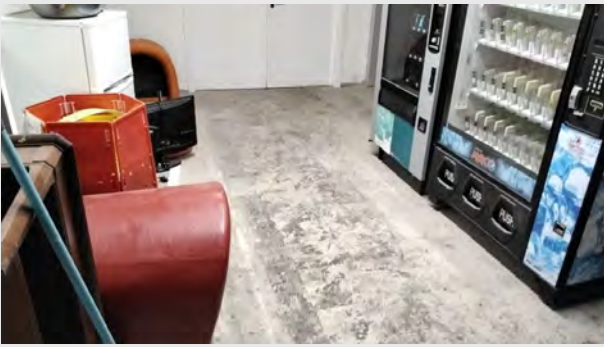
122.	As NO000307	Floor adhesive remnants	Ground Floor Bin store (Room G/031)	Does not contain asbestos.

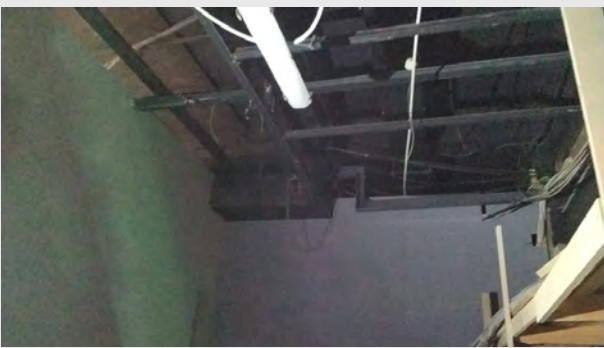
123.	As NO000315	Ceiling tiles	Ground Floor Store Room (Room G/032)	Does not contain asbestos.

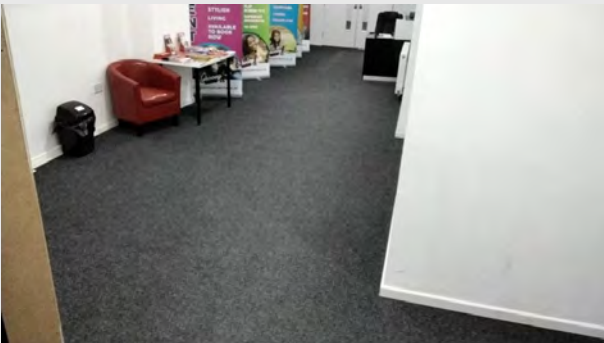
127.	As NO000307	Floor adhesive remnants	Ground Floor Entrance Hall/Foyer/Lobby (Room G/037)	Does not contain asbestos.

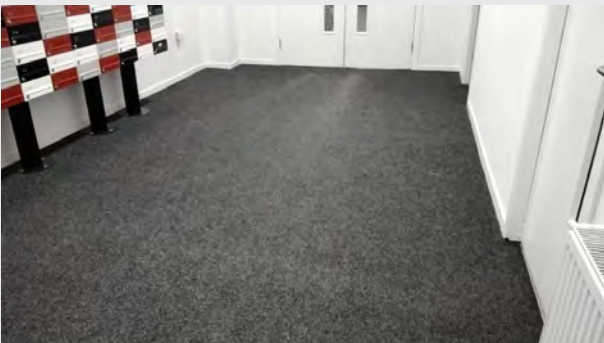
128.	As NO000307	Floor adhesive remnants	Ground Floor Hallway/Passageway (Room G/038)	Does not contain asbestos.

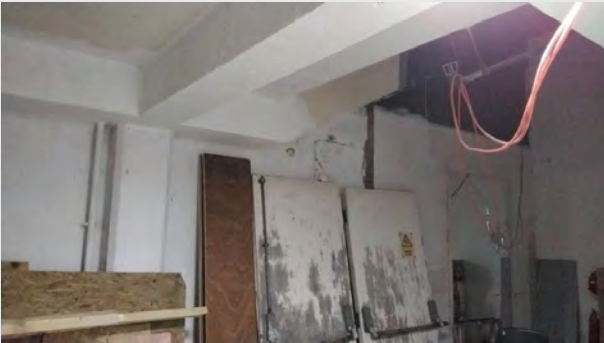
131.	NO000318	Wall – within hole in wall under stairs	Ground Floor Staircase/Stairwell (Room G/039)	Does not contain asbestos.

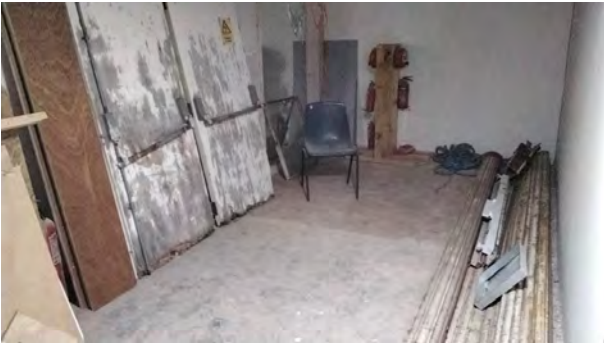
132.	NO000319	Window putty/seal to discarded window	Ground Floor Staircase/Stairwell (Room G/039)	Contains asbestos - Any change in its appearance should be recorded and passed to Property Services.

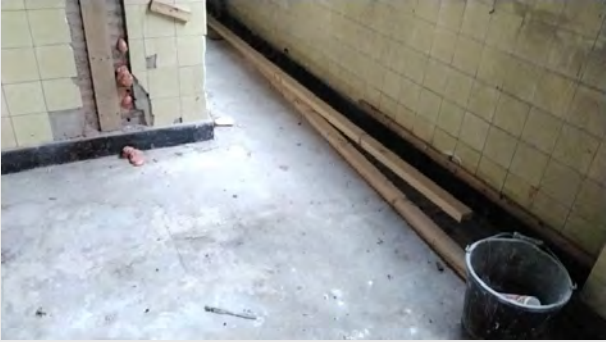
149.	As NO000321	Floor tile beneath carpet	Second Floor Store Room Former toilets (Room 2/019)	Does not contain asbestos.

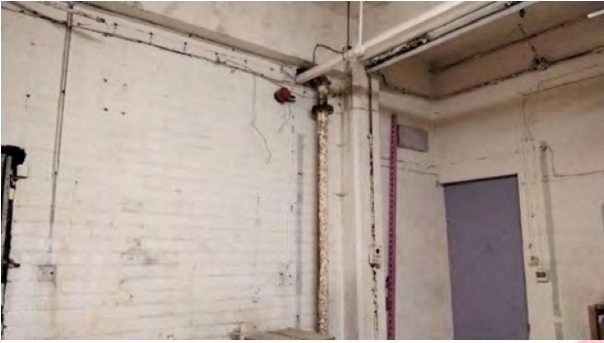
157.	Presumed	Pipework gaskets too deeply recessed to sample	Third Floor Store Room (Room 3/023)	Presumed to contain asbestos - Any change in its appearance should be recorded and passed to Property Services.

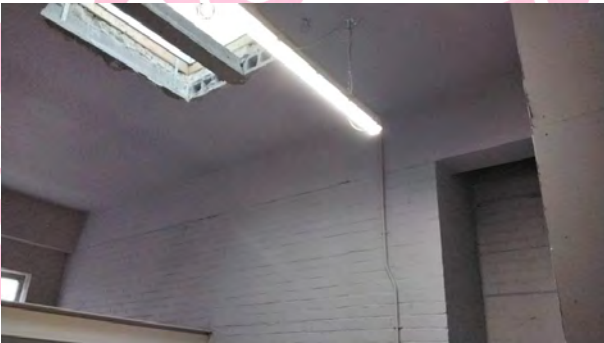
158.	As NO000335	Beam cladding suspected continuation from electric cupboard	Fourth Floor Landing (Room 4/001)	Presumed to contain asbestos - Any change in its appearance should be recorded and passed to Property Services.

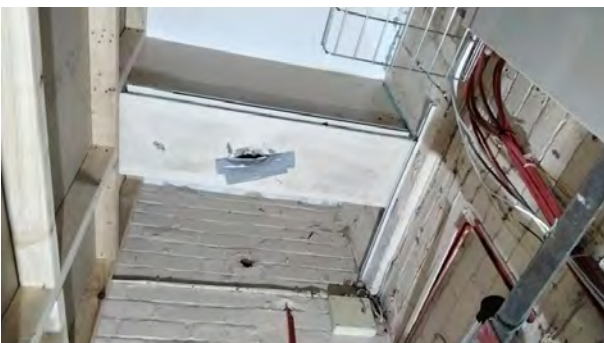
159.	As NO000335	Beam cladding beneath skim, sampled via pre-existing damage to skim	Fourth Floor Electric cupboard (Room 4/002)	Presumed to contain asbestos - Any change in its appearance should be recorded and passed to Property Services.

159.	As NO000335	Beam cladding beneath skim, sampled via pre-existing damage to skim	Fourth Floor Electric cupboard (Room 4/002)	This item should be removed by a licensed contractor asap

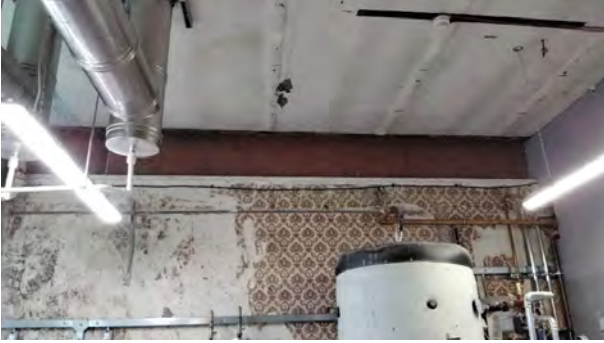
163.	As NO000336	<i>Beam cladding remnants beneath girder</i>	<i>Fourth Floor Plant Room (Room 4/007)</i>	<i>Removed Sept 2023</i>

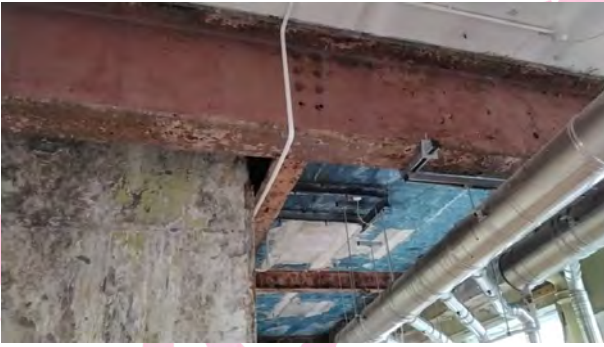
164.	As NO000337	<i>Debris/Residue to steel girder</i>	<i>Fourth Floor Plant Room (Room 4/007)</i>	<i>Removed Sept 2023</i>

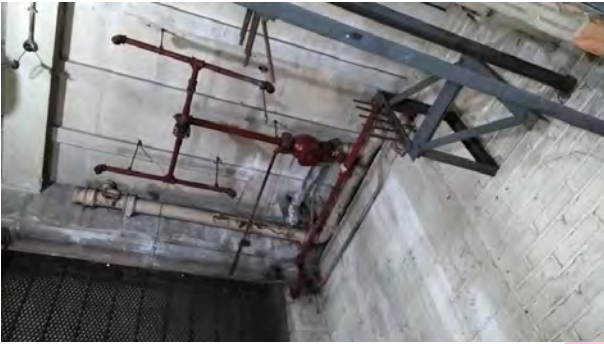
172.	Presumed	Pipework gaskets to sprinkler system	Mezzanine Switch Room midway between basement and ground floor	Presumed to contain asbestos - Any change in its appearance should be recorded and passed to Property Services.

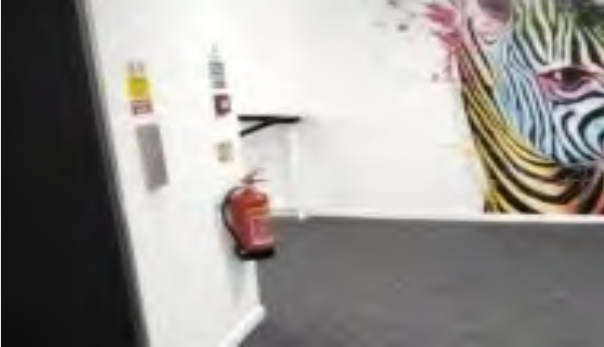
177.	As NG001609	Wall panel	First Floor, Entrance Hall/Foyer/Lobby Main lift lobby (Room 1/001)	Does not contain asbestos.

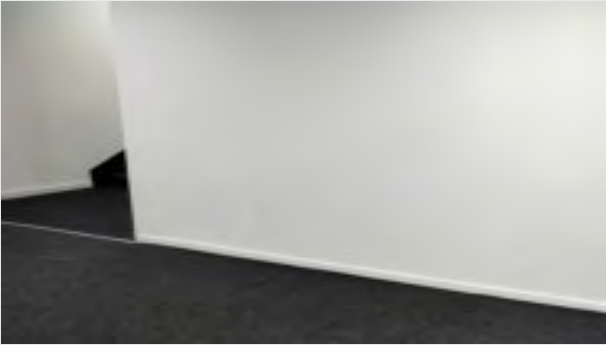
188.	NG001600	Wall panel	Entrance Hall/Foyer/Lobby Lift lobby east (Room 2/001)	Does not contain asbestos.

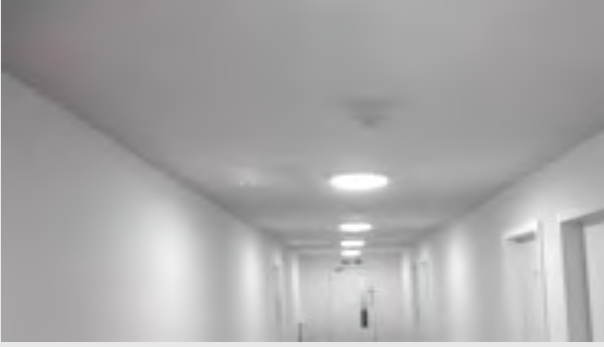
201.	As NG001613	Ceiling	Corridor West corridor (Room 2/011)	Does not contain asbestos.

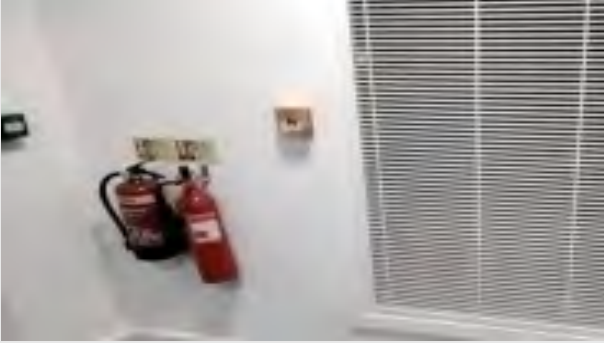
208.	NG001598	Wall panel	Entrance Hall/Foyer/Lobby (Room 3/005)	Does not contain asbestos.

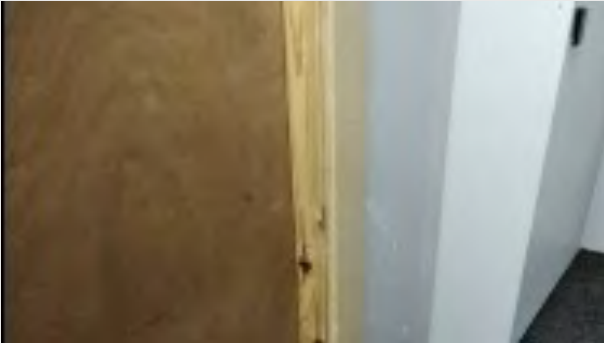
209.	NG001599	Wall panel	Staircase/Stairwell (Room 3/006)	Does not contain asbestos.

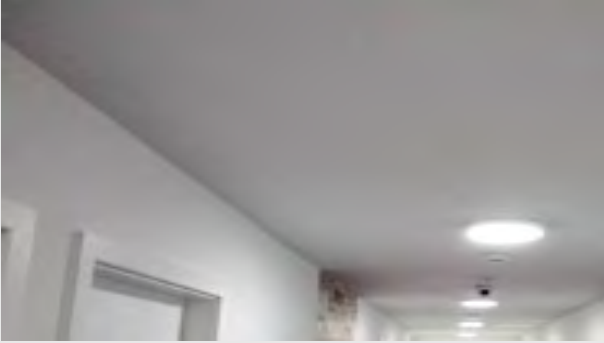
214.	As NG001614	Ceiling coating	Corridor West Corridor (Room 3/010)	Does not contain asbestos.

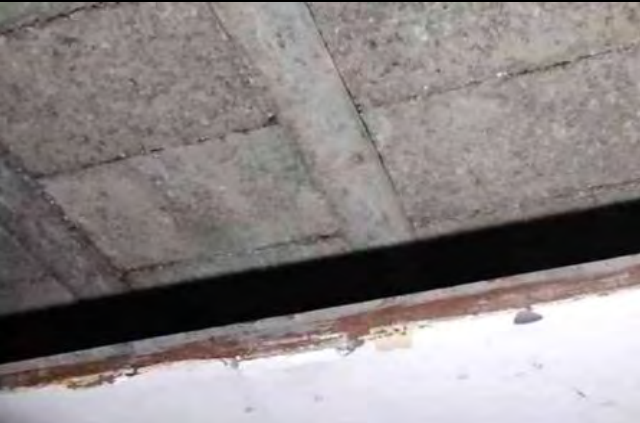
223.	AW005670	Ceiling void residue to redundant radiator	Corridor adjacent Room 214 (Room 2/002)	Does not contain asbestos.

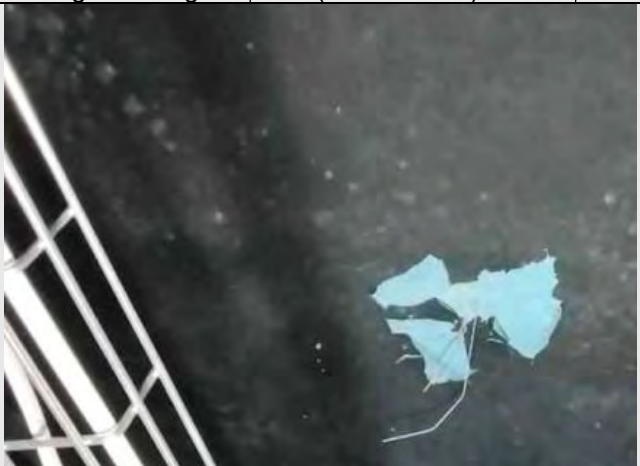
224.	AW005671	Ceiling void paint coating to ceiling	Corridor adjacent room 316 (Room 3/001)	Does not contain asbestos.

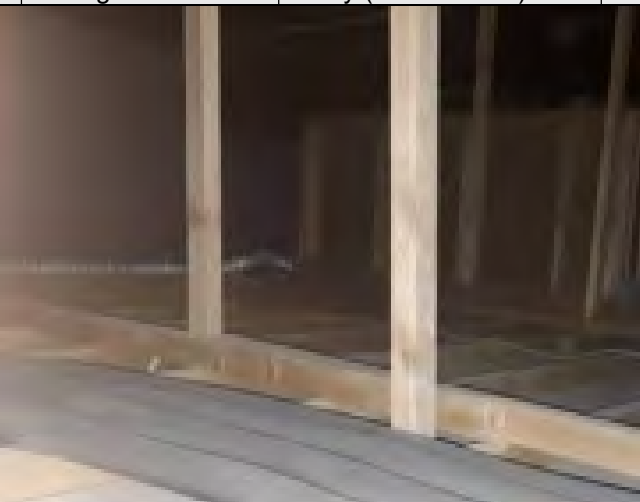
225.	NZ001414	Debris/Residue to ceiling floor below	Loft space within lift lobby (Room 1/001)	Does not contain asbestos.

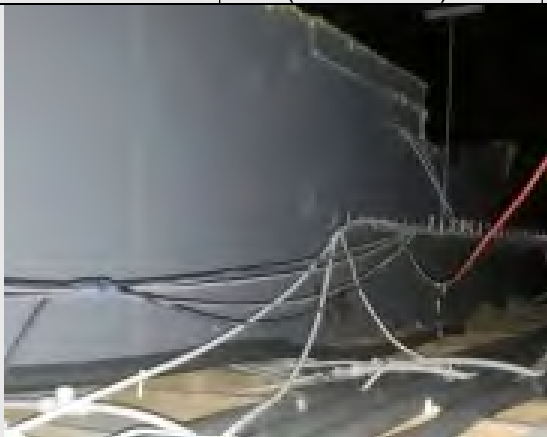
229.	NZ001416	Debris/Residue to ceiling floor below	Loft space within corridors to flats 112-119 (Room 1/005)	Does not contain asbestos.

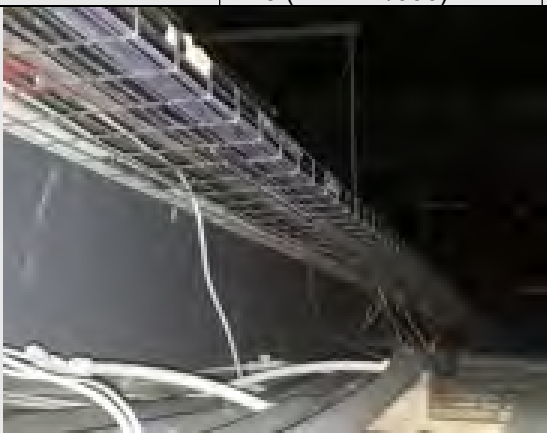
230.	As NZ001416	Debris/Residue to ceiling floor below	Loft space within corridors to flats 120-125 (Room 1/006)	Does not contain asbestos.

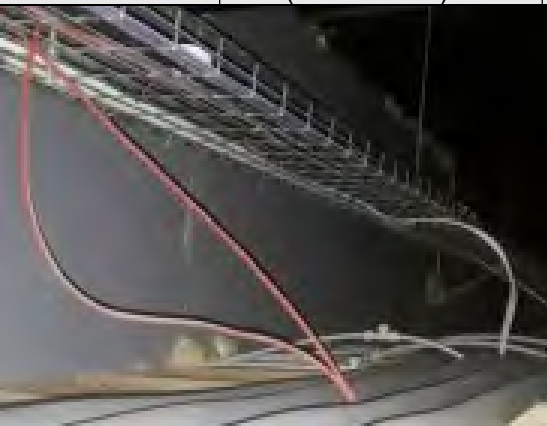
231.	NZ001417	Debris/Residue to ceiling floor below	Loft space within corridors to flats 126-130 (Room 1/007)	Does not contain asbestos.

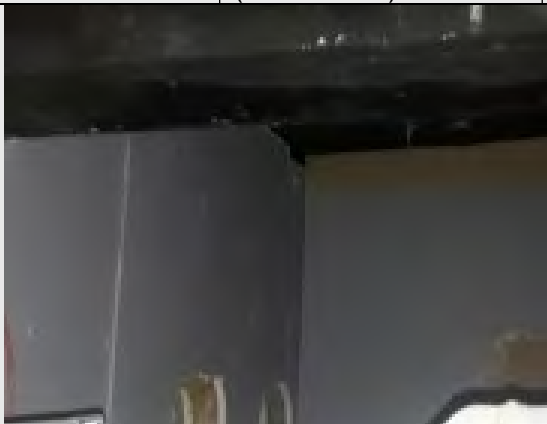
232.	As NZ001417	Debris/Residue to ceiling floor below	Loft space within corridor adjacent flat 130 (Room 1/008)	Does not contain asbestos.

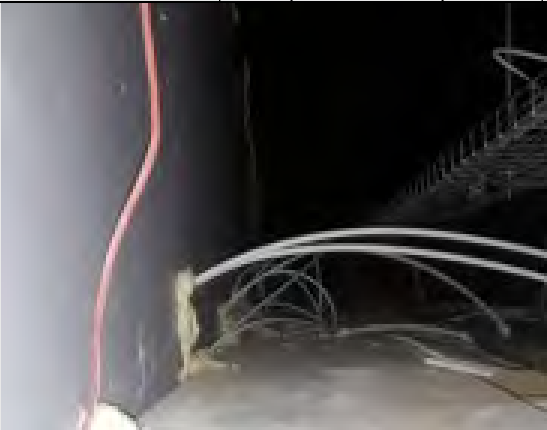
233.	NZ001418	Debris/Residue to ceiling floor below	Loft space within corridors to flats 101- 103 (Room 1/009)	Does not contain asbestos.

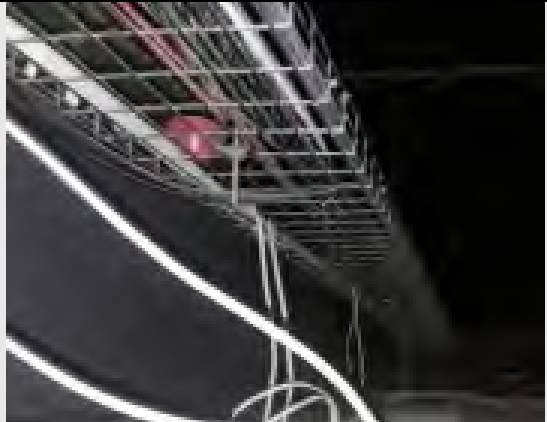
234.	As NZ001418	Debris/Residue to ceiling floor below	Loft space within corridors to flats 104- 105 (Room 1/010)	Does not contain asbestos.

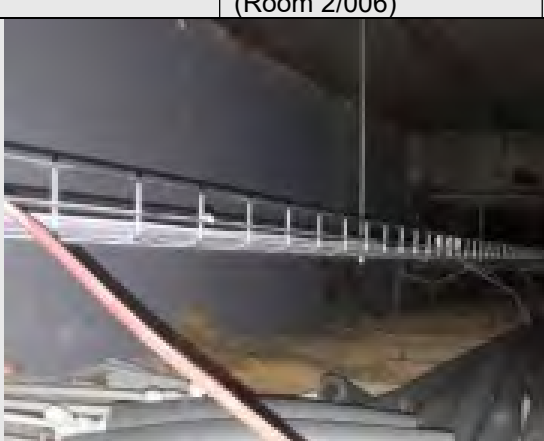
240.	As NZ001410	Debris/Residue to ceiling floor below	Loft space within corridor to flats 212-219 (Room 2/006)	Does not contain asbestos.

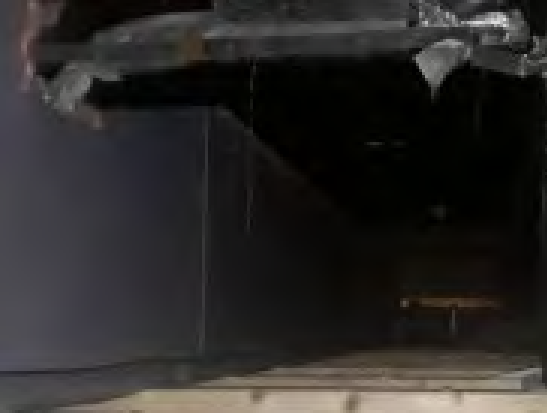
244.	As NZ001412	Debris/Residue to ceiling floor below	Loft space within corridor adjacent flat 230 (Room 2/010)	Does not contain asbestos.

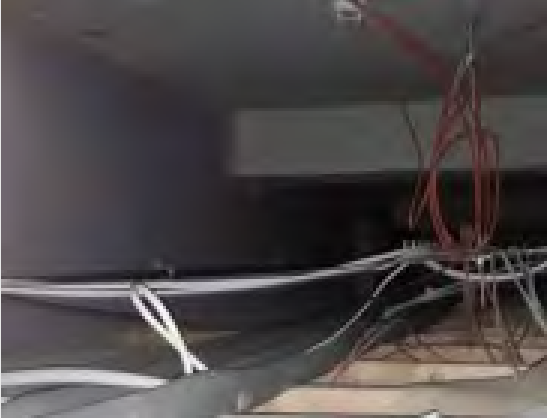
245.	NZ001413	Debris/Residue to ceiling floor below	Loft space within corridor to flats 201-203 (Room 2/011)	Does not contain asbestos.

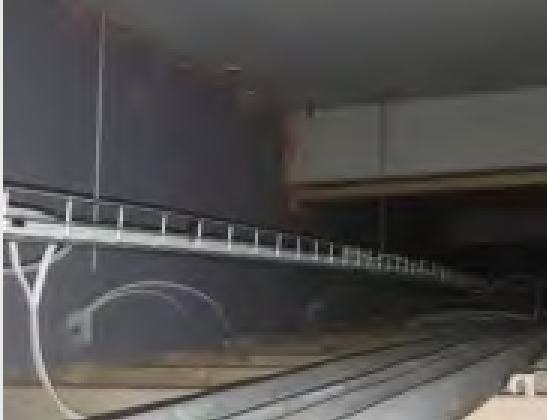
246.	As NZ001413	Debris/Residue to ceiling floor below	Loft space within corridor to flats 204-205 (Room 2/012)	Does not contain asbestos.

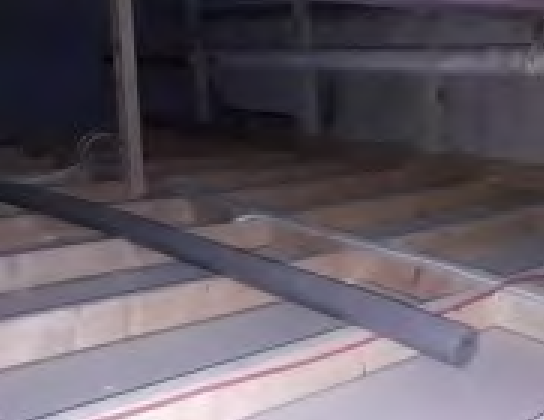
247.	NZ001403	Debris/Residue to ceiling floor below	Loft space within lobby (Room 3/001)	Does not contain asbestos.

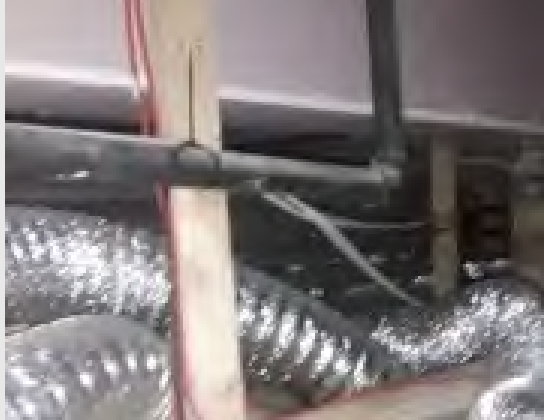
248.	As NZ001403	Debris/Residue to ceiling floor below	Loft space within football pool room lobby (Room 3/002)	Does not contain asbestos.

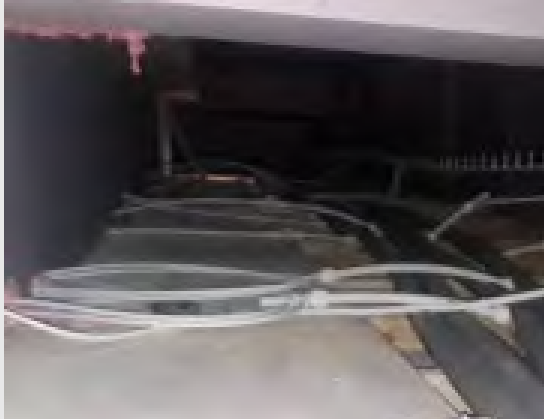
249.	NZ001404	Debris/Residue to ceiling floor below	Loft space within corridor to flats 306-311 (Room 3/003)	Does not contain asbestos.

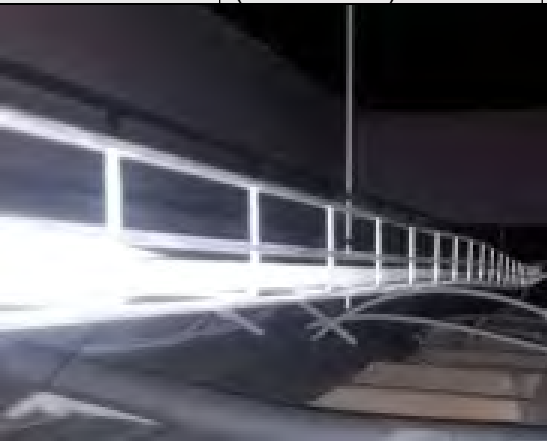
251.	NZ001405	Debris/Residue to ceiling floor below	Loft space within corridor to flats 312-319 (Room 3/005)	Does not contain asbestos.

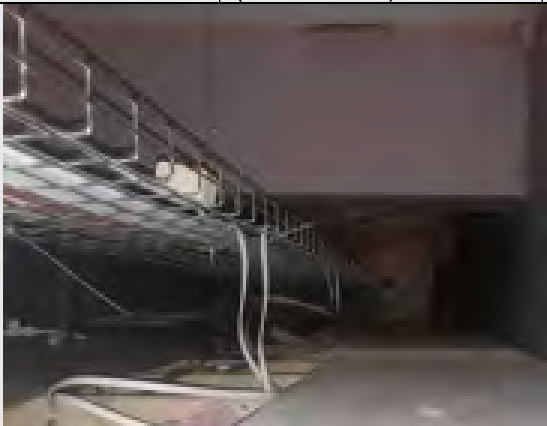
252.	As NZ001405	Debris/Residue to ceiling floor below	Loft space within corridor to flats 320-325 (Room 3/006)	Does not contain asbestos.

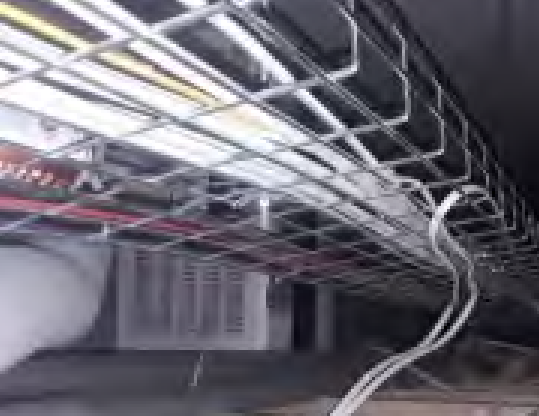
254.	NZ001406	Debris/Residue to ceiling floor below	Loft space within corridor to flats 326-330 (Room 3/008)	Does not contain asbestos.

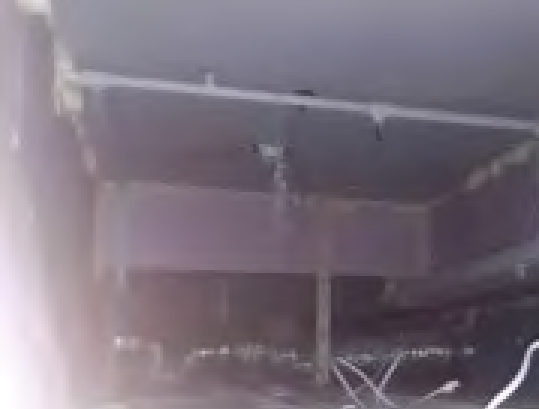
255.	As NZ001406	Debris/Residue to ceiling floor below	Loft space within corridor adjacent flat 330 (Room 3/009)	Does not contain asbestos.

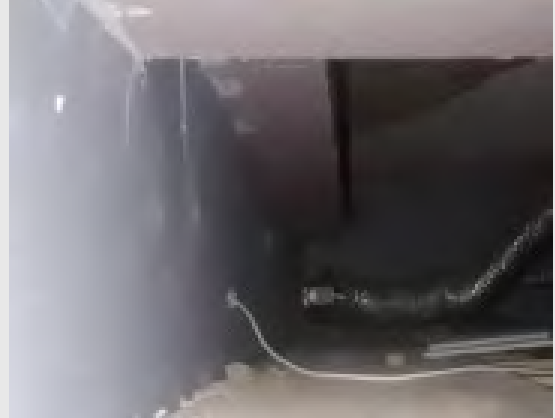
257.	As NZ001407	Debris/Residue to ceiling floor below	Loft space within corridor to flats 301-304 (Room 3/011)	Does not contain asbestos.

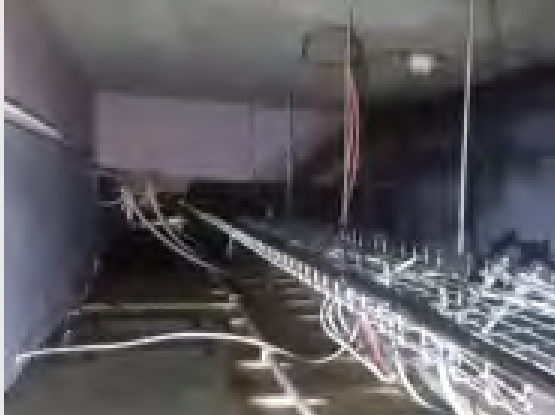
258.	NZ001401	Debris/Residue to ceiling floor below	Loft space within corridor to flats 413-414 (Room 4/001)	Does not contain asbestos.

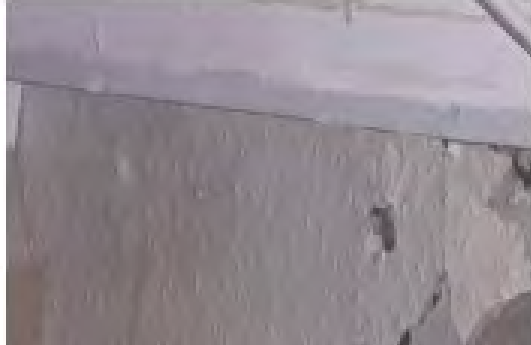
262.	EV005969	Textured coated wall & debris to ceiling loft space where the wall had been damaged to ducting installation	Loft space/Ceiling void (R/01)	Does not contain asbestos.
