ASBESTOS SURVEY REPORT FOR 24 CHISWICK SQUARE, SUNDERLAND

Asbestos Register for

24 CHISWICK SQUARE, SUNDERLAND

Date: 17 September 2024

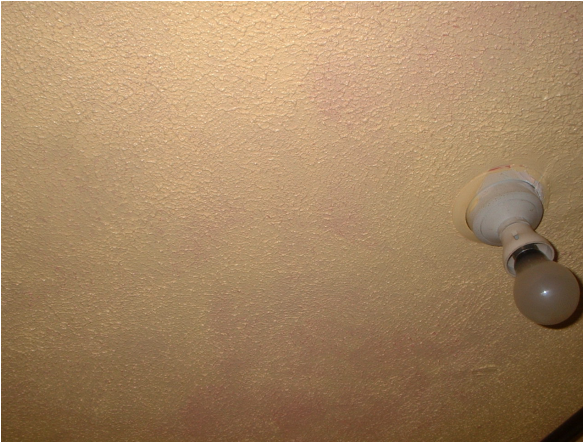
Item 1 Ref: Sample 01

The textured coating to the ceiling in the bathroom does not contain asbestos.

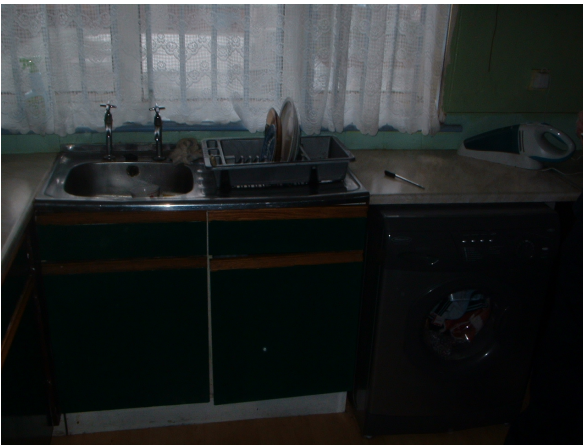
Item 2 - Ref: Sample 02

The sink pad to the kitchen does not contain asbestos.

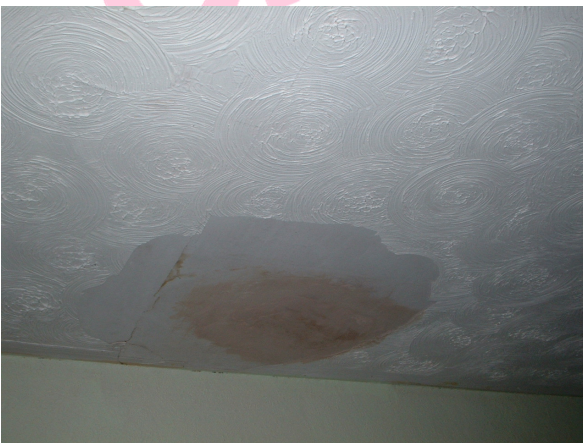
Item 3 - Ref: Sample 03

The textured coating to the ceiling in the kitchen does not contain asbestos.

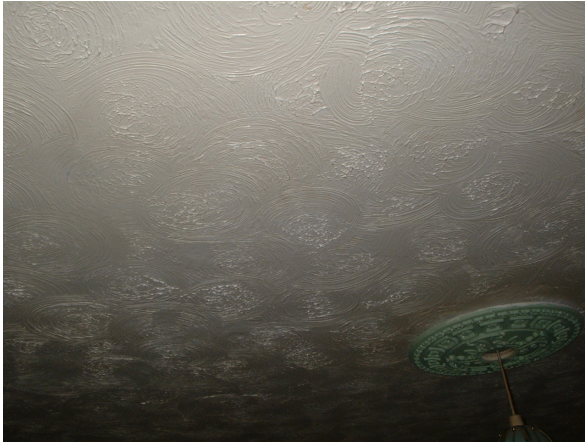
Item 4 - Ref: Sample 04

The textured coating to the ceiling in the living room does not contain asbestos.

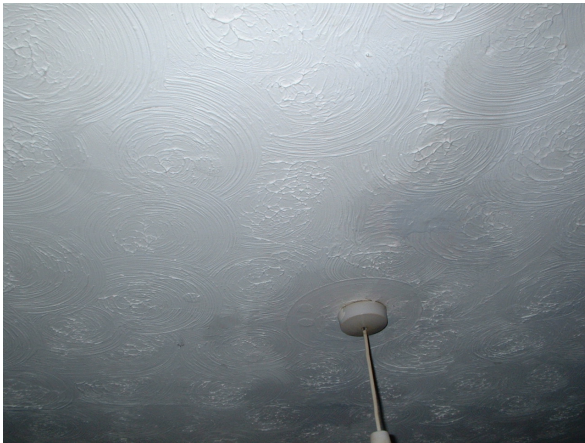
Item 5 - Ref: Sample 05

The textured coating to the ceiling in the bedroom does not contain asbestos.

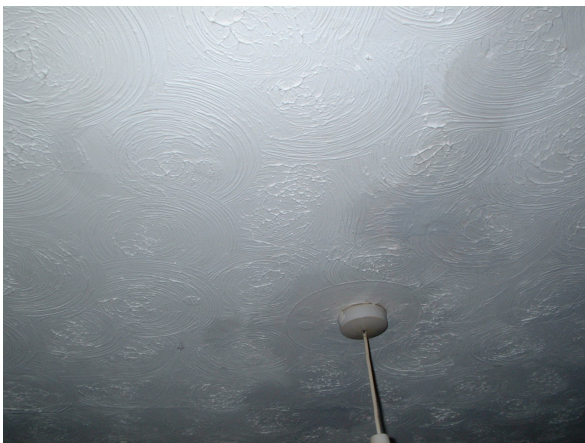
Item 6 - Ref: Sample 06

The textured coating to the ceiling in the corridor does not contain asbestos.

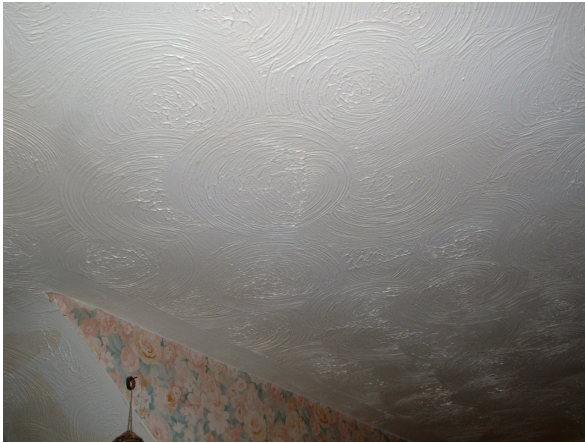
Item 7 - Ref: Sample 07

The textured coating to the ceiling in the bedroom does not contain asbestos.

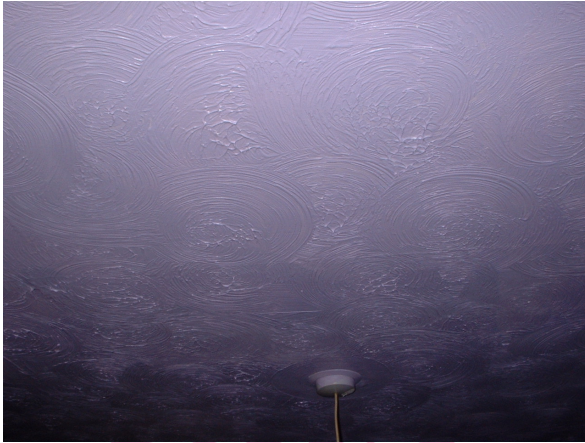
Item 8 - Ref: Sample 08

The textured coating to the ceiling in the bedroom does not contain asbestos.

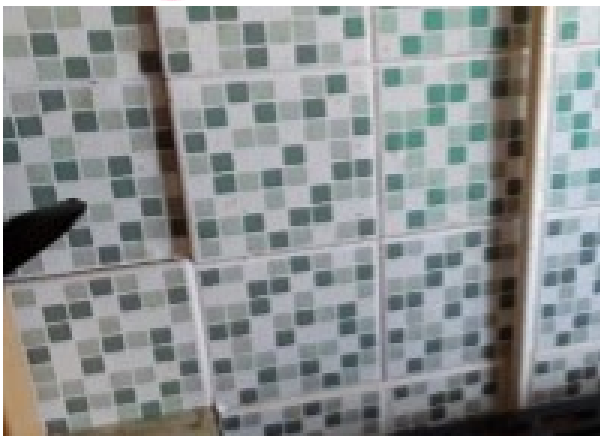
Item 9 - Ref: 20-27625-2

The ceramic tile adhesive in the kitchen does not contain asbestos.

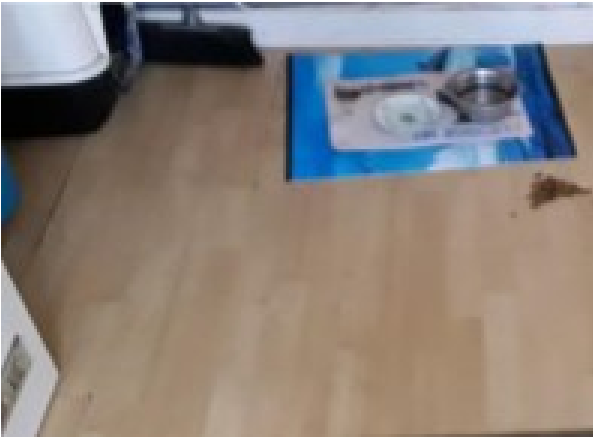
Item 10 - Ref: 20-27625-3

The tiles and adhesive under the laminate in the Kitchen does not contain asbestos.

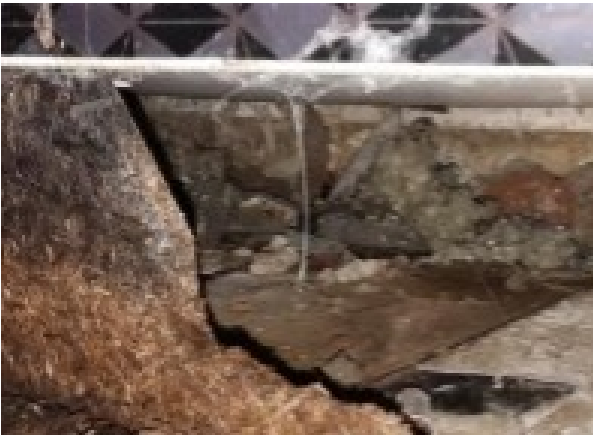
Item 11 - Ref: 20-27625-4

The debris under the sink unit does contain asbestos.

Noted as removed on reinspection survey 2024

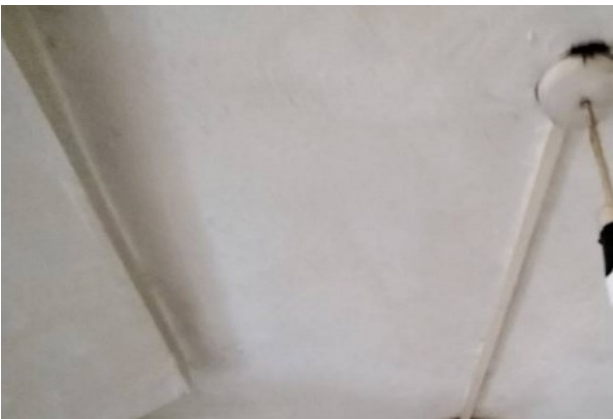
Item 12 - Ref: SC004898

The Textured coating to ceiling (Landing Rm 2/001) does not contain asbestos.

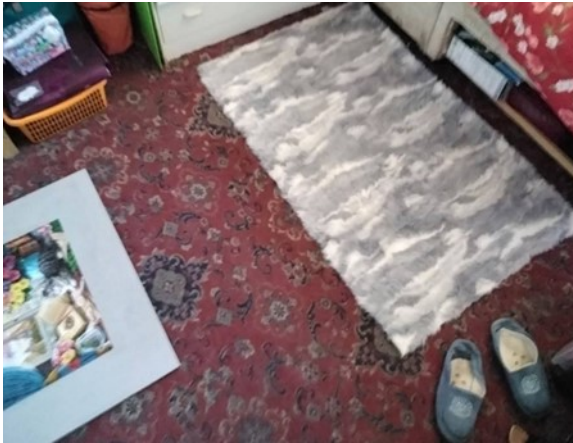
Item 13 - Ref: SC004900

The Floor tile under floor covering (Bedroom 3 Rm 2/005) does contain asbestos.

Noted as removed on survey 2023.

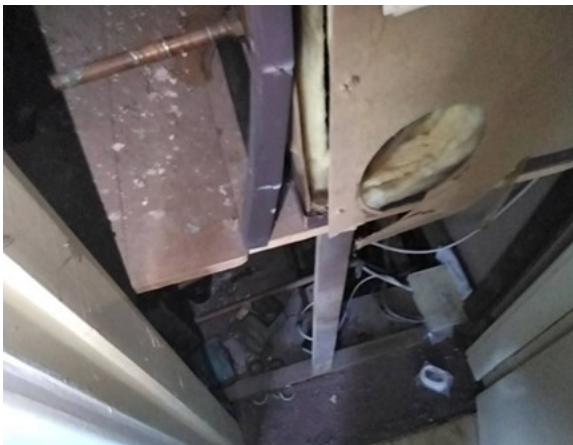
Item 14 - Ref: SC004897

The Tank with associated debris to floor (Heating Cupboard Rm 3/005) does not contain asbestos.

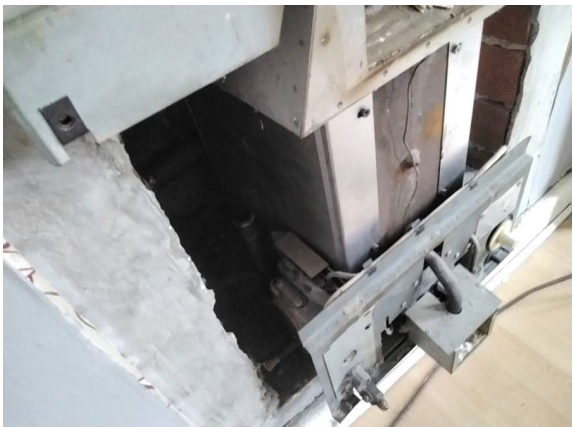
Item 15 - Ref: SC004975

The joint/gasket debris (Living Rm/Lounge Rm 1/001) does not contain asbestos.

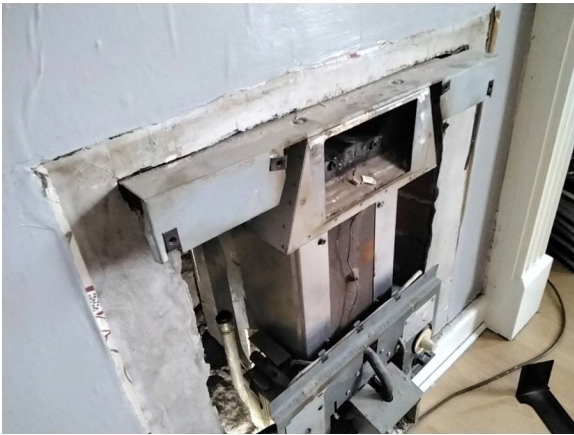
Item 16 - Ref: SC004976

The paper/card product debris (Living Rm/Lounge Rm 1/001) does not contain asbestos.

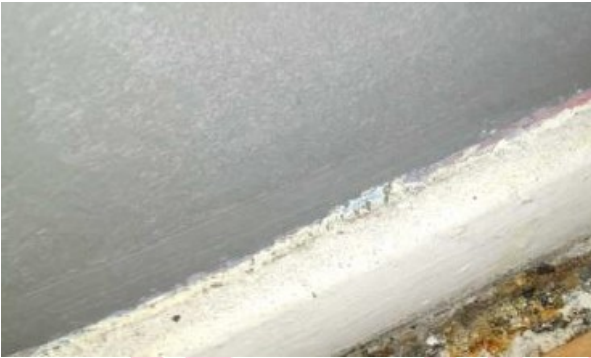
Item 17 - Ref: 23-62130-1

The floor adhesive below modern vinyl tiles in the Entrance Hall (Area 1) does contain asbestos.

Item 17	Floor adhesive below modern vinyl tiles (Entrance Hall Area 1)	Low Risk	6 monthly	21/12/2026
Item 18	Floor adhesive below modern vinyl flooring (Hall and Stairs Area 2)	Low Risk	6 monthly	21/12/2026

Any change in appearance should be reported to Property Services.

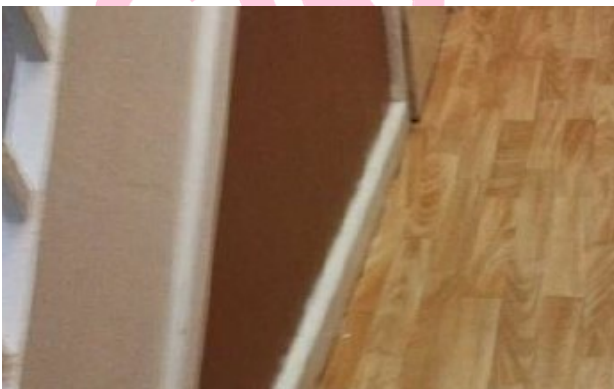
Item 18 - Ref: 23-62130-1

The floor adhesive below modern vinyl flooring in the Hall and Stairs (Area 2) does contain asbestos.

Any change in appearance should be reported to Property Services.

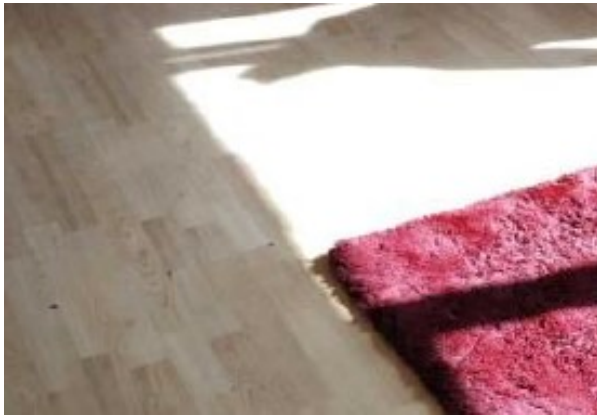
Item 19 - Ref: 23-62130-1

The floor below laminate flooring in the Lounge (Area 9) does contain asbestos.

Item 19	Floor below laminate flooring (Lounge Area 9)	Low Risk	6 monthly	21/12/2025

Any change in appearance should be reported to Property Services.

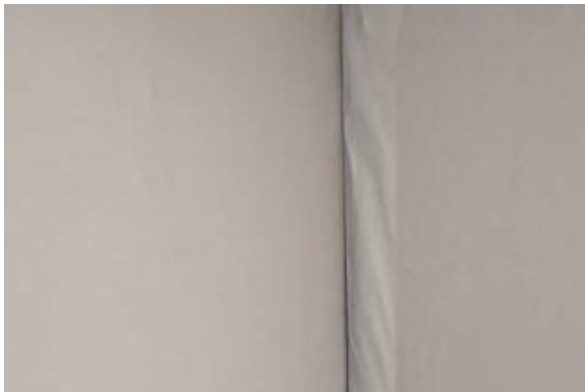
Item 20 - Ref: 23-62130-4

The boxing to wood panel in the Lounge (Area 9) does not contain asbestos.

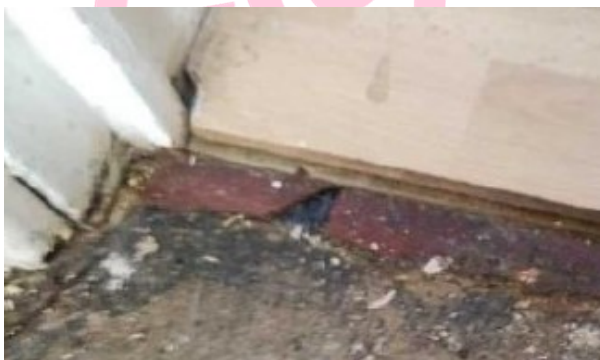
Item 21 - Ref: 23-62130-3

The tile and adhesive remnants at doorway in Bedroom 1 (Area 010) does contain asbestos.

Any change in appearance should be reported to Property Services.

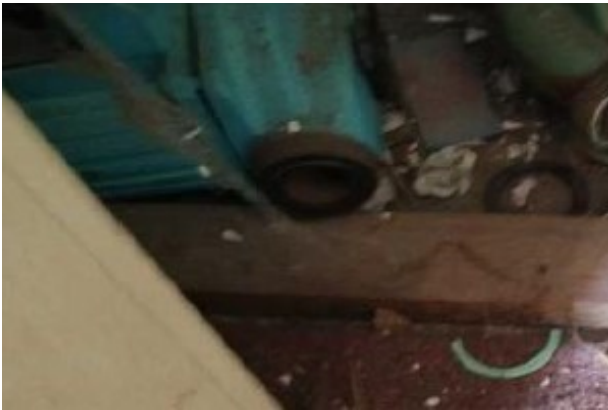
Item 22 - Ref: 23-62130-8

The gasket debris to floor in the Boiler/Heating Cupboard (Area 012) does not contain asbestos.

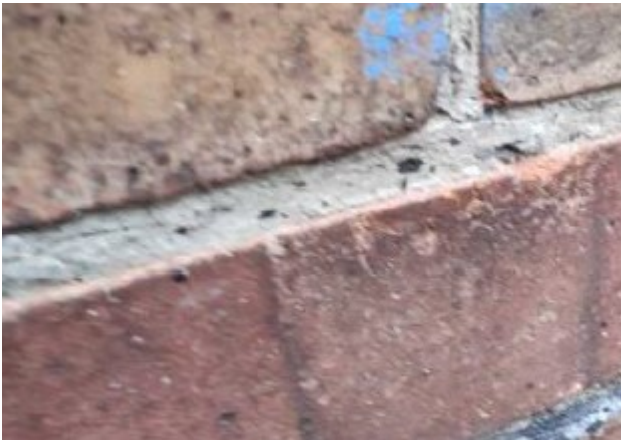
Item 23 - Ref: 23-62130-10

The damp proof course to wall External (Area 019) does contain asbestos.

Any change in appearance should be reported to Property Services.

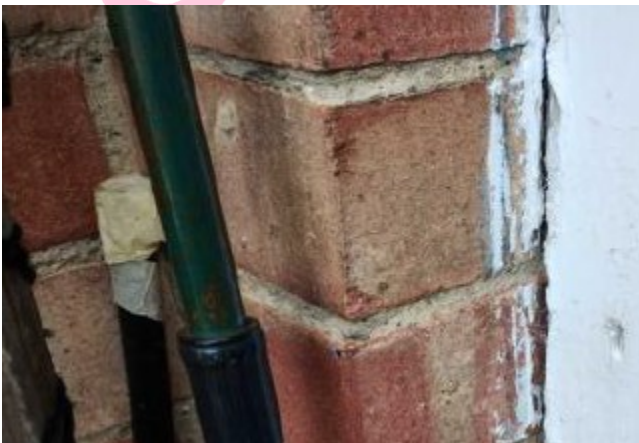
Item 24 - Ref: 23-62130-9

The sealant to the door frame External (Area 019) does contain asbestos.

Any change in appearance should be reported to Property Services.

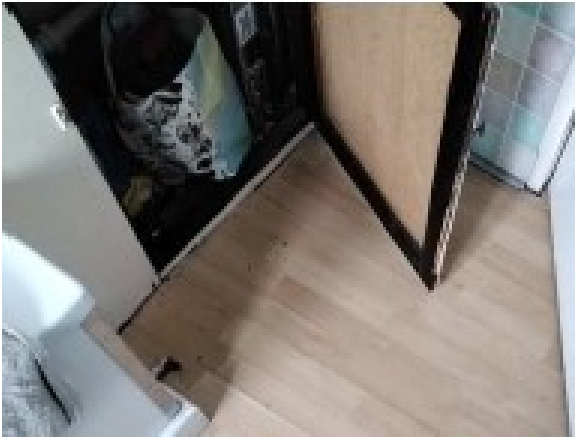
Item 26 - Ref: SC005472

The floor tile with adhesive (Bathroom Rm 1/001) does contain asbestos.

Removed February 2024.
