ASBESTOS SURVEY REPORT FOR ELDON GROVE ACADEMY, ELDON GROVE, HARTLEPOOL, TS26 9LY

Asbestos Register for Eldon Grove Academy

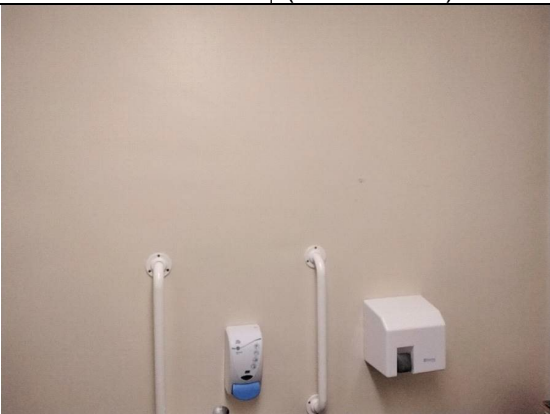
4	SC004855	Wall Coating	Main building Ground Floor, Toilets Disabled (Room G/005)	Does not contain asbestos.

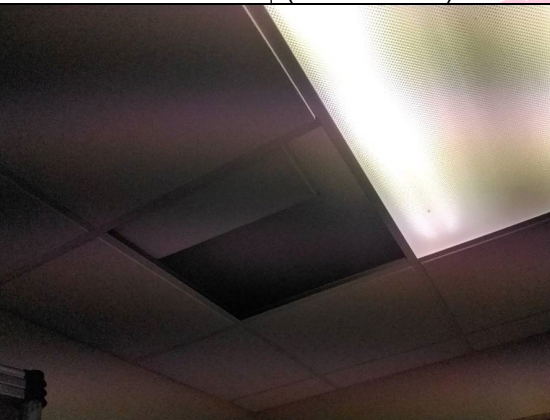
5	As SC004854	Ceiling Coating	Main building Ground Floor, Social Inclusion (Room G/006)	Does not contain asbestos.

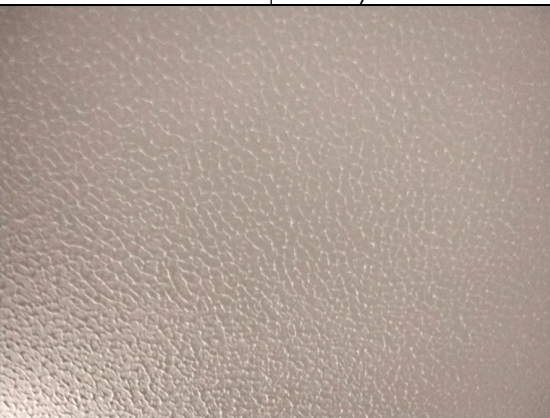
6	As SC004854	Ceiling Coating	Main building Ground Floor, Electrical Cupboard (Room G/009)	Does not contain asbestos.

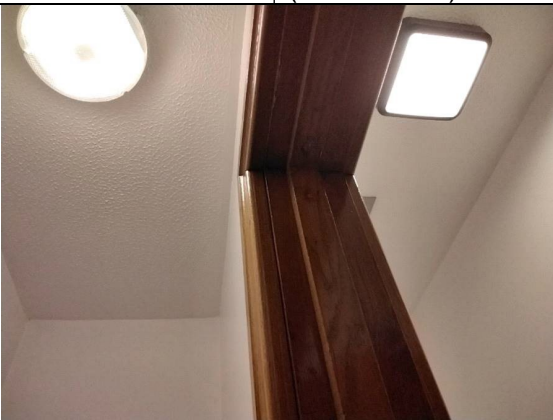
10	As SC004858	Ceiling Coating	Main building Ground Floor, Toilets Staff (Room G/013)	Does not contain asbestos.

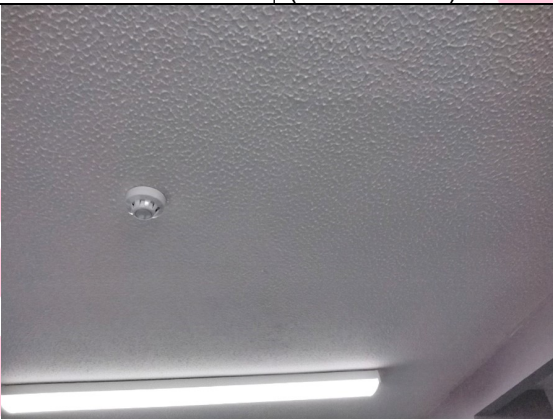
11	SC004859	Ceiling Coating	Main building Ground Floor, Classroom 1 (Room G/016)	Does not contain asbestos.

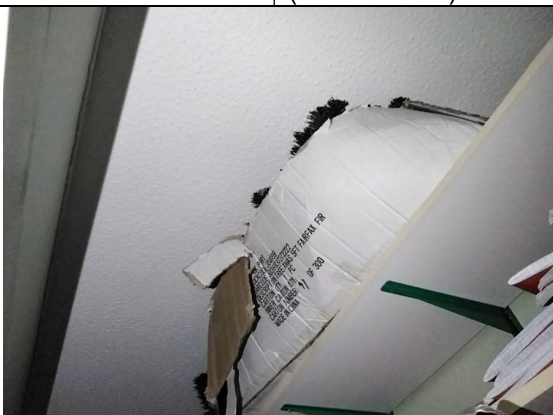
12	As SC004859	Ceiling Coating	Main building Ground Floor, Cupboard (Room G/017)	Does not contain asbestos.

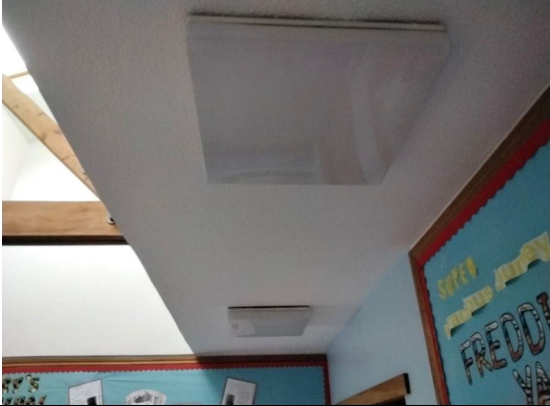
16	As SC004859	Ceiling Coating	Main building Ground Floor, Upper Cloakroom (Room G/022)	Does not contain asbestos.

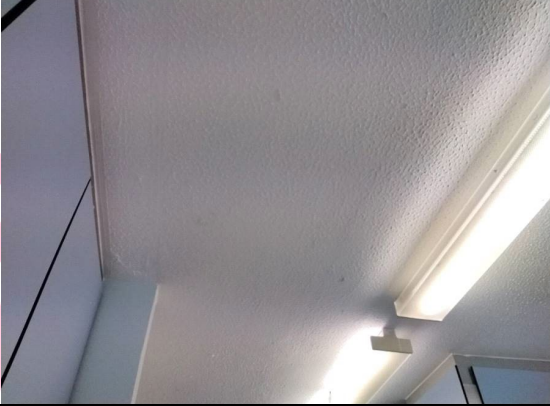
17	SC004860	Ceiling Coating	Main building Ground Floor, Toilets Male (Room G/023)	Does not contain asbestos.

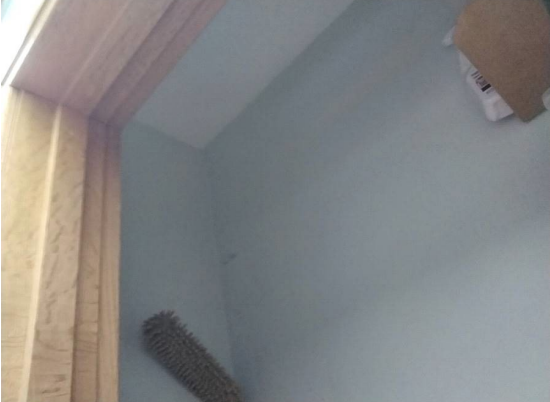
18	As SC004860	Ceiling Coating	Main building Ground Floor, Cleaners Cupboard (Room G/024)	Does not contain asbestos.

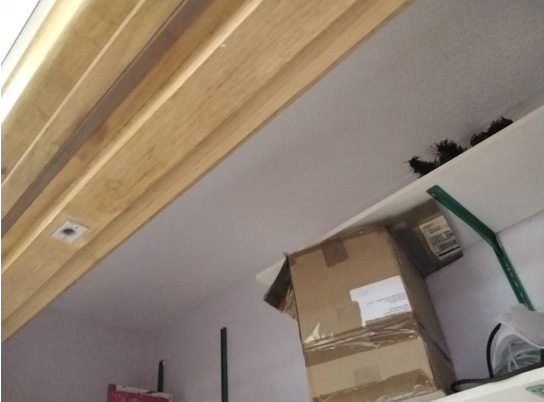
22	As SC004861	Ceiling Coating	Main building Ground Floor, Cupboard (Room G/039)	Does not contain asbestos.

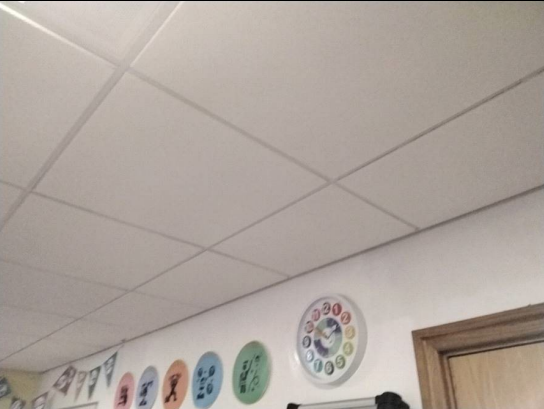
23	As SC004861	Ceiling Coating	Main building Ground Floor, Classroom 8 (Room G/041)	Does not contain asbestos.

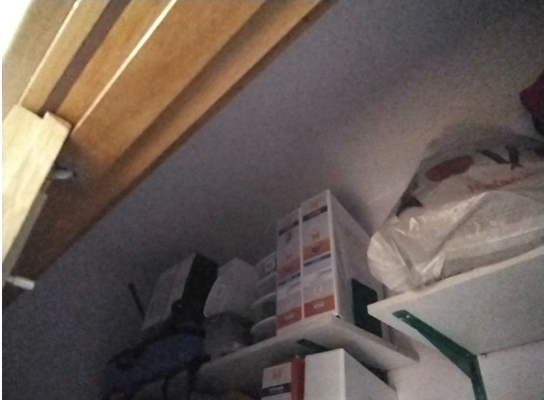
24	As SC004861	Ceiling Coating	Main building Ground Floor, Cupboard (Room G/042)	Does not contain asbestos.

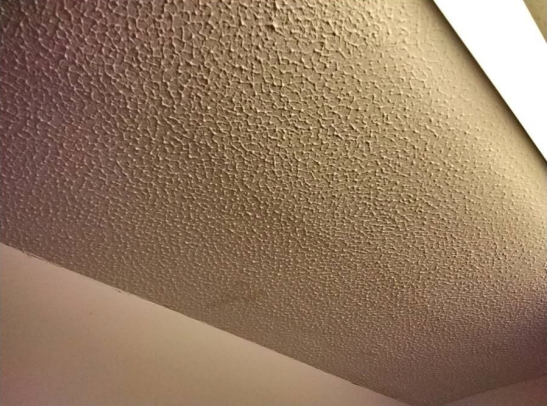
25	SC004862	Ceiling Coating	Main building Ground Floor, Photo copy room (Room G/043)	Does not contain asbestos.

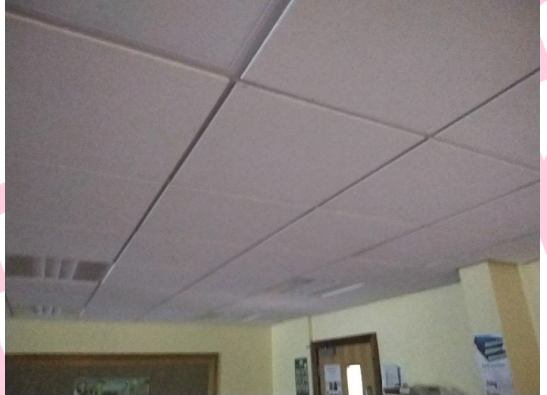
26	As SC004862	Ceiling Coating	Main building Ground Floor, Classroom 9 (Room G/044)	Does not contain asbestos.

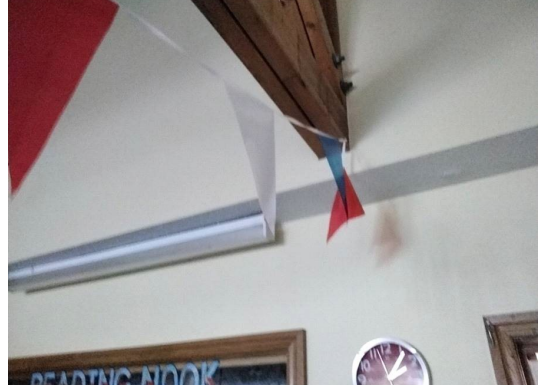
27	As SC004862	Ceiling Coating	Main building Ground Floor, Classroom 10 (Room G/045)	Does not contain asbestos.

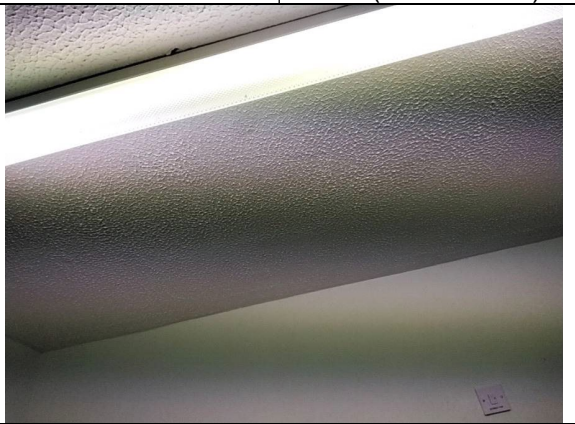
31	As SC004863	Ceiling Coating	Main building Ground Floor, Changing Room (Room G/048)	Does not contain asbestos.

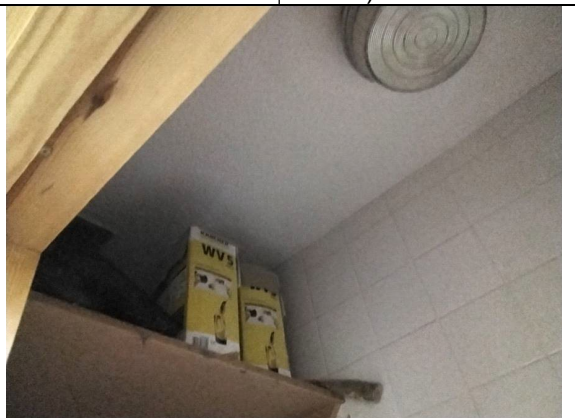
33	As SC004863	Ceiling Coating	Main building Ground Floor, Cleaners Cupboard (Room G/049)	Does not contain asbestos.

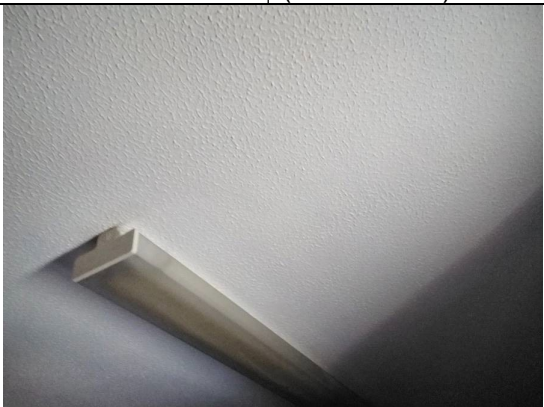
34	As SC004863	Ceiling Coating	Main building Ground Floor, Female Toilets (Room G/050)	Does not contain asbestos.

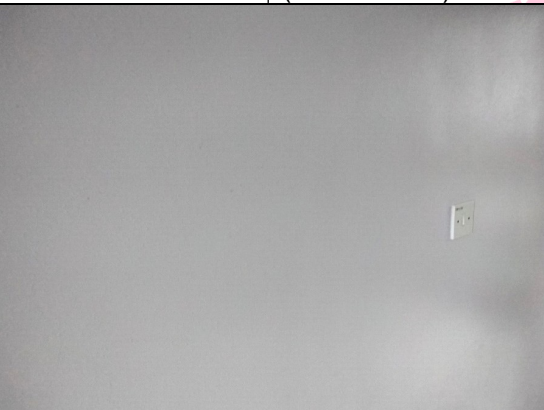
35	As SC004864	Wall Coating	Main building Ground Floor, Female Toilets (Room G/050)	Does not contain asbestos.

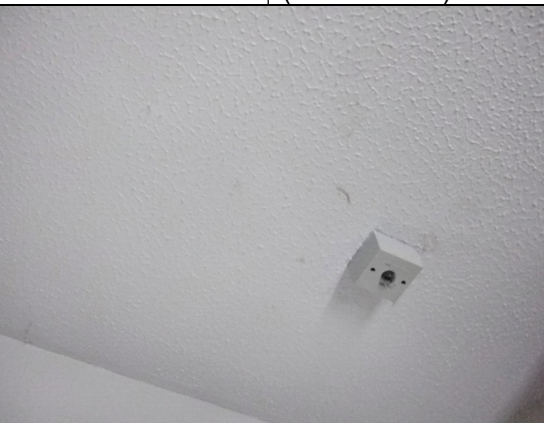
36	As SC004863	Ceiling Coating	Main building Ground Floor, Male Toilets (Room G/051)	Does not contain asbestos.

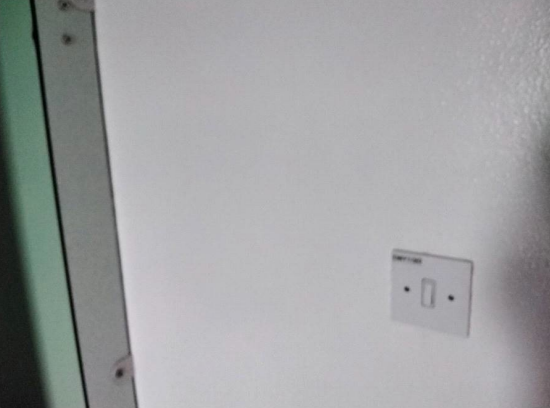
37	As SC004864	Wall Coating	Main building Ground Floor, Male Toilets (Room G/051)	Does not contain asbestos.

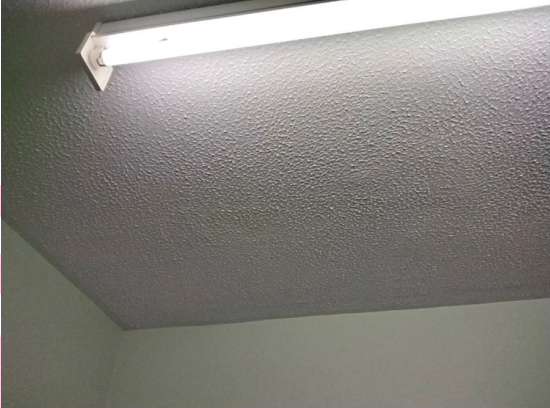
38	As SC004863	Ceiling Coating	Main building Ground Floor, Changing Room (Room G/052)	Does not contain asbestos.

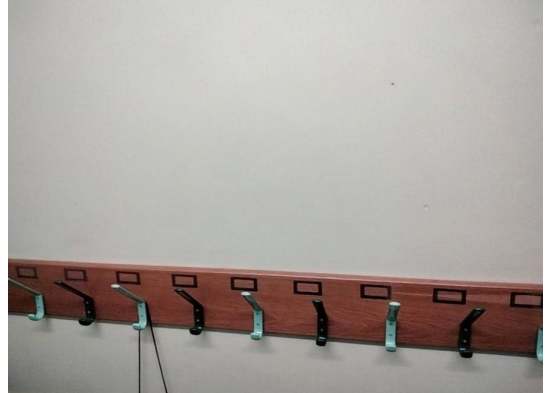
39	As SC004864	Wall Coating	Main building Ground Floor, Changing Room (Room G/052)	Does not contain asbestos.

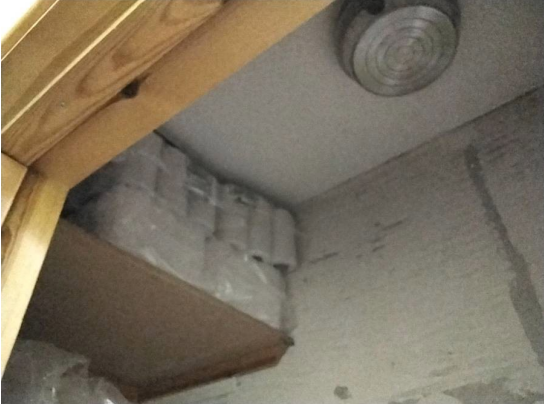
40	As SC004863	Ceiling Coating	Main building Ground Floor, Cleaners Cupboard (Room G/053)	Does not contain asbestos.

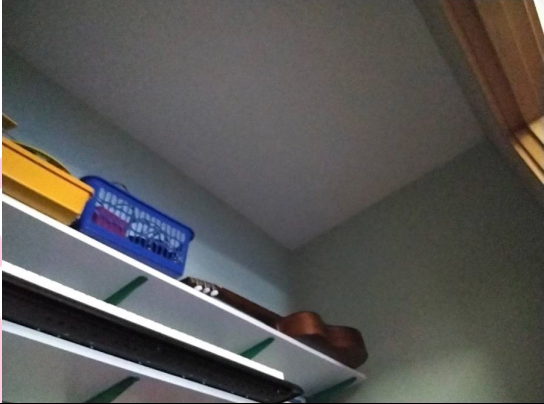
41	As SC004863	Ceiling Coating	Main building Ground Floor, Cupboard (Room G/055)	Does not contain asbestos.

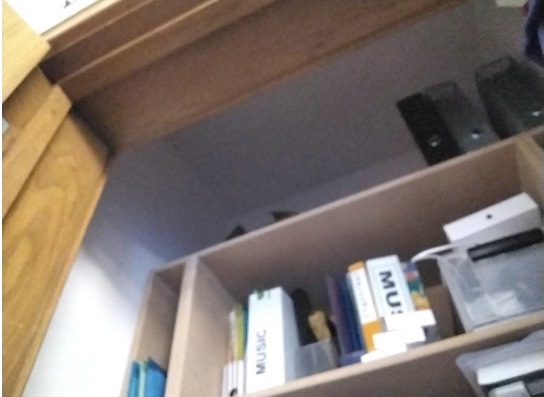
42	As SC004863	Ceiling Coating	Main building Ground Floor, Cupboard (Room G/056)	Does not contain asbestos.

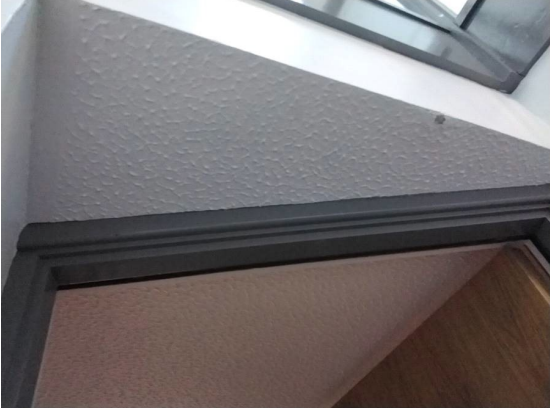
46	As SC004865	Ceiling Coating	Main building Ground Floor, Stairwell (Room G/062)	Does not contain asbestos.

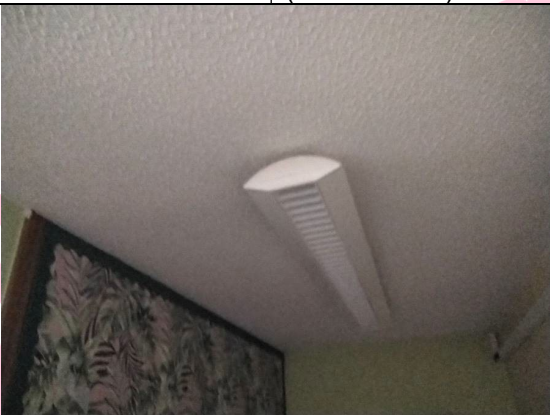
47	As SC004865	Ceiling Coating	Main building Ground Floor, Classroom 12 (Room G/063)	Does not contain asbestos.

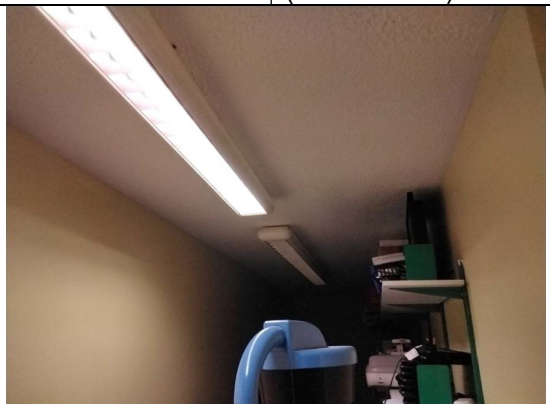
48	As SC004865	Ceiling Coating	Main building Ground Floor, Store Cupboard (Room G/064)	Does not contain asbestos.

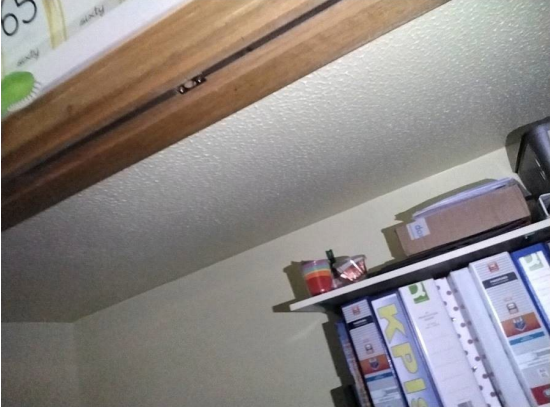
49	As SC004865	Ceiling Coating	Main building Ground Floor, Cupboard (Room G/065)	Does not contain asbestos.

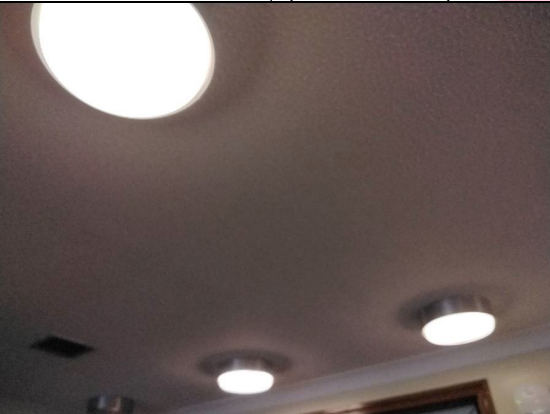
50	SC004866	Ceiling Coating	Main building Ground Floor, Classroom 13 (Room G/066)	Does not contain asbestos.

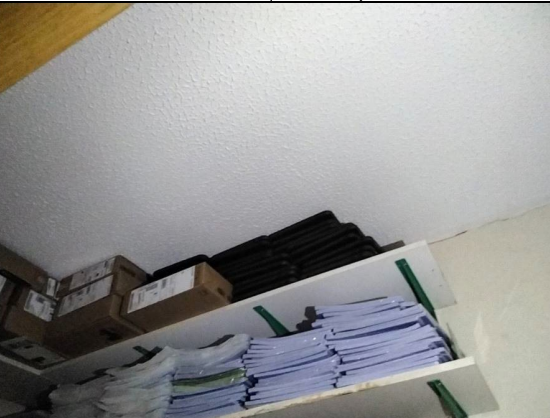
51	As SC004866	Ceiling Coating	Main building Ground Floor, Server Cupboard (Room G/067)	Does not contain asbestos.

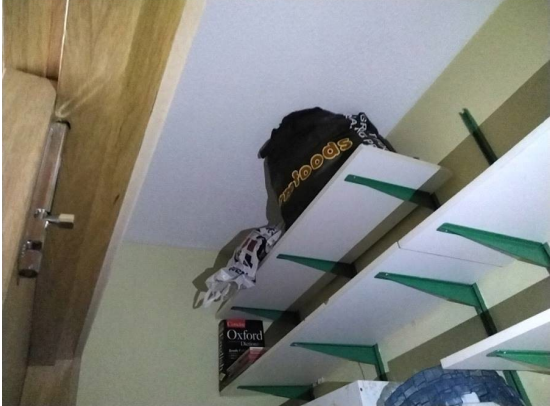
55	As SC004867	Ceiling Coating	Main building Ground Floor, Cupboard (Room G/073)	Does not contain asbestos.

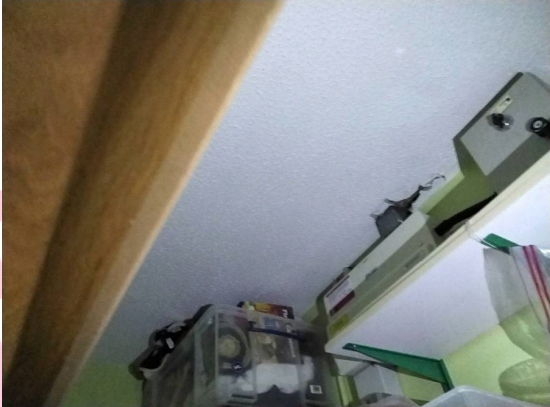
56	As SC004867	Ceiling Coating	Main building Ground Floor, Cupboard (Room G/074)	Does not contain asbestos.

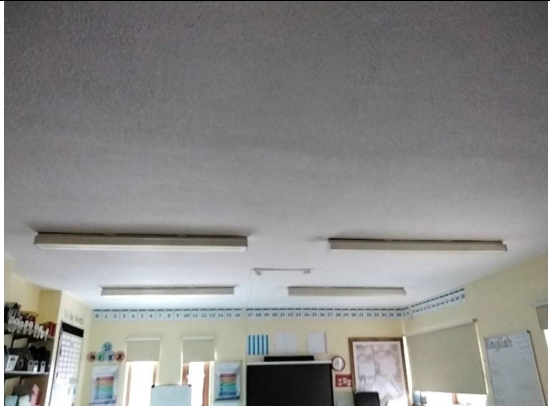
57	SC004868	Ceiling Coating	Main building Ground Floor, Classroom 15 (Room G/076)	Does not contain asbestos.

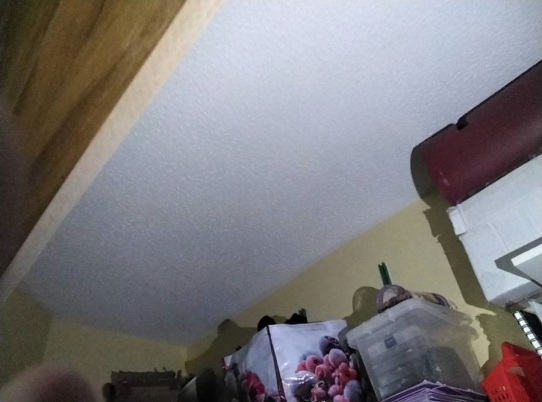
58	As SC004868	Ceiling Coating	Main building Ground Floor, Cupboard (Room G/077)	Does not contain asbestos.

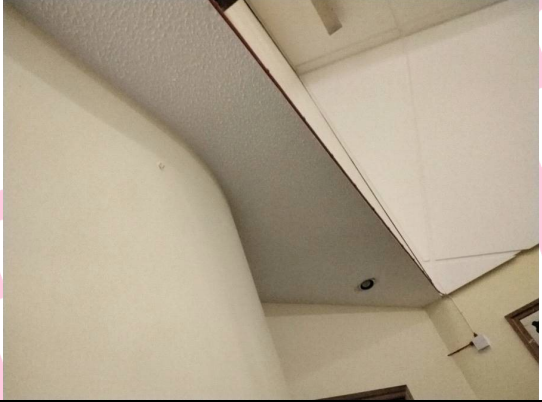
59	As SC004868	Ceiling Coating	Main building Ground Floor, Classroom 16 (Room G/078)	Does not contain asbestos.

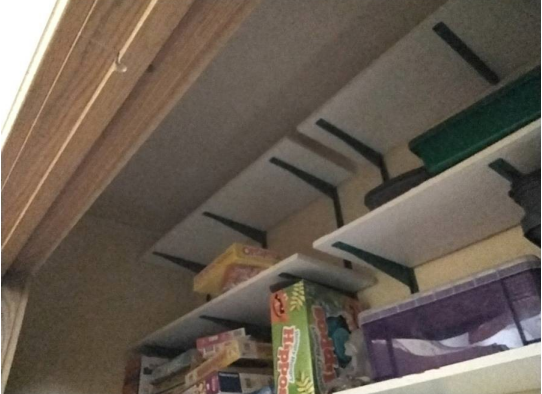
60	As SC004868	Ceiling Coating	Main building Ground Floor, Cupboard (Room G/079)	Does not contain asbestos.

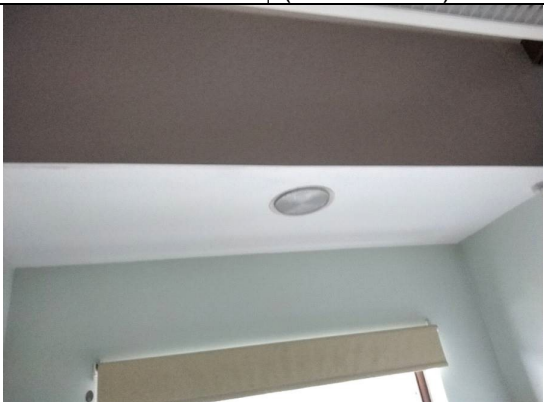
61	As SC004868	Ceiling Coating	Main building Ground Floor, Classroom 17 (Room G/081)	Does not contain asbestos.

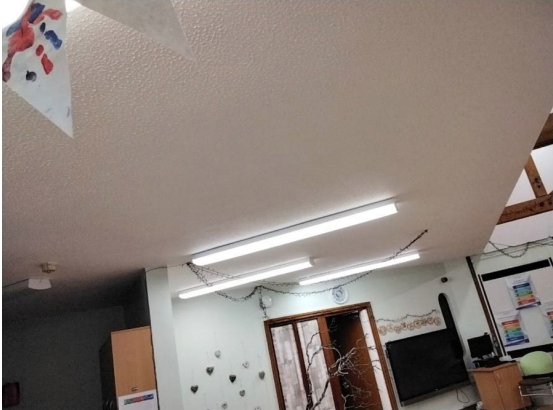
64	As SC004869	Ceiling Coating	Main building Ground Floor, Nursery (Room G/084)	Does not contain asbestos.

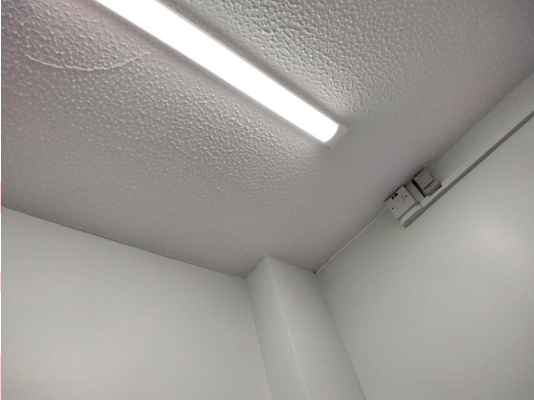
65	As SC004869	Ceiling Coating	Main building Ground Floor, Entrance Lobby (Room G/086)	Does not contain asbestos.

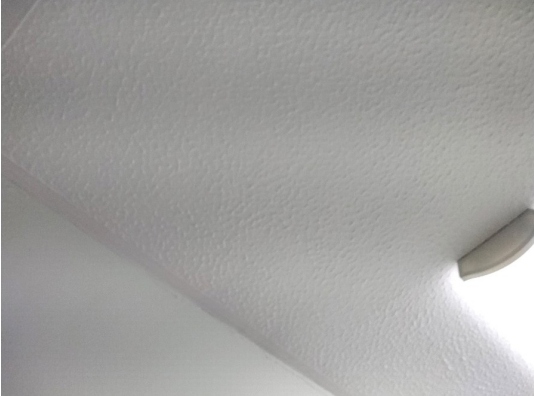
66	SC004870	Ceiling Coating	Main building Ground Floor, Staff WC (Room G/087)	Does not contain asbestos.

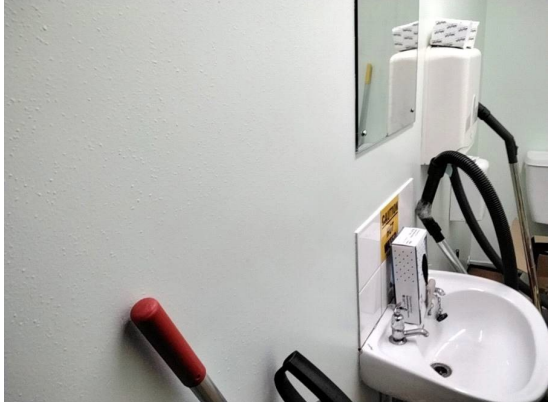
67	SC004871	Wall Coating	Main building Ground Floor, Staff WC (Room G/087)	Does not contain asbestos.

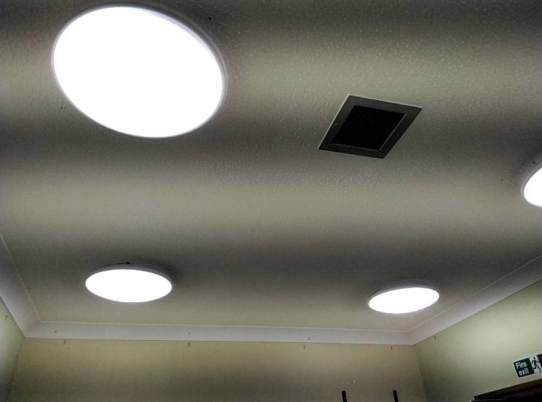
70	SC004872	Ceiling Coating	Main building Ground Floor, Staff Room Lobby (Room G/089)	Does not contain asbestos.

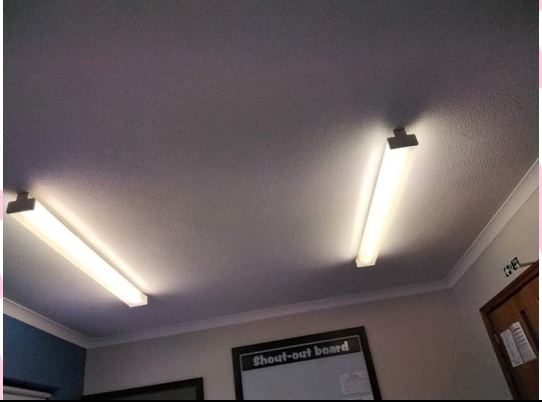
71	As SC004872	Ceiling Coating	Main building Ground Floor, Staff Room (Room G/090)	Does not contain asbestos.

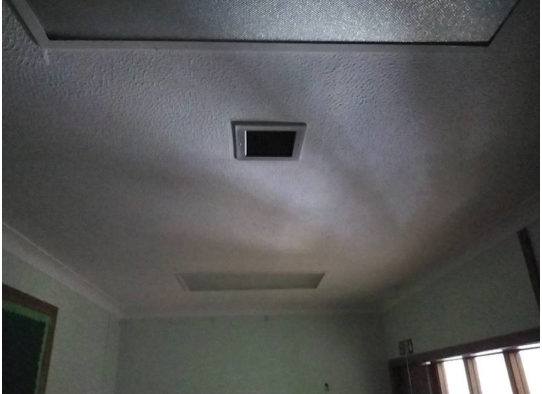
72	As SC004872	Ceiling Coating	Main building Ground Floor, Computer Room (Room G/093)	Does not contain asbestos.

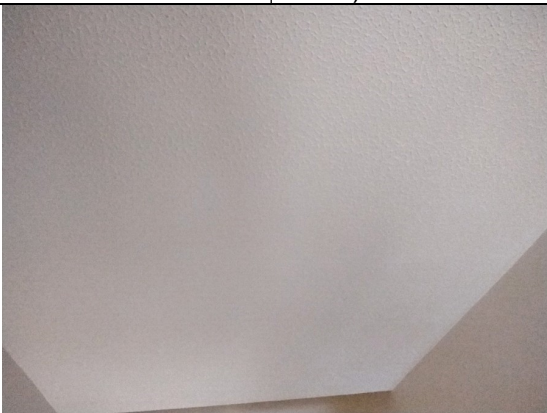
73	SC004873	Ceiling Coating	Main building First Floor Landing (Room 1/006)	Does not contain asbestos.

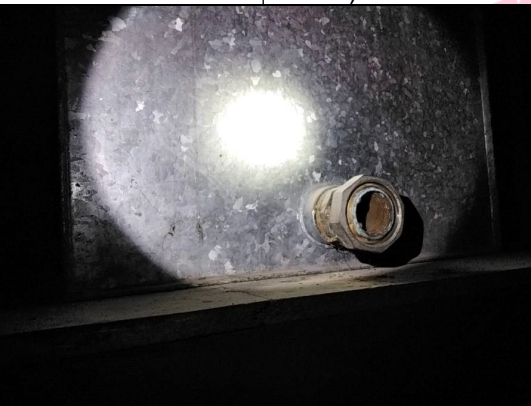
74	SC004887	Tank Pipework Gasket	Main building Roof void Loft space (Room R/001)	Does not contain asbestos.

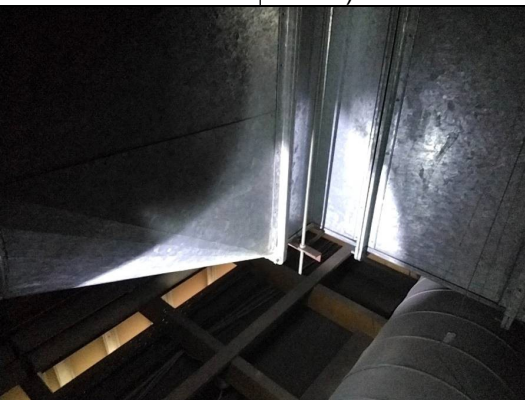
75	SC004888	Ductwork joints	Main building Roof void Loft space (Room R/001)	Does not contain asbestos.

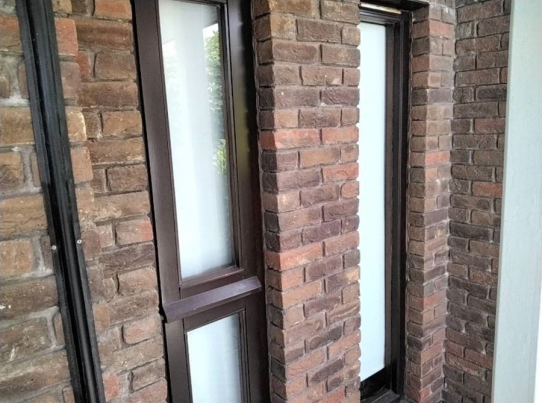
94	As SC004877	Window putty/seal	Main building External (Room E/003)	Does not contain asbestos.

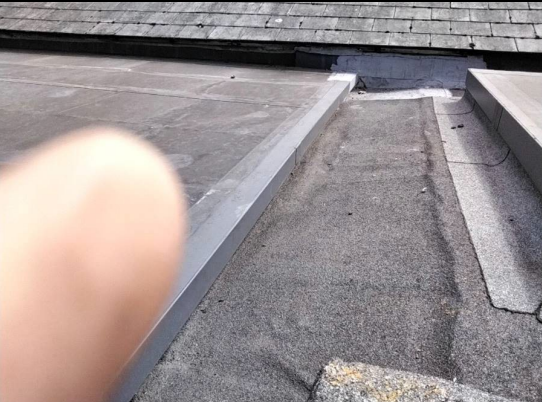
95	SC004878	Roof felt below all rubber coverings	Main building External (Room E/003)	Does not contain asbestos.

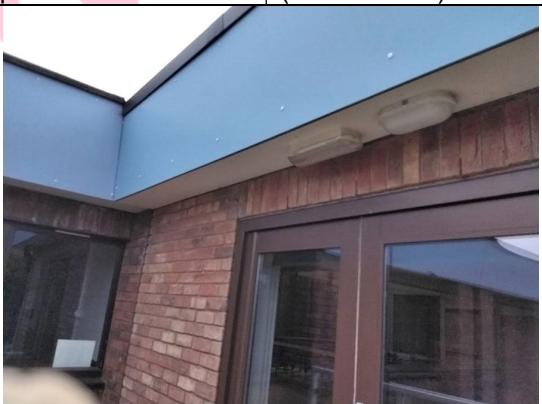
96	SC004879	Soffits to building perimeter	Main building External (Room E/003)	Does not contain asbestos.

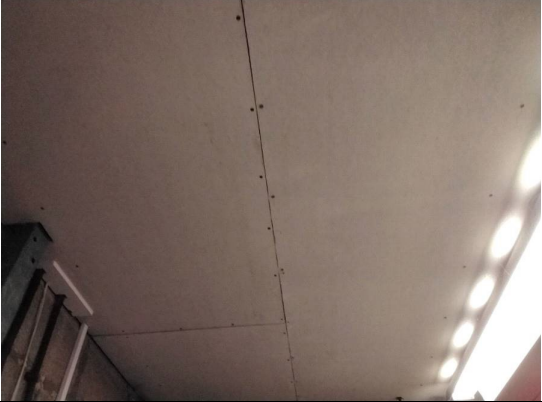
100	SC004882	Ceiling	Main building External Plant Room (Room E/006)	Does not contain asbestos.

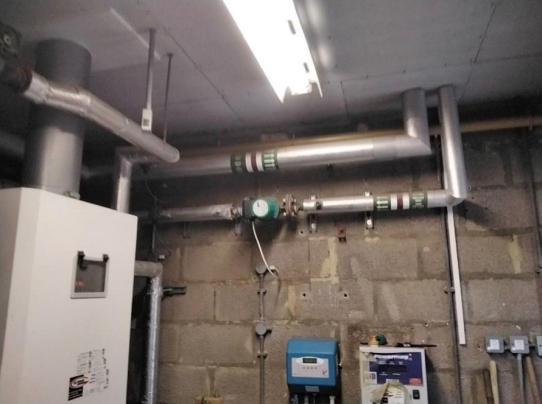
101	SC004883	Pipework Gaskets	Main building External Plant Room (Room E/006)	Does not contain asbestos.

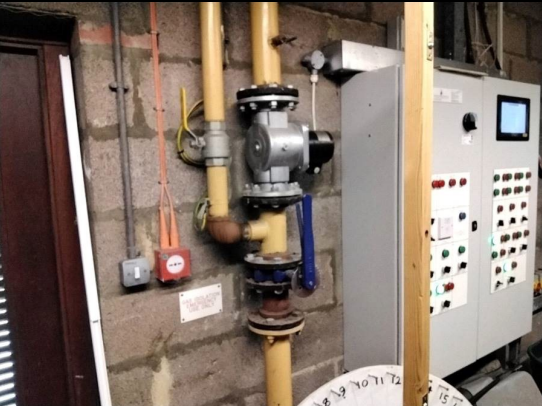
102	SC004884	Pipework Gaskets	Main building External Plant Room (Room E/006)	Does not contain asbestos.
