ASBESTOS SURVEY REPORT FOR ROSSMERE ACADEMY, CATCOTE ROAD, HARTLEPOOL, TS25 3JL.

Rossmere Academy, Hartlepool

Date: 24 July 2025

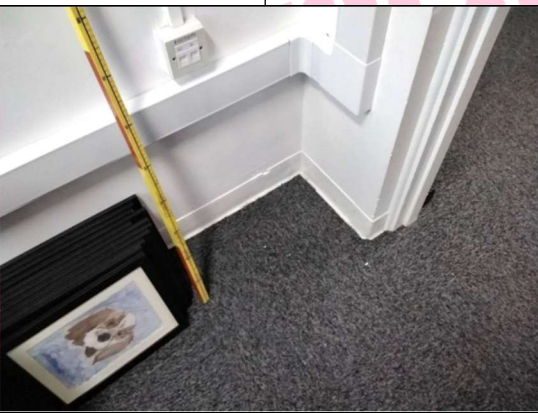
5	KX001574	Wall skirting	Block A Ground Floor Office (Room 002)	Contains asbestos - Any change in appearance should be recorded and passed to Property Services.

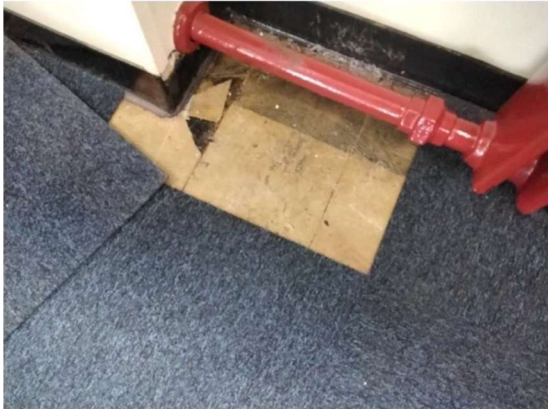
11	KX001576	Floor tile (under floor covering) black and grey below carpet	Block A Ground Floor Classroom (Room 006)	Contains asbestos - Any change in appearance should be recorded and passed to Property Services.

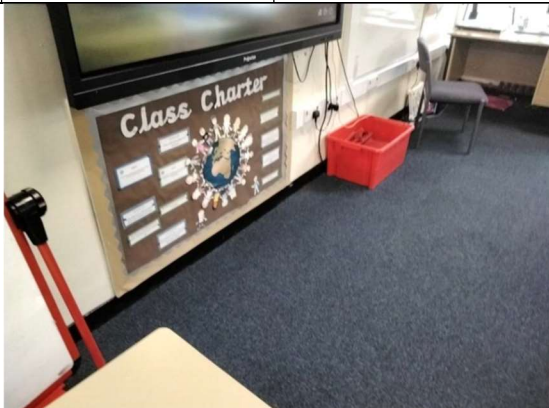
12	KX001577	Wall Skirting	Block A Ground Floor Classroom (Room 006)	Contains asbestos - Any change in appearance should be recorded and passed to Property Services.

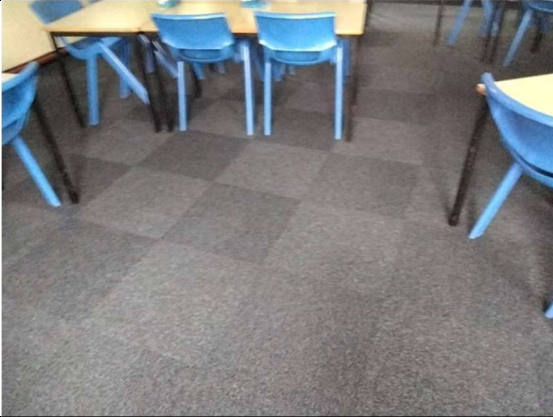
13	As KX001576	Floor tile (under floor covering) black and grey below carpet	Block A Ground Floor Classroom (Room 008)	Contains asbestos - Any change in appearance should be recorded and passed to Property Services.

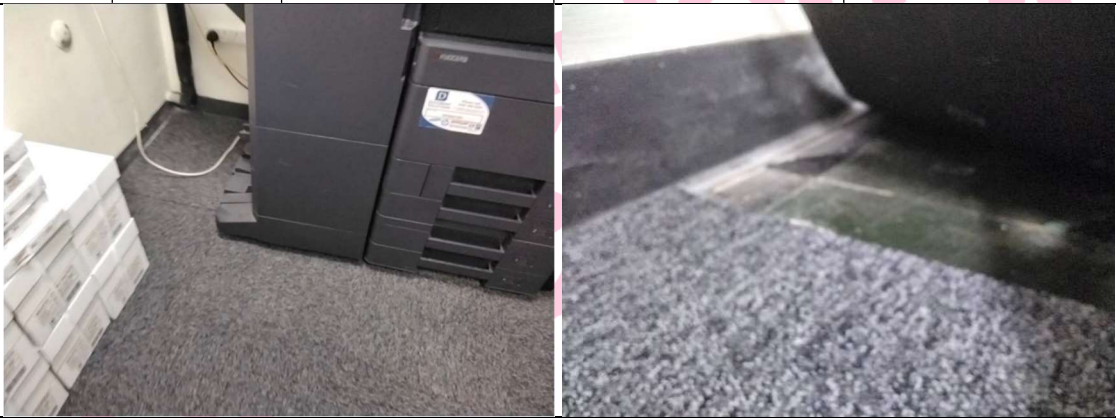
17	KX001579	Floor tile (under floor covering) black, green and grey	Block A Ground Floor Medical/First Aid (Room 015)	Contains asbestos - Any change in appearance should be recorded and passed to Property Services.

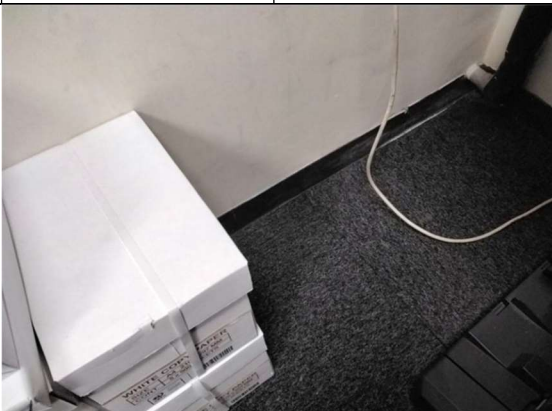
18	KX001580	Wall Skirting	Block A Ground Floor Medical/First Aid (Room 015)	Contains asbestos - Any change in appearance should be recorded and passed to Property Services.

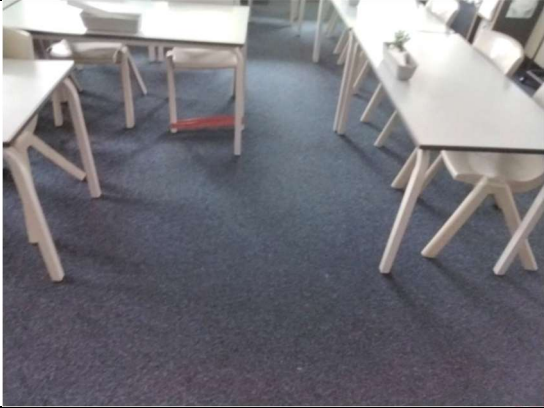
31	As KX001581	Floor adhesive residue under carpet and screed	Block A Ground Floor Classroom (Room 025)	Contains asbestos - Any change in appearance should be recorded and passed to Property Services.

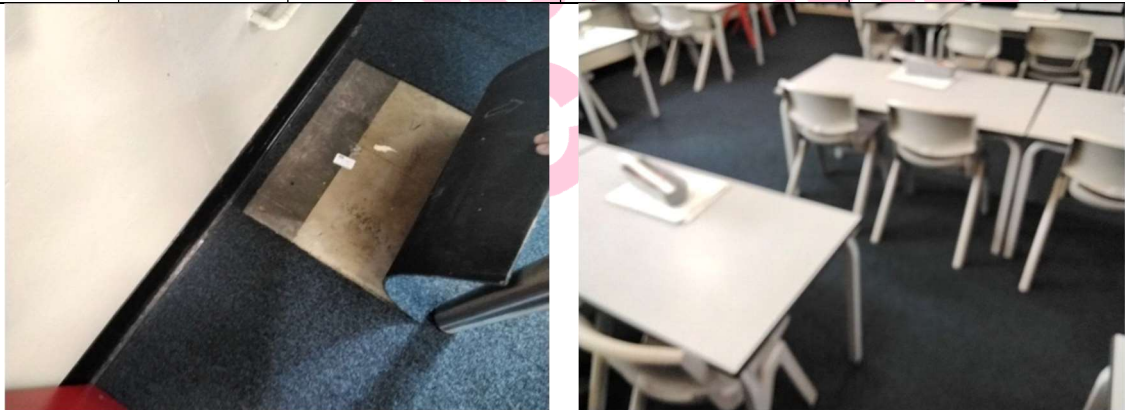
41	KX001588	Floor tile (under floor covering) brown and beige	Block A Ground Floor Classroom (Room 029)	Contains asbestos - Any change in appearance should be recorded and passed to Property Services.

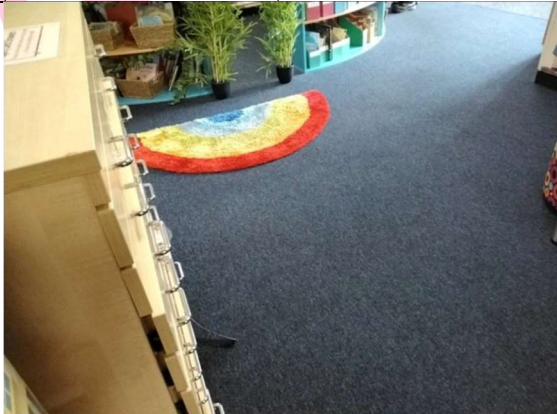
57	As KX001593	Floor tile (under floor covering) grey under screed	Block A Ground Floor Corridor (Room 060)	Contains asbestos - Any change in appearance should be recorded and passed to Property Services.

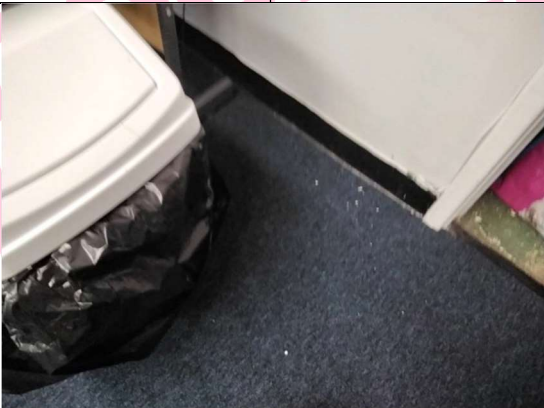
62	As KX001593	Floor tile (under floor covering) grey under screed	Block A Ground Floor Office (Room 56)	Contains asbestos - Any change in appearance should be recorded and passed to Property Services.

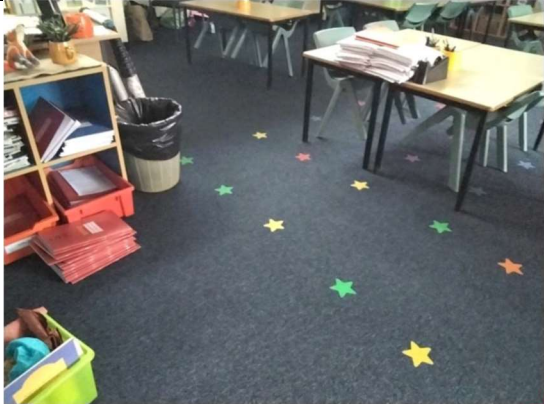
73	KX001594	Floor adhesive residue under carpet and screed	Block A Ground Floor Classroom (Room 065)	Contains asbestos - Any change in appearance should be recorded and passed to Property Services.

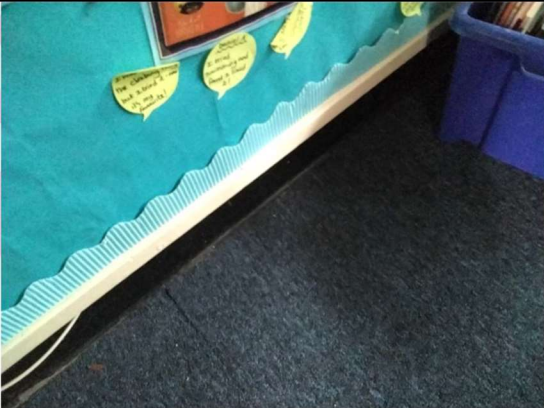
74	As KX001592	Wall skirting	Block A Ground Floor Classroom (Room 065)	Contains asbestos - Any change in appearance should be recorded and passed to Property Services.

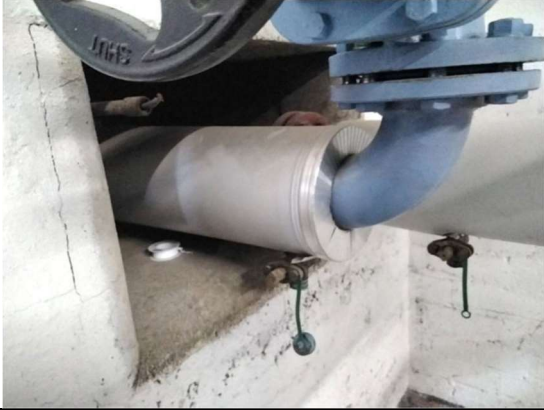
115	KX001603	Debris/Residue unsealed at entrance to floor duct - encapsulated	Block A Ground Floor Boiler Room (Room 089)	Medium Risk

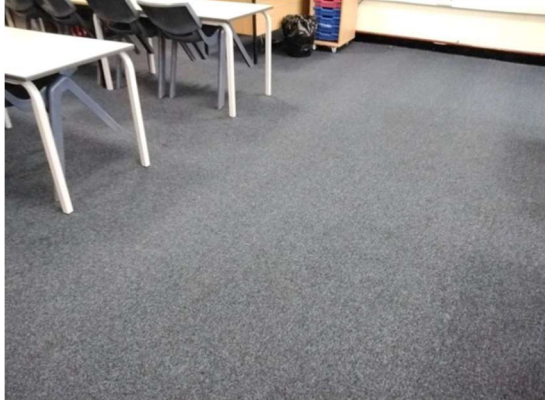
123	KX001605	Floor tile under floor covering	Block A First Floor Classroom (Room 90)	Contains asbestos - Any change in appearance should be recorded and passed to Property Services.

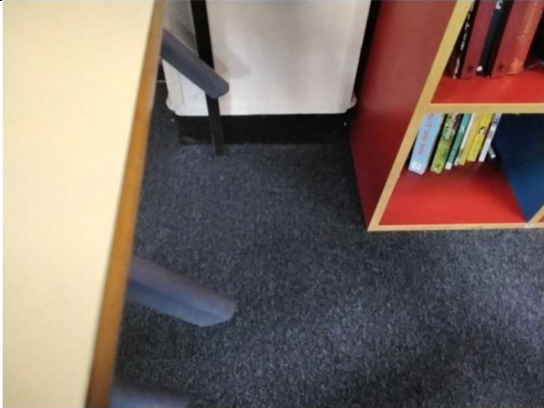
136	As KX001606	Wall skirting	Block A First Floor Classroom (Room 99)	Contains asbestos - Any change in appearance should be recorded and passed to Property Services.

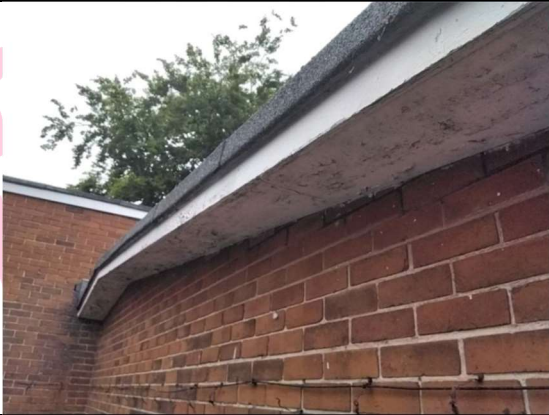
140	KX001608	Soffits Gable ends	Block A External	Contains asbestos - Any change in appearance should be recorded and passed to Property Services.

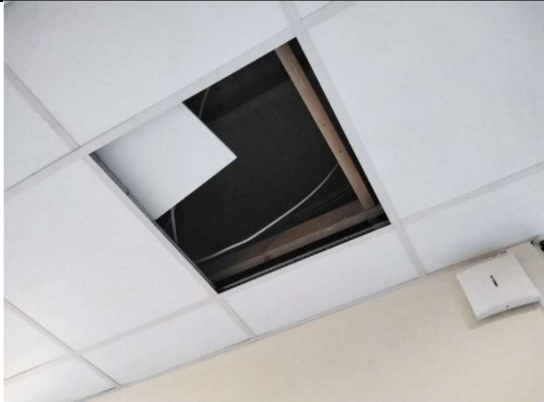
148	KX001619	Ceiling void debris to wooden framework and within nail holes - encapsulated	Block B Ground Floor Kitchen (Room 109)	Medium Risk

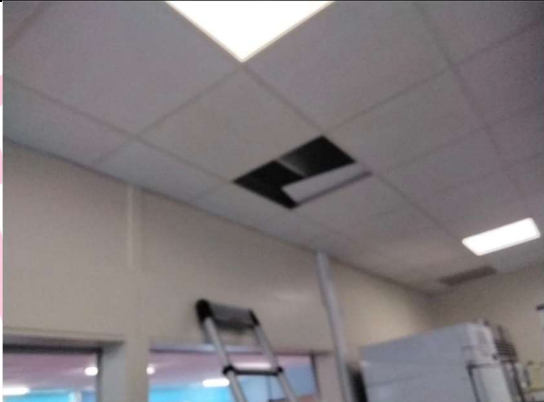
149	KX001620	Ceiling void debris to wooden framework and within nail holes - encapsulated	Block B Ground Floor Kitchen (Room 109)	Medium Risk

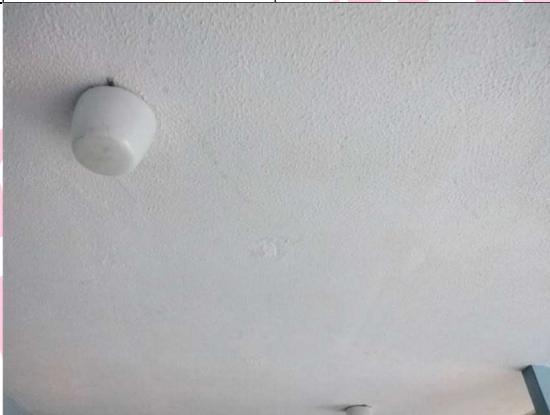
164	KX001626	Ceiling coating	Block B Ground Floor Entrance Hall Foyer Lobby (Room 130)	Contains asbestos - Any change in appearance should be recorded and passed to Property Services.
