ASBESTOS SURVEY REPORT FOR ROSSMERE ACADEMY, CATCOTE ROAD, HARTLEPOOL, TS25 3JL.

Asbestos Register for

Rossmere Academy, Hartlepool

Date: 07 July 2025

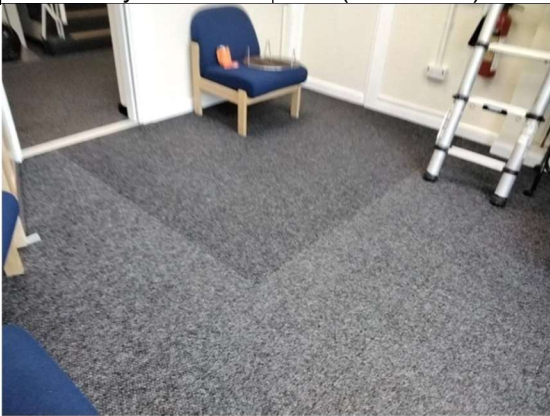
| 1 | KX001572 | Floor screed under lino and modern screed layer | Block A Ground Floor Reception Entrance Hall (Room 001) | Does not contain asbestos. |

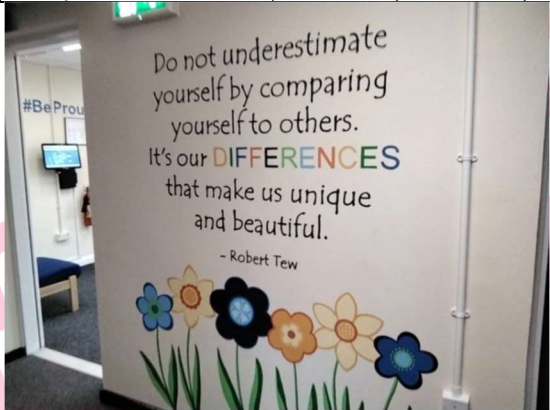
| 2 | KX001573 | Wall Coating fire flex paint | Block A Ground Floor Corridor (Room 014) | Does not contain asbestos. |

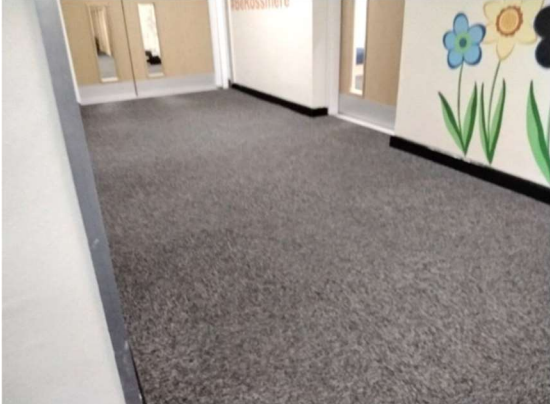
| 3 | As KX001572 | Floor screed under carpet and modern screed layer | Block A Ground Floor Corridor (Room 014) | Does not contain asbestos. |

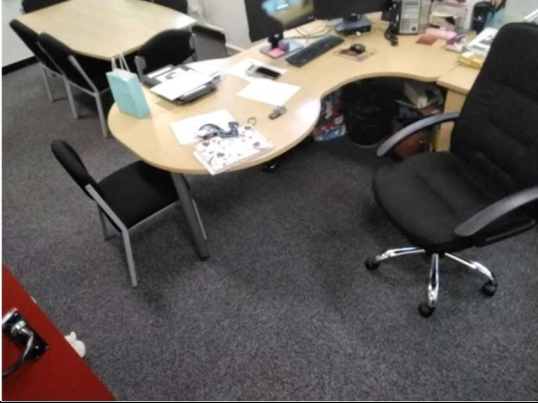
| 4 | As KX001572 | Floor screed under carpet and modern screed layer | Block A Ground Floor Office (Room 002) | Does not contain asbestos. |

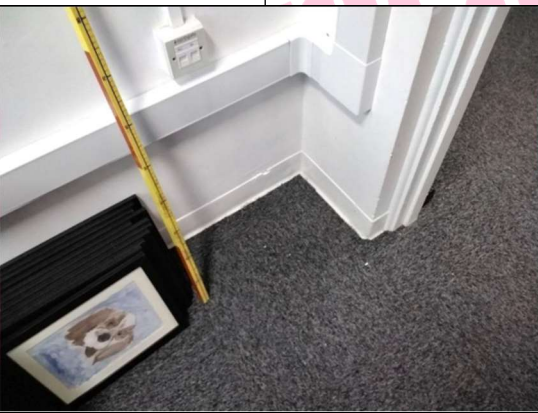
| Item No. | Sample Ref. | Area Sampled | Location Name | Inspection Frequency |
|---|---|---|---|---|
| 5 | KX001574 | Wall skirting | Block A Ground Floor Office (Room 002) | Low Risk |

| 5 | KX001574 | Wall skirting | Block A Ground Floor Office (Room 002) | Contains asbestos - Any change in appearance should be recorded and passed to Property Services. |

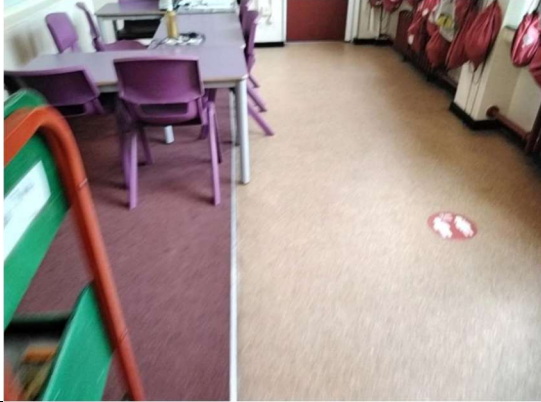
| 10 | As KX001572 | Floor screed under carpet and modern screed layer | Block A Ground Floor Hallway Passageway (Room 007) | Does not contain asbestos. |

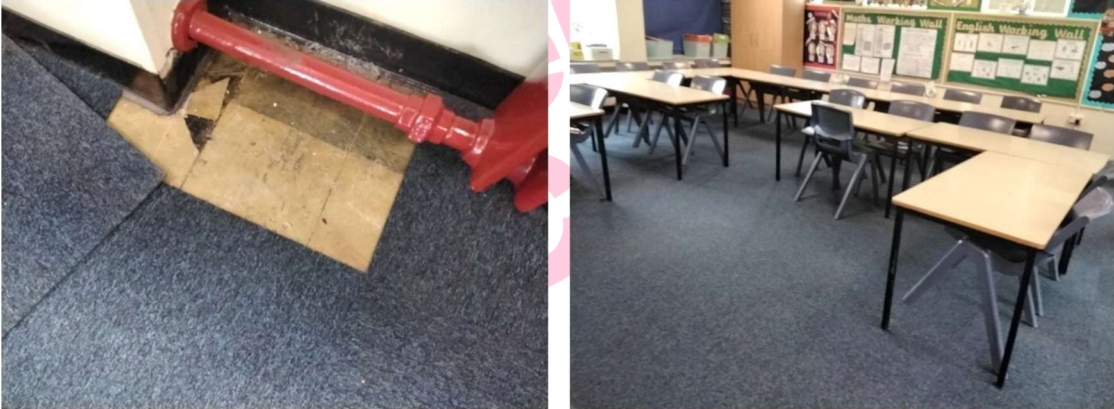
| Item No. | Sample Ref. | Area Sampled | Location Name | Inspection Frequency |
|---|---|---|---|---|
| 11 | KX001576 | Floor tile (under floor covering) black and grey below carpet | Block A Ground Floor Classroom (Room 006) | Low Risk |

| 11 | KX001576 | Floor tile (under floor covering) black and grey below carpet | Block A Ground Floor Classroom (Room 006) | Contains asbestos - Any change in appearance should be recorded and passed to Property Services. |

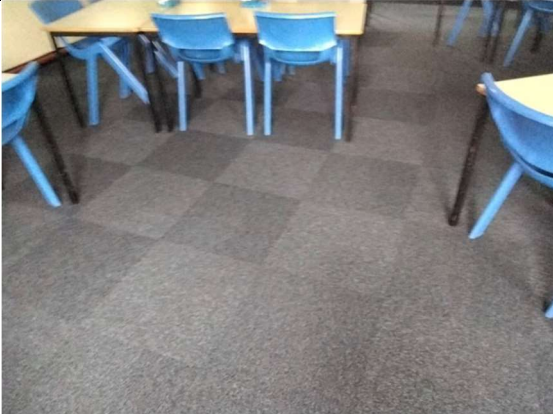
| Item No. | Sample Ref. | Area Sampled | Location Name | Inspection Frequency |
|---|---|---|---|---|
| 13 | As KX001576 | Floor tile (under floor covering) black and grey below carpet | Block A Ground Floor Classroom (Room 008) | Low Risk |

| 13 | As KX001576 | Floor tile (under floor covering) black and grey below carpet | Block A Ground Floor Classroom (Room 008) | Contains asbestos - Any change in appearance should be recorded and passed to Property Services. |

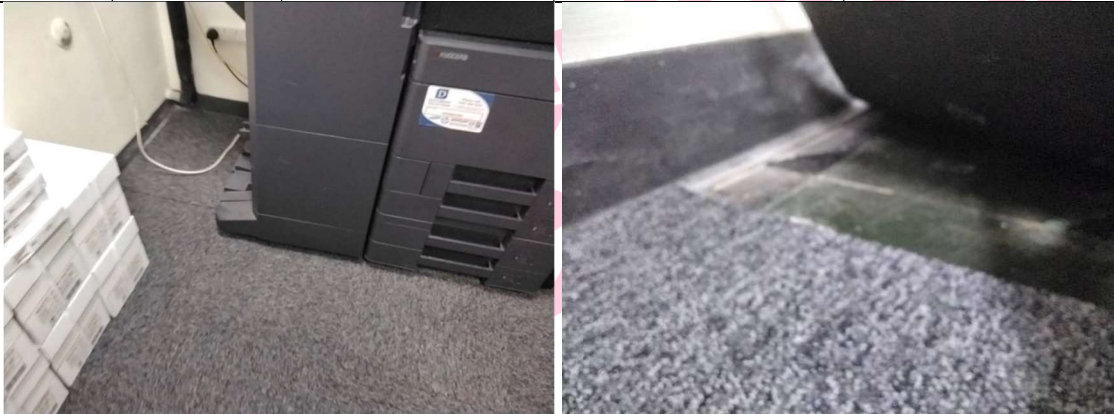
| Item No. | Sample Ref. | Area Sampled | Location Name | Inspection Frequency |
|---|---|---|---|---|
| 17 | KX001579 | Floor tile (under floor covering) | Block A Ground Floor Medical/First Aid (Room 015) | Low Risk |

| 17 | KX001579 | Floor tile (under floor covering) black, green and grey | Block A Ground Floor Medical/First Aid (Room 015) | Contains asbestos - Any change in appearance should be recorded and passed to Property Services. |

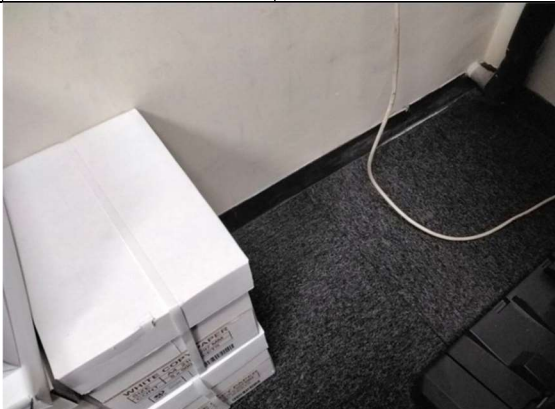
| 18 | KX001580 | Wall Skirting | Block A Ground Floor Medical/First Aid (Room 015) | Low Risk |

| 18 | KX001580 | Wall Skirting | Block A Ground Floor Medical/First Aid (Room 015) | Contains asbestos - Any change in appearance should be recorded and passed to Property Services. |

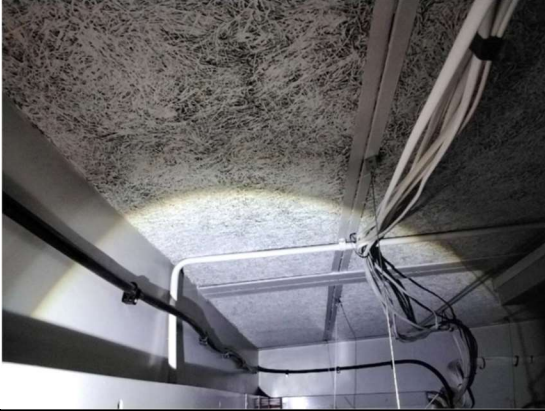
| 25 | KX001584 | Ceiling void above ceiling | Block A Ground Floor Store Room (Room 039) | Does not contain asbestos. |

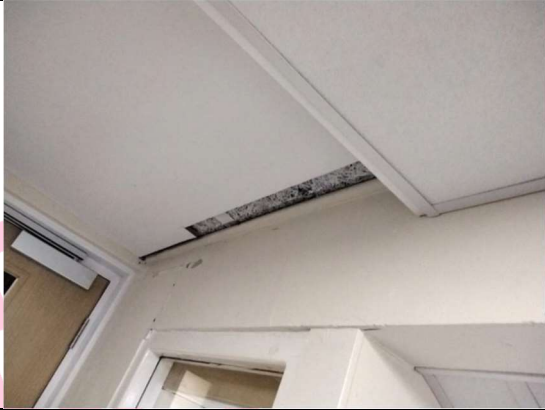
| 26 | As KX001584 | Ceiling void above ceiling | Block A Ground Floor Corridor (Room 036) | Does not contain asbestos. |

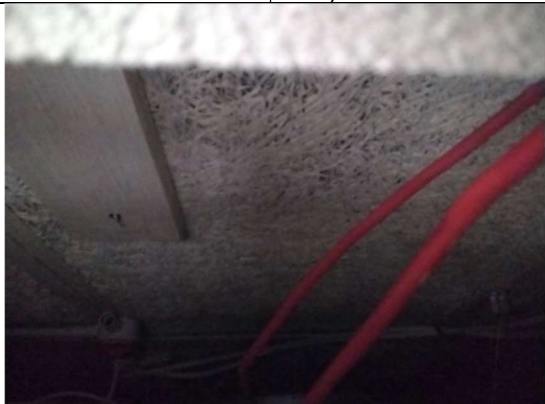
| 27 | As KX001584 | Ceiling void above ceiling | Block A Ground Floor Classroom (Room 021) | Does not contain asbestos. |

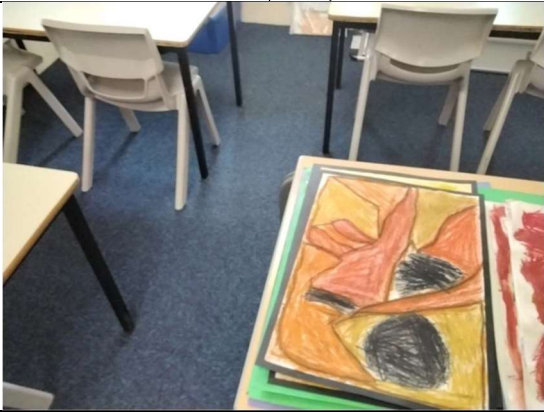
| 28 | KX001586 | Floor screed under carpet and screed | Block A Ground Floor Classroom (Room 021) | Does not contain asbestos. |

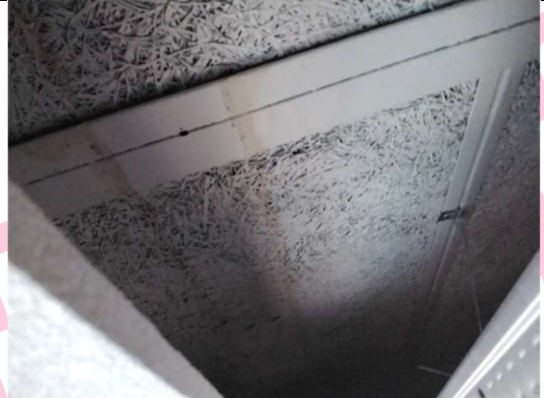
| 29 | As KX001584 | Ceiling void above ceiling | Block A Ground Floor Corridor (Room 037) | Does not contain asbestos. |

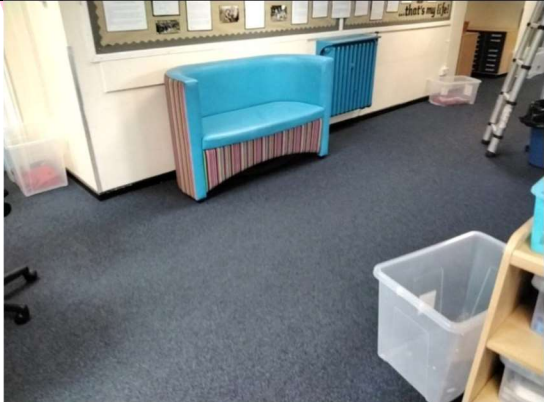
| 30 | KX001586 | Floor screed under carpet and screed | Block A Ground Floor Corridor (Room 037) | Does not contain asbestos. |

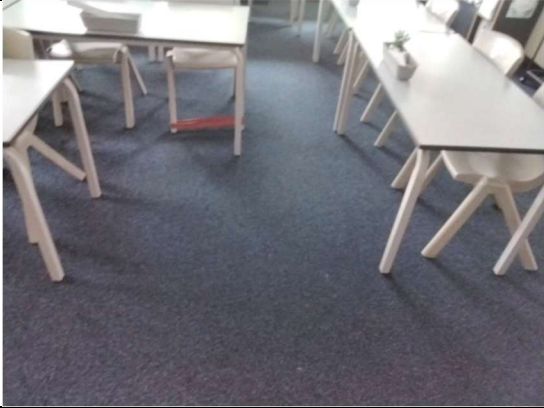
| 31 | As KX001581 | Floor adhesive residue under carpet and screed | Block A Ground Floor Classroom (Room 025) | Contains asbestos - Any change in appearance should be recorded and passed to Property Services. |

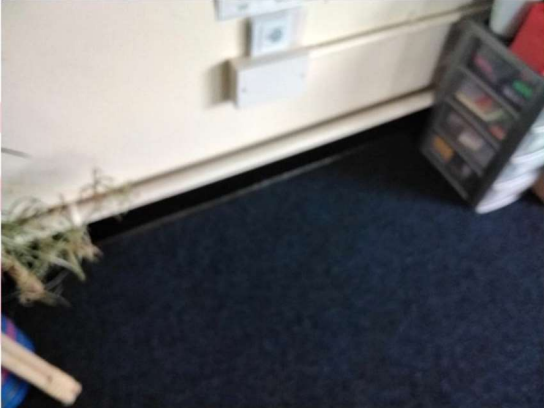
| 32 | TL001255 | Wall Skirting | Block A Ground Floor Classroom (Room 025) | Does not contain asbestos. |

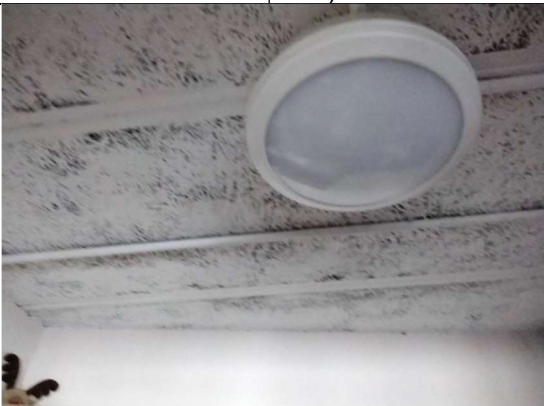
| 33 | As KX001584 | Ceiling | Block A Ground Floor Cupboard (Room 026) | Does not contain asbestos. |

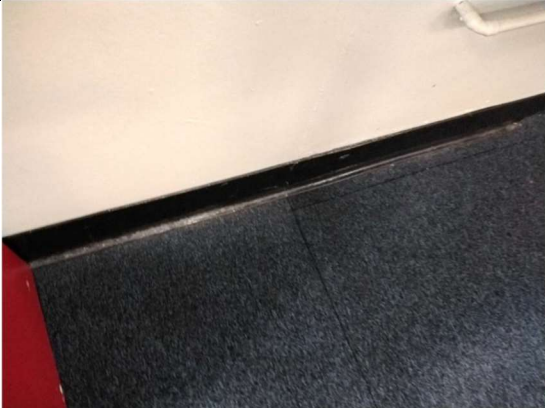
| 40 | As KX001580 | Wall Skirting | Block A Ground Floor Classroom (Room 029) | Contains asbestos - Any change in appearance should be recorded and passed to Property Services. |

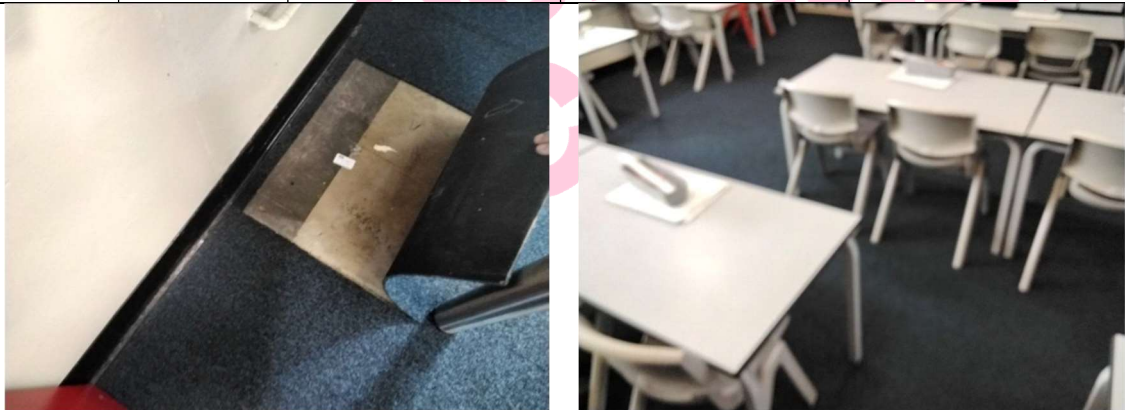
| 41 | KX001588 | Floor tile (under floor covering) brown and beige | Block A Ground Floor Classroom (Room 029) | Contains asbestos - Any change in appearance should be recorded and passed to Property Services. |

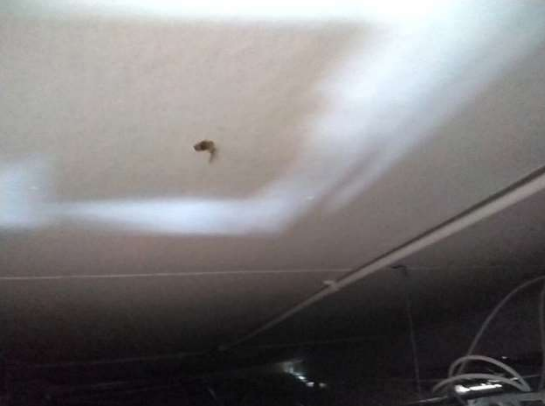
| 42 | KX001589 | Ceiling void ceiling above | Block A Ground Floor Classroom (Room 029) | Does not contain asbestos. |

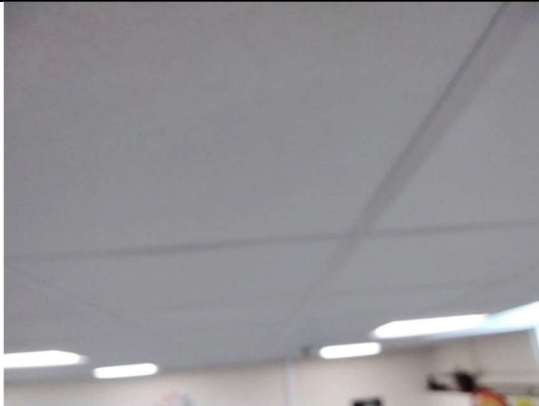
| 49 | As KX001589 | Ceiling void ceiling above | Block A Ground Floor Classroom (Room 034) | Does not contain asbestos. |

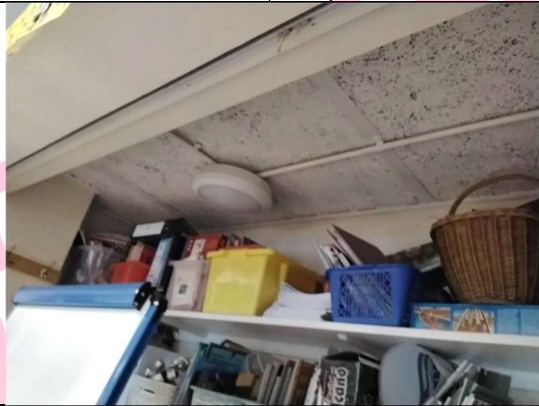
| 50 | As KX001584 | Ceiling void above ceiling | Block A Ground Floor Classroom (Room 034) | Does not contain asbestos. |

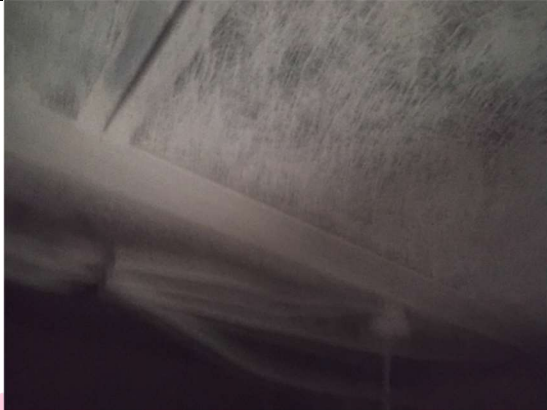
| 56 | KX001591 | Ceiling void ceiling above | Block A Ground Floor Corridor (Room 060) | Does not contain asbestos. |

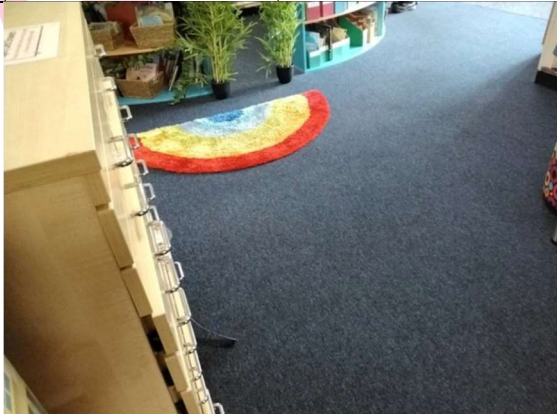
| 57 | As KX001593 | Floor tile (under floor covering) grey under screed | Block A Ground Floor Corridor (Room 060) | Contains asbestos - Any change in appearance should be recorded and passed to Property Services. |

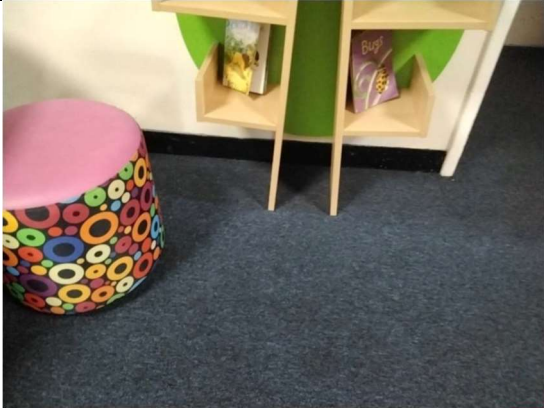
| 58 | As KX001592 | Wall skirting | Block A Ground Floor Corridor (Room 060) | Contains asbestos - Any change in appearance should be recorded and passed to Property Services. |

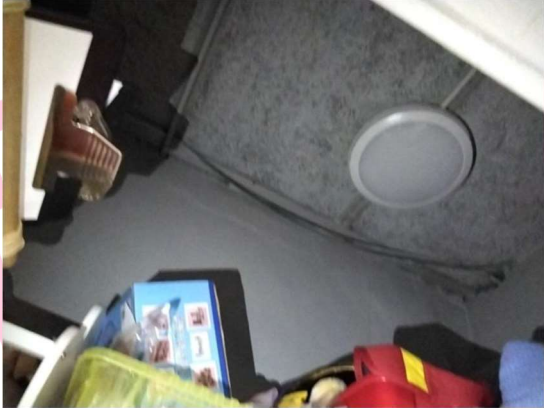
| 59 | As KX001591 | Ceiling void ceiling above | Block A Ground Floor Cupboard (Room 057) | Does not contain asbestos. |

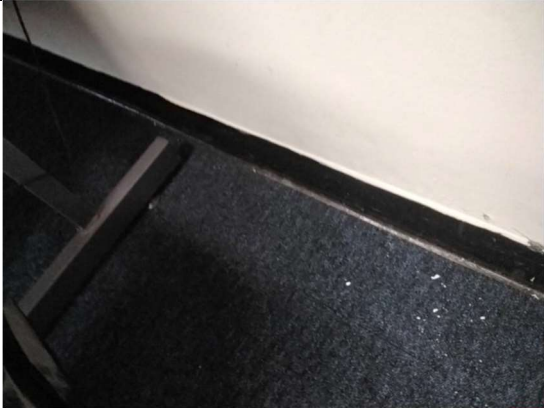
| 61 | As KX001592 | Wall skirting | Block A Ground Floor Office (Room 56) | Contains asbestos - Any change in appearance should be recorded and passed to Property Services. |

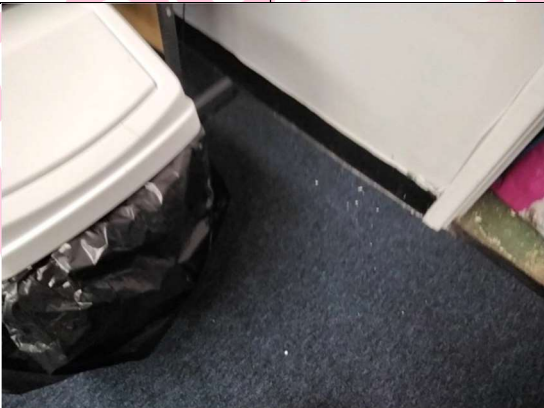
| 62 | As KX001593 | Floor tile (under floor covering) grey under screed | Block A Ground Floor Office (Room 56) | Contains asbestos - Any change in appearance should be recorded and passed to Property Services. |

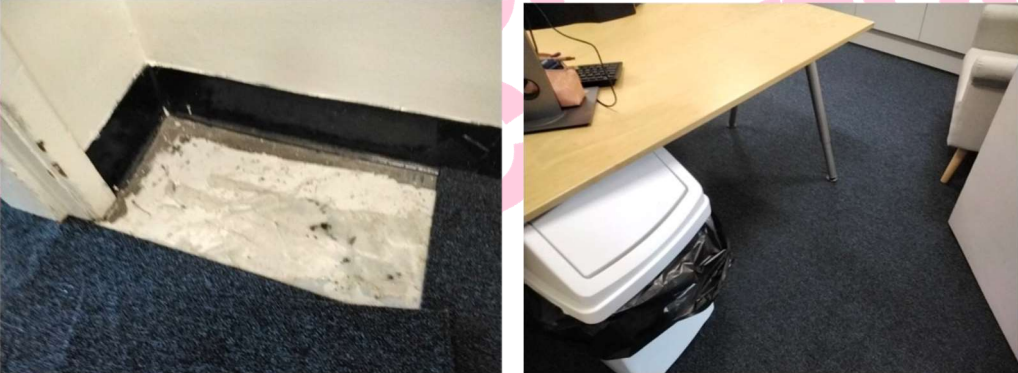
| 65 | As KX001593 | Floor tile (under floor covering) grey under screed | Block A Ground Floor Office (Room 59) | Contains asbestos - Any change in appearance should be recorded and passed to Property Services. |

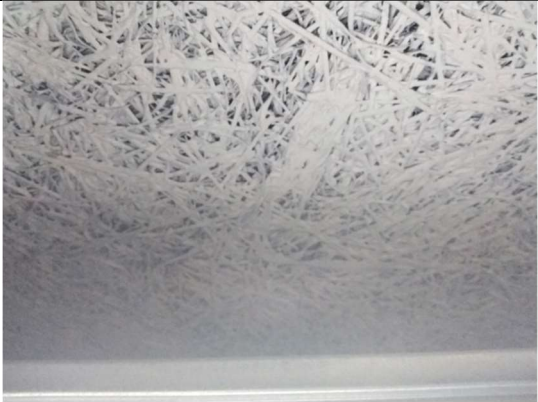
| 70 | As KX001591 | Ceiling void ceiling above | Block A Ground Floor Corridor (Room 078) | Does not contain asbestos. |

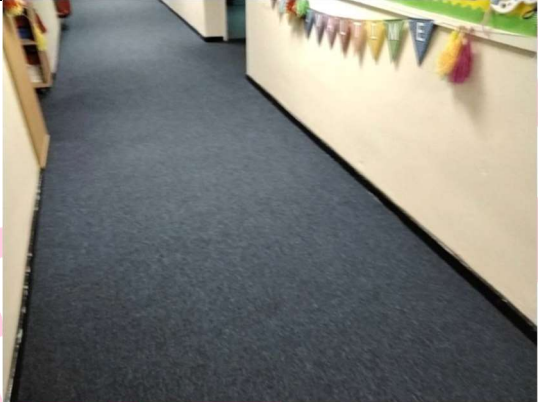
| 71 | As KX001572 | Floor screed under carpet and modern screed layer | Block A Ground Floor Corridor (Room 078) | Does not contain asbestos. |

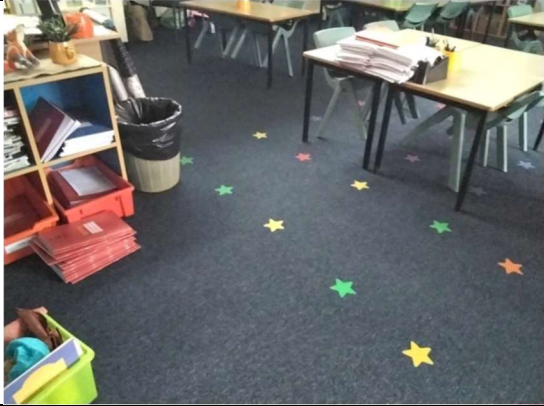
| 73 | KX001594 | Floor adhesive residue under carpet and screed | Block A Ground Floor Classroom (Room 065) | Contains asbestos - Any change in appearance should be recorded and passed to Property Services. |

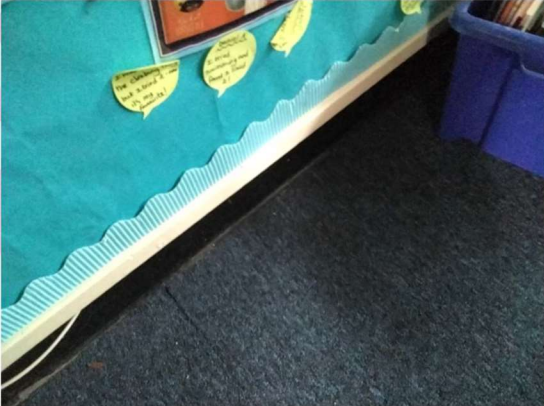
| 74 | As KX001592 | Wall skirting | Block A Ground Floor Classroom (Room 065) | Contains asbestos - Any change in appearance should be recorded and passed to Property Services. |

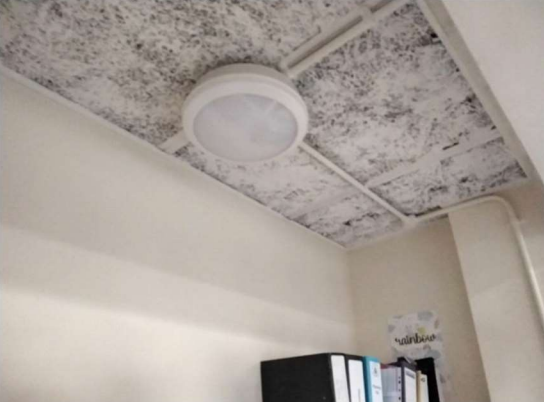
| 75 | As KX001591 | Ceiling alcove | Block A Ground Floor Classroom (Room 065) | Does not contain asbestos. |

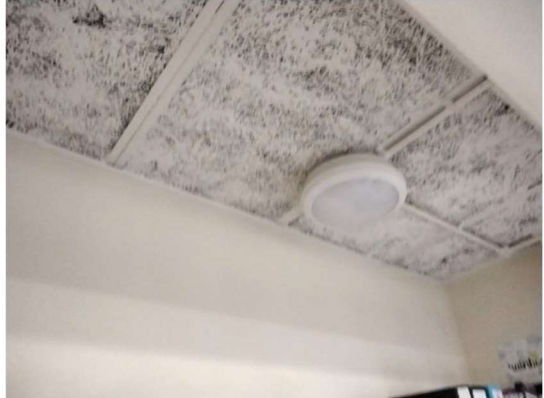
| 78 | As KX001591 | Ceiling | Block A Ground Floor Classroom (Room 069) | No Risk |

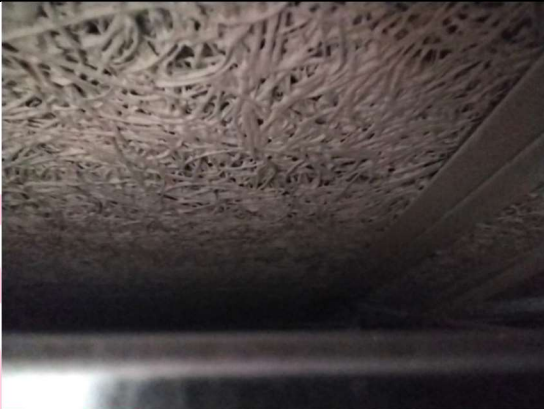
| 83 | As KX001591 | Ceiling | Block A Ground Floor Classroom (Room 076) | Does not contain asbestos. |

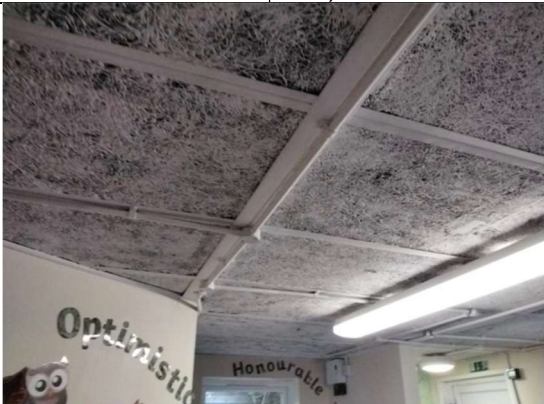
| 84 | As KX001591 | Ceiling | Block A Ground Floor Cloakroom (Room 072) | Does not contain asbestos. |

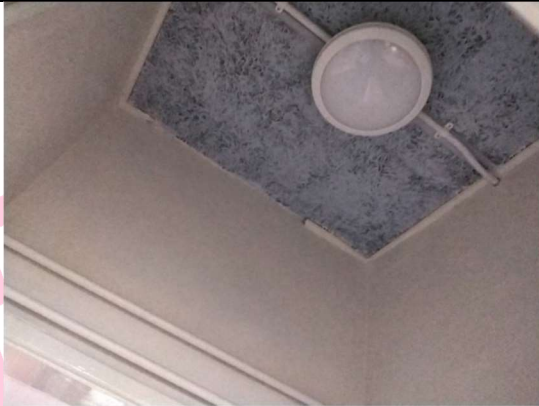
| 98 | As KX001591 | Ceiling | Block A Ground Floor Hallway Passageway (Room 062) | Does not contain asbestos. |

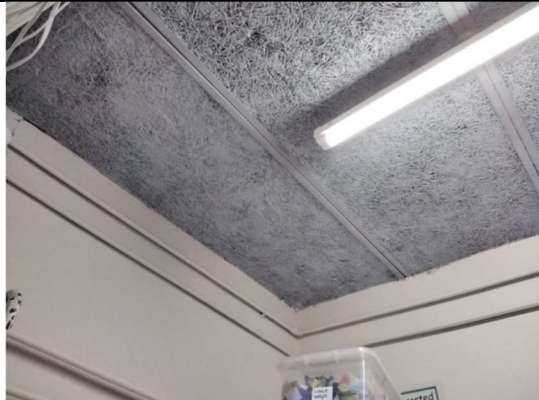
| 99 | As KX001591 | Ceiling | Block A Ground Floor Store Room (Room 044) | Does not contain asbestos. |

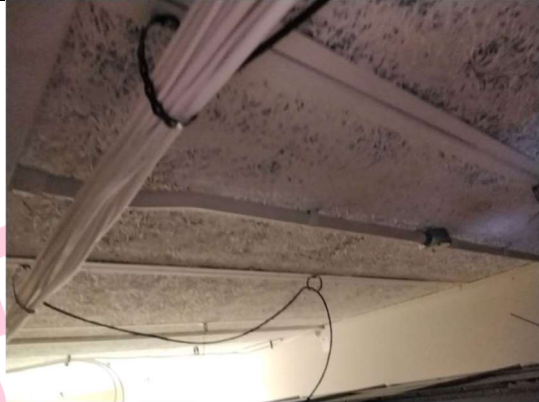
| 119 | As KX001591 | Ceiling void ceiling above | Block A First Floor Corridor (Room 106a) | Does not contain asbestos. |

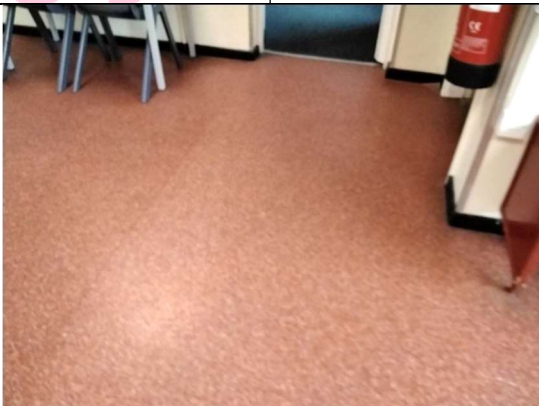
| 120 | KX001604 | Floor screed under modern lino and screed | Block A First Floor Corridor (Room 106a) | Does not contain asbestos. |

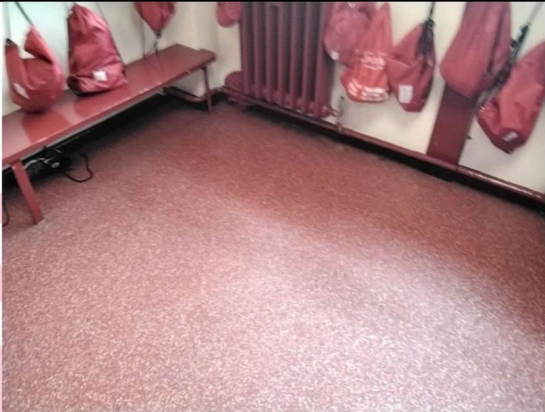
| 122 | KX001604 | Floor screed under modern lino and screed | Block A First Floor Cloakroom (Room 105) | Does not contain asbestos. |

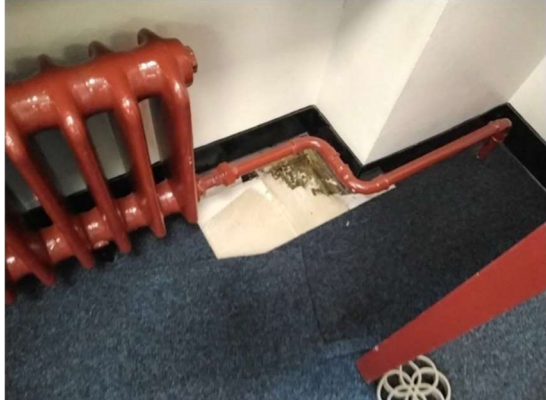
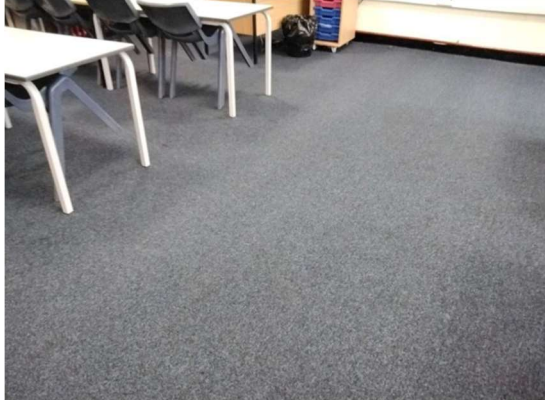
| 123 | KX001605 | Floor tile under floor covering | Block A First Floor Classroom (Room 90) | Contains asbestos - Any change in appearance should be recorded and passed to Property Services. |

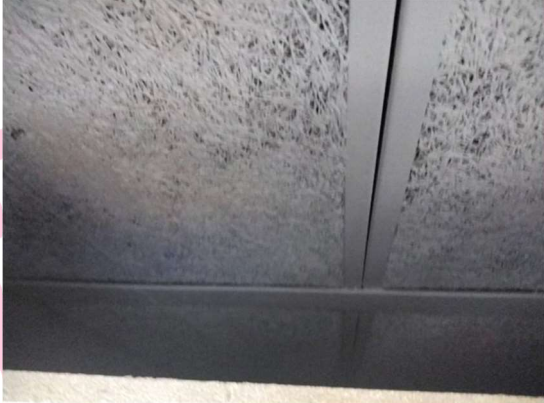
| 137 | As KX001591 | Ceiling void ceiling above | Block A First Floor Office (Room 104) | Does not contain asbestos. |

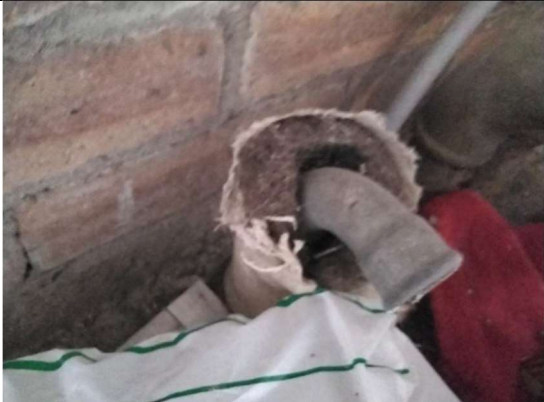
| 138 | As KX001585 | Pipework insulation string binding to fibreglass | Block A Second Floor Storage Area (Room 019) | Contains asbestos - Any change in appearance should be recorded and passed to Property Services. |

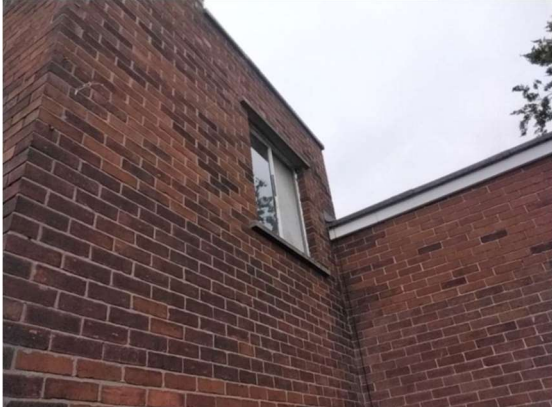
| 141 | KX001609 | Window putty seal second floor store window | Block A External | Does not contain asbestos. |

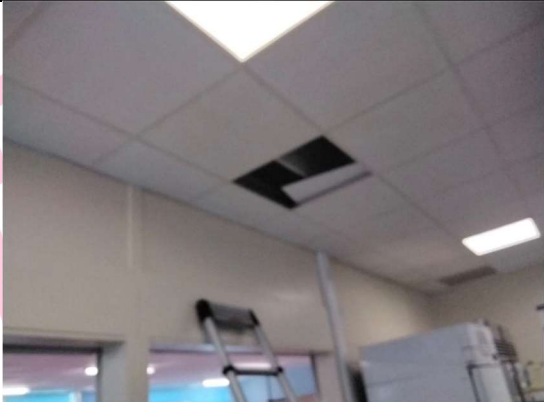
| 149 | KX001620 | Ceiling void debris to wooden framework and within nail holes - encapsulated | Block B Ground Floor Kitchen (Room 109) | Medium Risk |

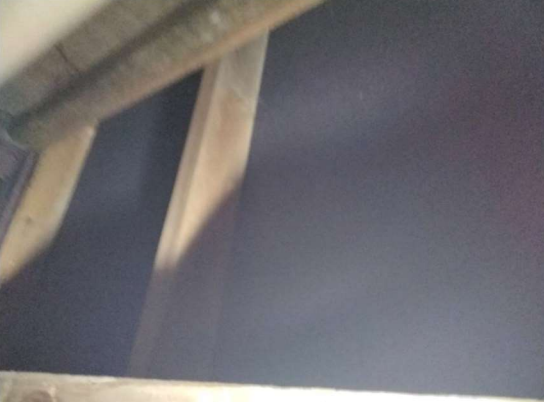
| 150 | As KX001621 | Ceiling void wall lining | Block B Ground Floor Kitchen (Room 109) | Does not contain asbestos. |

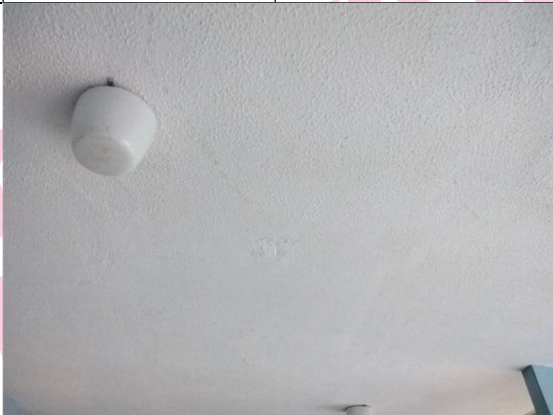
| 164 | KX001626 | Ceiling coating | Block B Ground Floor Entrance Hall Foyer Lobby (Room 130) | Contains asbestos - Any change in appearance should be recorded and passed to Property Services. |

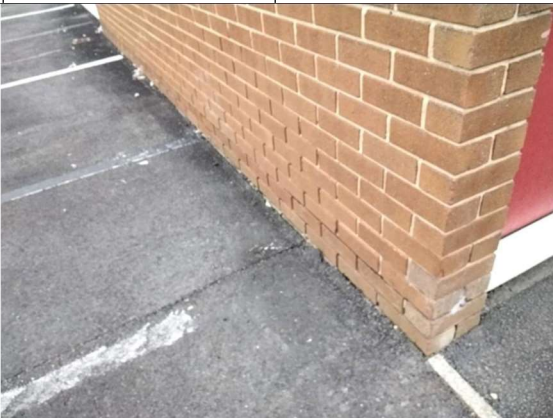
| 165 | KX001614 | Damp proof course | Block B External | Does not contain asbestos. |
