ASBESTOS SURVEY REPORT FOR ROSSMERE ACADEMY, CATCOTE ROAD, HARTLEPOOL, TS25 3JL.

Asbestos Register for

Rossmere Academy, Hartlepool

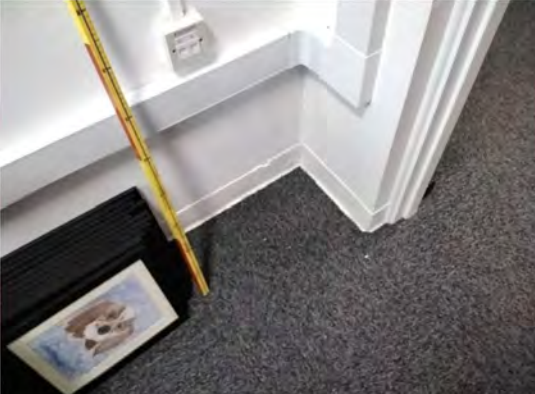
5	KX001574	Wall skirting	Block A Ground Floor Office (Room 002)	Contains asbestos - Any change in appearance should be recorded and passed to Property Services.

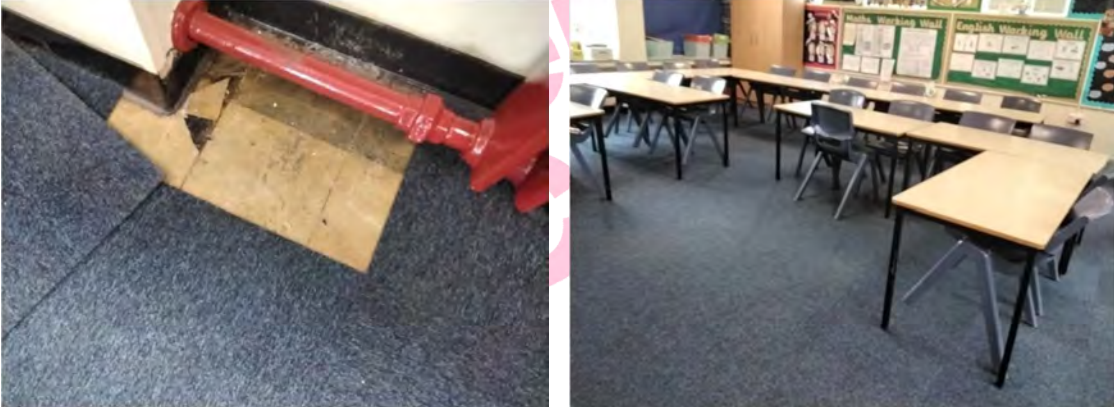
11	KX001576	Floor tile (under floor covering) black and grey below carpet	Block A Ground Floor Classroom (Room 006)	Contains asbestos - Any change in appearance should be recorded and passed to Property Services.

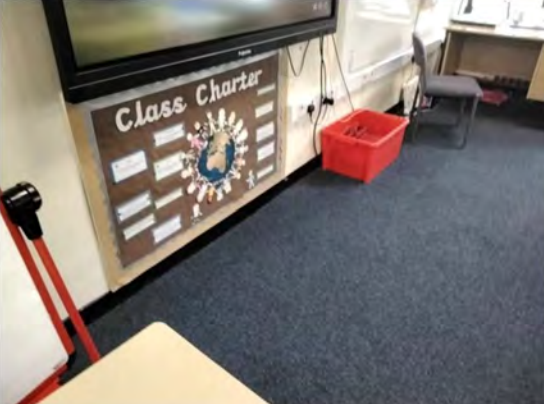
12	KX001577	Wall Skirting	Block A Ground Floor Classroom (Room 006)	Contains asbestos - Any change in appearance should be recorded and passed to Property Services.

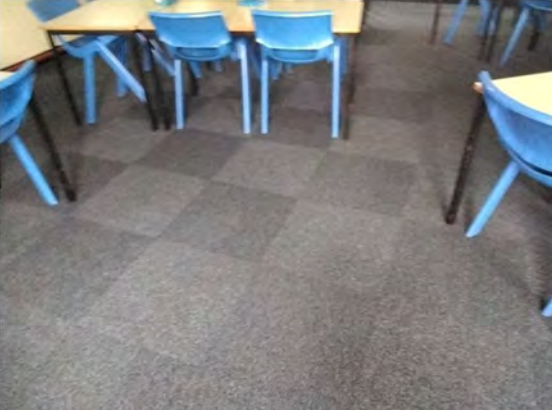
13	As KX001576	Floor tile (under floor covering) black and grey below carpet	Block A Ground Floor Classroom (Room 008)	Contains asbestos - Any change in appearance should be recorded and passed to Property Services.

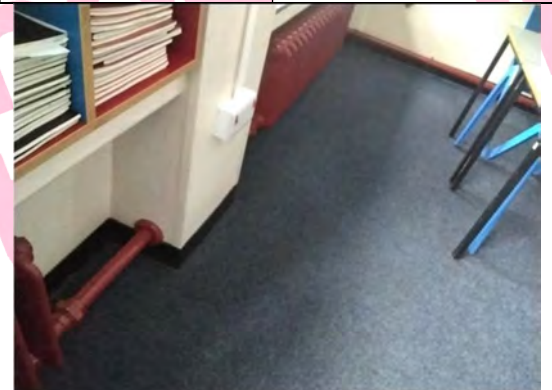
14	As KX001577	Wall Skirting	Block A Ground Floor Classroom (Room 008)	Contains asbestos - Any change in appearance should be recorded and passed to Property Services.

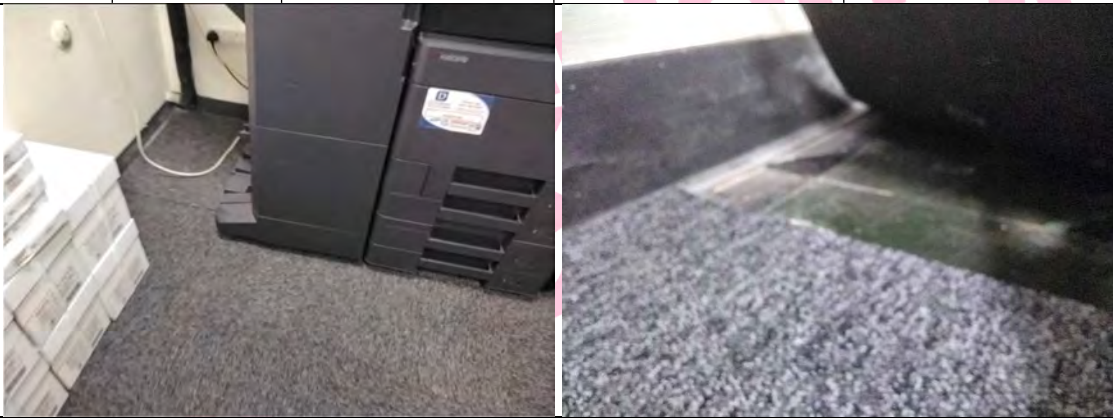
17	KX001579	Floor tile (under floor covering) black, green and grey	Block A Ground Floor Medical/First Aid (Room 015)	Contains asbestos - Any change in appearance should be recorded and passed to Property Services.

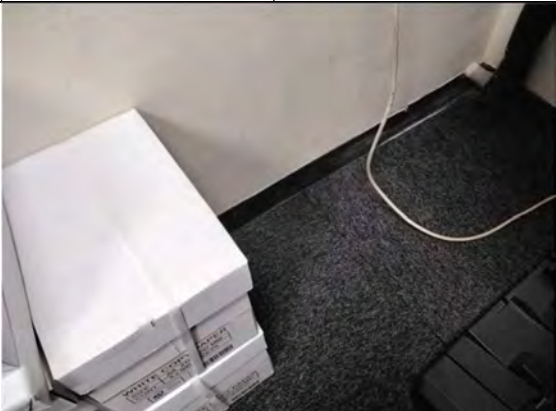
18	KX001580	Wall Skirting	Block A Ground Floor Medical/First Aid (Room 015)	Contains asbestos - Any change in appearance should be recorded and passed to Property Services.

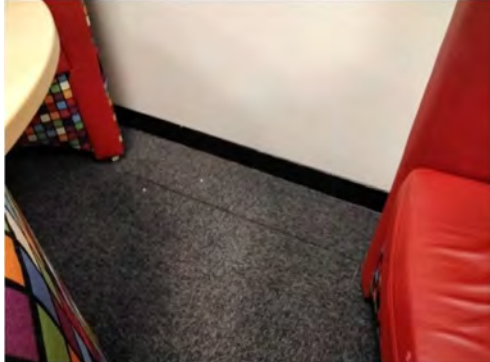
19	As KX001580	Wall Skirting	Block A Ground Floor Hallway/Passageway (Room 020)	Contains asbestos - Any change in appearance should be recorded and passed to Property Services.

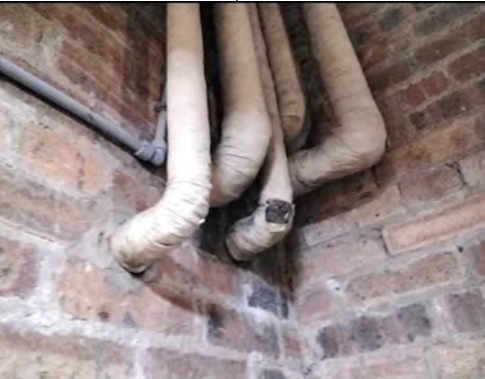
24	KX001585	Pipework insulation string binding to fibreglass	Block A Ground Floor Stairwell/Staircase (Room 017)	Contains asbestos - Any change in appearance should be recorded and passed to Property Services.

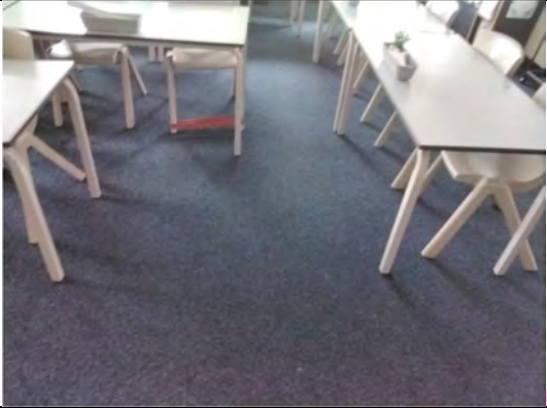
31	As KX001581	Floor adhesive residue under carpet and screed	Block A Ground Floor Classroom (Room 025)	Contains asbestos - Any change in appearance should be recorded and passed to Property Services.

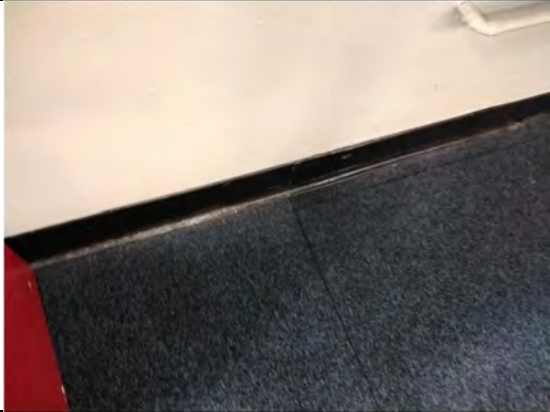
40	As KX001580	Wall Skirting	Block A Ground Floor Classroom (Room 029)	Contains asbestos - Any change in appearance should be recorded and passed to Property Services.

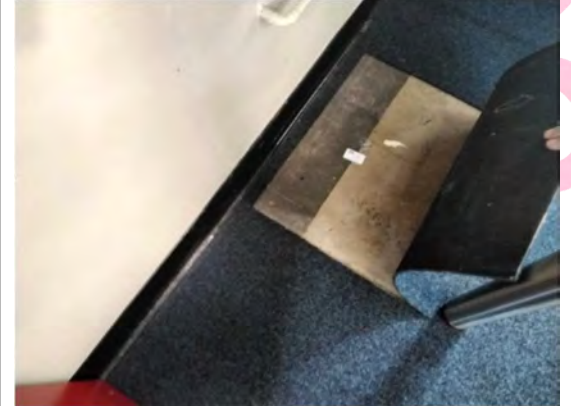
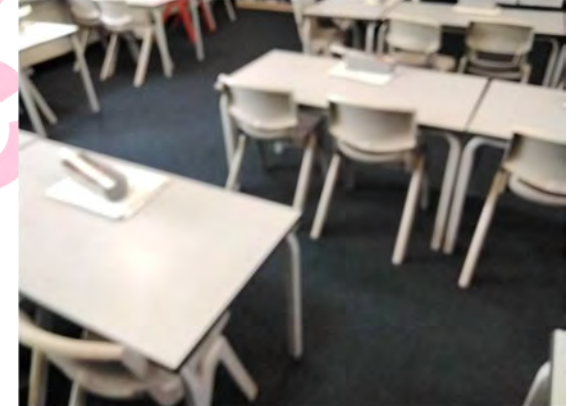
41	KX001588	Floor tile (under floor covering) brown and beige	Block A Ground Floor Classroom (Room 029)	Contains asbestos - Any change in appearance should be recorded and passed to Property Services.

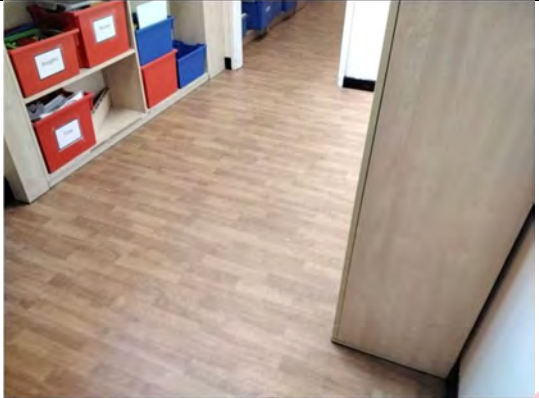
52	As KX001590	Floor adhesive residue	Block A Ground Floor Corridor (Room 041a)	Contains asbestos - Any change in appearance should be recorded and passed to Property Services.

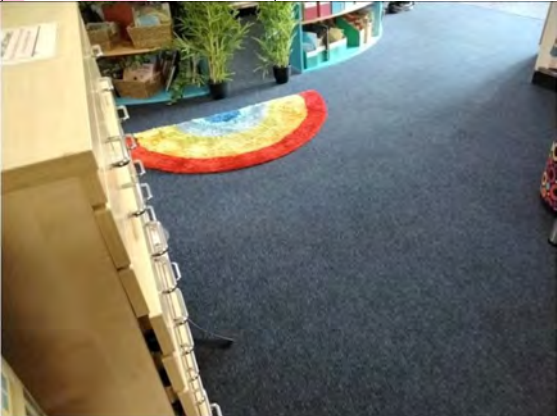
57	As KX001593	Floor tile (under floor covering) grey under screed	Block A Ground Floor Corridor (Room 060)	Contains asbestos - Any change in appearance should be recorded and passed to Property Services.

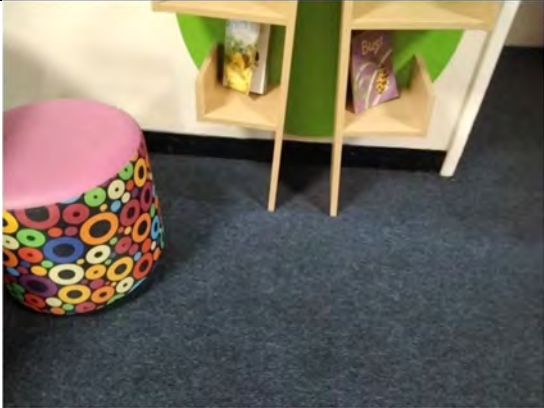
58	As KX001592	Wall skirting	Block A Ground Floor Corridor (Room 060)	Contains asbestos - Any change in appearance should be recorded and passed to Property Services.

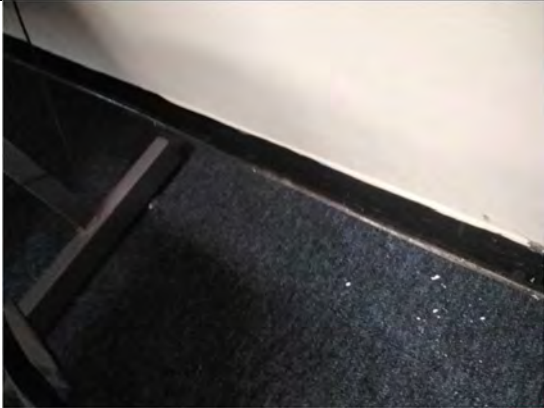
61	As KX001592	Wall skirting	Block A Ground Floor Office (Room 56)	Contains asbestos - Any change in appearance should be recorded and passed to Property Services.

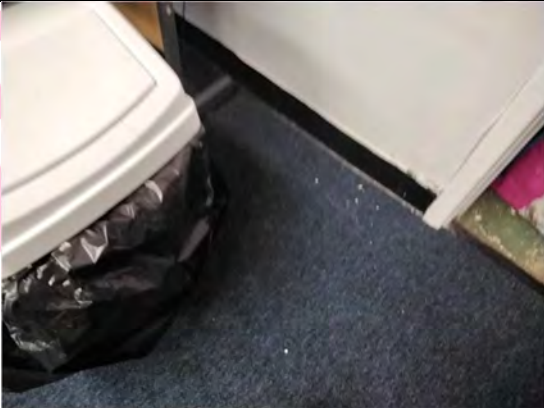
62	As KX001593	Floor tile (under floor covering) grey under screed	Block A Ground Floor Office (Room 56)	Contains asbestos - Any change in appearance should be recorded and passed to Property Services.

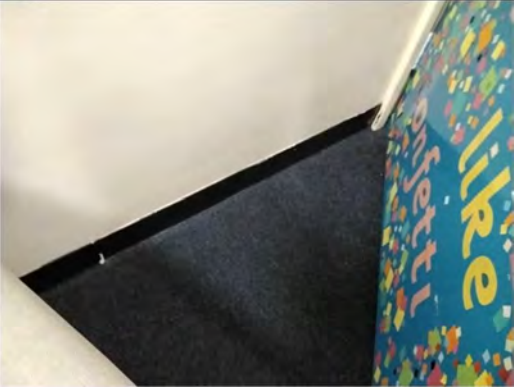
64	As KX001592	Wall skirting	Block A Ground Floor Office (Room 59)	Contains asbestos - Any change in appearance should be recorded and passed to Property Services.

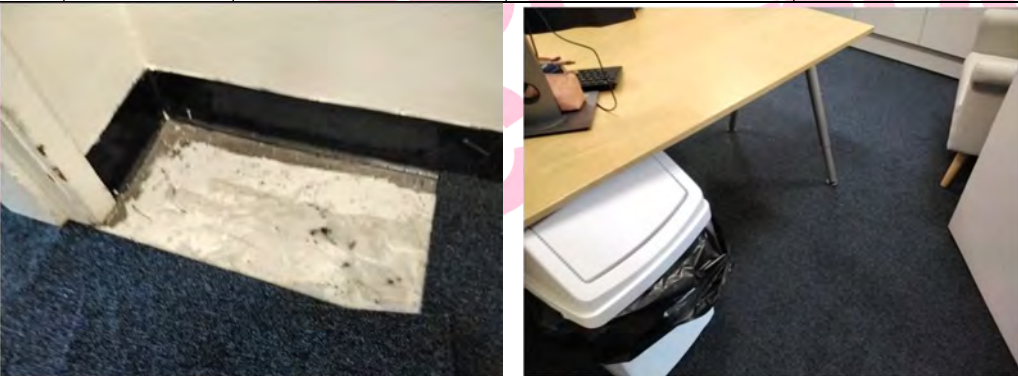
65	As KX001593	Floor tile (under floor covering) grey under screed	Block A Ground Floor Office (Room 59)	Contains asbestos - Any change in appearance should be recorded and passed to Property Services.

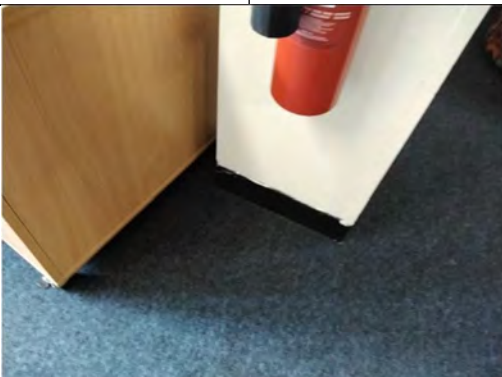
66	As KX001592	Wall skirting	Block A Ground Floor Corridor (Room 61)	Contains asbestos - Any change in appearance should be recorded and passed to Property Services.

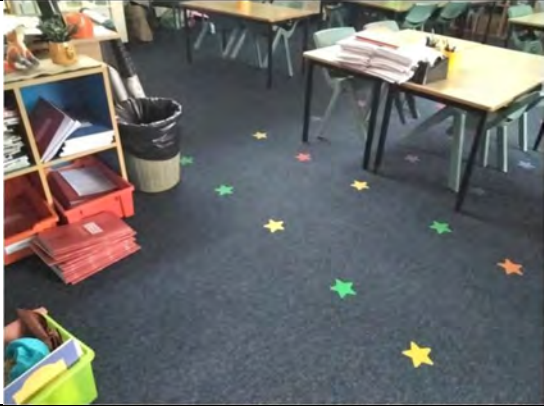
73	KX001594	Floor adhesive residue under carpet and screed	Block A Ground Floor Classroom (Room 065)	Contains asbestos - Any change in appearance should be recorded and passed to Property Services.

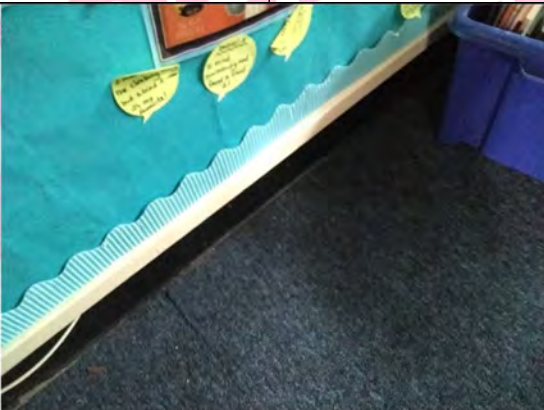
74	As KX001592	Wall skirting	Block A Ground Floor Classroom (Room 065)	Contains asbestos - Any change in appearance should be recorded and passed to Property Services.

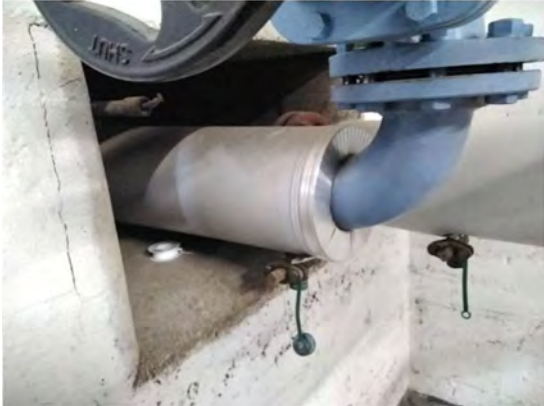
115	KX001603	Debris/Residue unsealed at entrance to floor duct - encapsulated	Block A Ground Floor Boiler Room (Room 089)	Medium Risk

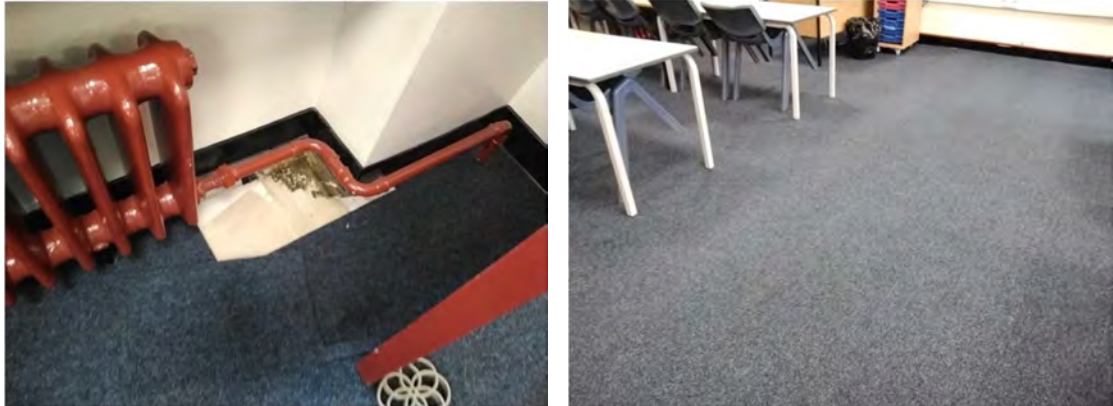
123	KX001605	Floor tile under floor covering	Block A First Floor Classroom (Room 90)	Contains asbestos - Any change in appearance should be recorded and passed to Property Services.

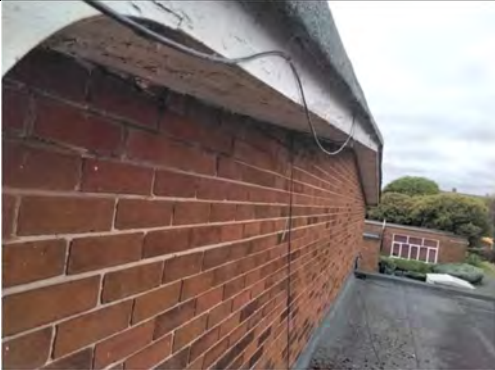
139	KX001607	Soffits Gable ends	Block A External	Contains asbestos - Any change in appearance should be recorded and passed to Property Services.

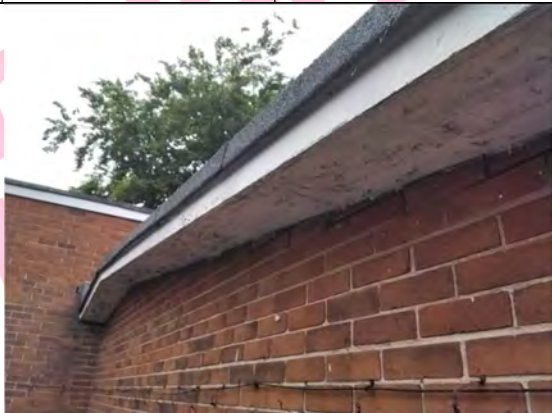
140	KX001608	Soffits Gable ends	Block A External	Contains asbestos - Any change in appearance should be recorded and passed to Property Services.

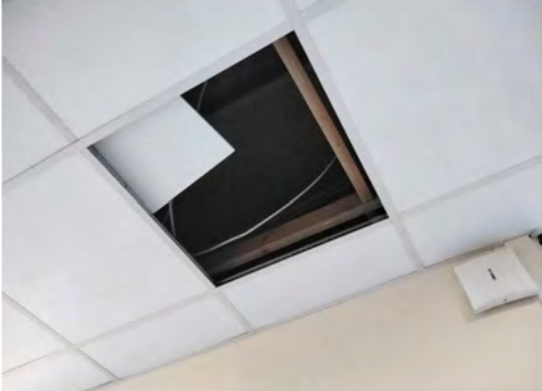
148	KX001619	Ceiling void debris to wooden framework and within nail holes - encapsulated	Block B Ground Floor Kitchen (Room 109)	Medium Risk

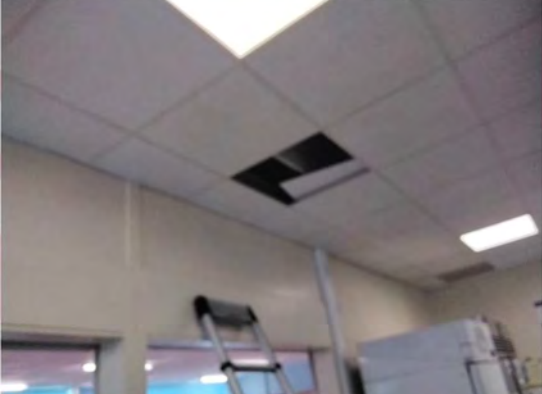
149	KX001620	Ceiling void debris to wooden framework and within nail holes - encapsulated	Block B Ground Floor Kitchen (Room 109)	Medium Risk

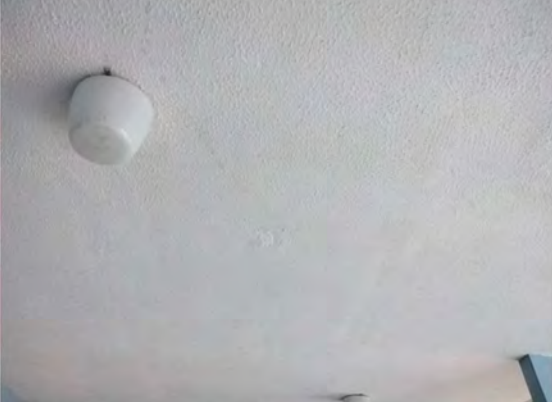
164	KX001626	Ceiling coating	Block B Ground Floor Entrance Hall Foyer Lobby (Room 130)	Contains asbestos - Any change in appearance should be recorded and passed to Property Services.
