ASBESTOS SURVEY REPORT FOR THORNTREE ACADEMY, BIRKHALL ROAD, MIDDLESBOROUGH, TS3 9JW.

Asbestos Register for Thorntree Academy, Middlesbrough

Date: 13 May 2026

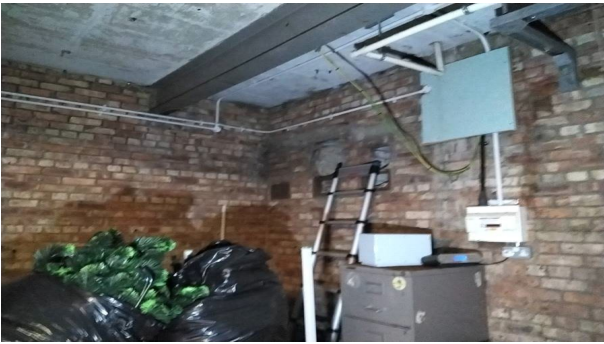
4	KX001656	Debris/residue to walls adjacent to flue openings	Main Building Boiler Room (Room 098)	6 monthly

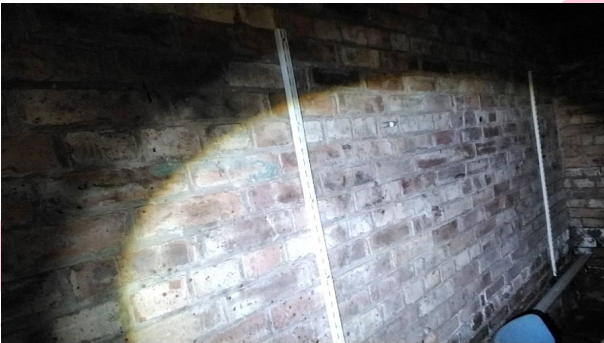
5	KX001657	Debris/residue to walls in paint	Main Building Boiler Room (Room 098)	6 monthly

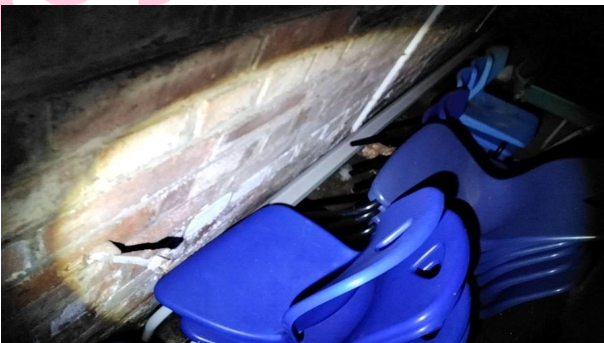
6	KX001658	Debris/residue to walls and old pipe hangars	Main Building Boiler Room (Room 098)	6 monthly

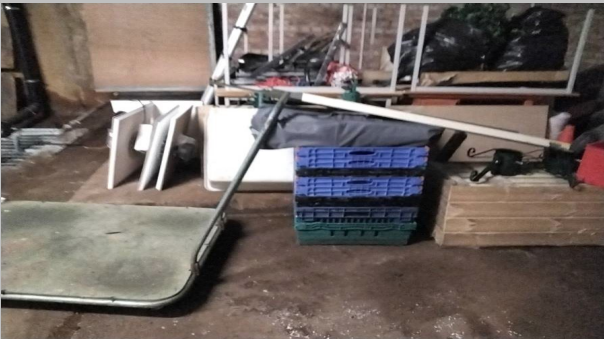
7	KX001659	Debris/residue to floor off plinths	Main Building Boiler Room (Room 098)	No Risk

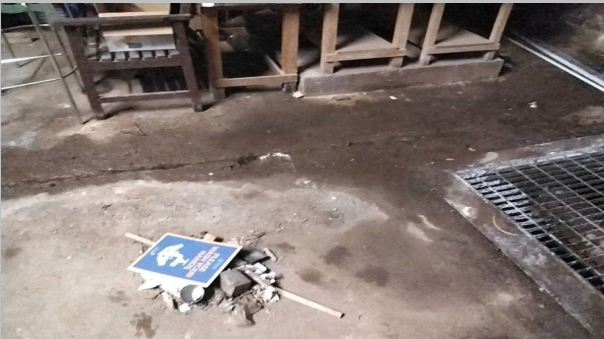
8	KX001660	Debris/residue to floor, drainage gulleys	Main Building Boiler Room (Room 098)	No Risk

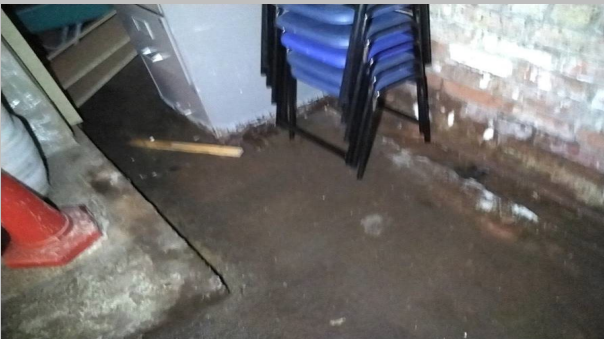
9	KX001661	Debris/residue to floor, at walls behind boiler plinths	Main Building Boiler Room (Room 098)	No Risk

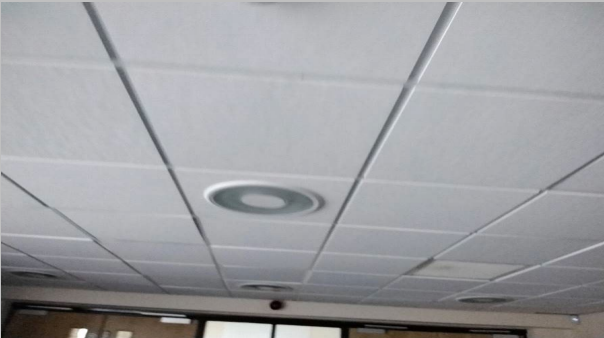
10	KX001635	Ceiling void ceiling above	Main Building Reception/Entrance (Room 001)	No Risk

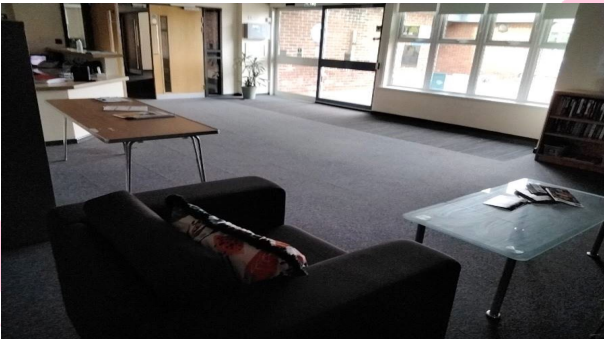
11	KX001636	Floor adhesive residue under carpet and screed	Main Building Reception/Entrance (Room 001)	6 monthly

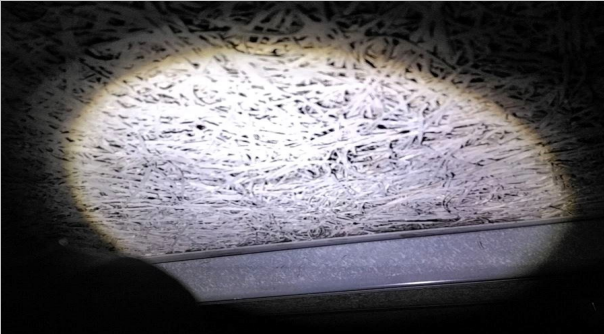
12	As KX001635	Ceiling void ceiling above	Main Building Store Cupboard (Room 002)	No Risk

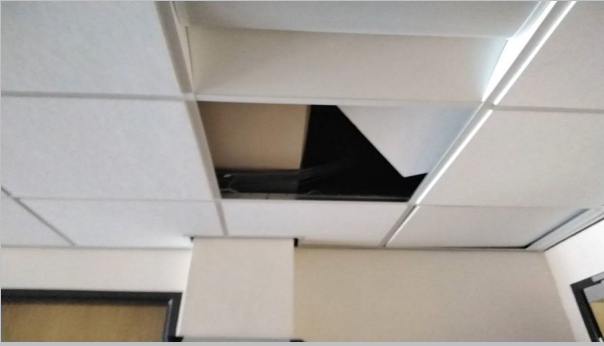
13	As KX001635	Ceiling void ceiling above	Main Building Reception (Room 007)	No Risk

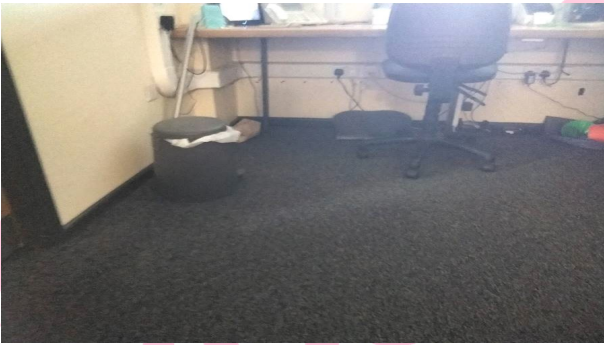
14	As KX001636	Floor adhesive residue under carpet and screed	Main Building Reception (Room 007)	6 monthly

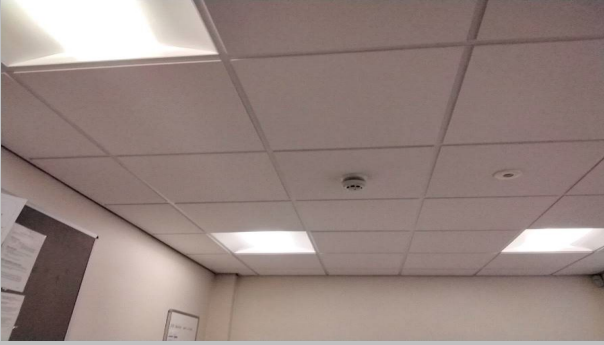
15	As KX001635	Ceiling void ceiling above	Main Building Office (Room 008)	No Risk

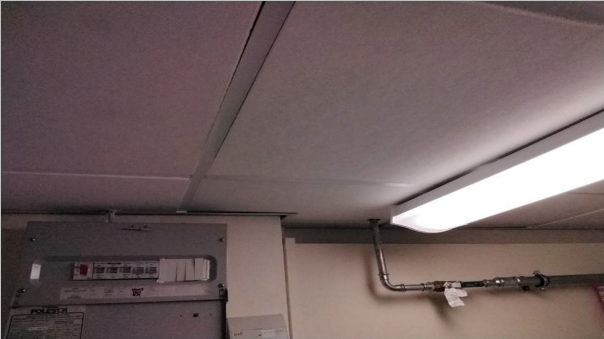
22	As KX001635	Ceiling void ceiling above	Main Building Office (Room 009)	No Risk

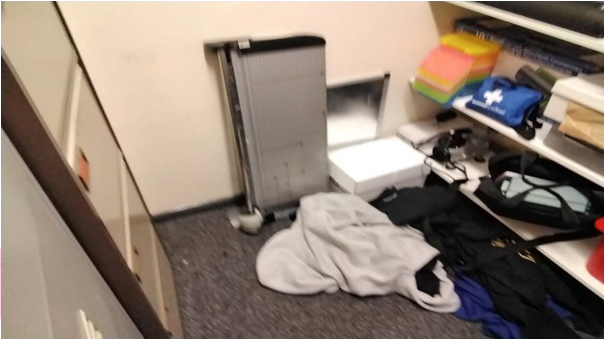
23	As KX001636	Floor adhesive residue under carpet and screed	Main Building Office (Room 009)	12 monthly

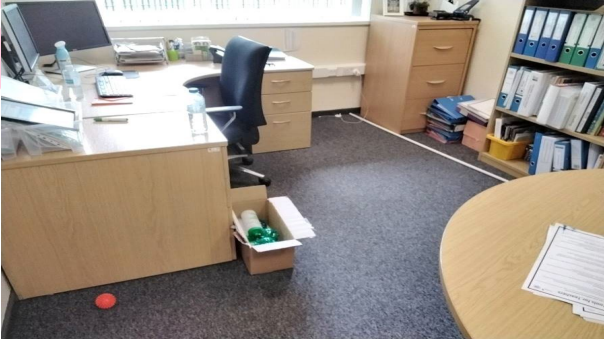
24	KX001638	Floor adhesive residue under carpet	Main Building Office (Room 011)	6 monthly

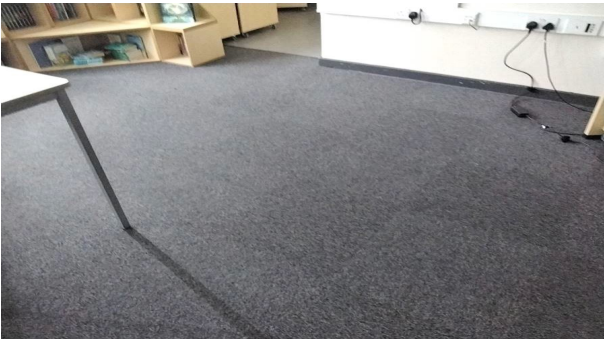
28	As KX001638	Floor adhesive residue under carpet	Main Building Classroom (Room 013)	6 monthly

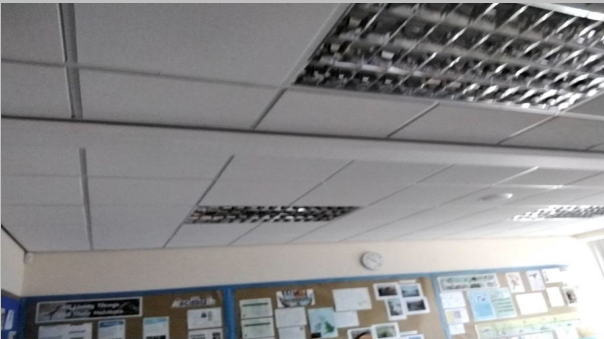
29	As KX001635	Ceiling void ceiling above	Main Building Classroom (Room 013)	No Risk

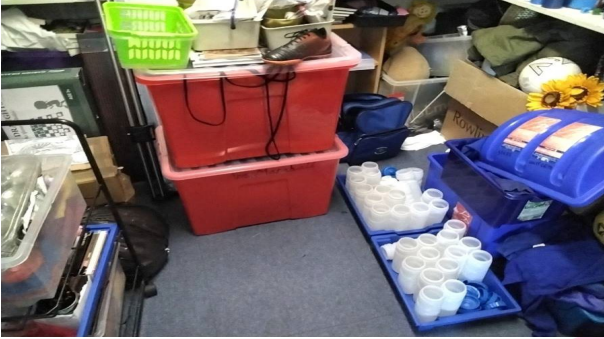
43	Presumed	Floor duct pipe insulation binding to fibreglass pipe insulation within floor duct under concrete slab (identified in previous report)	Main Building Storeroom (Room 024)	12 monthly

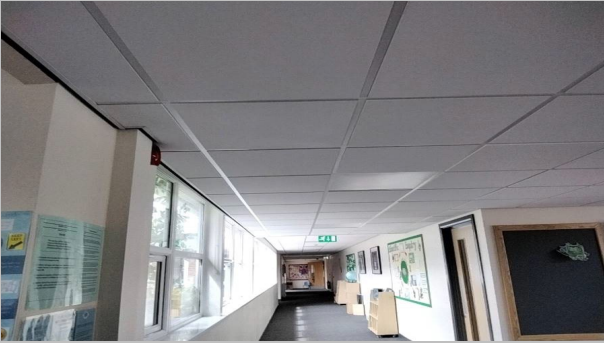
44	As KX001635	Ceiling void ceiling above	Main Building Corridor (Room 025)	No Risk

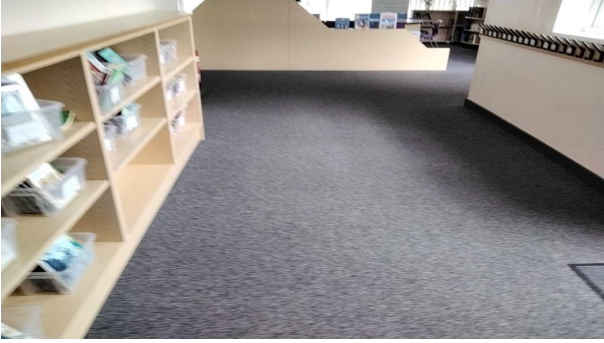
45	As KX001639	Floor adhesive residue under carpet	Main Building Corridor (Room 025)	6 monthly

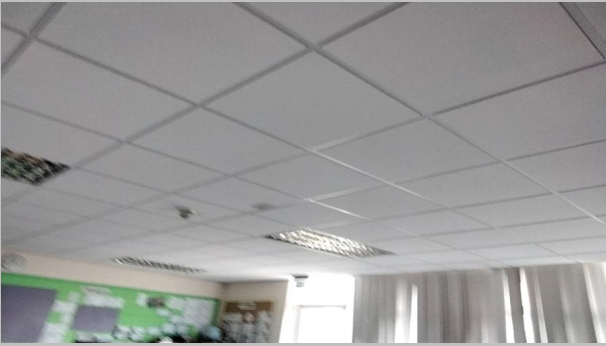
46	As KX001635	Ceiling void ceiling above	Main Building Classroom (Room 026)	No Risk

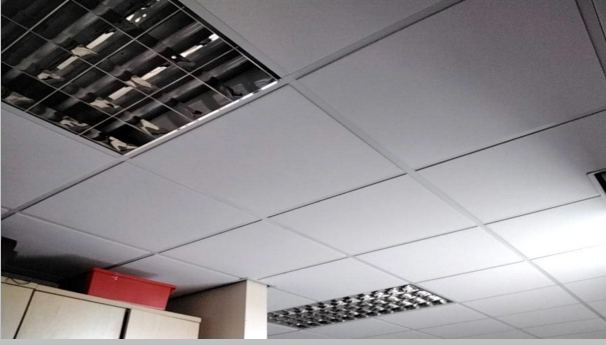
47	As KX001635	Ceiling void ceiling above	Main Building Hallway/passageway (Room 027)	No Risk

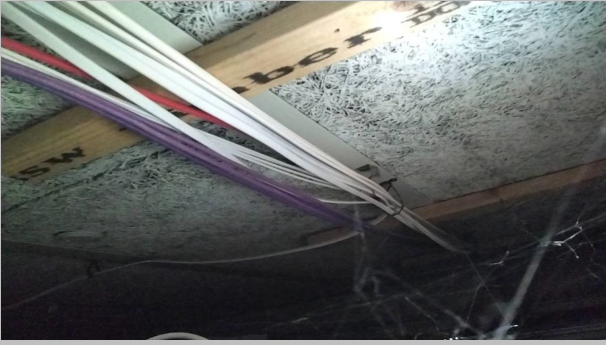
48	As KX001635	Ceiling void ceiling above	Main Building Classroom (Room 028)	No Risk

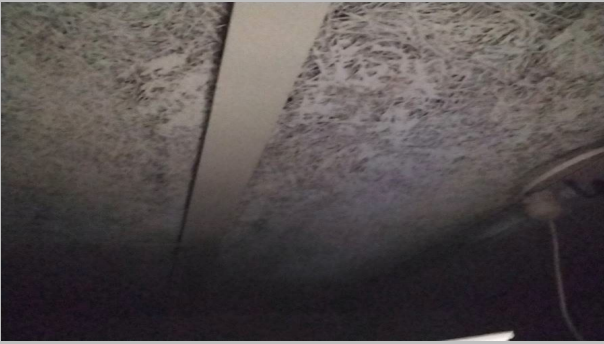
49	As KX001635	Ceiling void ceiling above	Main Building Storeroom (Room 029)	No Risk

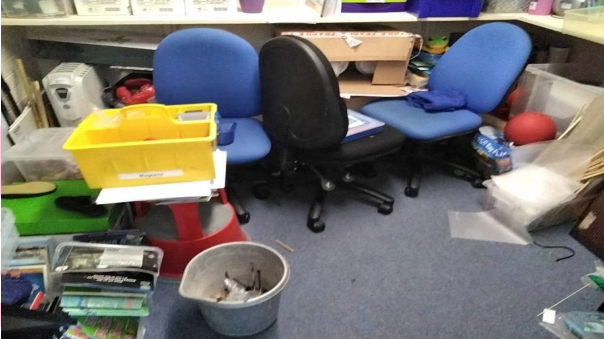
50	Presumed	Floor void/duct string binding to pipework within floor duct under concrete slab (identified in previous report)	Main Building Storeroom (Room 029)	12 monthly

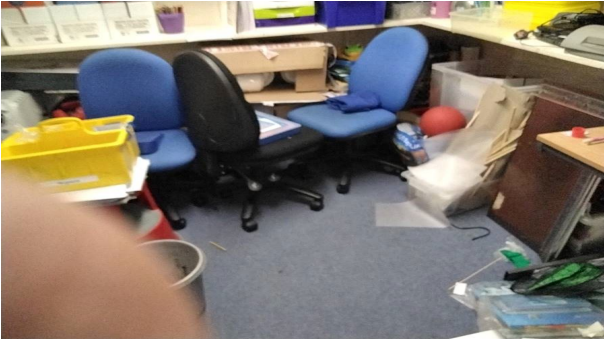
51	Presumed	Floor void/duct pipe sleeves through concrete slab in floor duct	Main Building Storeroom (Room 029)	12 monthly

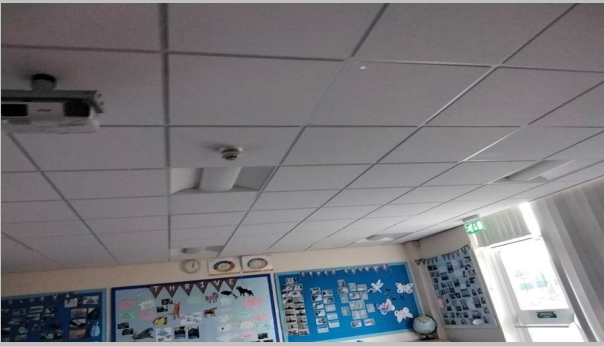
52	As KX001635	Ceiling void ceiling above	Main Building Classroom (Room 030)	No Risk

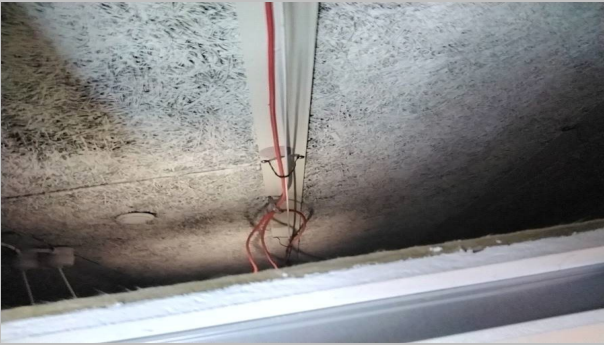
53	As KX001635	Ceiling void ceiling above	Main Building Hallway/passageway (Room 031)	No Risk

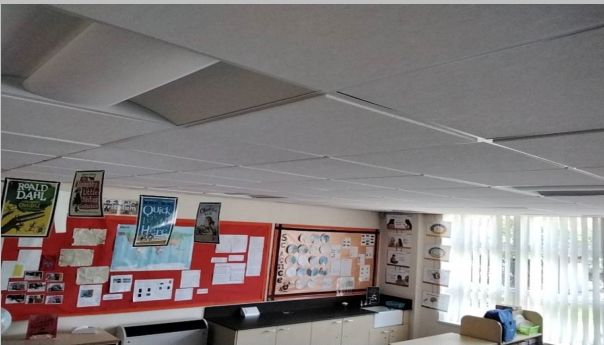
54	As KX001635	Ceiling void ceiling above	Main Building Classroom (Room 032)	No Risk

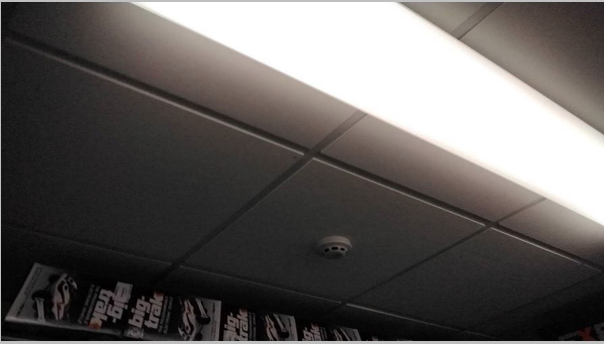
55	As KX001635	Ceiling void ceiling above	Main Building Storeroom (Room 033)	No Risk

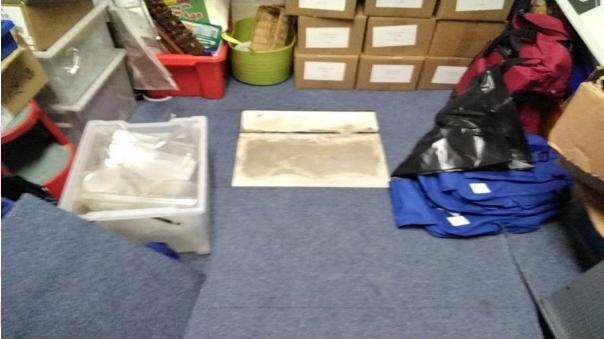
56	Presumed	Floor void/duct string binding to pipework within floor duct under concrete slab (identified in previous report)	Main Building Storeroom (Room 033)	12 monthly

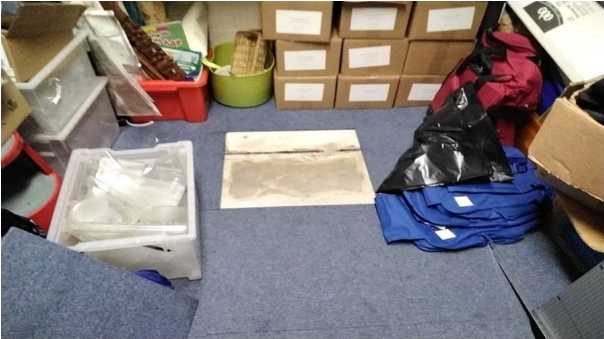
57	Presumed	Floor void/duct pipe sleeves through concrete slab in floor duct	Main Building Storeroom (Room 033)	12 monthly

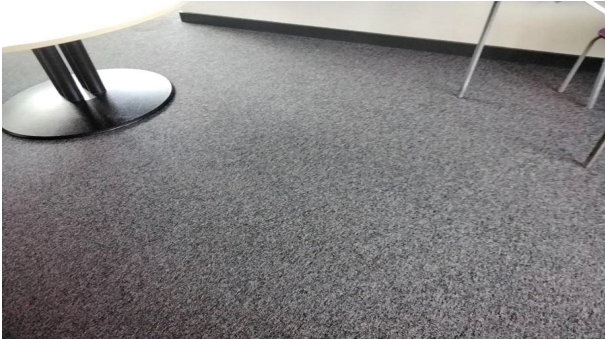
64	As KX001639	Floor adhesive residue under carpet	Main Building Library (Room 051)	6 monthly

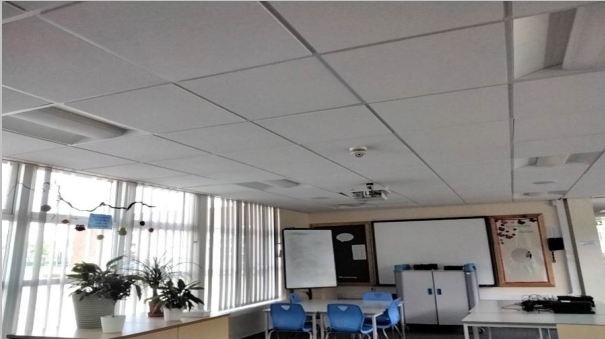
65	As KX001635	Ceiling void ceiling above	Main Building Hallway/Passageway (Room 052)	No Risk

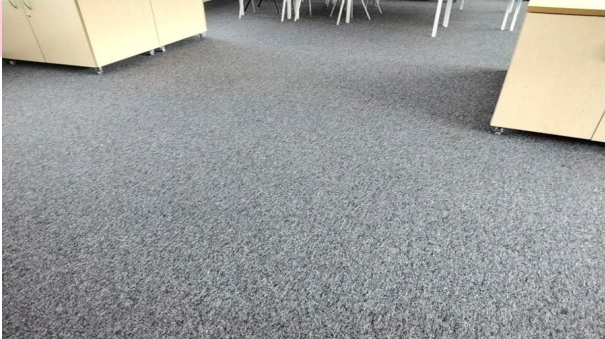
66	As KX001639	Floor adhesive residue under carpet	Main Building Hallway/Passageway (Room 052)	6 monthly

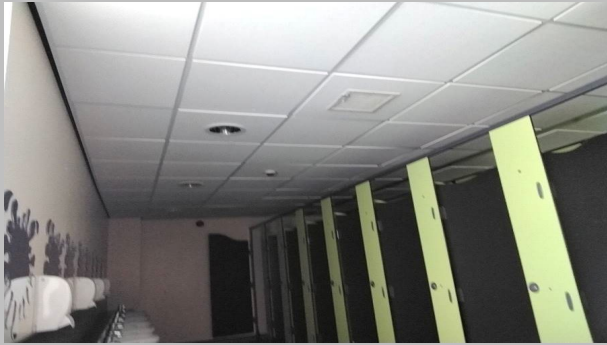
67	As KX001635	Ceiling void ceiling above	Main Building Male Toilets (Room 053)	No Risk

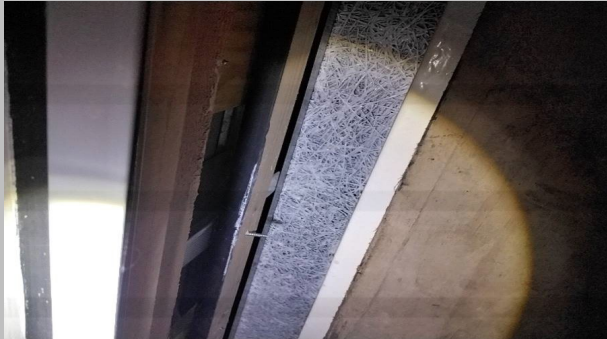
68	As KX001635	Ceiling void ceiling above	Main Building Cleaners Cupboard (Room 053a)	No Risk

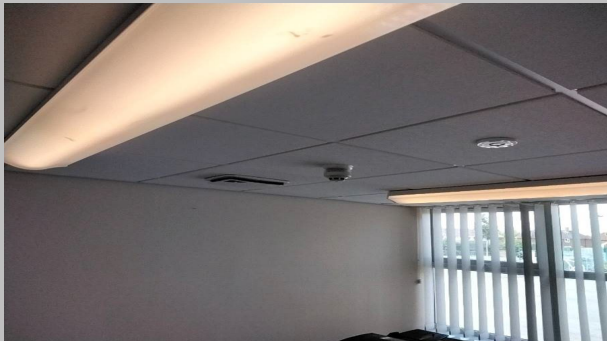
69	As KX001635	Ceiling void ceiling above	Main Building Photocopy Room (Room 054)	No Risk

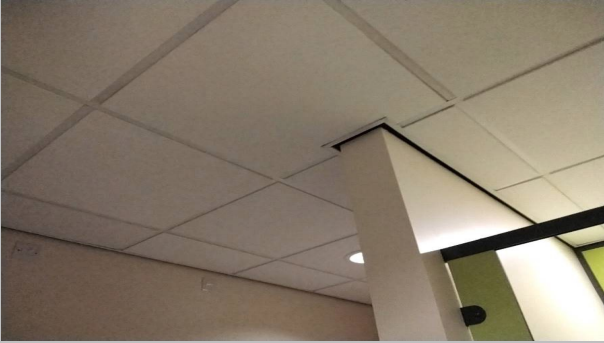
70	As KX001635	Ceiling void ceiling above	Main Building Female Toilets (Room 055)	No Risk

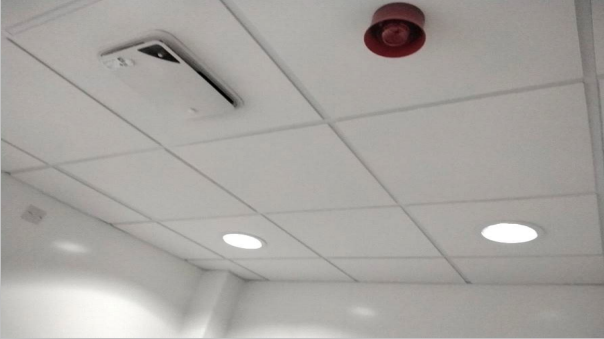
71	As KX001635	Ceiling void ceiling above	Main Building Toilets (Room 056)	No Risk

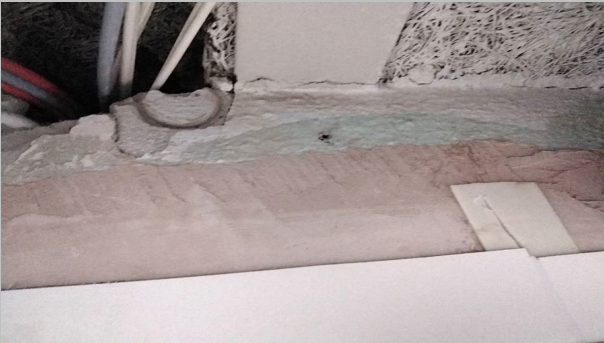
72	KX001641	Wall coating skimmed cladding visible in ceiling void	Main Building Toilets (Room 056)	No Risk

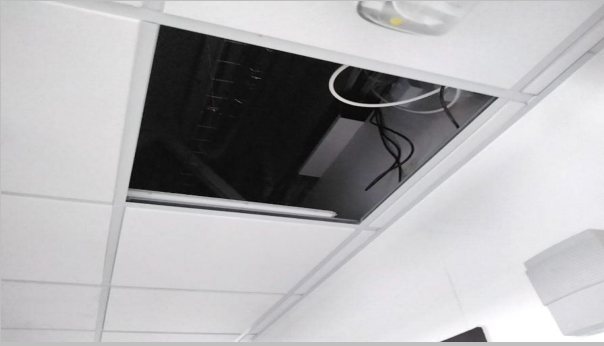
73	As KX001641	Wall coating skimmed cladding visible in ceiling void	Main Building Kitchen (Room 038)	No Risk

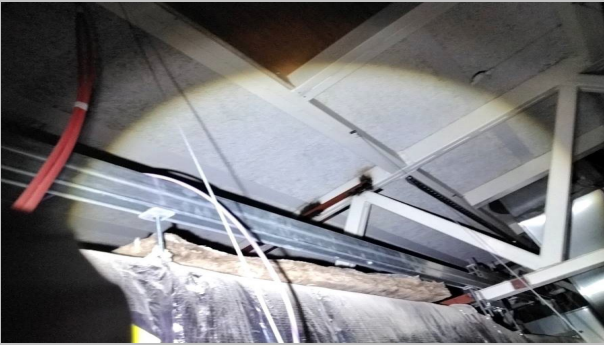
74	KX001642	Ceiling void ductwork sealant to joints	Main Building Kitchen (Room 038)	No Risk

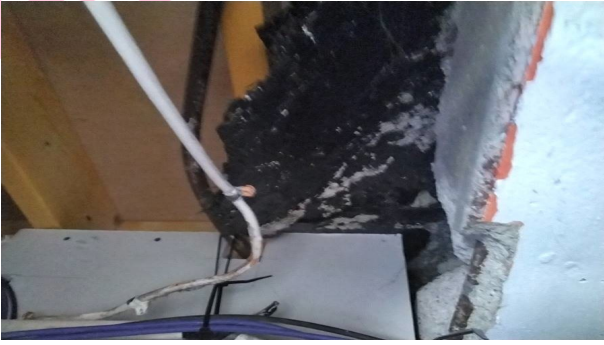
75	KX001643	Ceiling void roof felt debris	Main Building Corridor (Room 037a)	6 monthly

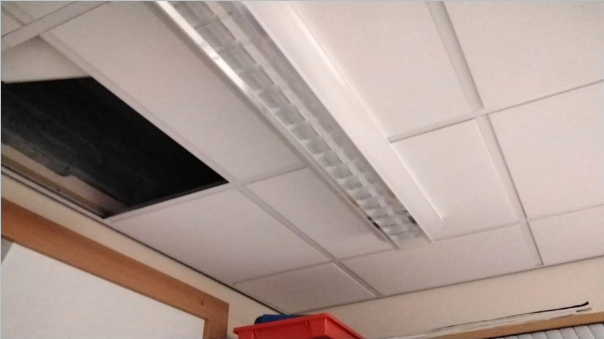
83	As KX001645	Ceiling void ceiling above	Main Building Office (Room 060)	No Risk

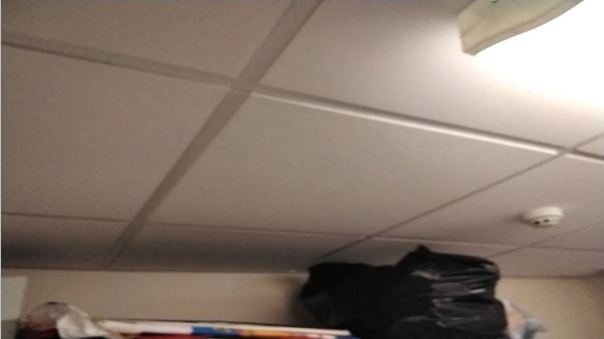
84	As KX001645	Ceiling void ceiling above	Main Building Cupboard Store (Room 062)	No Risk

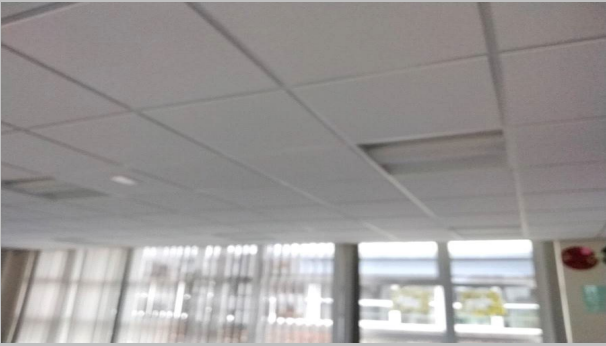
85	As KX001645	Ceiling void ceiling above	Main Building Classroom (Room 061)	No Risk

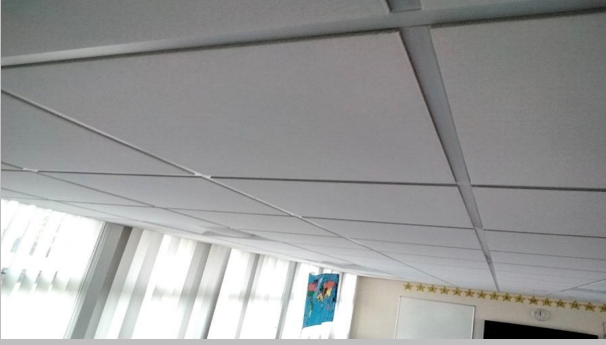
86	As KX001645	Ceiling void ceiling above	Main Building Classroom (Room 063)	No Risk

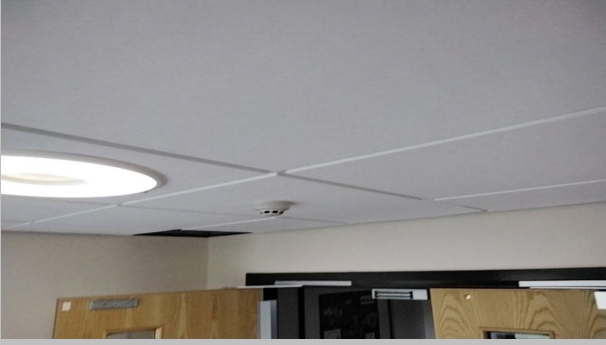
87	As KX001645	Ceiling void ceiling above	Main Building Entrance Hall/Foyer/Lobby (Room 064)	No Risk

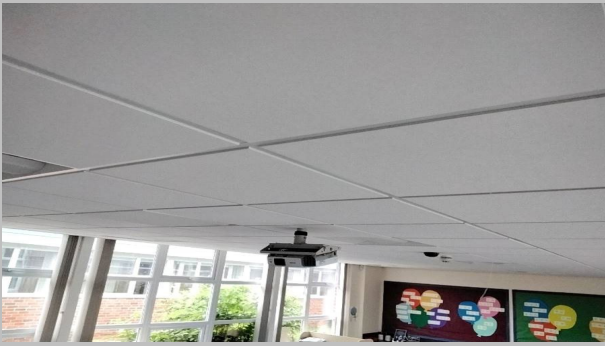
91	As KX001645	Ceiling void ceiling above	Main Building Classroom (Room 068)	No Risk

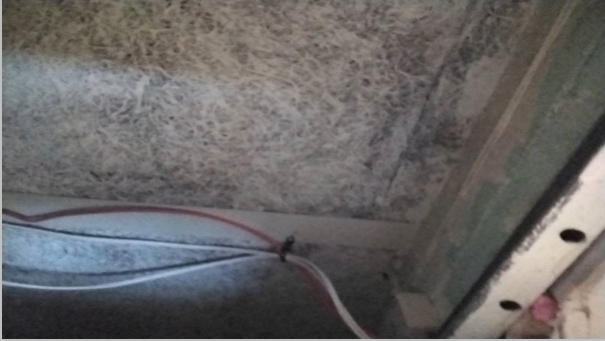
92	As KX001645	Ceiling void ceiling above	Main Building Cupboard Store (Room 069)	No Risk

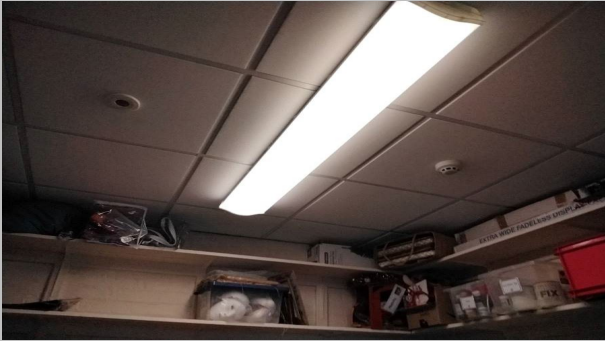
93	As KX001645	Ceiling void ceiling above	Main Building Cupboard Store (Room 072)	No Risk

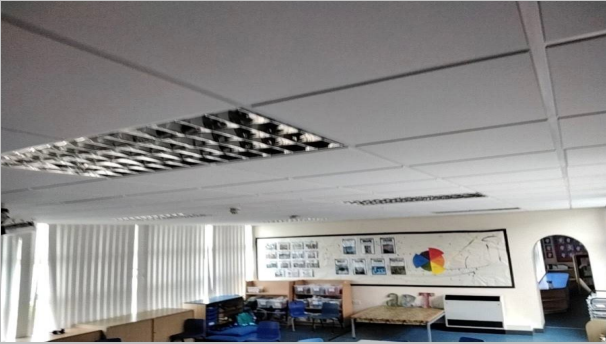
94	As KX001645	Ceiling void ceiling above	Main Building Classroom (Room 071)	No Risk

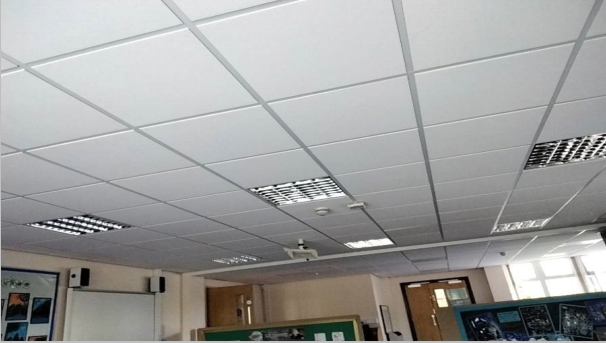
95	As KX001645	Ceiling void ceiling above	Main Building Classroom (Room 073)	No Risk

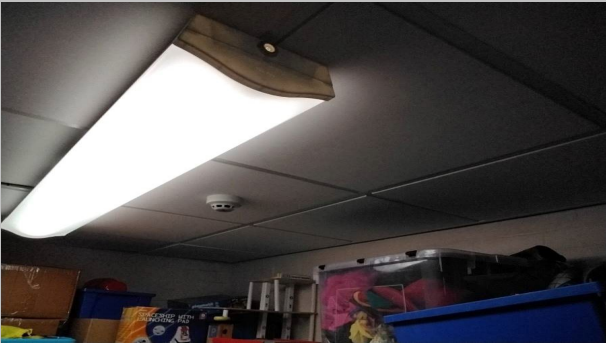
96	As KX001645	Ceiling void ceiling above	Main Building Store Room (Room 075)	No Risk

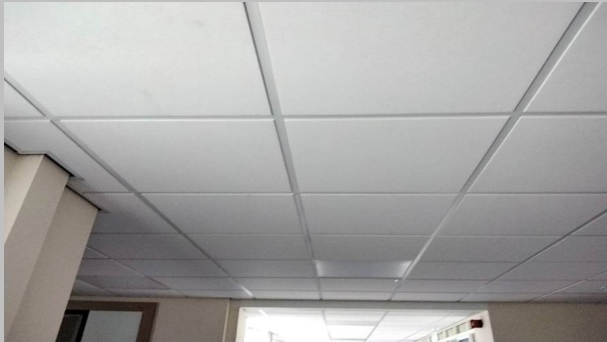
98	As KX001645	Ceiling void ceiling above	Main Building Corridor (Room 070a)	No Risk

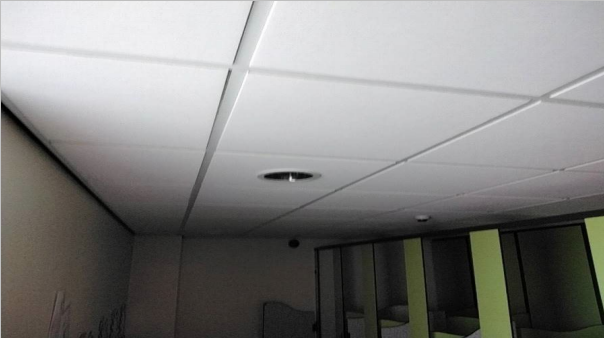
101	As KX001635	Ceiling void ceiling above	Main Building Female Toilets (Room 092)	No Risk

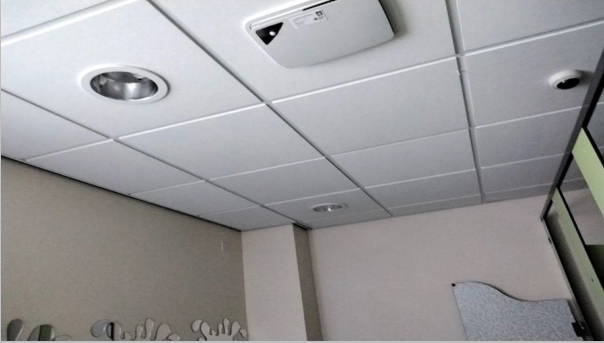
109	As KX001635	Ceiling void ceiling above	Main Building Female Toilets (Room 097)	No Risk

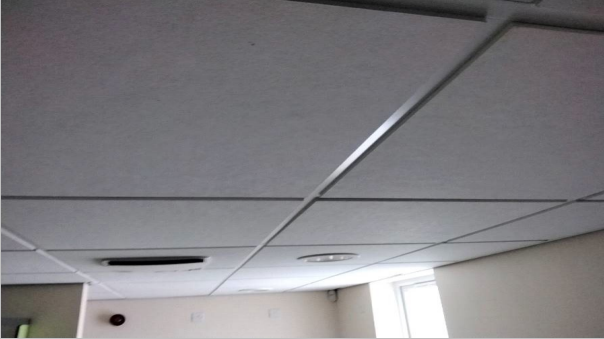
110	As KX001635	Ceiling void ceiling above	Main Building Male Toilets (Room 097a)	No Risk

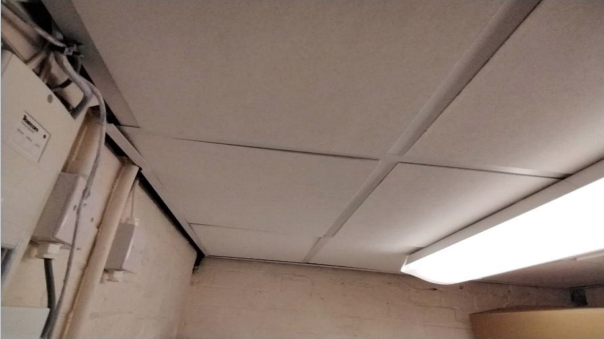
111	As KX001645	Ceiling void ceiling above	Main Building Caretakers Room (Room 077)	No Risk

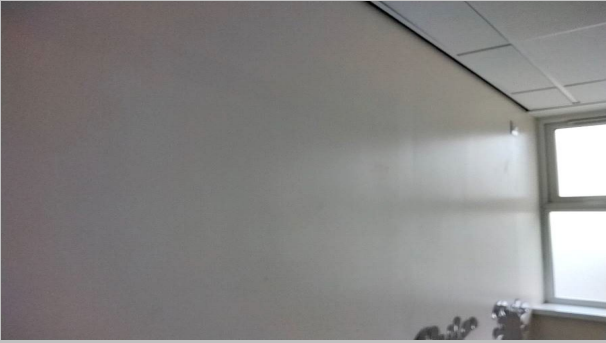
115	As KX001667	Wall Coating	Main Building Toilets (Room 080)	No Risk

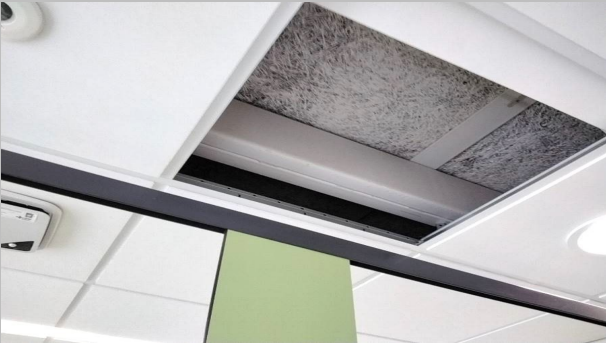
116	As KX001645	Ceiling void ceiling above	Main Building Toilets (Room 080)	No Risk

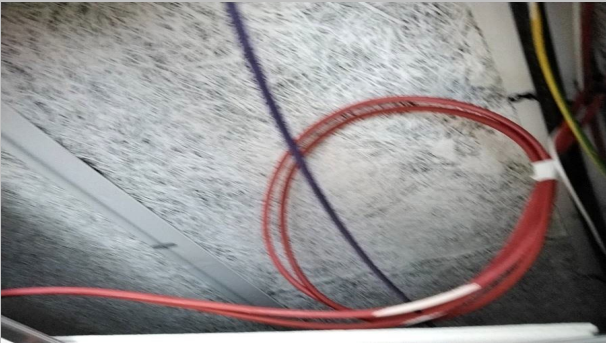
117	As KX001645	Ceiling void ceiling above	Main Building Hallway/passageway (Room 076a)	No Risk

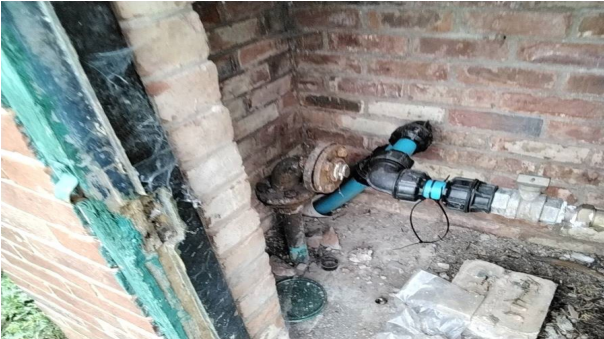
124	Presumed	Pipework gaskets	External Meter Cupboard (Room 03)	12 monthly

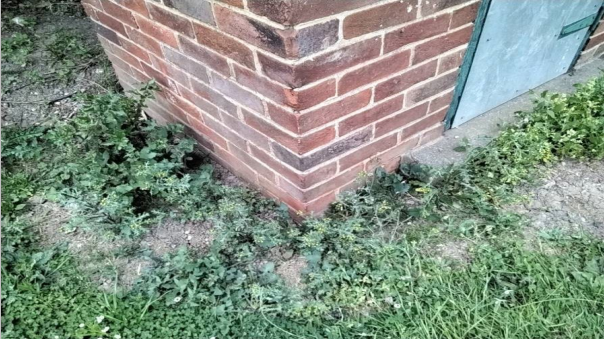
125	KX001666	Damp proof course including packing to roof	External Meter Cupboard (Room 03)	No Risk
