ASBESTOS SURVEY REPORT FOR THORNTREE ACADEMY, BIRKHAL ROAD, MIDDLESBOROUGH, TS3 9JW.

Asbestos Register for Thorntree Academy, Middlesbrough

Date: 09 May 2025

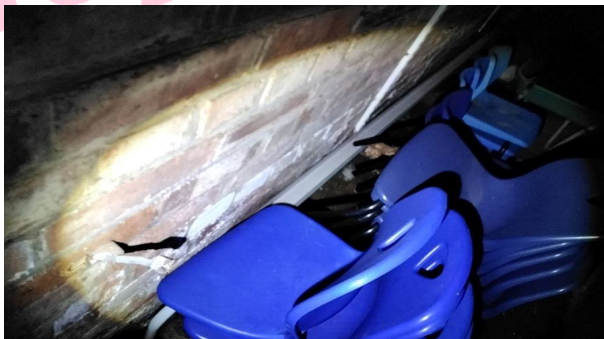
6	KX001658	Debris/residue to walls and old pipe hangars	Main Building Boiler Room (Room 098)	6 monthly

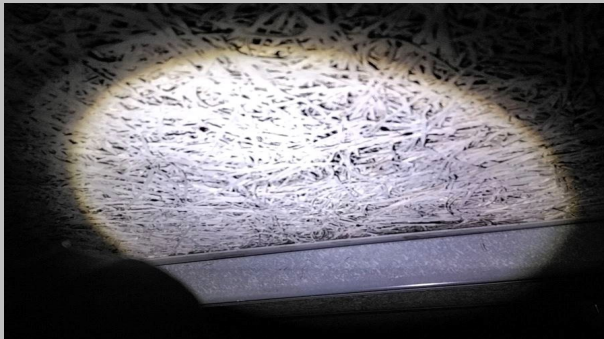
12	As KX001635	Ceiling void ceiling above	Main Building Store Cupboard (Room 002)	No Risk

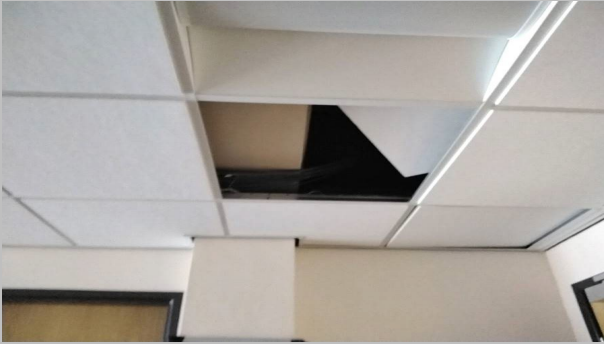
13	As KX001635	Ceiling void ceiling above	Main Building Reception (Room 007)	No Risk

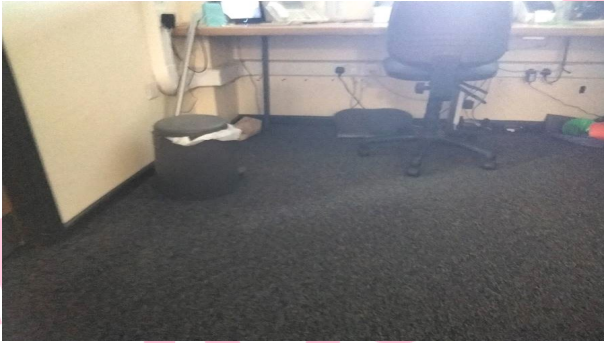
14	As KX001636	Floor adhesive residue under carpet and screed	Main Building Reception (Room 007)	6 monthly

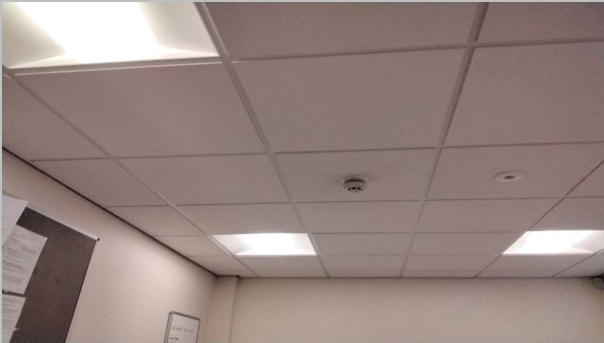
15	As KX001635	Ceiling void ceiling above	Main Building Office (Room 008)	No Risk

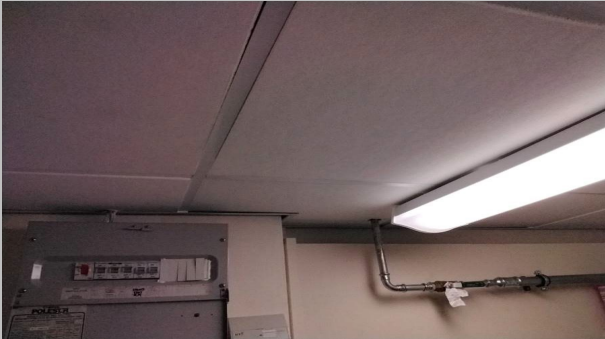
22	As KX001635	Ceiling void ceiling above	Main Building Office (Room 009)	No Risk

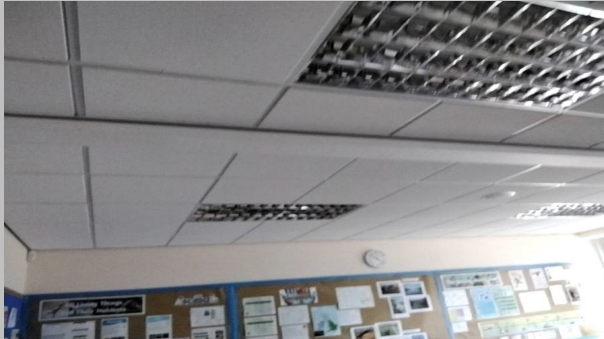
29	As KX001635	Ceiling void ceiling above	Main Building Classroom (Room 013)	No Risk

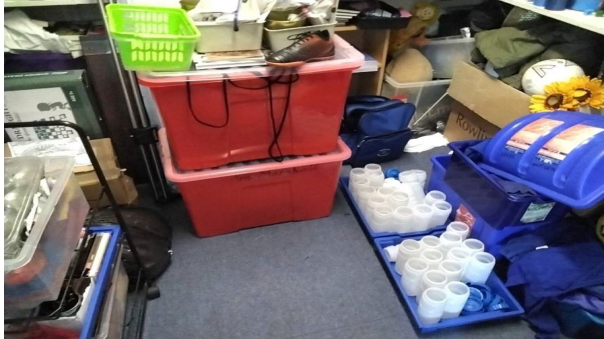
43	Presumed	Floor duct pipe insulation binding to fibreglass pipe insulation within floor duct under concrete slab (identified in previous report)	Main Building Storeroom (Room 024)	12 monthly

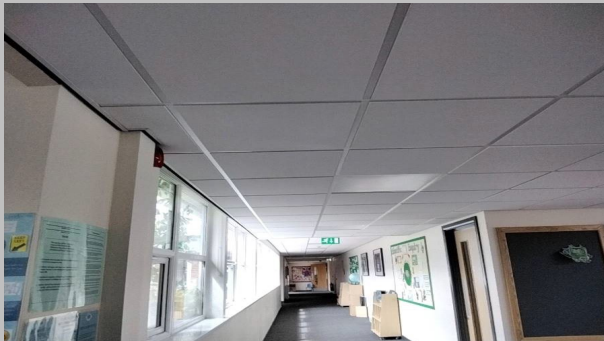
44	As KX001635	Ceiling void ceiling above	Main Building Corridor (Room 025)	No Risk

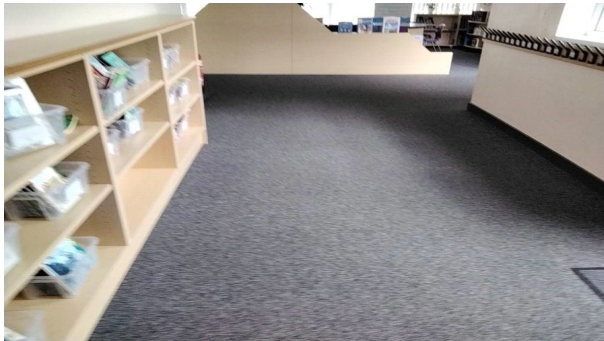
45	As KX001639	Floor adhesive residue under carpet	Main Building Corridor (Room 025)	6 monthly

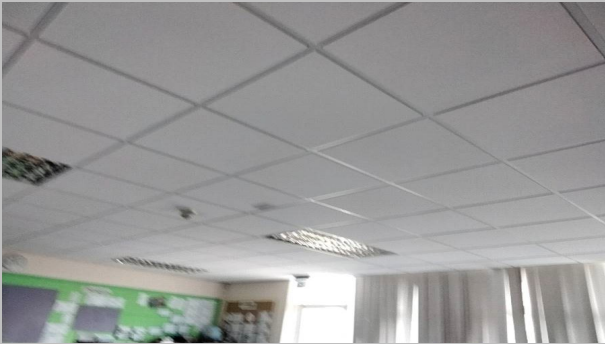
46	As KX001635	Ceiling void ceiling above	Main Building Classroom (Room 026)	No Risk

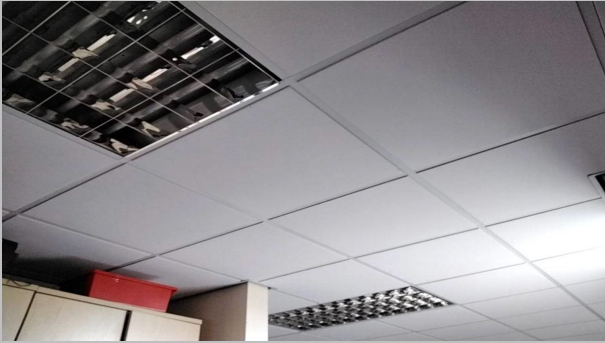
47	As KX001635	Ceiling void ceiling above	Main Building Hallway/passageway (Room 027)	No Risk

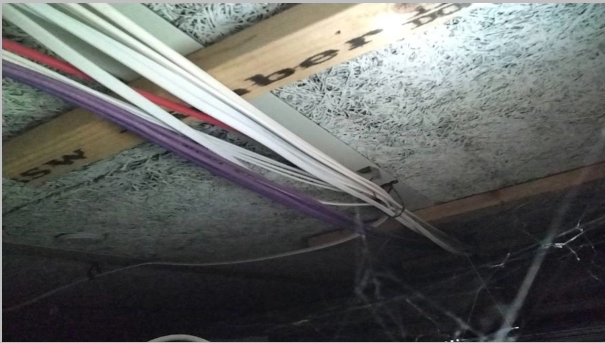
48	As KX001635	Ceiling void ceiling above	Main Building Classroom (Room 028)	No Risk

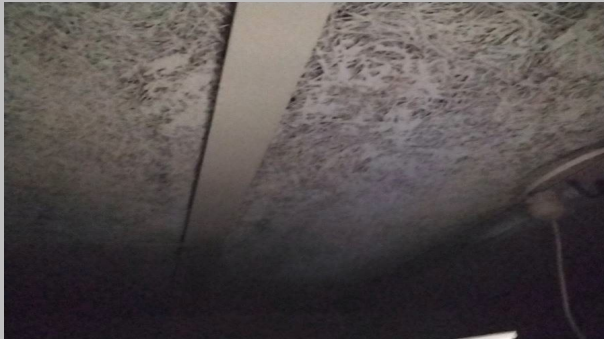
49	As KX001635	Ceiling void ceiling above	Main Building Storeroom (Room 029)	No Risk

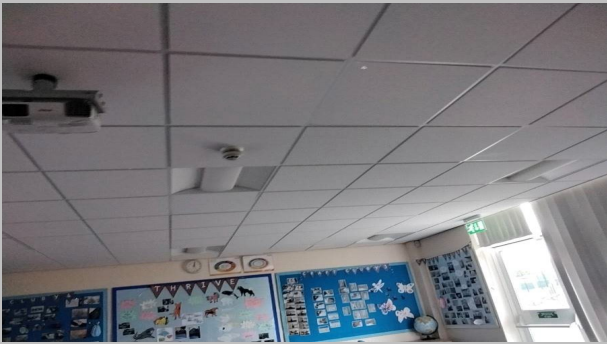
52	As KX001635	Ceiling void ceiling above	Main Building Classroom (Room 030)	No Risk

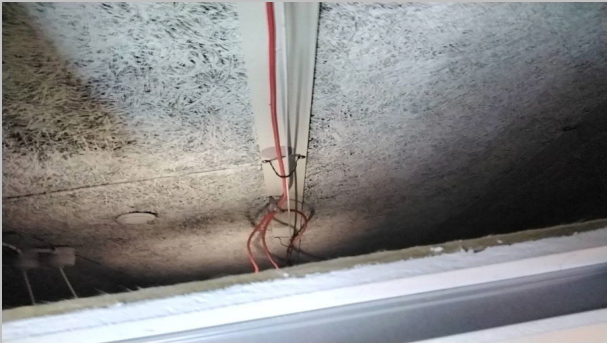
53	As KX001635	Ceiling void ceiling above	Main Building Hallway/passageway (Room 031)	No Risk

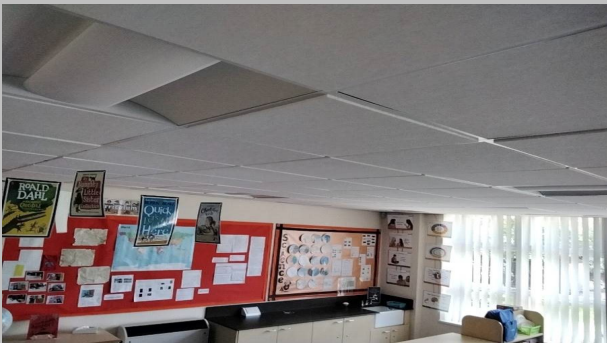
54	As KX001635	Ceiling void ceiling above	Main Building Classroom (Room 032)	No Risk

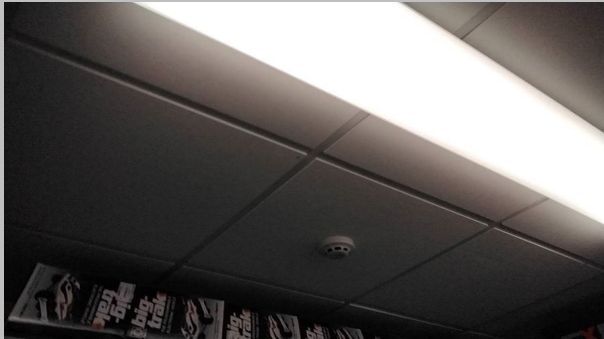
55	As KX001635	Ceiling void ceiling above	Main Building Storeroom (Room 033)	No Risk

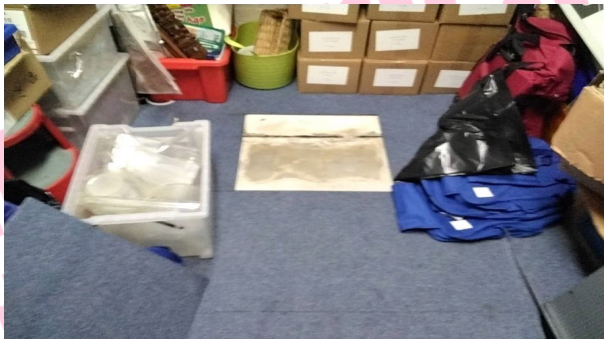
56	Presumed	Floor void/duct string binding to pipework within floor duct under concrete slab (identified in previous report)	Main Building Storeroom (Room 033)	12 monthly

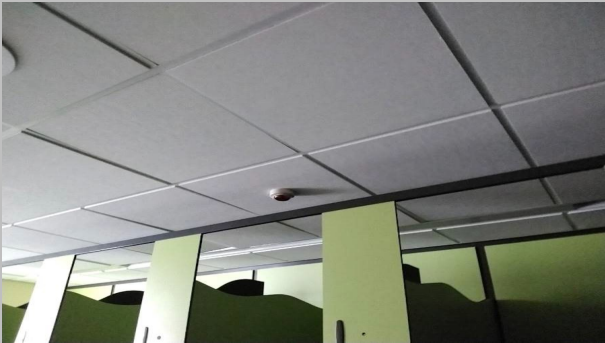
61	As KX001635	Ceiling void ceiling above	Main Building Female Toilets (Room 050)	No Risk

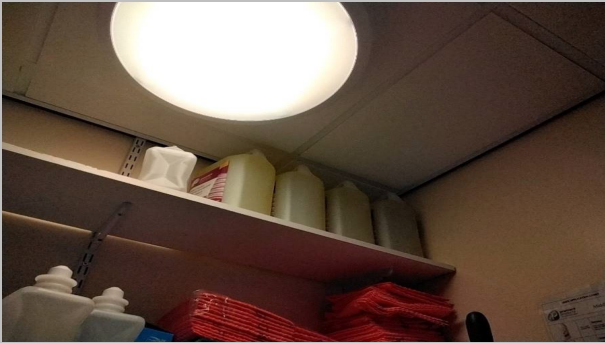
62	As KX001635	Ceiling void ceiling above	Main Building Cupboard (Room 050a)	No Risk

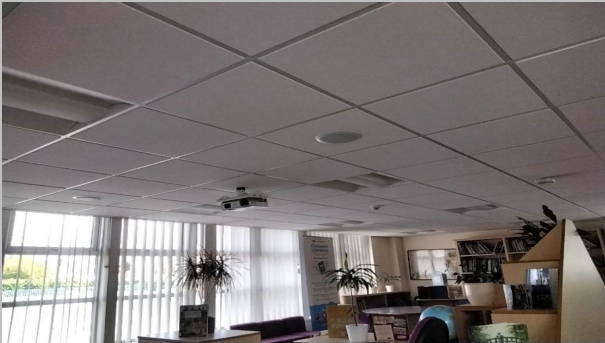
63	As KX001635	Ceiling void ceiling above	Main Building Library (Room 051)	No Risk

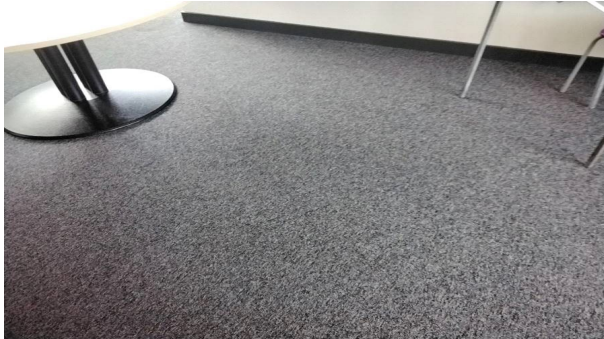
64	As KX001639	Floor adhesive residue under carpet	Main Building Library (Room 051)	6 monthly

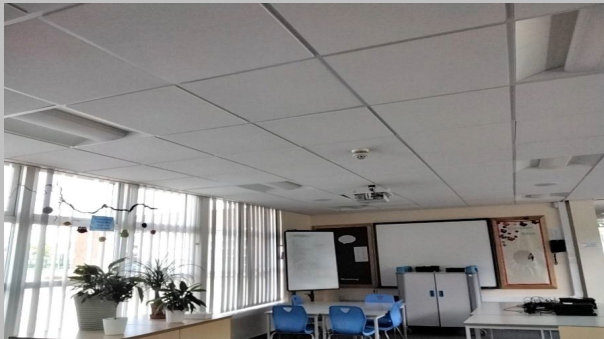
65	As KX001635	Ceiling void ceiling above	Main Building Hallway/Passageway (Room 052)	No Risk

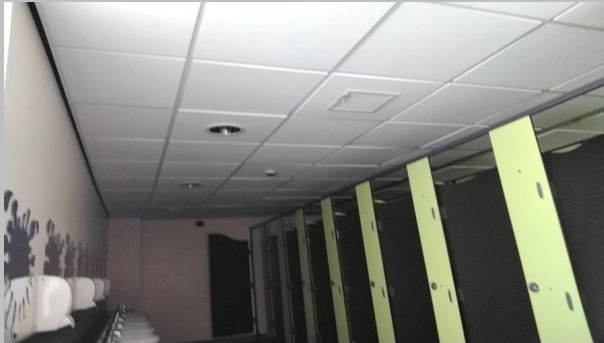
67	As KX001635	Ceiling void ceiling above	Main Building Male Toilets (Room 053)	No Risk

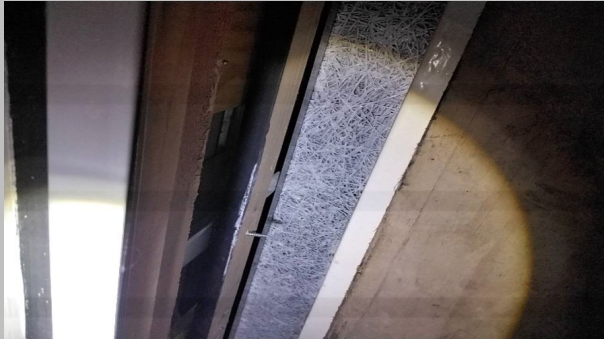
68	As KX001635	Ceiling void ceiling above	Main Building Cleaners Cupboard (Room 053a)	No Risk

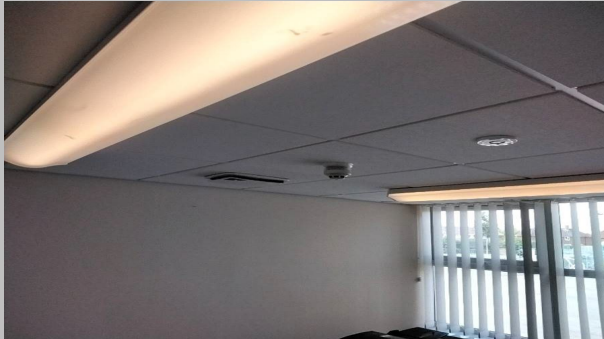
69	As KX001635	Ceiling void ceiling above	Main Building Photocopy Room (Room 054)	No Risk

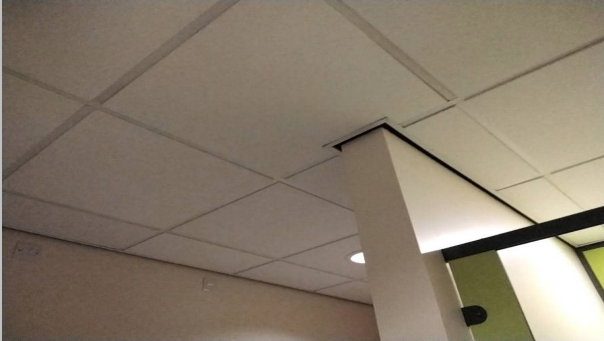
70	As KX001635	Ceiling void ceiling above	Main Building Female Toilets (Room 055)	No Risk

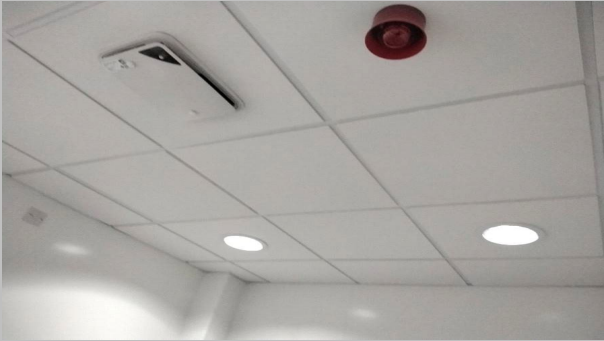
71	As KX001635	Ceiling void ceiling above	Main Building Toilets (Room 056)	No Risk

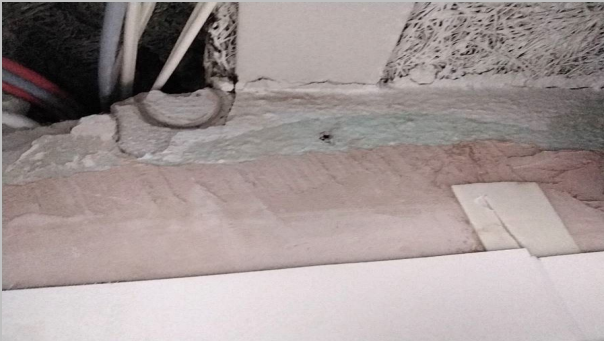
72	KX001641	Wall coating skimmed cladding visible in ceiling void	Main Building Toilets (Room 056)	No Risk

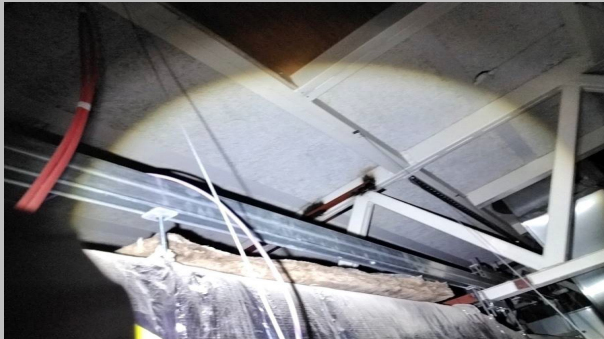
74	KX001642	Ceiling void ductwork sealant to joints	Main Building Kitchen (Room 038)	No Risk

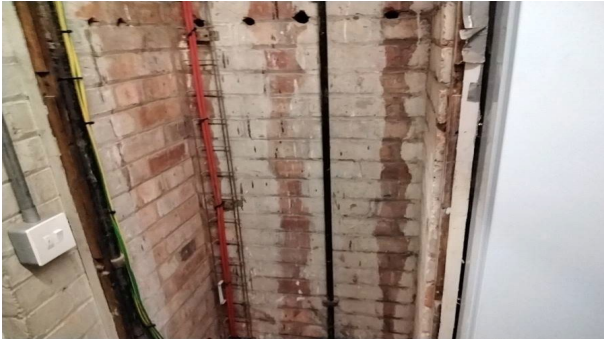
82	KX001662	Debris/residue to walls in riser	Main Building Switch Room (Room 040a)	3 monthly

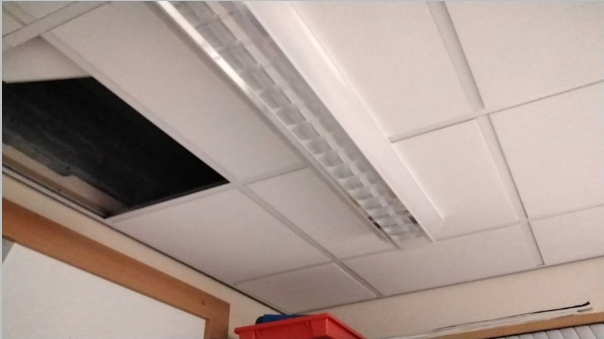
83	As KX001645	Ceiling void ceiling above	Main Building Office (Room 060)	No Risk

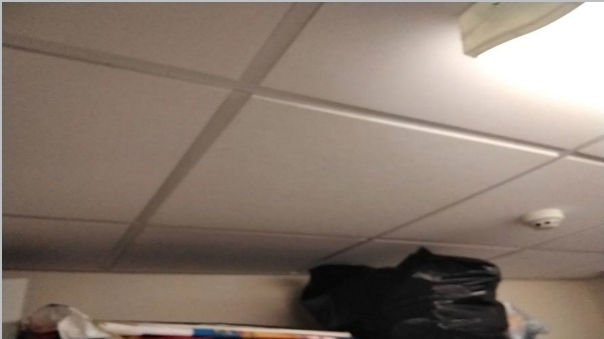
84	As KX001645	Ceiling void ceiling above	Main Building Cupboard Store (Room 062)	No Risk

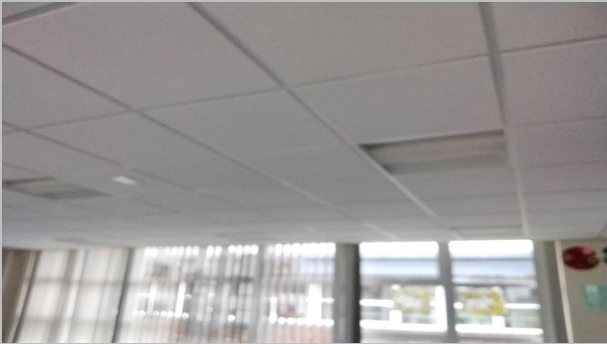
85	As KX001645	Ceiling void ceiling above	Main Building Classroom (Room 061)	No Risk

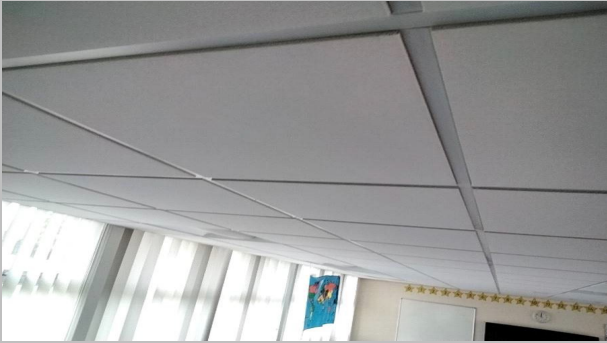
86	As KX001645	Ceiling void ceiling above	Main Building Classroom (Room 063)	No Risk

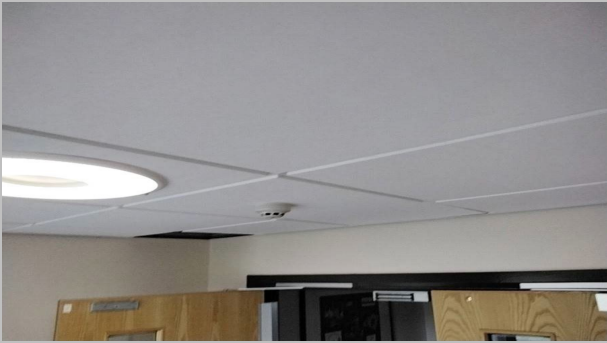
87	As KX001645	Ceiling void ceiling above	Main Building Entrance Hall/Foyer/Lobby (Room 064)	No Risk

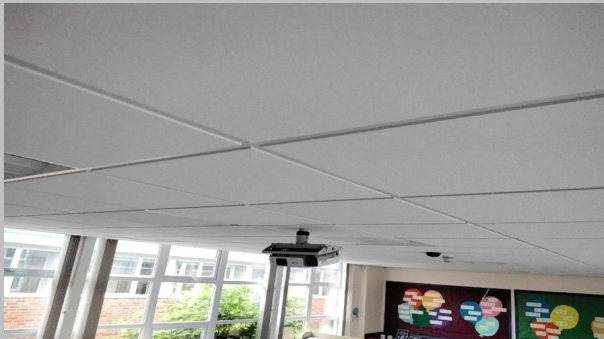
91	As KX001645	Ceiling void ceiling above	Main Building Classroom (Room 068)	No Risk

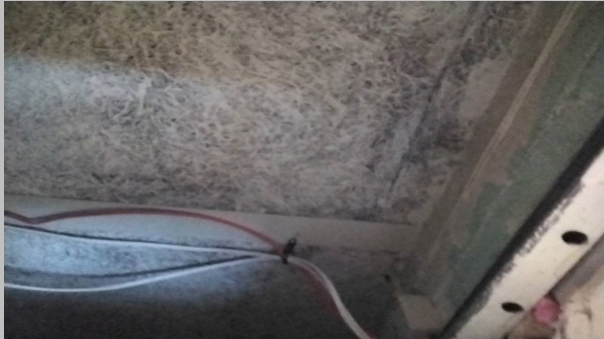
92	As KX001645	Ceiling void ceiling above	Main Building Cupboard Store (Room 069)	No Risk

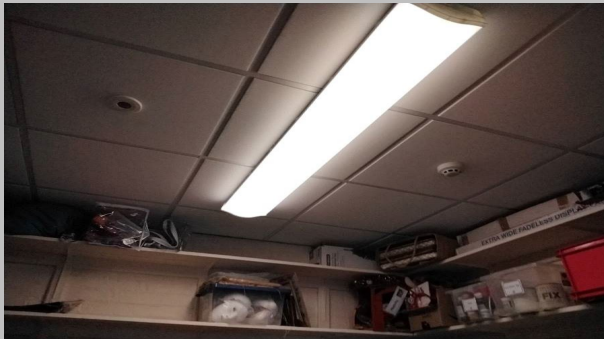
93	As KX001645	Ceiling void ceiling above	Main Building Cupboard Store (Room 072)	No Risk

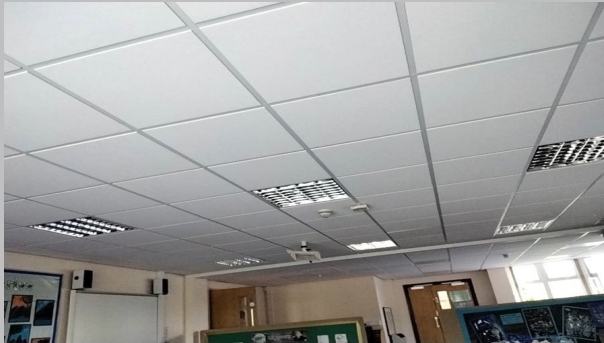
95	As KX001645	Ceiling void ceiling above	Main Building Classroom (Room 073)	No Risk

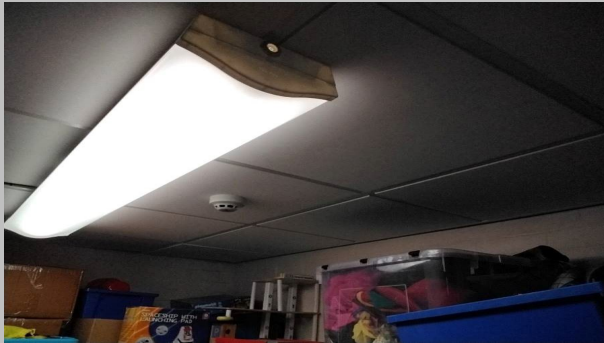
96	As KX001645	Ceiling void ceiling above	Main Building Store Room (Room 075)	No Risk

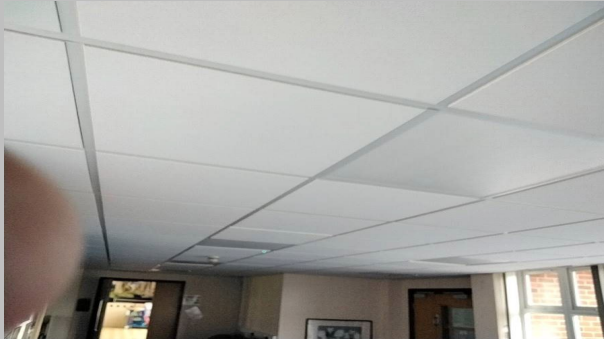
100	As KX001645	Ceiling void ceiling above	Main Building Corridor (Room 070)	No Risk

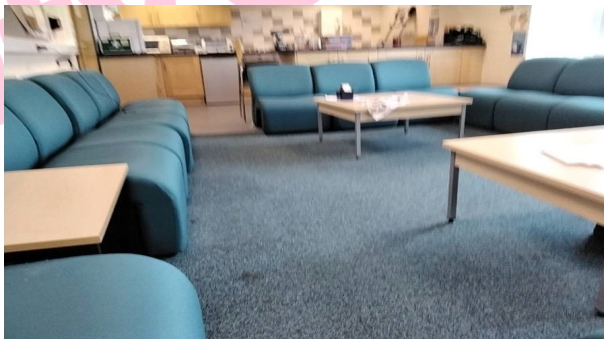
102	As KX001644	Floor adhesive residue	Main Building Staff Room (Room 095)	6 monthly

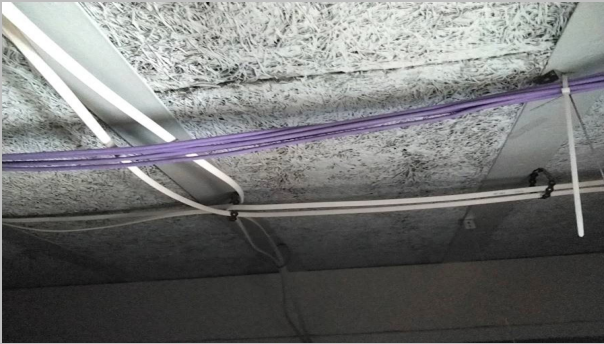
106	As KX001645	Ceiling void ceiling above	Main Building Classroom (Room 096)	No Risk

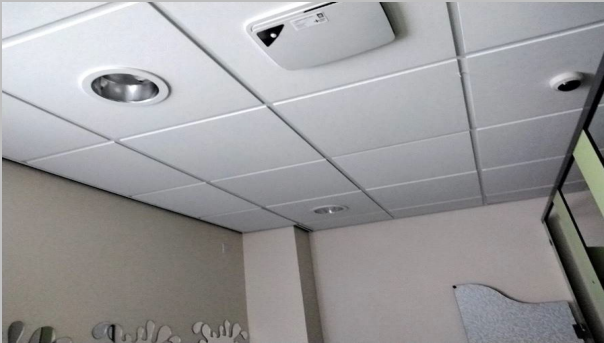
109	As KX001635	Ceiling void ceiling above	Main Building Female Toilets (Room 097)	No Risk

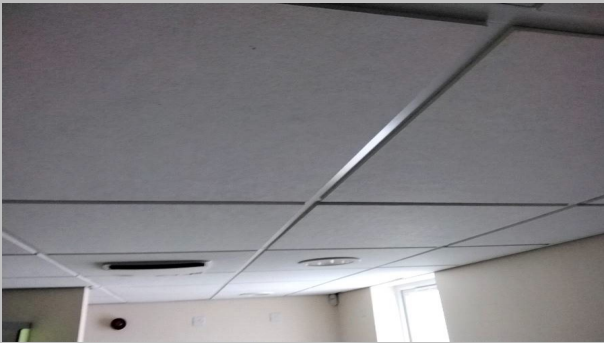
110	As KX001635	Ceiling void ceiling above	Main Building Male Toilets (Room 097a)	No Risk

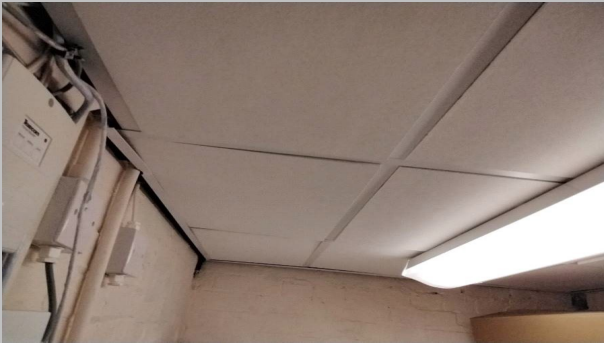
111	As KX001645	Ceiling void ceiling above	Main Building Caretakers Room (Room 077)	No Risk

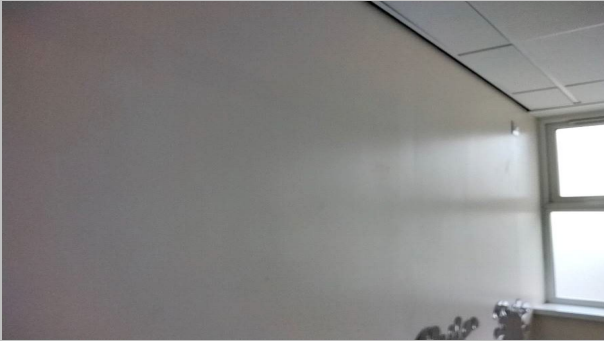
115	As KX001667	Wall Coating	Main Building Toilets (Room 080)	No Risk

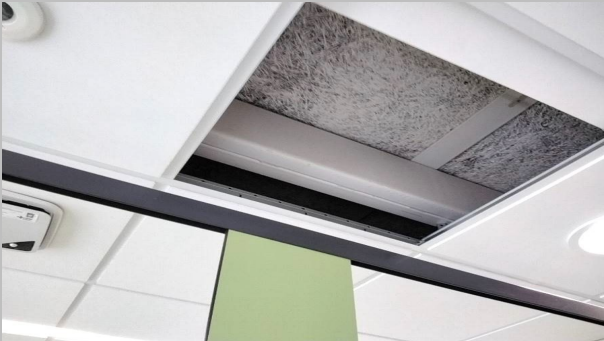
116	As KX001645	Ceiling void ceiling above	Main Building Toilets (Room 080)	No Risk

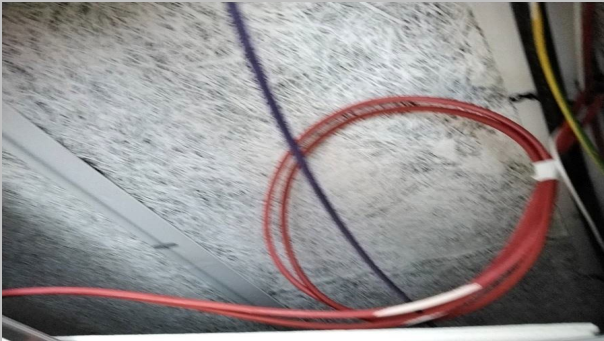
117	As KX001645	Ceiling void ceiling above	Main Building Hallway/passageway (Room 076a)	No Risk

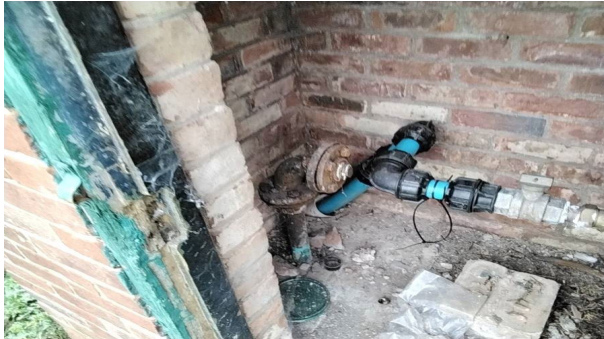
124	Presumed	Pipework gaskets	External Meter Cupboard (Room 03)	12 monthly

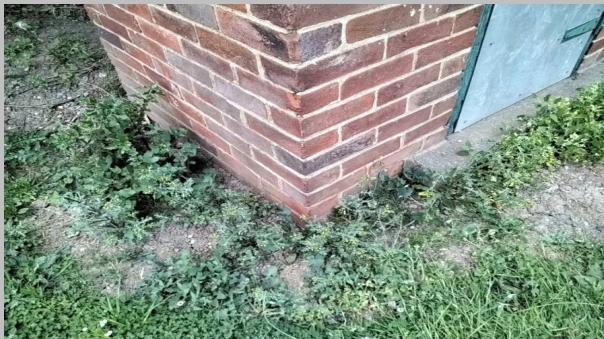
125	KX001666	Damp proof course including packing to roof	External Meter Cupboard (Room 03)	No Risk
