ASBESTOS SURVEY REPORT FOR THORNTREE ACADEMY, BIRKHALL ROAD, MIDDLESBOROUGH, TS3 9JW.

## **Asbestos Register for Thorntree Academy, Middlesbrough**

**Date: 23 July 2025**

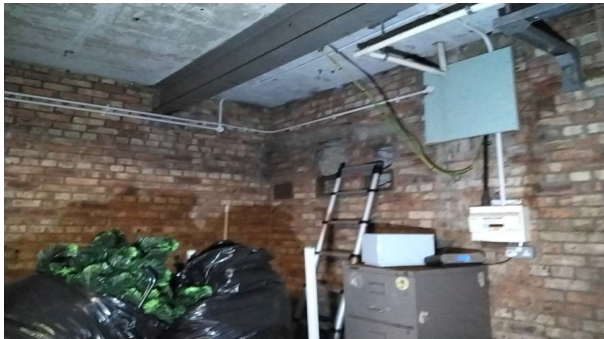
4	KX001656	Debris/residue to walls adjacent to flue openings	Main Building Boiler Room (Room 098)	6 monthly

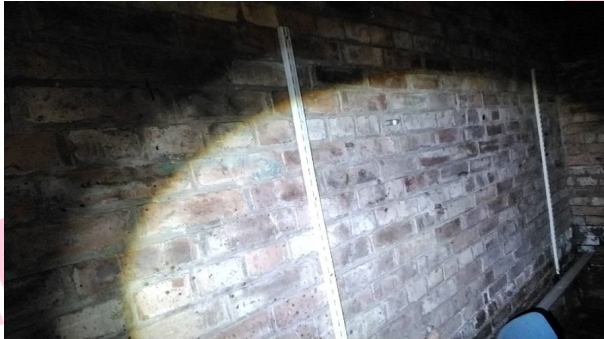
5	KX001657	Debris/residue to walls in paint	Main Building Boiler Room (Room 098)	6 monthly

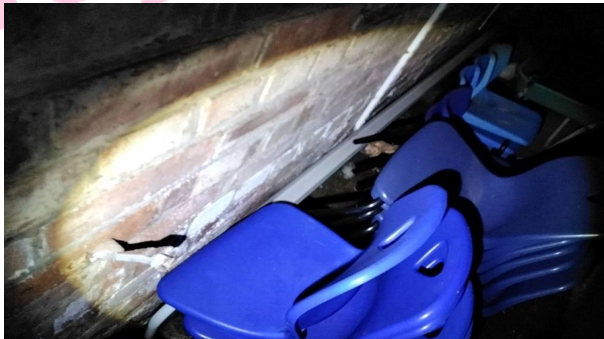
6	KX001658	Debris/residue to walls and old pipe hangars	Main Building Boiler Room (Room 098)	6 monthly

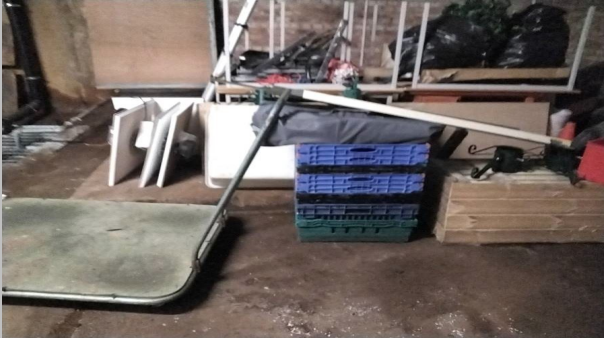
7	KX001659	Debris/residue to floor off plinths	Main Building Boiler Room (Room 098)	No Risk

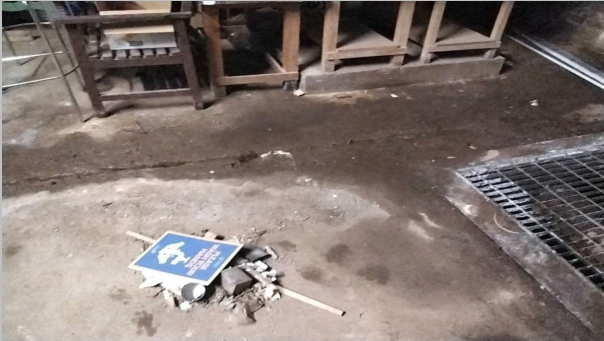
8	KX001660	Debris/residue to floor, drainage gulleys	Main Building Boiler Room (Room 098)	No Risk

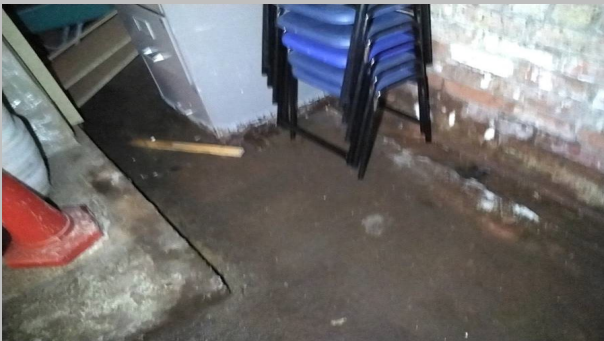
9	KX001661	Debris/residue to floor, at walls behind boiler plinths	Main Building Boiler Room (Room 098)	No Risk

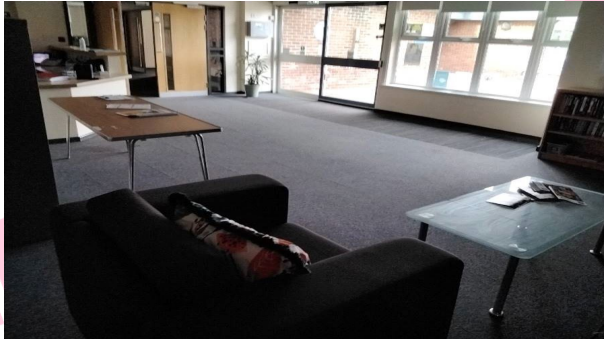
11	KX001636	Floor adhesive residue under carpet and screed	Main Building Reception/Entrance (Room 001)	6 monthly

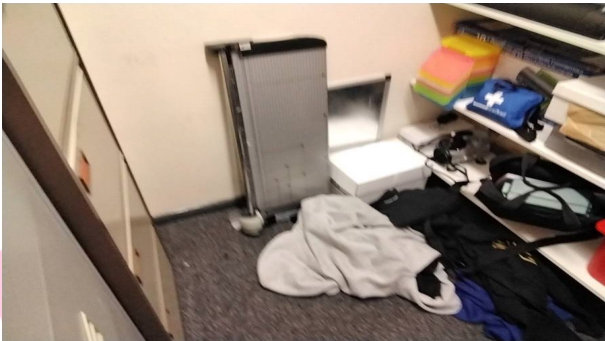
23	As KX001636	Floor adhesive residue under carpet and screed	Main Building Office (Room 009)	12 monthly

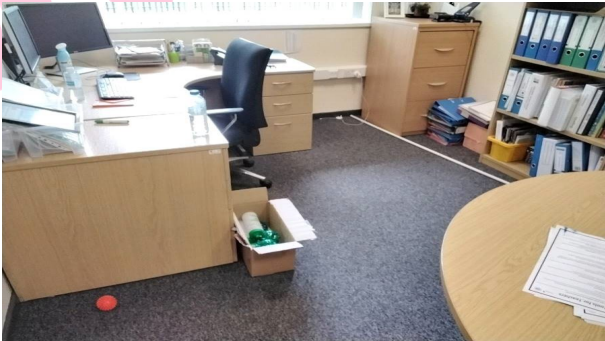
24	KX001638	Floor adhesive residue under carpet	Main Building Office (Room 011)	6 monthly

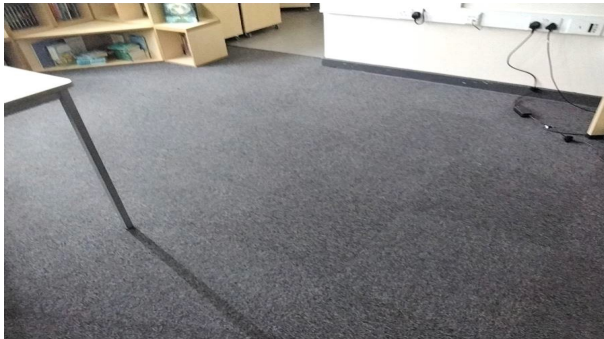
28	As KX001638	Floor adhesive residue under carpet	Main Building Classroom (Room 013)	6 monthly

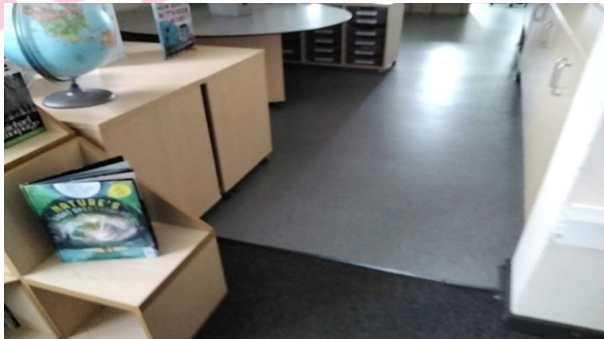
30	As KX001638	Floor adhesive residue under carpet	Main Building Hallway/passageway (Room 015)	6 monthly

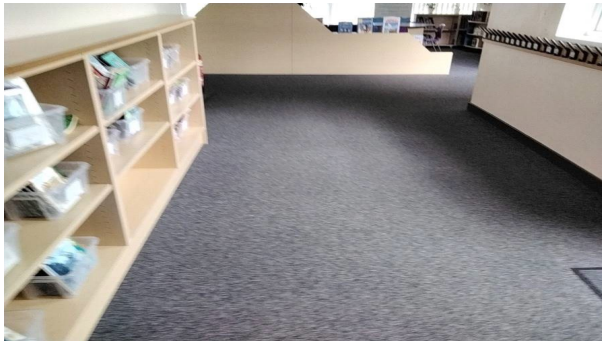
45	As KX001639	Floor adhesive residue under carpet	Main Building Corridor (Room 025)	6 monthly

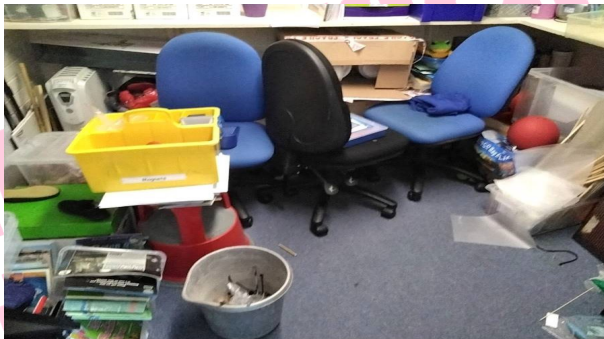
50	Presumed	Floor void/duct string binding to pipework within floor duct under concrete slab (identified in previous report)	Main Building Storeroom (Room 029)	12 monthly

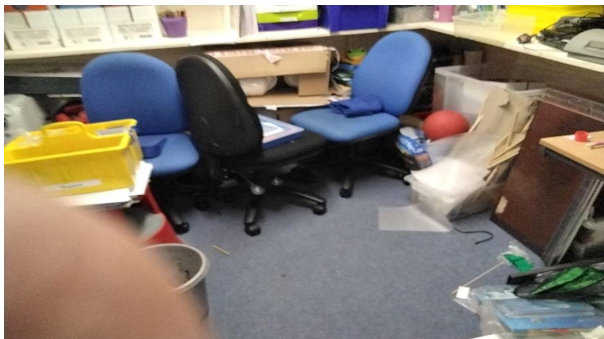
51	Presumed	Floor void/duct pipe sleeves through concrete slab in floor duct	Main Building Storeroom (Room 029)	12 monthly

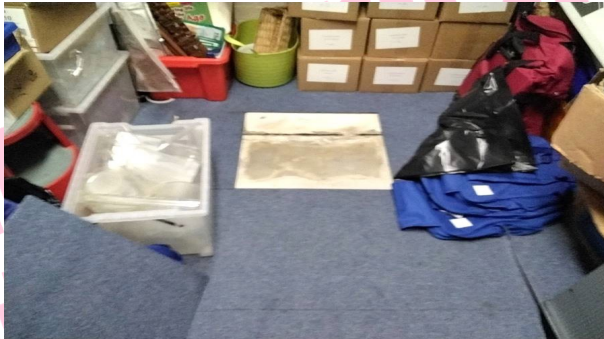
56	Presumed	Floor void/duct string binding to pipework within floor duct under concrete slab (identified in previous report)	Main Building Storeroom (Room 033)	12 monthly

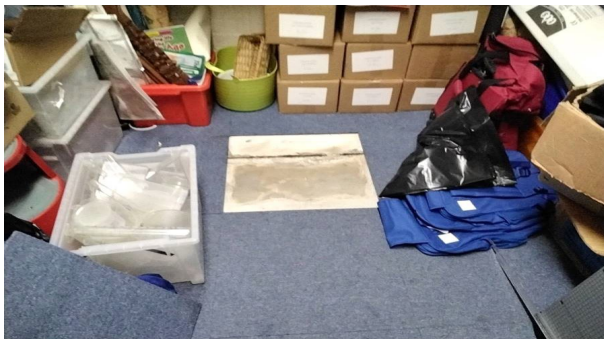
57	Presumed	Floor void/duct pipe sleeves through concrete slab in floor duct	Main Building Storeroom (Room 033)	12 monthly

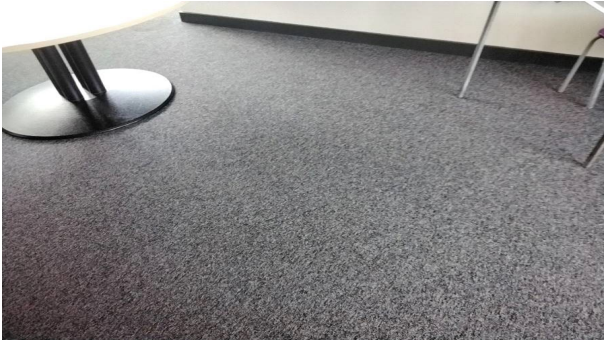
64	As KX001639	Floor adhesive residue under carpet	Main Building Library (Room 051)	6 monthly

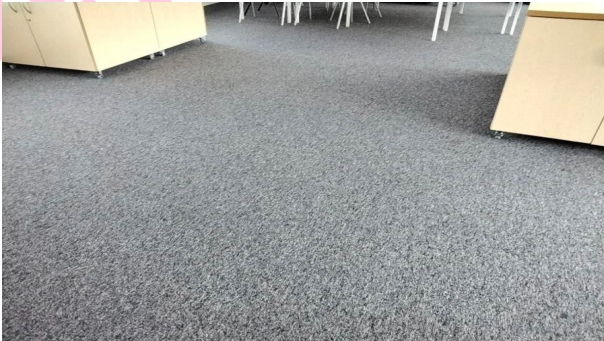
66	As KX001639	Floor adhesive residue under carpet	Main Building Hallway/Passageway (Room 052)	6 monthly

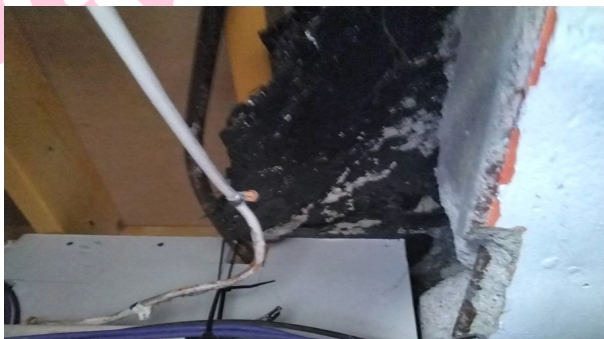
75	KX001643	Ceiling void roof felt debris	Main Building Corridor (Room 037a)	6 monthly

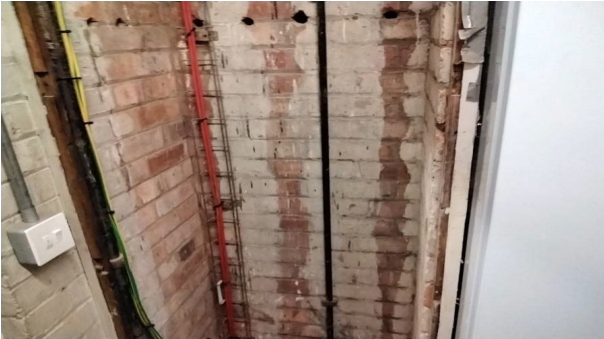
82	KX001662	Debris/residue to walls in riser	Main Building Switch Room (Room 040a)	3 monthly

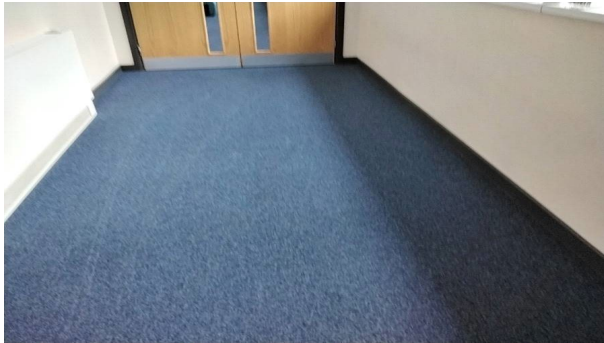
97	As KX001644	Floor adhesive residue	Main Building Corridor (Room 070a)	6 monthly

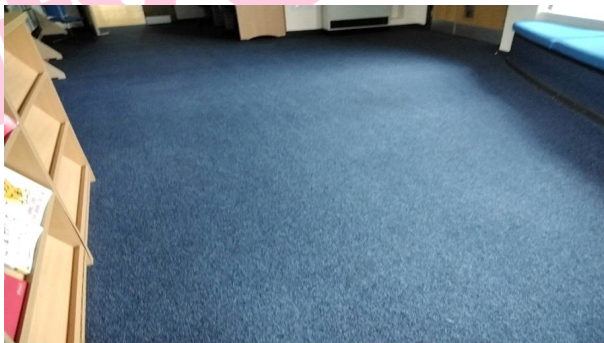
99	As KX001644	Floor adhesive residue	Main Building Corridor (Room 070)	6 monthly

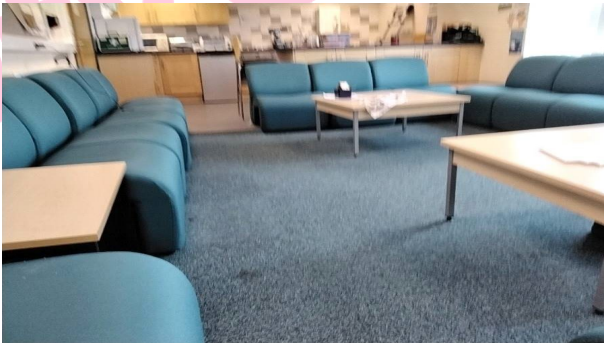
102	As KX001644	Floor adhesive residue	Main Building Staff Room (Room 095)	6 monthly

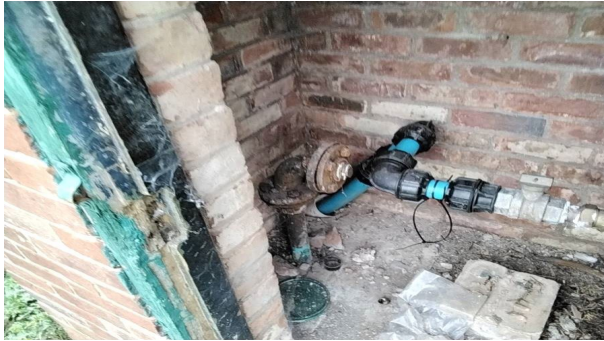
124	Presumed	Pipework gaskets	External Meter Cupboard (Room 03)	12 monthly
