ASBESTOS SURVEY REPORT FOR 9 CLAREMONT TERRACE,
ASHBROOKE, SUNDERLAND, SR2 7LB

9 Claremont Terrace, Ashbrooke, SR2 7LB

Date: 28 April 2025

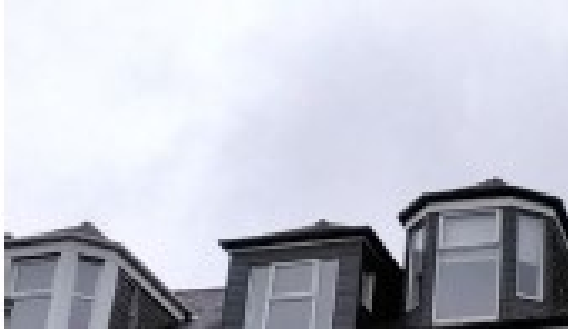
Item 1 Ref: Presumed

The roof tiles to the dormer window are presumed to contain asbestos.

Any change in its appearance should be recorded and passed to Property Services.

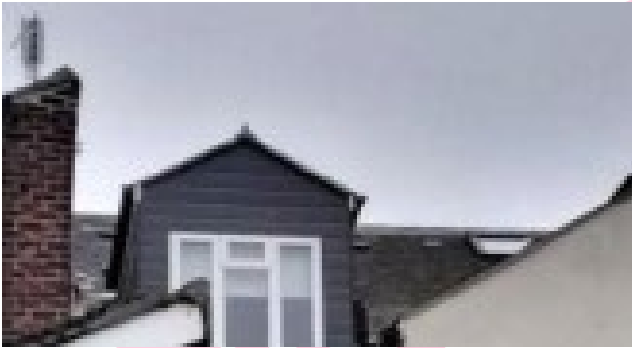
Item 2 Ref: Presumed

The under cloak is presumed to contain asbestos.

Any change in its appearance should be recorded and passed to Property Services.
