### ASBESTOS SURVEY REPORT FOR BROADWAY YOUTH & COMMUNITY CENTRE (FORMALLY GRINDON CA), CORTINA AVENUE, SUNDERLAND

**Asbestos Register for**

**GRINDON COMMUNITY CENTRE, SUNDERLAND**

**Date: 28<sup>th</sup> April 2025**

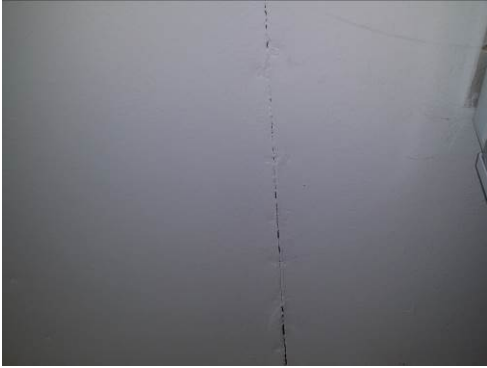
### **Item 1 Ref: 120755-1**

The ceiling to the lobby (Room 001) does not contain asbestos.

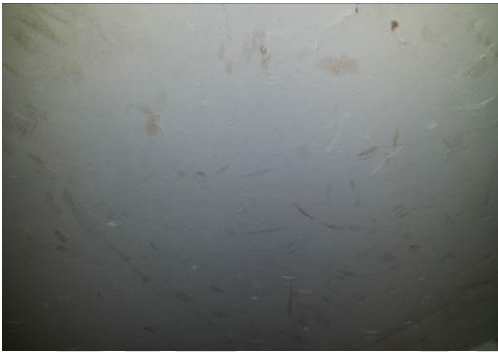
### **Item 2 - Ref: As 120755-1**

The ceiling to the store (Room 003) does not contain asbestos.

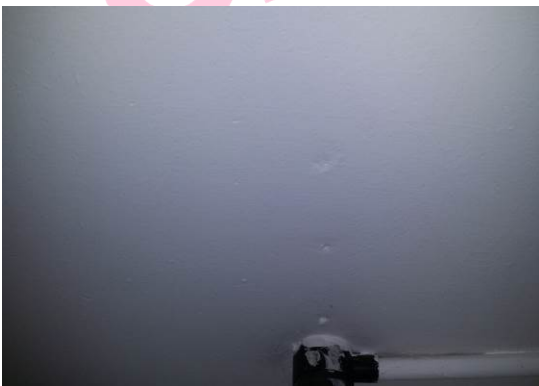
### **Item 3 - Ref: As 120755-1**

The ceiling to the ladies WC (Room 004) does not contain asbestos.

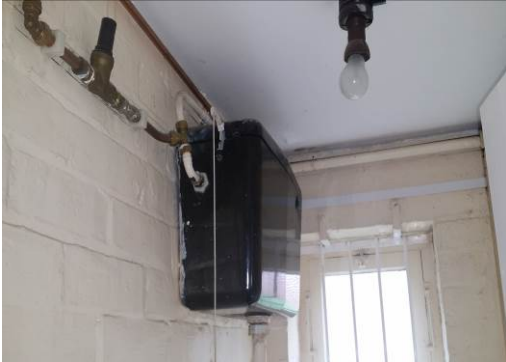
### **Item 4 Ref: 120755-2**

The high level toilet cistern to the ladies toilet (Room 004) contains asbestos.

Any change in its appearance should be noted and passed to Property Services.

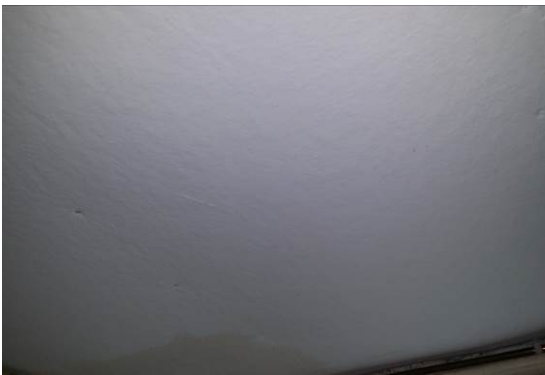
### **Item 5 - Ref: As 120755-1**

The ceiling to the male toilets (Room 005) does not contain asbestos.

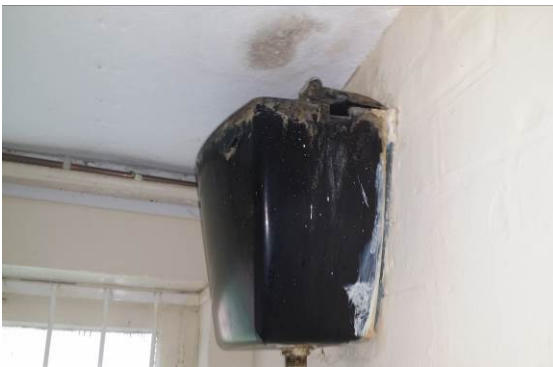
### **Item 6 - Ref: As 120755-2**

The high level cistern to the male WC (Room 005) contains asbestos.

*Removed however no waste removal certificates received.*

Any change in its appearance should be noted and passed to Property Services.

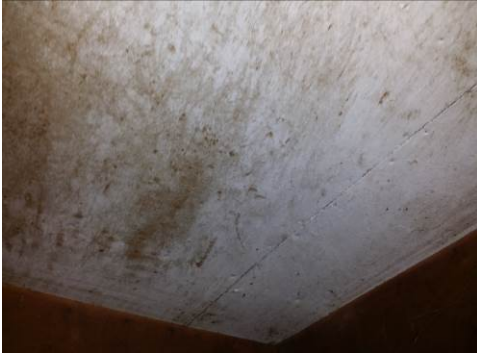
### **Item 7 Ref: 120755-4**

The ceiling to the store (Room 005) does not contain asbestos.

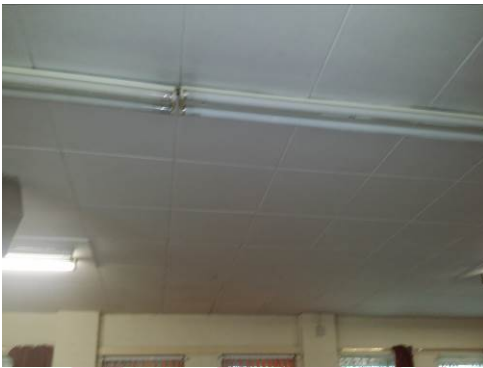
### **Item 8 - Ref: 120755-3**

The ceiling to the hall (Room 007) contains asbestos.

Any change in its appearance should be noted and passed to Property Services.

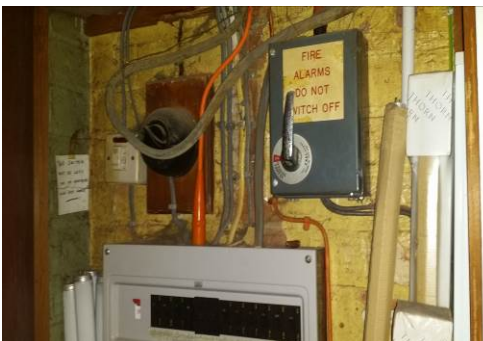
### **Ref: Presumed**

There was no access to the electrics in the hall (Room 007)

Prior to any work taking place, further investigation will need to be carried out.

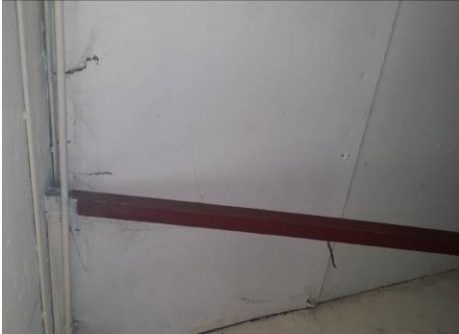
### **Item 9 Ref: 120755-5**

The ceiling to the stage (Room 008) does not contain asbestos.

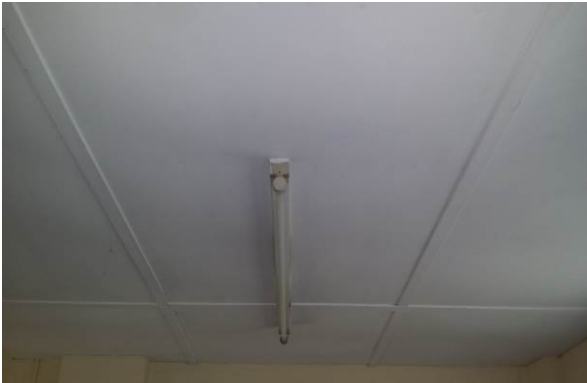
### **Item 10 - Ref: 120755-6**

The ceiling to the changing room (Room 009) does not contain asbestos.

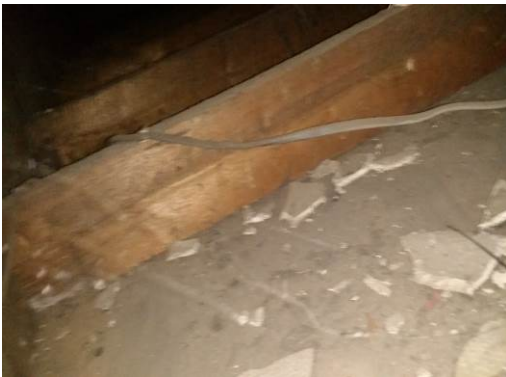
### **Item 11 Ref: 120755-7**

**THERE IS SIGNIFICANT ASBESTOS CEMENT DEBRIS TO THE LOFT AREA AND CEILING VOIDS. THERE IS TO BE NO ACCESS UNTIL AN ENVIRONMENTAL CLEAN IS CARRIED OUT.**

There debris to the ceiling void in the changing room (Room 009) contains asbestos.

There should be **no access** to the area, prior to the area being cleaned.
