### **ASBESTOS SURVEY REPORT FOR BROADWAY YOUTH & COMMUNITY CENTRE (FORMALLY GRINDON CA), CORTINA AVENUE, SUNDERLAND**

## **Asbestos Register for GRINDON COMMUNITY CENTRE, SUNDERLAND**

**Date: 28<sup>th</sup> April 2025**

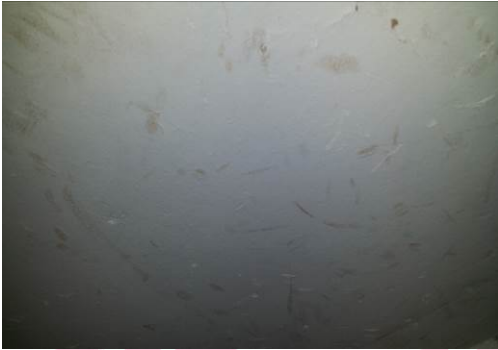
### **Item 2 - Ref: As 120755-1**

The ceiling to the store (Room 003) does not contain asbestos.

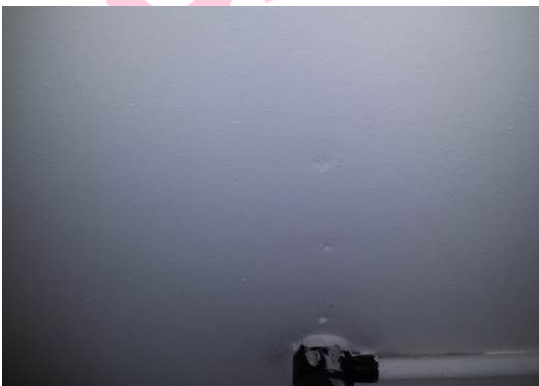
### **Item 3 - Ref: As 120755-1**

The ceiling to the ladies WC (Room 004) does not contain asbestos.

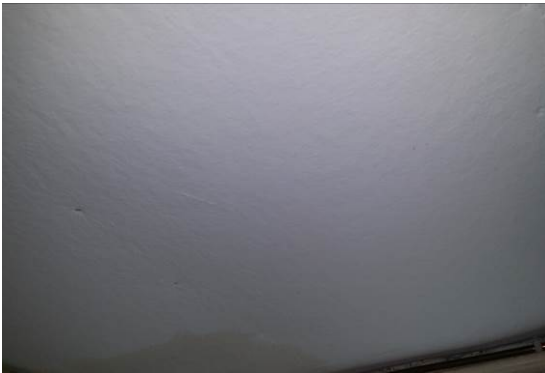
### **Item 5 - Ref: As 120755-1**

The ceiling to the male toilets (Room 005) does not contain asbestos.

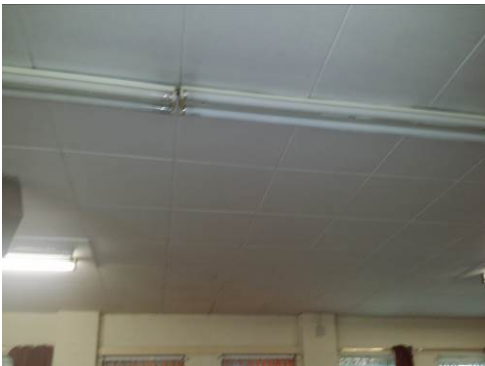
### **Item 8 - Ref: 120755-3**

The ceiling to the hall (Room 007) contains asbestos.

Any change in its appearance should be noted and passed to Property Services.

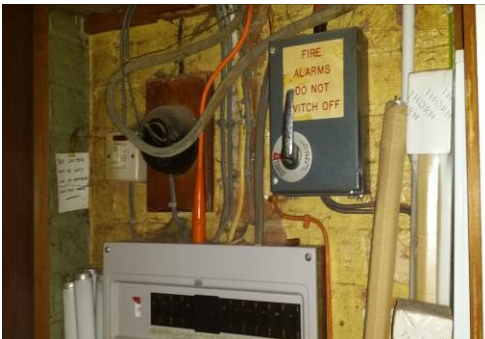
### **Ref: Presumed**

There was no access to the electrics in the hall (Room 007)

Prior to any work taking place, further investigation will need to be carried out.

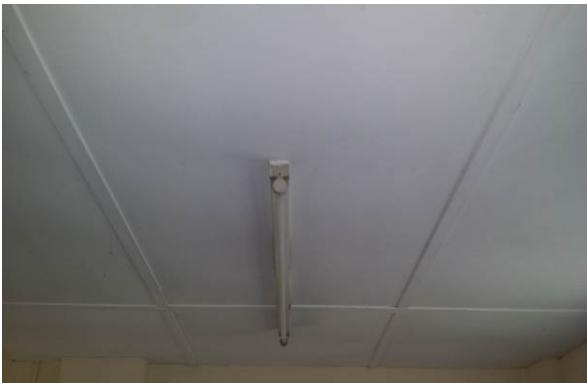
### **Item 10 - Ref: 120755-6**

The ceiling to the changing room (Room 009) does not contain asbestos.

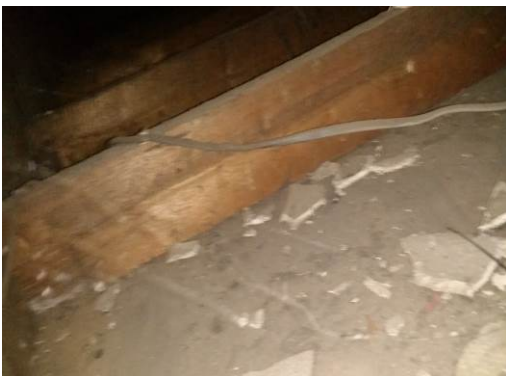
### **Item 11 Ref: 120755-7**

**THERE IS SIGNIFICANT ASBESTOS CEMENT DEBRIS TO THE LOFT AREA AND CEILING VOIDS. THERE IS TO BE NO ACCESS UNTIL AN ENVIRONMENTAL CLEAN IS CARRIED OUT.**

There debris to the ceiling void in the changing room (Room 009) contains asbestos.

There should be **no access** to the area, prior to the area being cleaned.
