ASBESTOS SURVEY REPORT FOR 1 MARLOW DRIVE, MOORSIDE,  
DOXFORD PARK, SR3 2RW

## **Asbestos Register for**

**1 Marlow Drive, Moorside, SR3 2RW**

**Date: 23 September 2025**

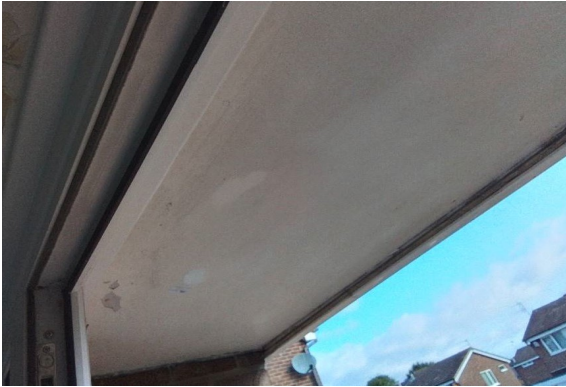
### **Item 1 Ref: Presumed**

The canopy ceiling externally (E/001) contains asbestos.

Any change in its appearance should be recorded and passed to Property Services.

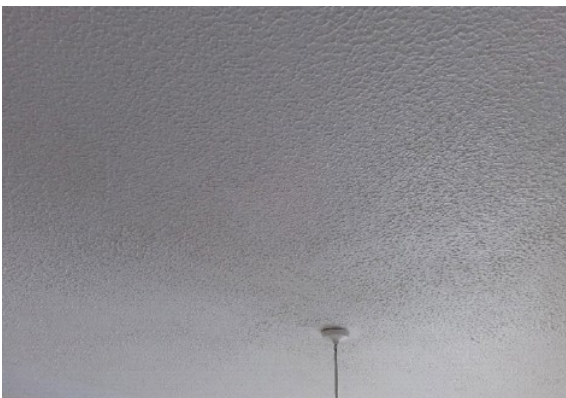
### **Item 3 Ref: As PZ000414**

The ceiling coating in the Dining Room G/003 does not contain asbestos.

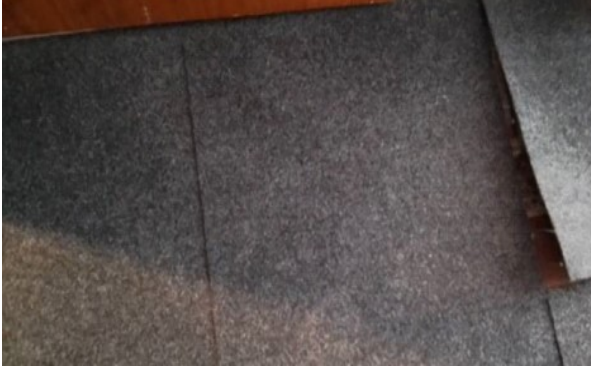
### **Item 4 Ref: PZ000415**

The floor adhesive in the Hallway/Passageway rear of property does not contain asbestos.

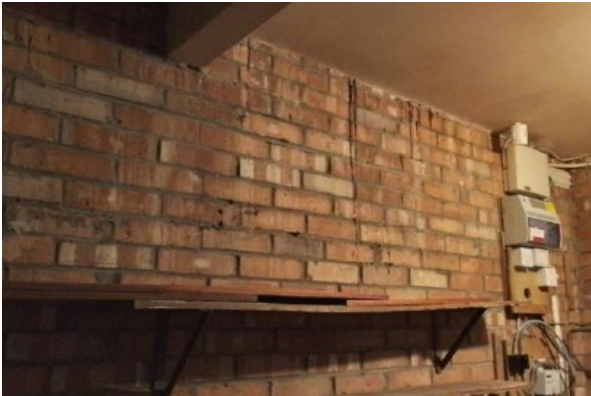
### **Item 5 Ref: PZ000416**

The roof felt adhesive in the Garage G/007 does not contain asbestos.

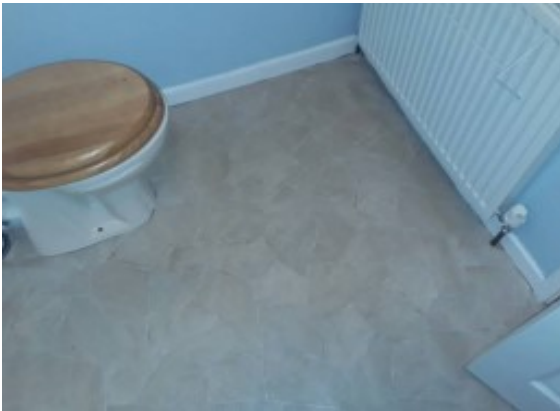
**Item 11 Ref: NZ000699**

The floor covering bottom layer in Bathroom 1/001 does not contain asbestos.

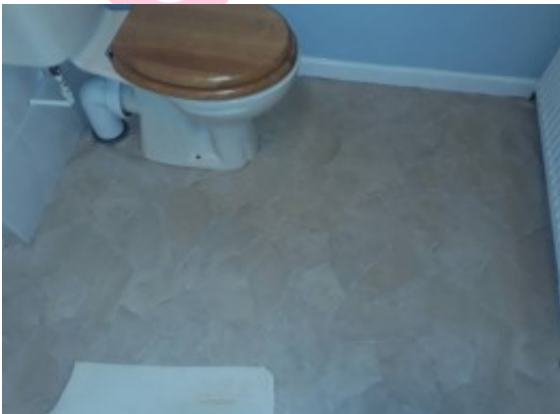
**Item 12 Ref: NZ000700**

The floor covering top layer in Bathroom 1/001 does not contain asbestos.
