ASBESTOS SURVEY REPORT FOR FULWEL JUNIOR SCHOOL, SEA ROAD, SUNDERLAND, SR6 9EE.

Asbestos Register for

Fulwell Junior School, Sea Road, Sunderland, SR6 9EE

Date: 04 March 2026

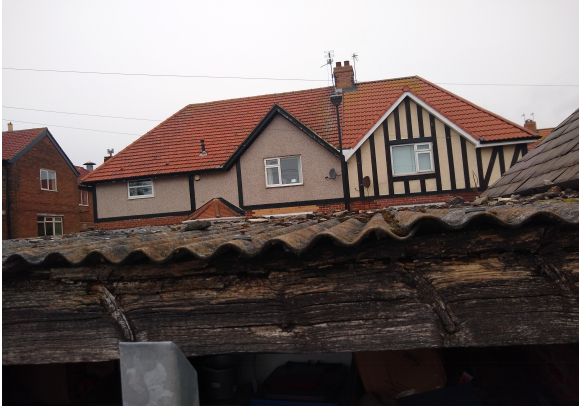
Item 1 Ref: As 392632-36

*The bin shed roof (External)
contains asbestos.*

Removed April 2024

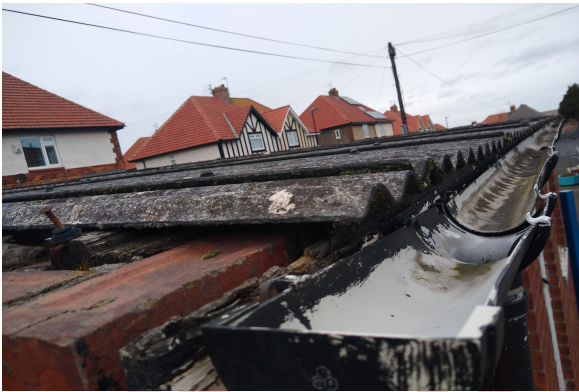
Item 2 Ref: As 392632-37

*The chair store roof (External)
contains asbestos.*

Removed April 2024

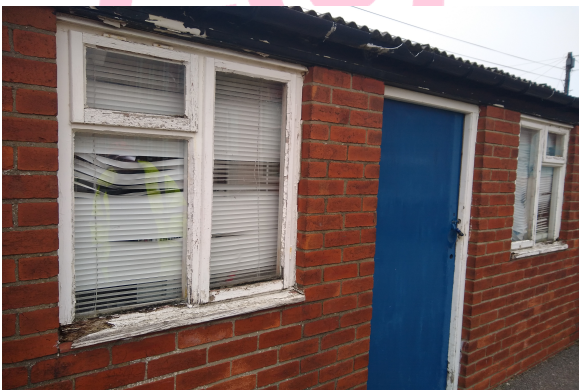
Item 3 Ref: As 392632-38

*The putty to window panes to
the bin/chair store (External)
does not contain asbestos.*

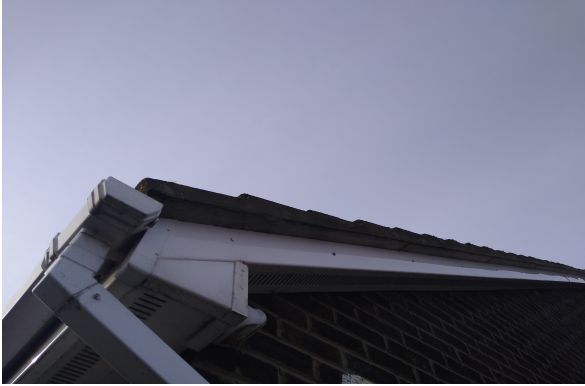
Item 4 Ref: 392632-33

The undercloaking to the caretaker's house (External) does not contain asbestos.

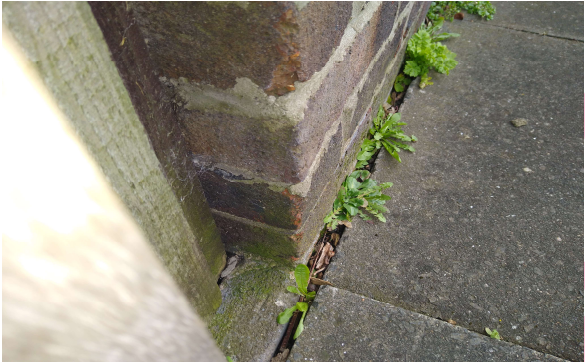
Item 5 Ref: 392632-31

The damp proof course to the caretaker's house (External) does not contain asbestos.

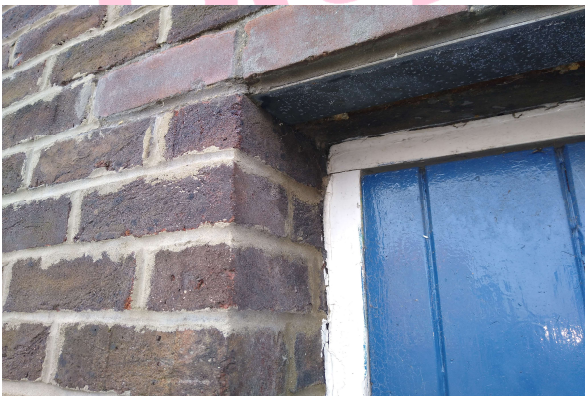
Item 6 Ref: 392632-32

The sealant to bin store door frame (External) contains asbestos.

Any change in its appearance should be recorded and passed to Property Services.

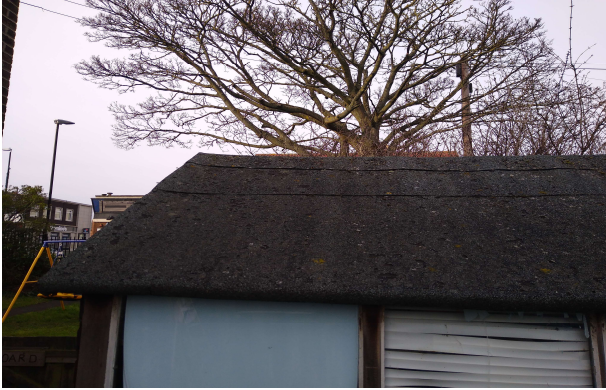
Item 7 Ref: 392632-34

The roof felt to the timber shed (External) does not contain asbestos.

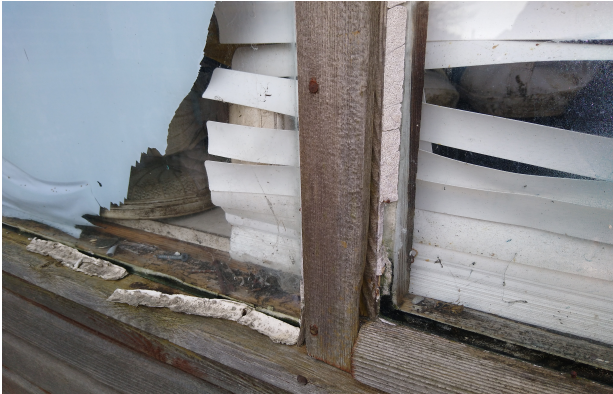
Item 8 Ref: 392632-35

The putty to glazing in the caretaker's house (External) does not contain asbestos.

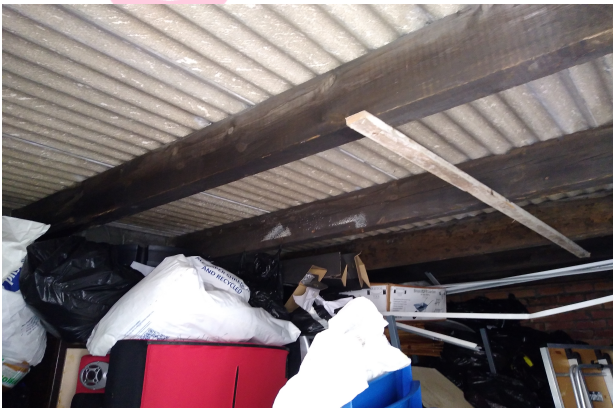
Item 9 Ref: 392632-37

The corrugated roof to the external store (Rm 0/01) contains asbestos.

Removed April 2024

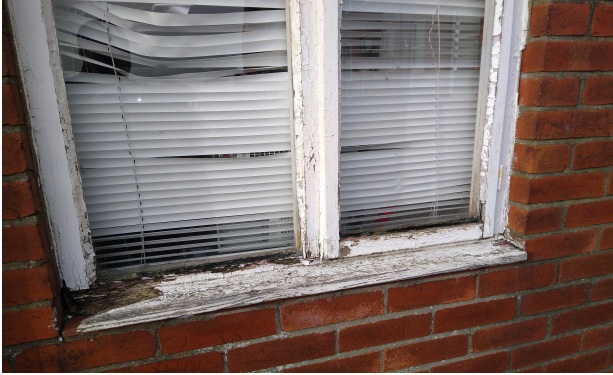
Item 10 Ref: 392632-38

The putty to glazing in the external store (Rm 0/01 - External) does not contain asbestos.

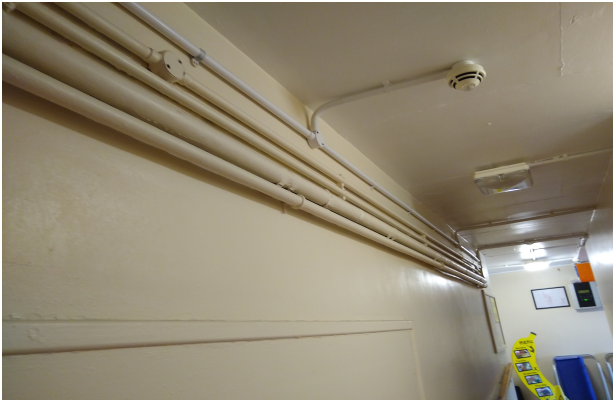
Item 11 Ref: Presumed

- (Item 11) Ref: Presumed – Below pipework lagging (boxed in - 2024) ([Link corridor/Rm 002](#)) – Low Risk
- (Item 12) Ref: 392632-24 – Sink paint (Kitchen/Rm 007) – No Risk

The lagging below pipework in the link corridor (Rm 0/02) is presumed to contain asbestos.

Any change in its appearance should be recorded and passed to Property Services.

(Pipework boxed - 2024)

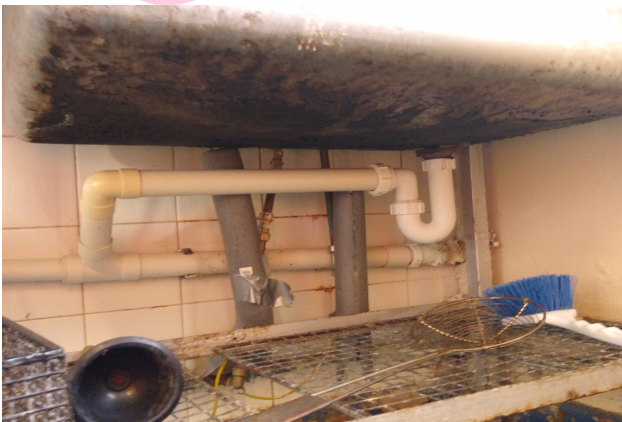
Item 12 Ref: 392632-24

The sink paint in the Dining hall building kitchen (Rm 0/07) does not contain asbestos.

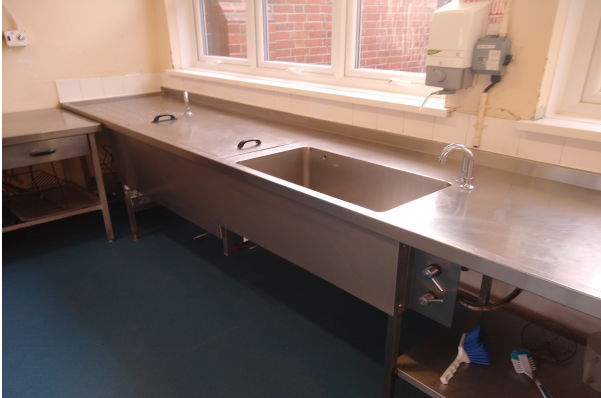
Item 13 Ref: 392632-25

The sink pad in the Dining hall building kitchen (Rm 0/07) does not contain asbestos.

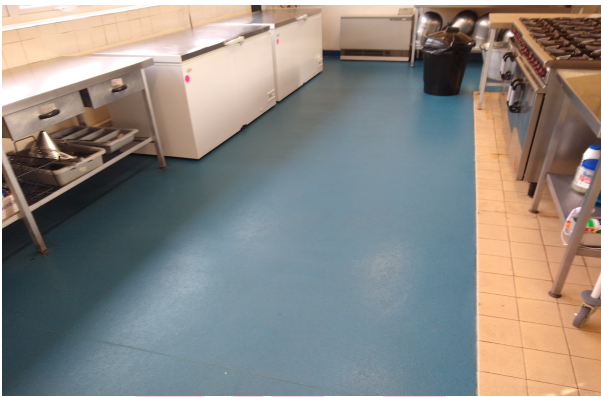
Item 14 Ref: Presumed

The adhesive below the lino and screed in the Dining hall building kitchen (Rm 0/07) is presumed to contain asbestos.

Any change in its appearance should be recorded and passed to Property Services.

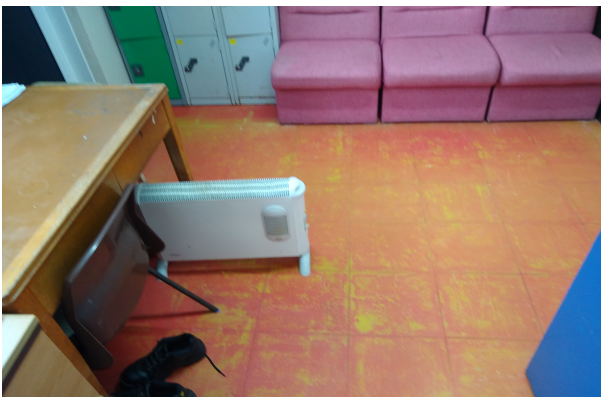
Item 15 Ref: 392632-26

The floor covering in the Dining hall building staff room (Rm 0/09) contains asbestos.

Any change in its appearance should be recorded and passed to Property Services.

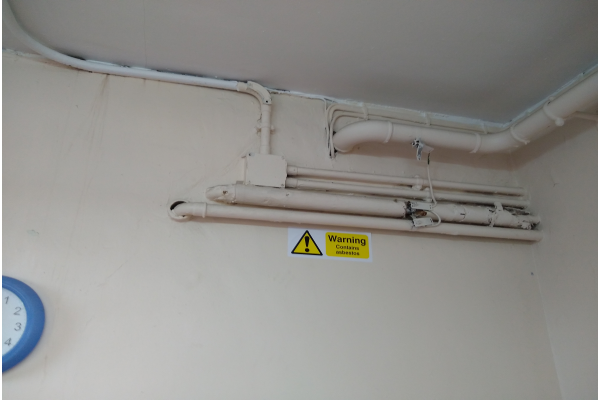
Item 16 Ref: 392632-27

The insulation to pipework elbow in the Dining hall building staff room (Rm 0/09) does not contain asbestos.

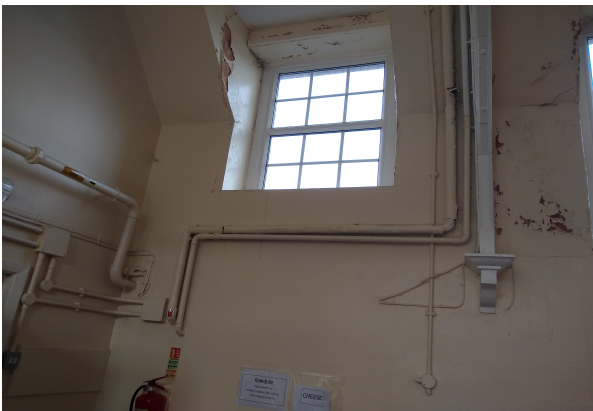
Item 17 Ref: 392632-28

The pipework lagging to elbows in the Dining hall building dining hall (Rm 0/10) does not contain asbestos.

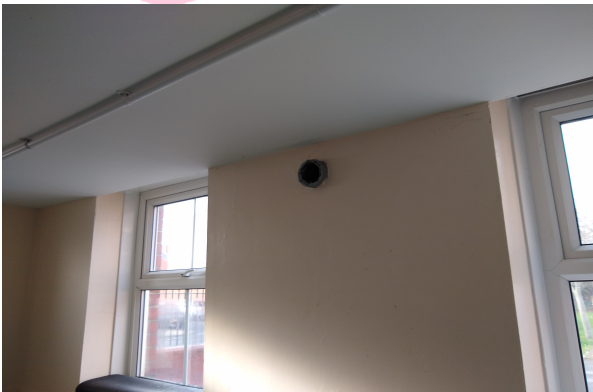
Item 18 Ref: 392632-29

The redundant flue in the Dining hall building food container store (Rm 0/11) contains asbestos.

Removed 2024 – waiting WCN's

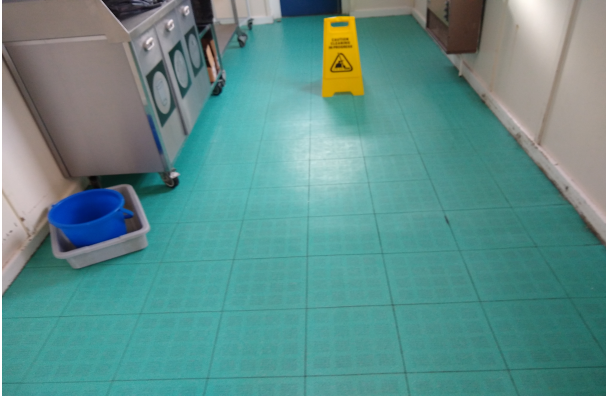
Item 19 Ref: 392632-30

The floor covering (red below top layer) in the Dining hall building food container store (Rm 0/11) contains asbestos.

Any change in its appearance should be recorded and passed to Property Services.

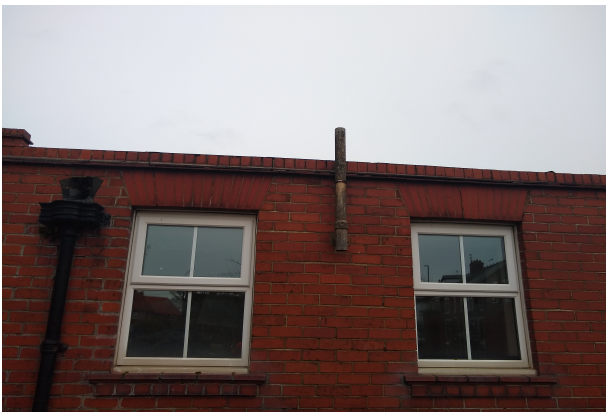
Item 20 Ref:As392632-29

The redundant flue to the Dining hall building (External) contains asbestos.

Removed 2024 – waiting WCN's

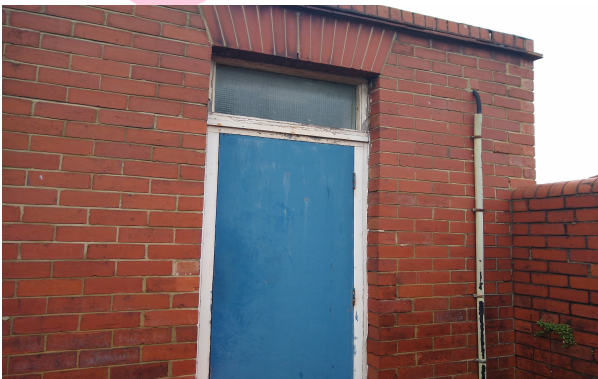
Item 21 Ref: 392632-39

The sealant to fire door of area 0/11 to the Dining hall building (External) does not contain asbestos.

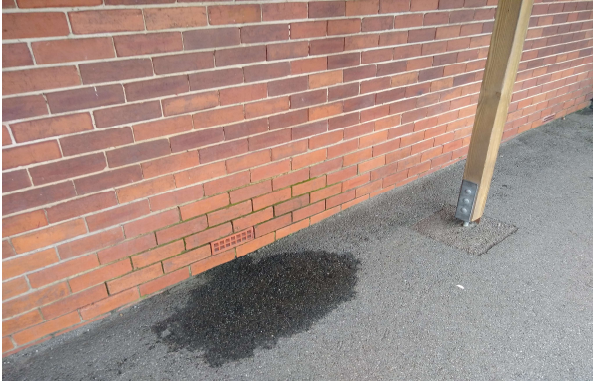
Item 22 Ref: 392632-40

The damp proof course to the Dining hall building (External) does not contain asbestos.

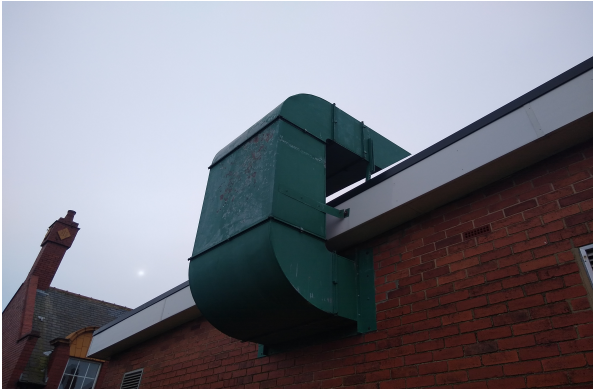
Item 23 Ref: 392632-41

The sealant to extractor ducting joints to the Dining hall building (External) does not contain asbestos.

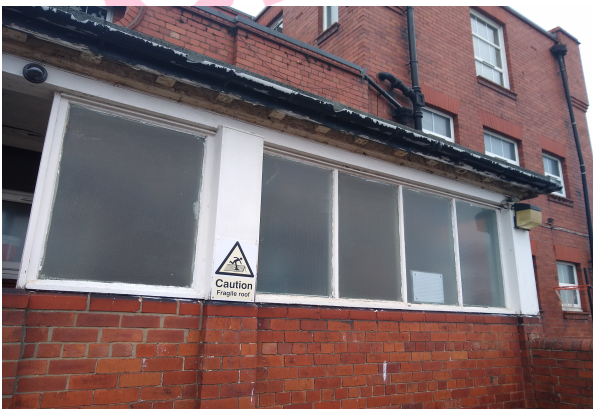
Item 24 Ref: 392632-42

The putty to window panes to the porch of the main building (External) does not contain asbestos.

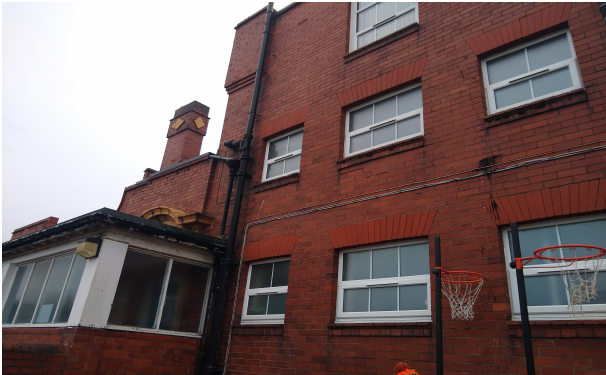
Item 25 Ref: 392632-43

The sealant to downpipe joints to the main building (External) does not contain asbestos.

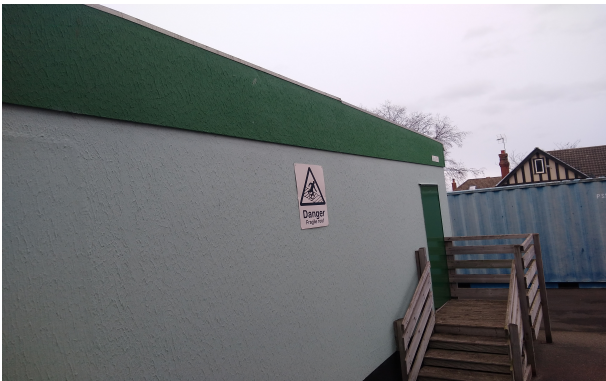
Item 26 Ref: 392632-44

The walls to the prefab classroom (External) do not contain asbestos.

Demolished in refurb 2024

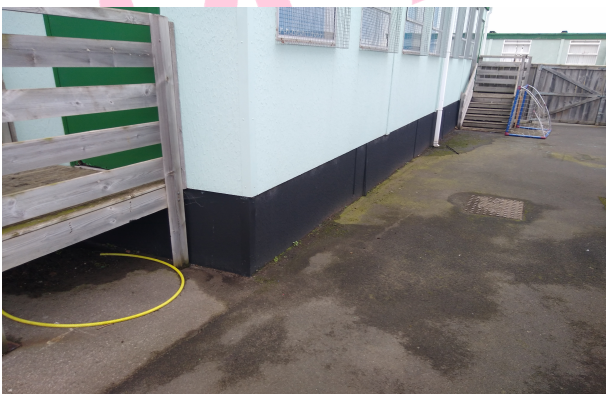
Item 27 Ref: 392632-45

The fascia board to floor void area to prefab building (External) does not contain asbestos.

Demolished in refurb 2024

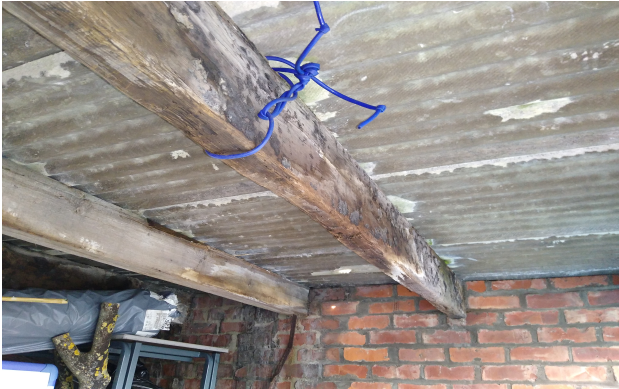
Item 28 Ref: 392632-36

The corrugated roof to the bin store (Rm 0/01) contains asbestos.

Removed April 2024

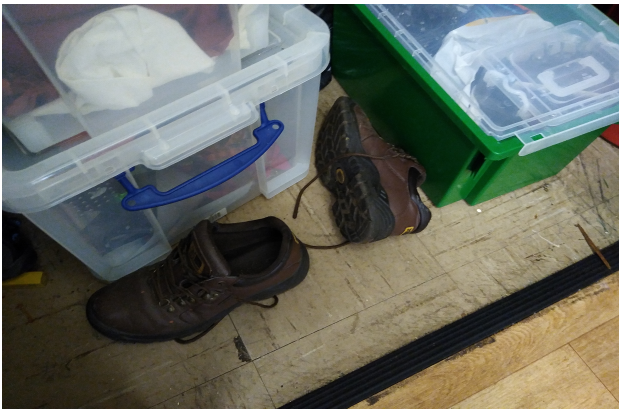
Item 29 Ref: 392632-11

The floor covering to the standalone portacabin store (Rm 0/02) does not contain asbestos.

Demolished in refurb 2024

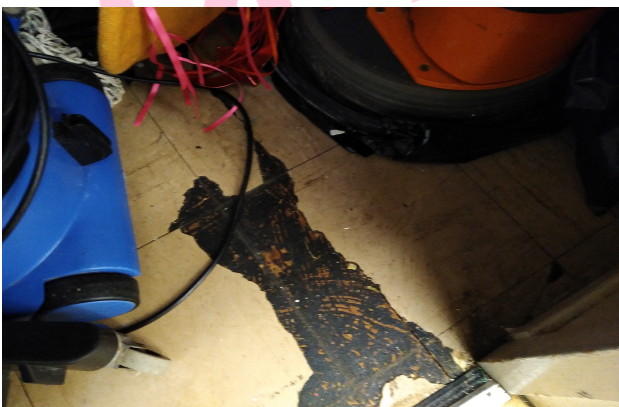
Item 30 Ref:As392632-11

The floor covering to the standalone portacabin electrical cupboard (Rm 0/04) does not contain asbestos.

Demolished in refurb 2024

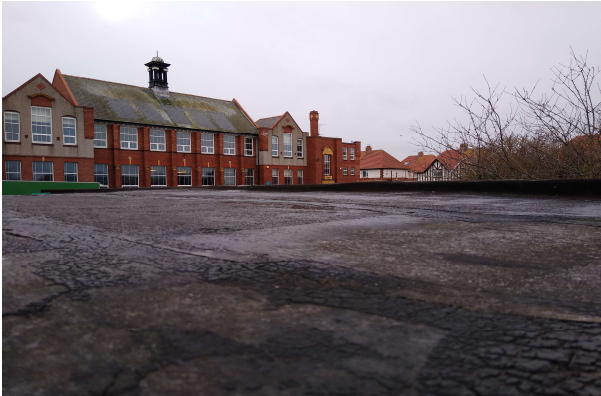
Item 31 Ref: 392632-12

The flat roof lining to the standalone portacabin (External) does not contain asbestos.

Demolished in refurb 2024

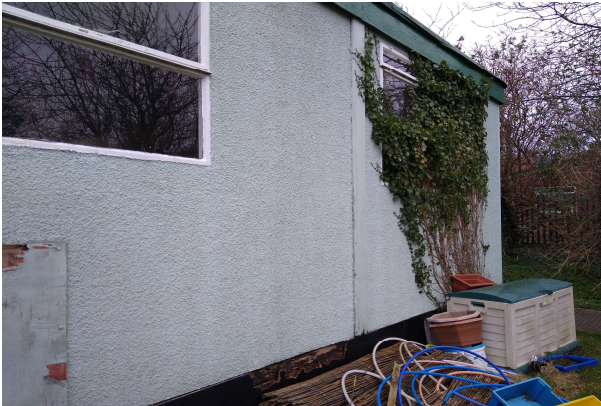
Item 32 Ref: 392632-13

The wall coating to the standalone portacabin (External) does not contain asbestos.

Demolished in refurb 2024

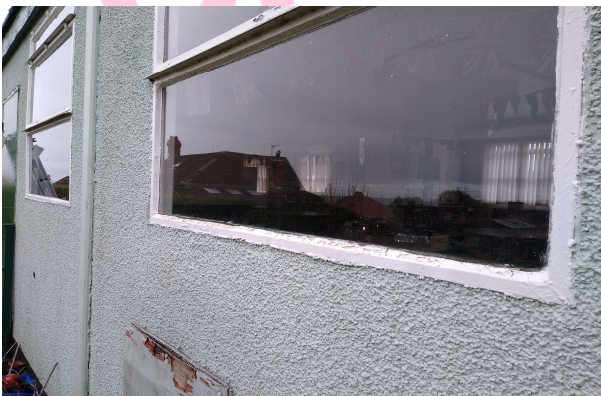
Item 33 Ref: 392632-14

The sealant to window frames to the standalone portacabin (External) does not contain asbestos.

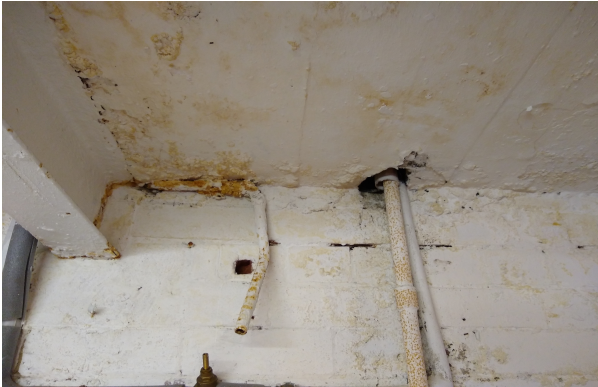
Item 34 Ref: 392632-20

The debris within ceiling pipework penetration to the boiler room (Rm -1/01) does not contain asbestos.

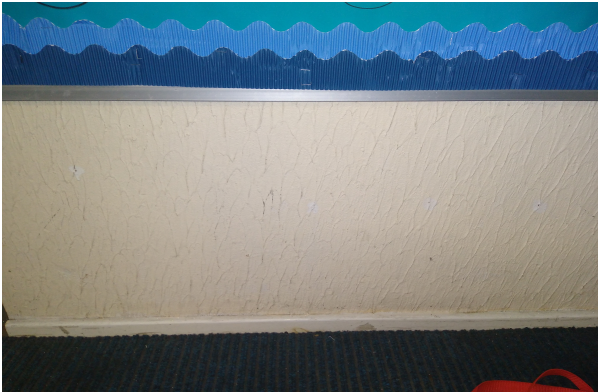
Item 35 Ref: 392632-22

The textured coating to walls in the lobby (Rm 0/03) does not contain asbestos.

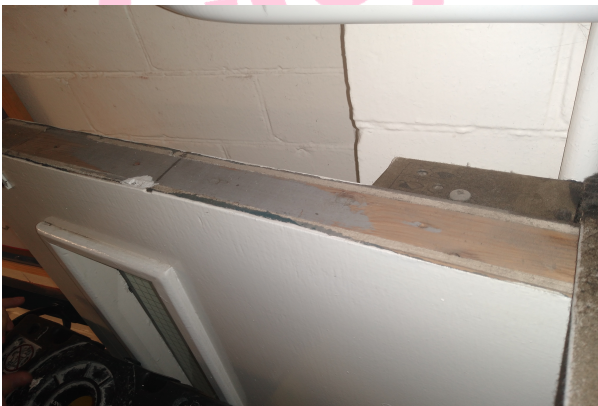
Item 36 Ref: 392632-23

The panels within the fire doors in the stairwell and corridor (Rm 0/04) does not contain asbestos.

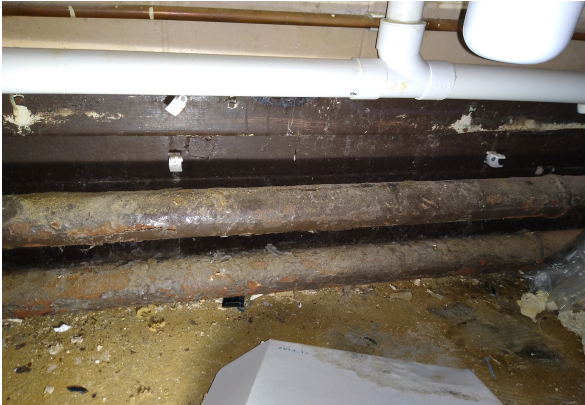
Item 37 Ref: 392632-9

The remnant insulation to pipework below vanity units in the girls wc (Rm 0/05a) does not contain asbestos.

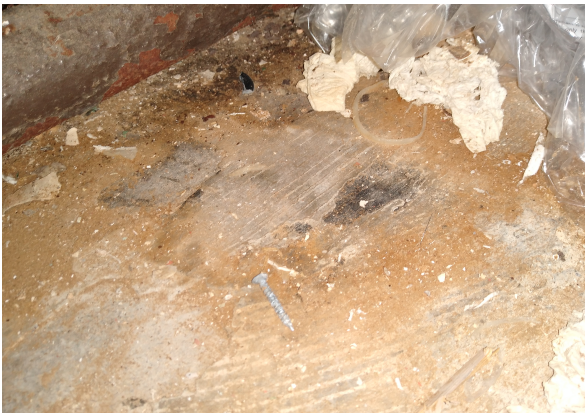
Item 38 Ref: 392632-10

The remnant adhesive below linoleum in the girls wc (Rm 0/05a) contains asbestos.

Any change in its appearance should be recorded and passed to Property Services.

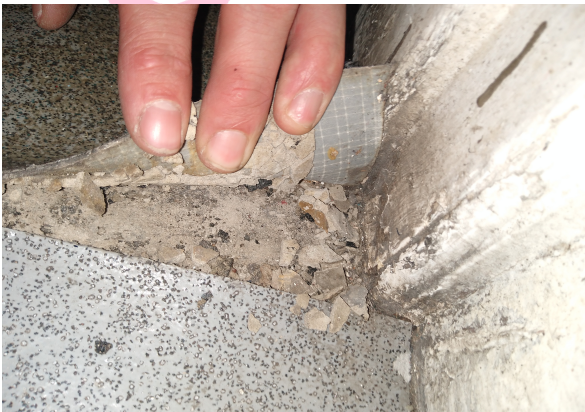
Item 39 Ref: 392632-21

The floor covering below modern screed in the lobby (Rm 0/05b) contains asbestos.

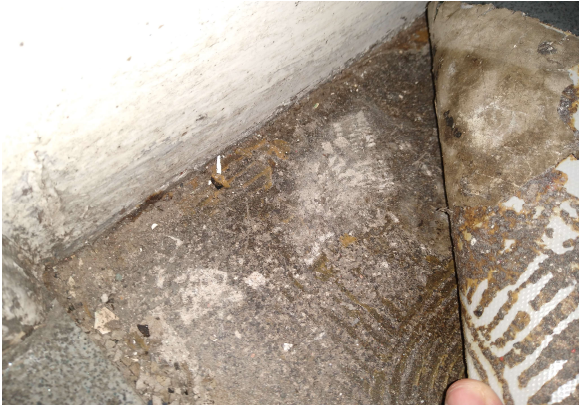
Item 40 Ref:As392632-21

The floor covering in the male staff wc (Rm 0/05d) contains asbestos.

Any change in its appearance should be recorded and passed to Property Services.

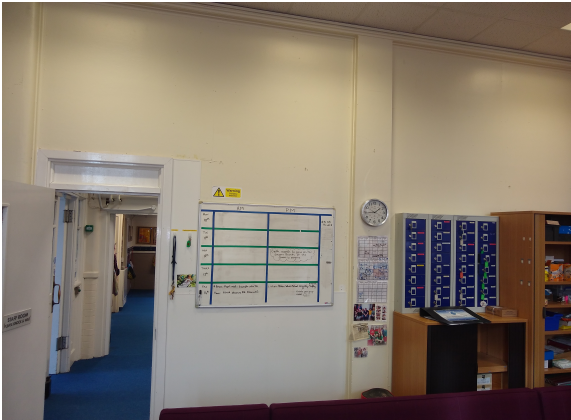
Item 41 Ref: 392632-18

The partition walls in the staff room (Rm 0/08) contains asbestos.

Removed March 2024

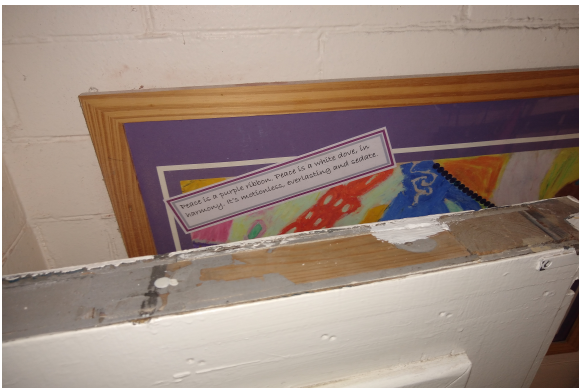
Item 42 Ref: 392632-19

The panels within the fire doors to 0/009 in the corridor (Rm 0/08a) does not contain asbestos.

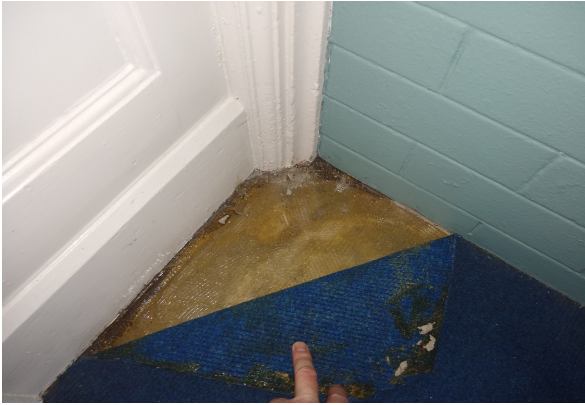
Item 43 Ref: 392632-5

The remnant adhesive to floor below modern screed in the reception lobby (Rm 0/11) contains asbestos.

Any change in its appearance should be recorded and passed to Property Services.

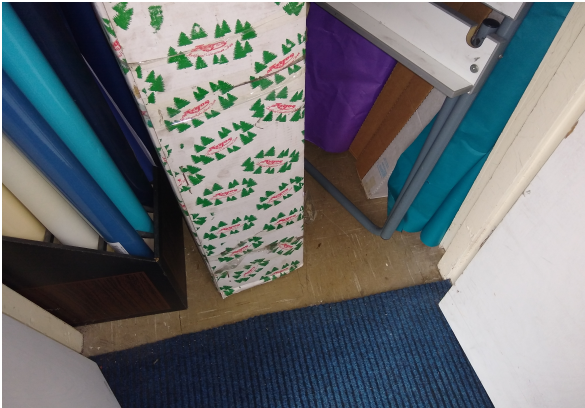
Item 44 Ref: 392632-15

The floor covering in the store (Rm 0/011a) does not contain asbestos.

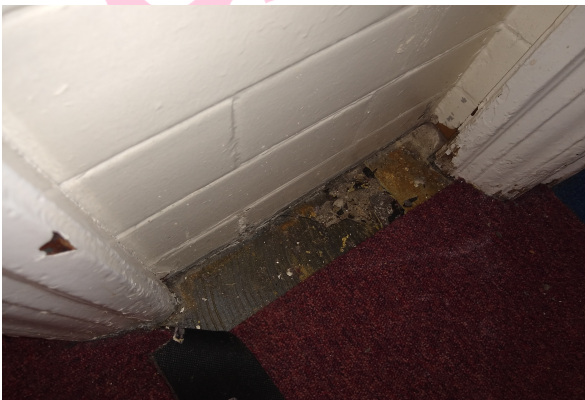
Item 45 Ref: 392632-16

The floor covering below carpet in the lobby (Rm 0/12) contains asbestos.

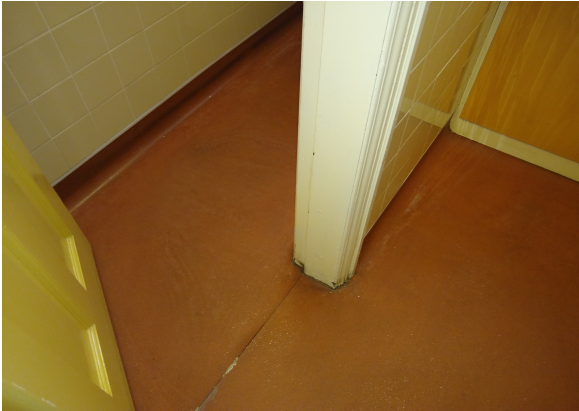
Item 46 Ref: 392632-17

The remnant adhesive below screed in the staff wc (Rm 0/14) contains asbestos.

Any change in its appearance should be recorded and passed to Property Services.

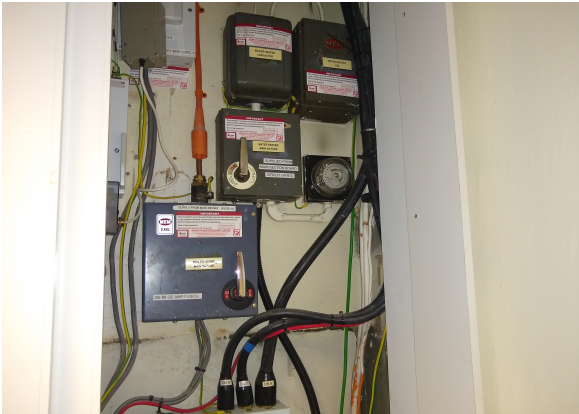
Item 47 Ref: Presumed

The electrics M.E.M in the office (Rm 0/15) contains asbestos.

Any change in its appearance should be recorded and passed to Property Services.

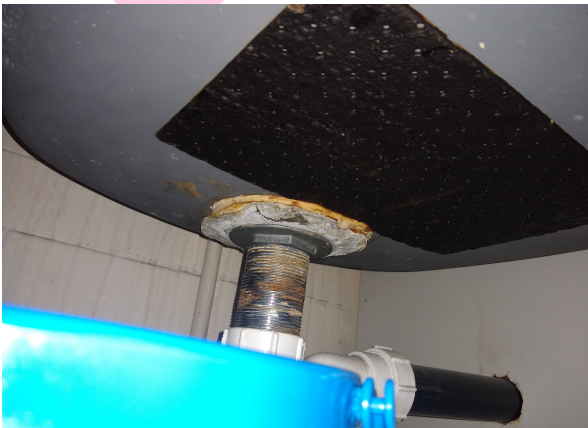
Item 48 Ref: 392632-3

The sink pad in the lobby (Rm 1/01) does not contain asbestos.

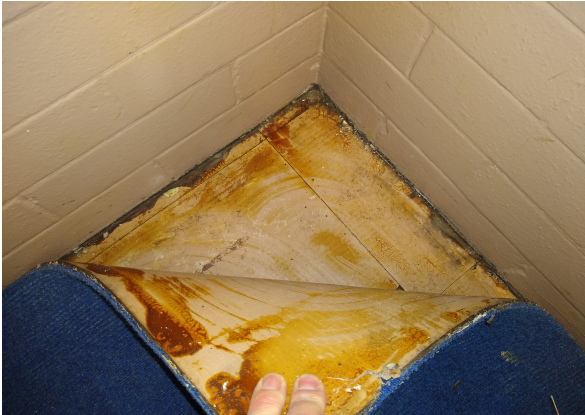
Item 49 Ref: 392632-1

The subfloor to mezzanine in the stairwell landing (Rm 1/04) does not contain asbestos.

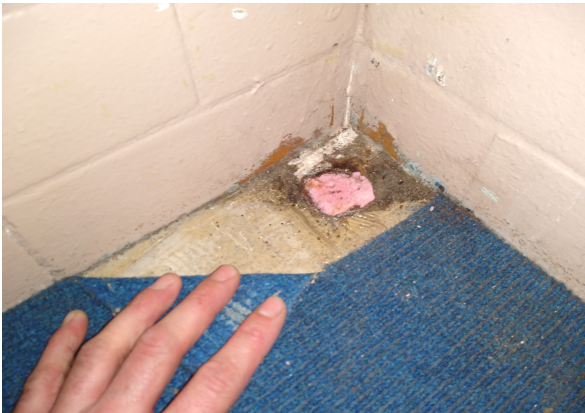
Item 50 Ref: 392632-7

The subfloor to mezzanine in the stairwell landing (Rm 1/09) does not contain asbestos.

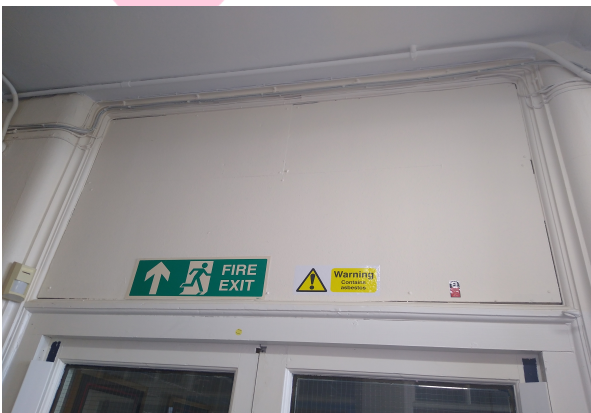
Item 51 Ref: 392632-6

The panel above door to stairwell in the corridor and lobby (Rm 1/12) contains asbestos.

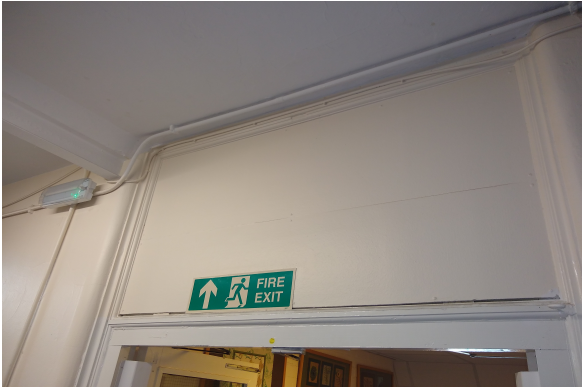
Item 52 Ref: 392632-4

The panel above door to stairwell in the corridor (Rm 1/19) contains asbestos.

Removed March 2023

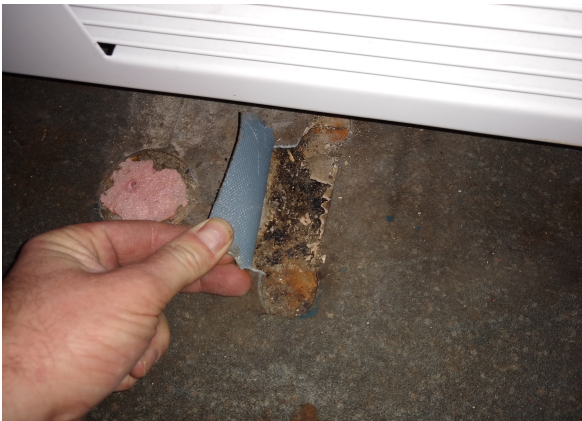
Item 53 Ref: 392632-2

The remnant adhesive to floor in the boys wc (Rm 1/M001) contains asbestos.

Any change in its appearance should be recorded and passed to Property Services.

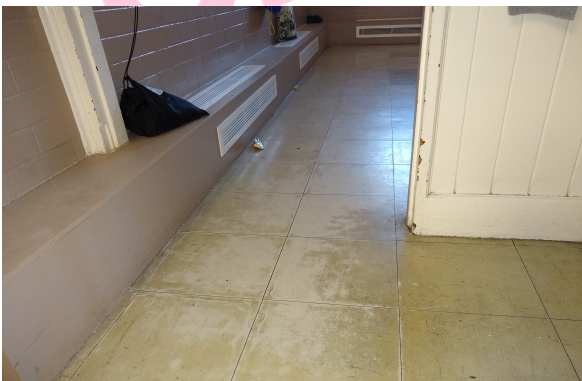
Item 54 Ref: As 392632-1

The floor covering in the cloakroom (Rm 1/M002) does not contain asbestos.

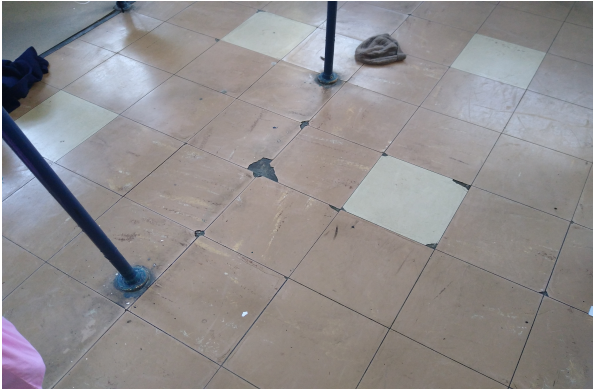
Item 55 Ref: 392632-8

The floor covering in the cloakroom (Rm 1/M003) does not contain asbestos.

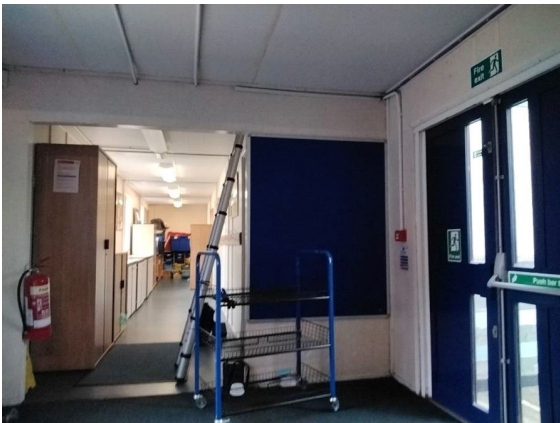
Item 56 Ref: CF006517

The wall coating (Entrance/Hall/Foyer/Lobby G/001) does not contain asbestos.

Demolished in refurb 2024

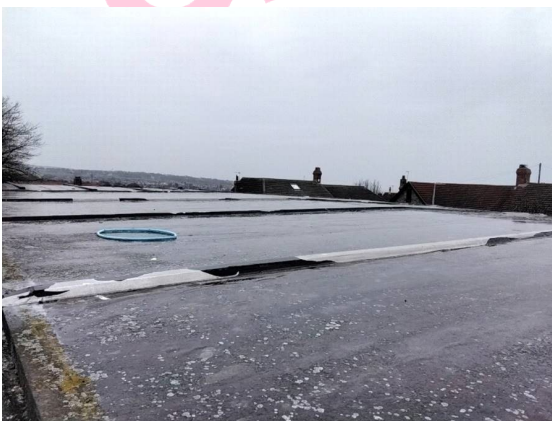
Item 57 Ref: CF006518

The roof jointing compound (External/E001) does not contain asbestos.

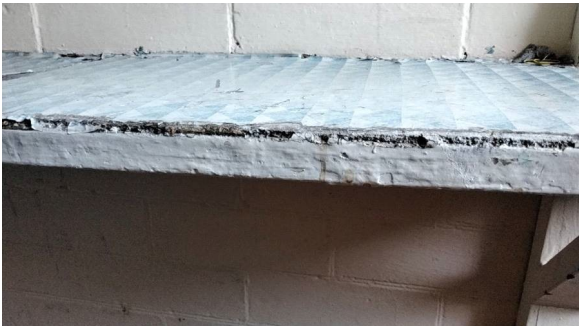
Item 92 Ref: NO000606

The Shelving heat pads to bottom and underside of shelf above (Cupboard Store G/034) contain asbestos.

Any change in its appearance should be recorded and passed to Property Services.

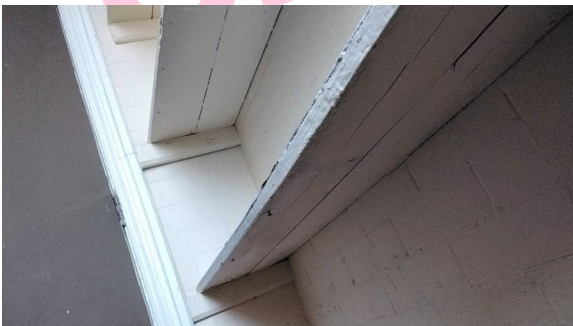
Item 93 Ref: NO000607

The Shelving remnants to shelving/nails etc (Cupboard Store G/034) contain asbestos.

Any change in its appearance should be recorded and passed to Property Services.

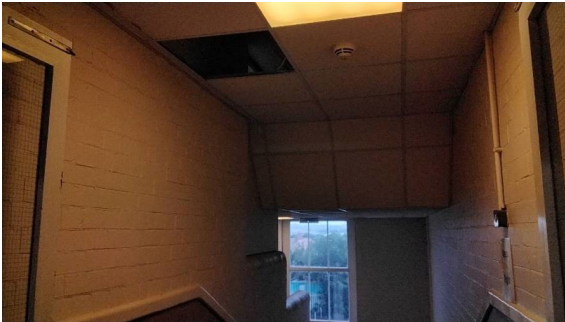
Item 95 Ref: NO000596

The Wall coating (Landing 1/001) does not contain asbestos.

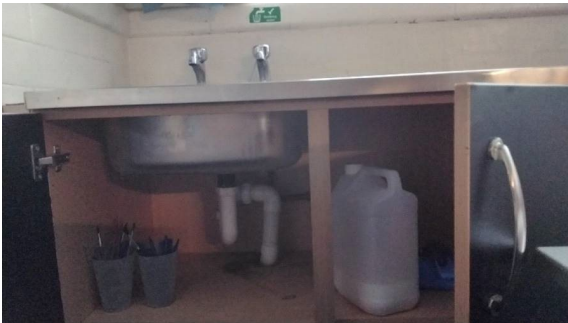
Item 104 Ref: As NO000598

The Under sink mat (Classroom 1/017) does not contain asbestos.

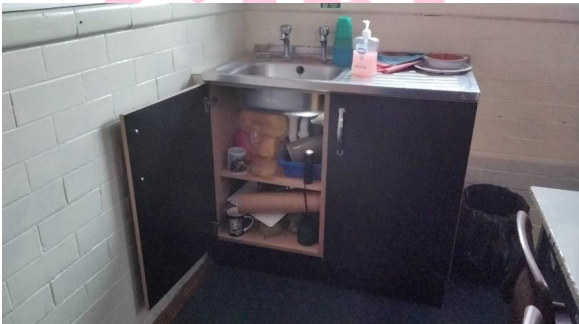
Item 105 Ref: As NO000598

The Under sink mat (Classroom 1/018) does not contain asbestos.

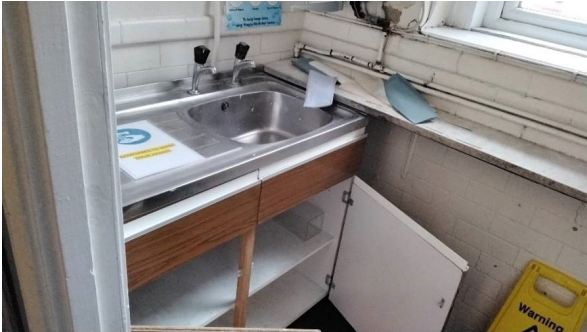
Item 106 Ref: NO000599

The Under sink mat (Corridor 1/019) does not contain asbestos.

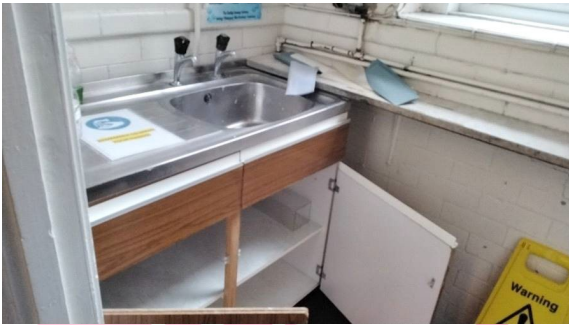
Item 107 Ref: As NO000597

The Pipework to sink water pipe (Corridor 1/019) does not contain asbestos.

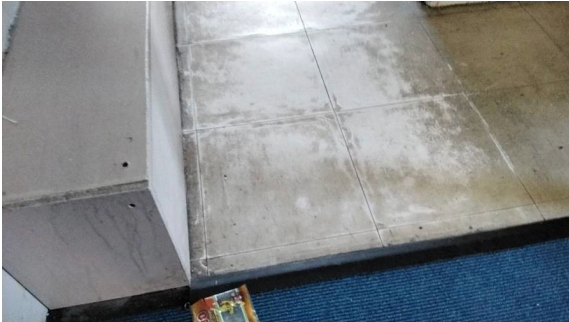
Item 109 Ref: NO000608

The Floor tile beige under carpet (Landing MZ/001) contains asbestos.

Any change in its appearance should be recorded and passed to Property Services.

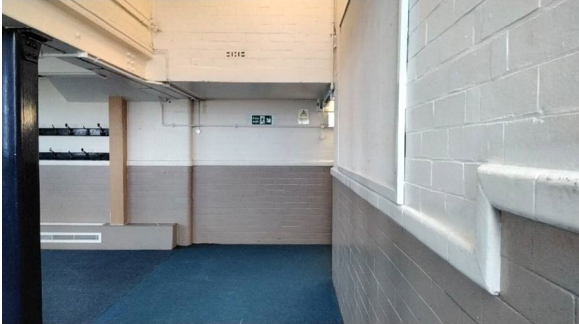
Item 112 Ref: As NO000600

The Wall coating fire flex paint (Landing MZ/003) does not contain asbestos.

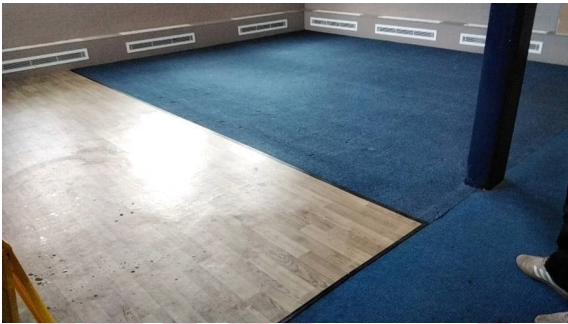
Item 113 Ref: As NO000608

The Floor adhesive (Landing MZ/003) contains asbestos.

Any change in its appearance should be recorded and passed to Property Services.

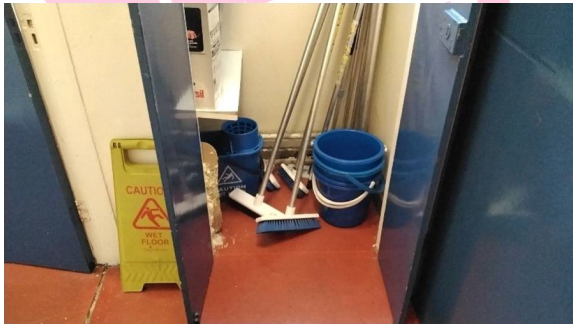
Item 120 Ref: NO000585

The Floor covering red (Cupboard G/003) contains asbestos.

Any change in its appearance should be recorded and passed to Property Services.

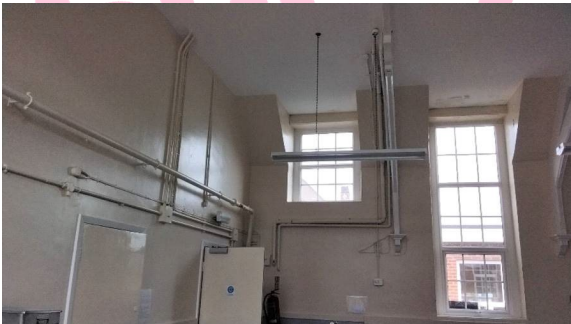
Item 129 Ref: Presumed

The Pipework insulation (Dining hall/area G/009) is presumed to contain asbestos.

Any change in its appearance should be recorded and passed to Property Services.
