ASBESTOS SURVEY REPORT FOR 260-261 HIGH STREET WEST,
SUNDERLAND, STR1 3DH

Asbestos Register for

260-261 High Street West, Sunderland

Date: 22 April 2026

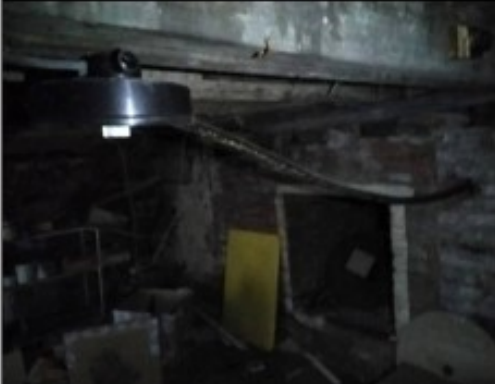
1	SC004721	Electrical services – cable braiding/insulation	Cellar Room Z1/001	No Risk

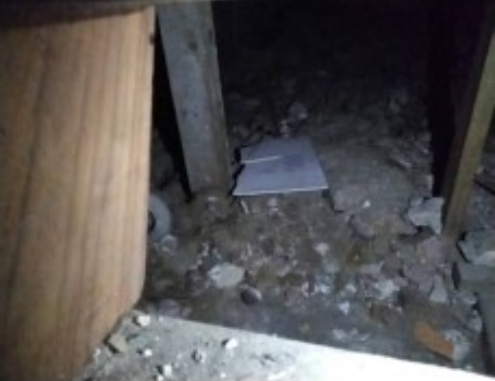
2	SC004722	Debris	Cellar Room Z1/001	No Risk

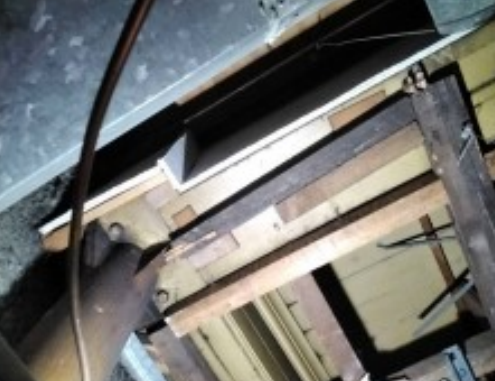
3	SC004715	Ceiling void - Beam cladding running between two central columns	Shop Floor G/001	No Risk

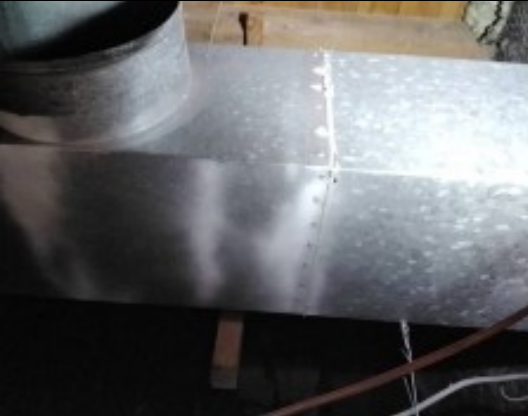
4	SC004716	Ceiling void - Ductwork	Shop Floor G/001	Does not contain asbestos

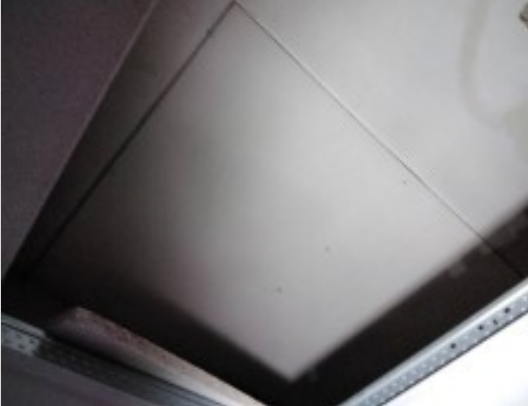
5	SC004717	Ceiling void – ceiling panel	Shop Floor G/001	Does not contain asbestos

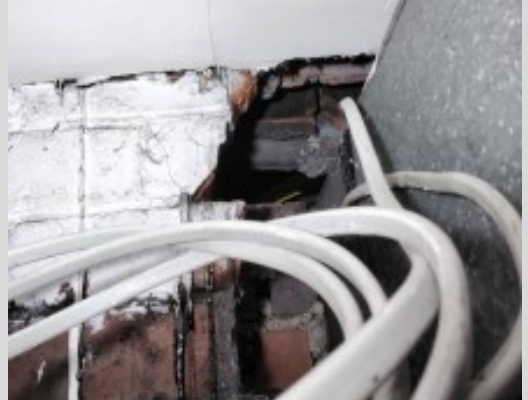
6	SC004718	Ceiling void – debris/residue	Shop Floor G/001	Does not contain asbestos

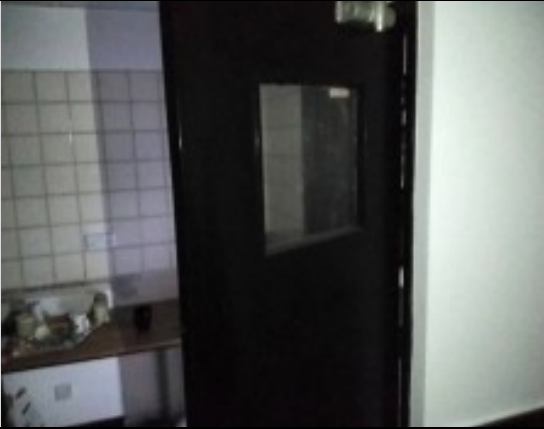
19	SC004728	Door – window beading	Staff Room 1/005	Does not contain asbestos

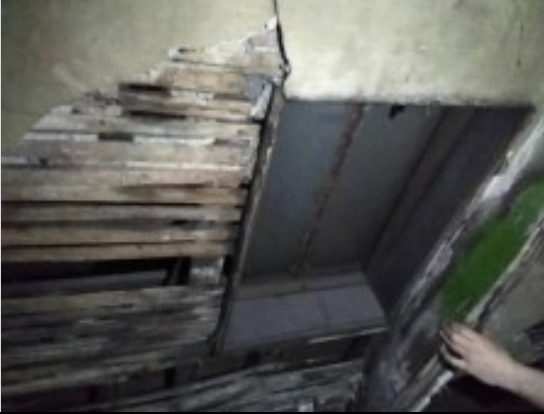
28	SC004735	Window putty/seal	Loft Space R/001	Does not contain asbestos

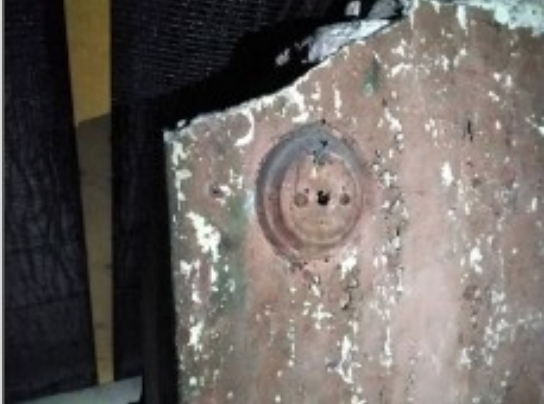
29	SC004736	Seal to former light switch	Loft Space R/001	Does not contain asbestos

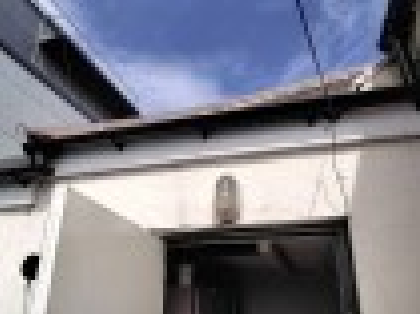
30	SC004733	Electrical Services light fitting	External canopy ceiling with woodchip paper E/001	Contains asbestos - Any change in its appearance should be recorded and passed to Property Services.

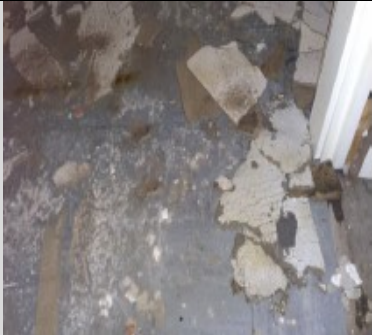
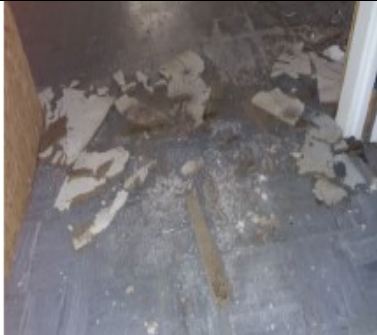
31	IJ006246	Timber firebreboard – floor	Rear Corridor G/01	No Risk
