ASBESTOS SURVEY REPORT FOR CASTLETOWN PRIMARY SCHOOL

Asbestos Register for CASTLETOWN PRIMARY SCHOOL

Castletown Primary - Last updated 13/05/2026 – Version 2

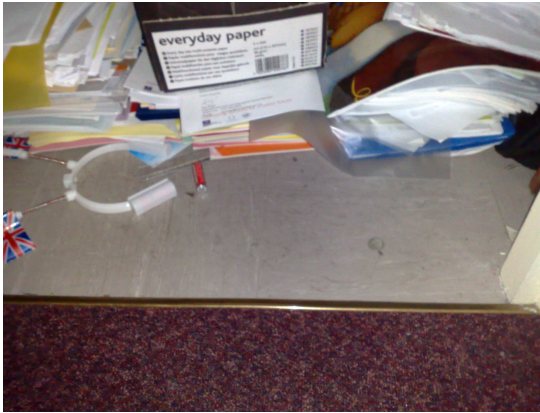
Various Ref: CS09/237

The vinyl flooring to the Heads room does not contain asbestos.

Similar vinyl flooring is located in:

Staff Rm, Repro Rm, Base 11/12, Base 13/14, CT Office, Base 7/8, Base 9/10, Base 3/4, Base 3/4 Stores, Base 5/6 Stores, Toy Store, Library Store, Cleaners Cupbd, Servery Staff Wc, Dep Ht Stores, Cleaners Store, Equipment Store, Reception Store, Base 2 Store, Secure Store 1 and Cleaners Equip Store.

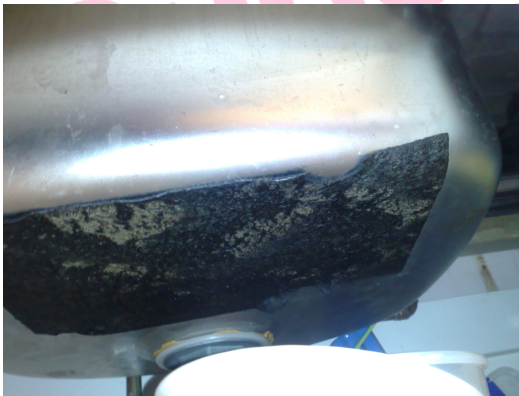
Various - Ref: CS09/238

The sink pad in the staff room does not contain asbestos.

Similar sink pads are located in;

Repro Rm, Base 11/12, Base 13/14, Base 7/8, Base 9/10, Base 5/6, Base 1/2 Prac, Nursery Playroom, Kitchen and Tea Room.

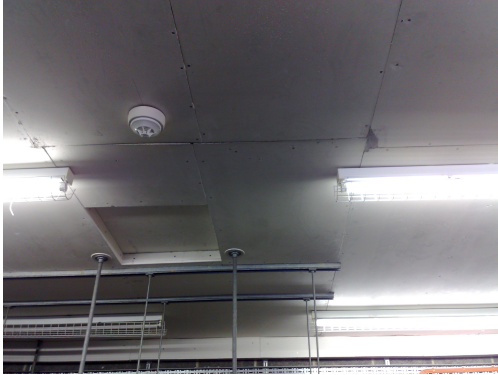
Various - Ref: CS09/239

The ceiling panels in the boiler room do not contain asbestos.

Similar ceilings are located in the electric room and Gas Room.

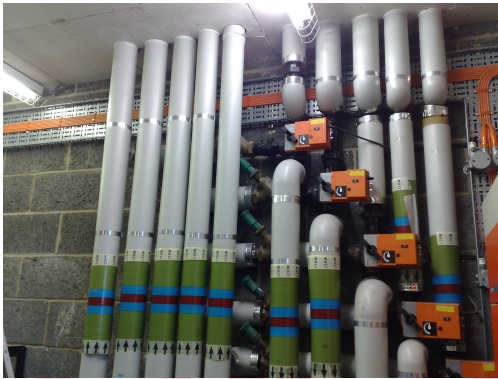
Item 29 - Ref: CS09/240

The pipe insulation to the boiler room does not contain asbestos.

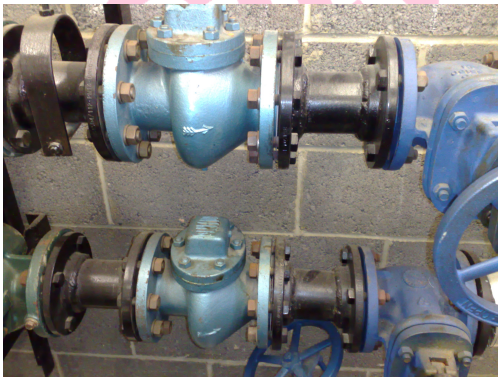
Item 30 - Ref: CS09/241

The gaskets throughout the Boiler Room contained asbestos.

These were removed in August 2015.

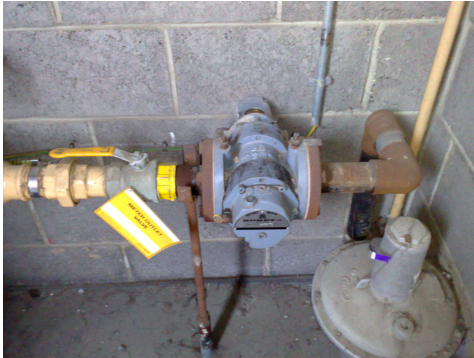
Item 33- Ref: CS09/242

The gaskets throughout the Gas Room contain asbestos.

Any change in their appearance should be recorded and passed to Property Services.

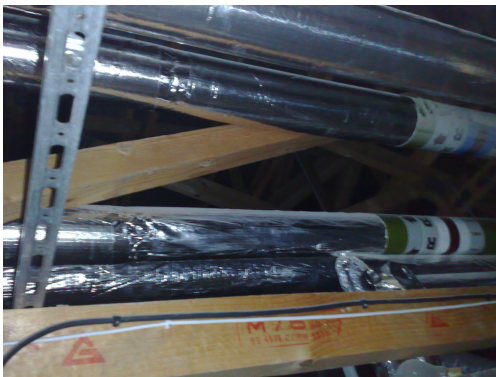
Item 36- Ref: CS09/243

The pipe insulation to the loft space does not contain asbestos.

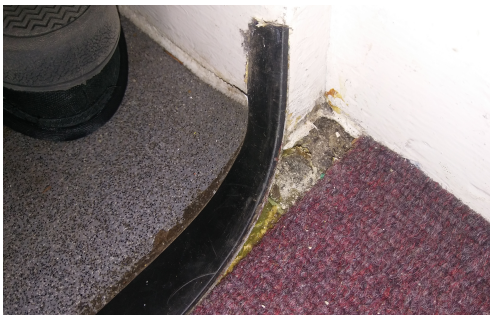
Item 41- Ref: As 343959-1

The screed to the floor in Year 5 Classroom does not contain asbestos.

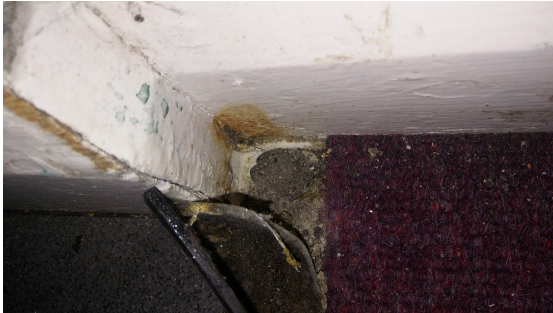
Item 42- Ref: 343959-1

The screed to the floor in Year 6 Classroom does not contain asbestos.

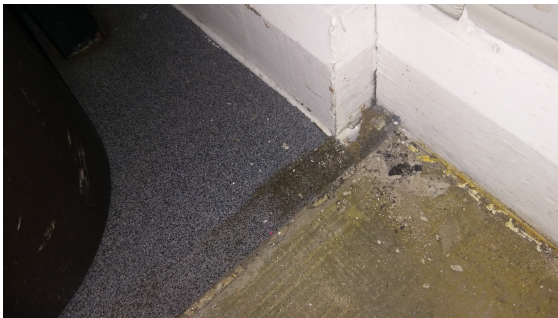
Item 43- Ref: 343959-1

The screed to the floor in Year 3 Classroom does not contain asbestos.

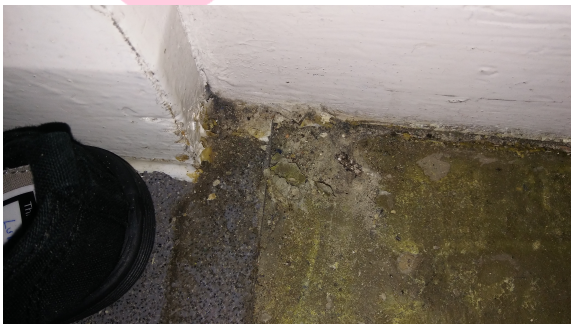
Item 44- Ref: 343959-1

The screed to the floor in Year 4 Classroom does not contain asbestos.

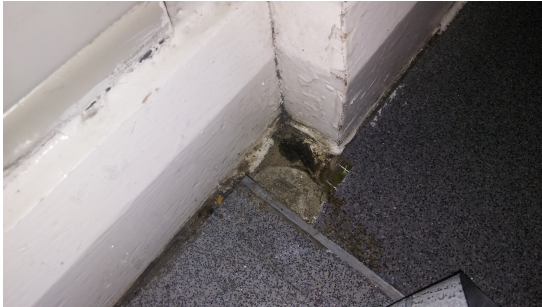
Item 45- Ref: 343959-1

The screed to the floor in Year 1 Classroom does not contain asbestos.

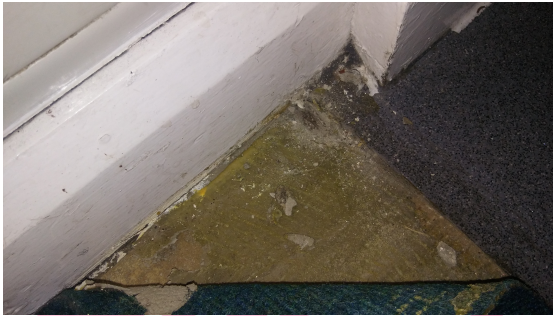
Item 46- Ref: 343959-1

The screed to the floor in Year 2 Classroom does not contain asbestos.

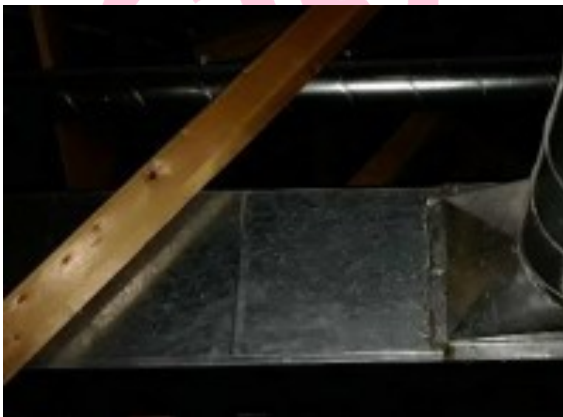
Item 47- Ref: 21-33433-1

The vessels – ducting inside ceiling void (Mastic) in the ceiling void above Boys Changing Rooms and Classroom does not contain asbestos.

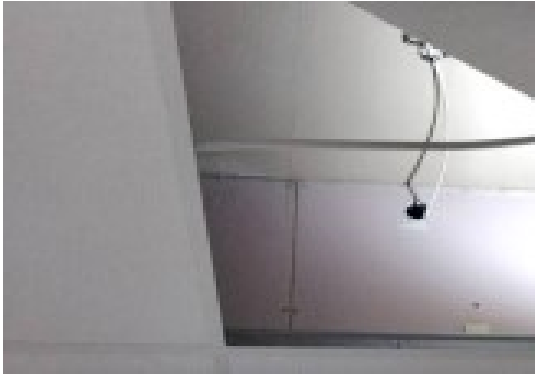
Item 48- Ref: NO000679

The fire breaks in the ceiling void in the Kitchen (G/001) does not contain asbestos.

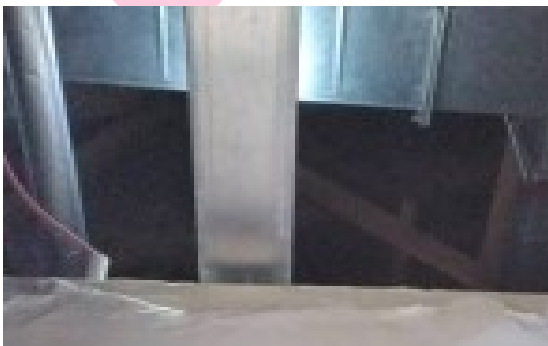
Item 50- Ref: NO000681

The fire breaks in the ceiling void in the Corridor (G/002) does not contain asbestos.

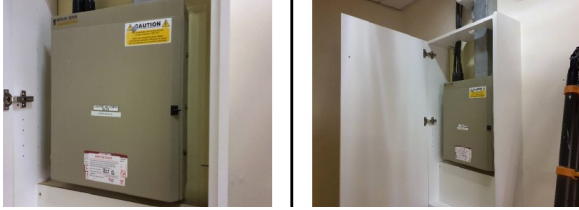
Item 60 Ref: Presumed

The Flash Guards - Distribution board (Sensory Room G/002) are presumed to contain asbestos.

Any change in appearance should be recorded and passed to Property Services.

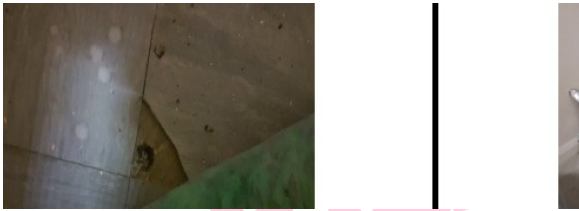
Item 61 Ref: As RC000655

The Bitumen - Beneath carpet, tiles and screed (Sensory Room G/002) does not contain asbestos.

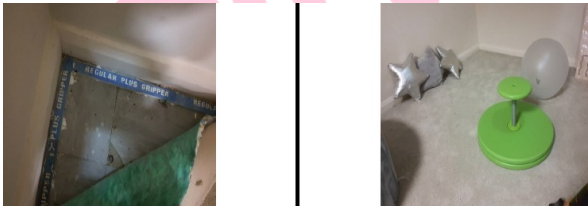
Item 62 Ref: RC000656

The Tiles - Beneath carpet (Sensory Room G/002) do not contain asbestos.

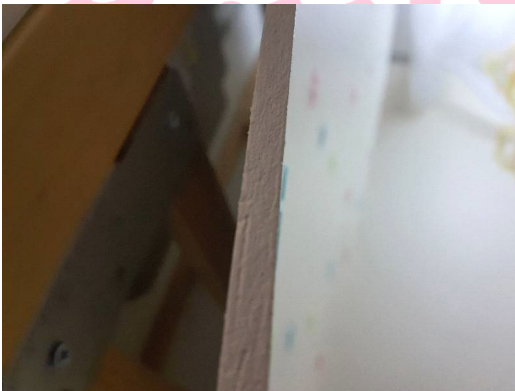
Item 65 Ref: Presumed

The Flash Guards - Distribution board (Sensory Room G/005) are presumed to contain asbestos.

Any change in appearance should be recorded and passed to Property Services.
