ASBESTOS SURVEY REPORT FOR WINCHESTER HOUSE, SUNDERLAND,
TYNE AND WEAR, SR5 4LW

Asbestos Register for

Winchester House, Sunderland, SR5 4LW

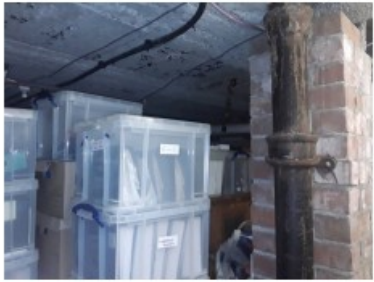
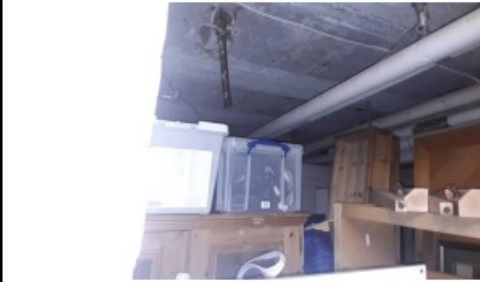
1	Presumed	Electrical services cable braiding/insulation	Store room restricted access due to stored items Z1/002	Very Low Risk – 12 monthly
Photo 1: Wide Angle			Photo 2: Close-up

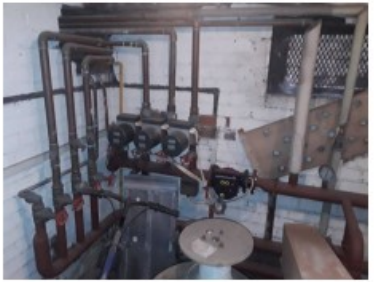
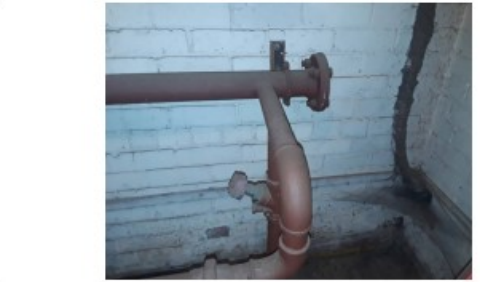
2	NZ001192	Pipework Gasket	Boiler Room Z1/003	Very Low Risk – 12 monthly
Photo 1: Wide Angle			Photo 2: Close-up

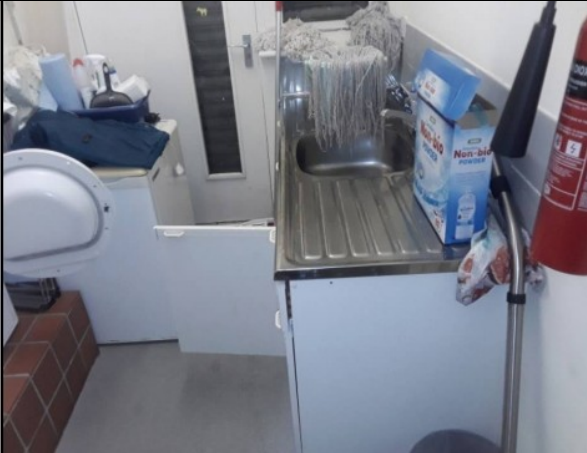
3	NZ001184	Under Sink Mat	Laundry G/008	No Risk

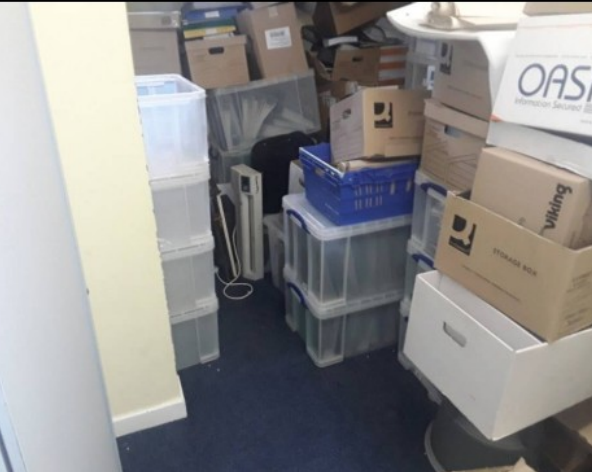
4	NZ001185	Floor tile with adhesive (under carpet)	Store Room G/021	No Risk

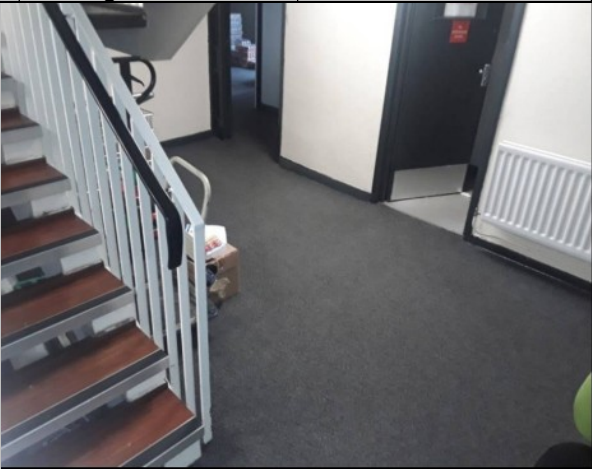
5	NZ001186	Floor covering under carpet running up skirting	Stairwell/Staircase G/026	No Risk

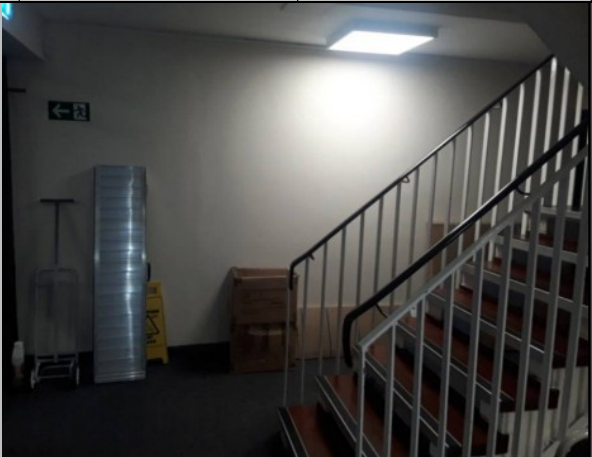
6	NZ001187	Wall coating	Stairwell/Staircase G/026	No Risk

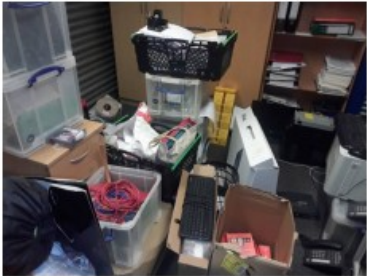
8	NZ001188	Floor adhesive under carpet	Hub/Network Room G/030	Very Low Risk – 12 monthly
Photo 1: Wide Angle		Photo 2: Close-up

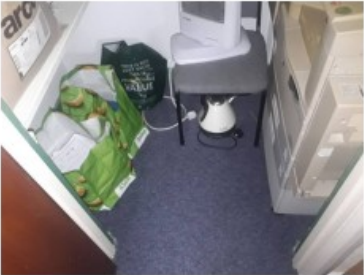
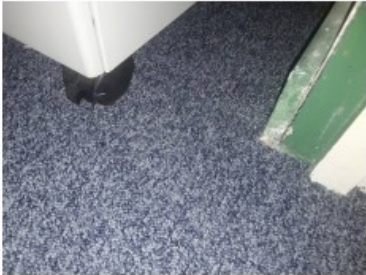
22	As NZ001191	Floor adhesive under carpet and modern screed	Cupboard 2 Office 1/022	Very Low Risk – 12 monthly
Photo 1: Wide Angle			Photo 2: Close-up

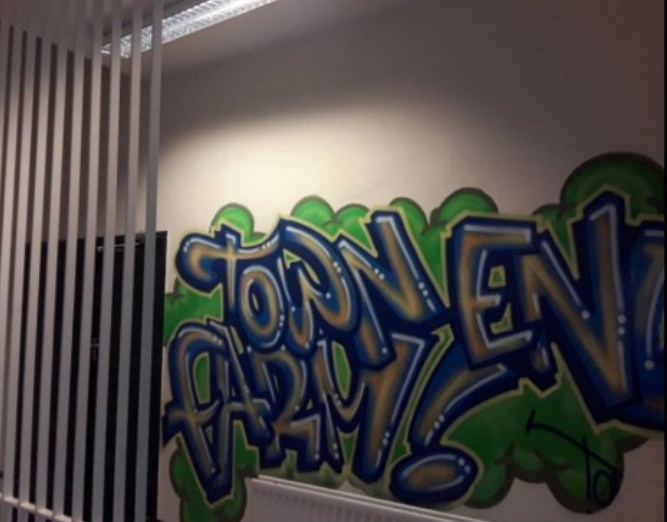
23	As NZ001190	Wall coating	Landing 2/001	No Risk

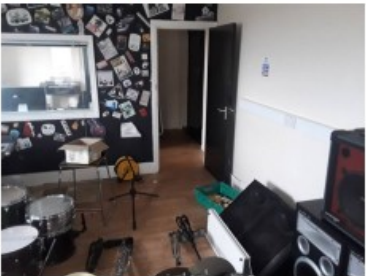
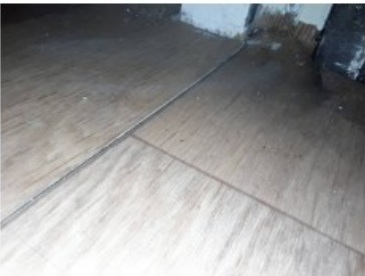
24	NZ001195	Floor adhesive under modern flooring	Corridor 2/002	Very Low Risk – 12 monthly
Photo 1: Wide Angle			Photo 2: Close-up

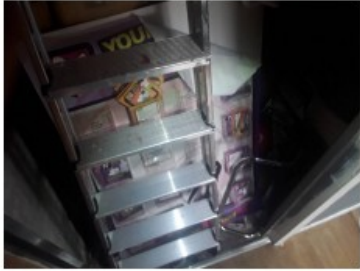
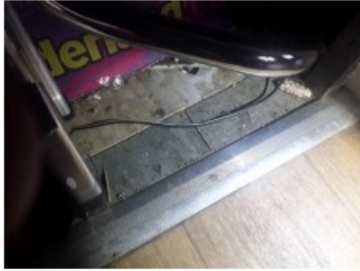
37	As NZ001196	Floor tile (with adhesive) with old adhesive on rear	Cupboard 2/020	Very Low Risk – 12 monthly
Photo 1: Wide Angle			Photo 2: Close-up

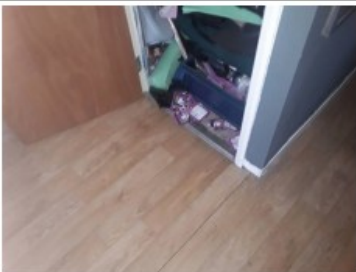
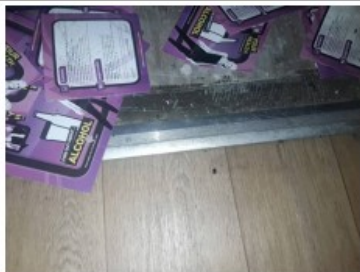
38	As NZ001196	Floor tile (with adhesive) with old adhesive on rear to the threshold only	Cupboard 2/021	Very Low Risk – 12 monthly
Photo 1: Wide Angle			Photo 2: Close-up

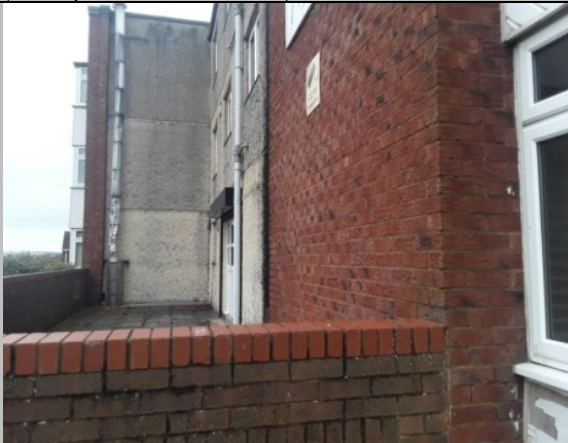
39	NZ001193	Wall jointing compound	External E/001	No Risk

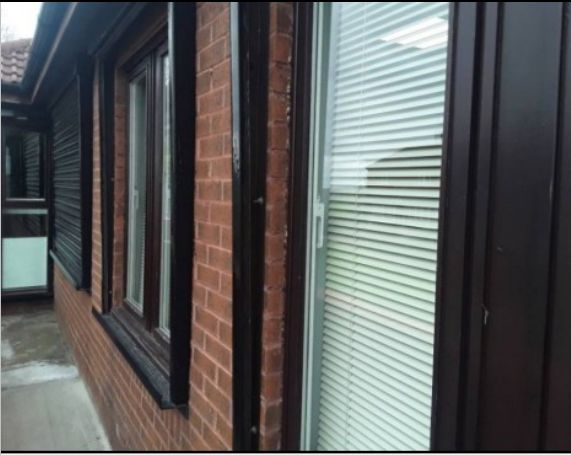
40	NZ001194	Window putty seal to frame wall door and windows. Timber frame to nursery extension	External E/001	No Risk

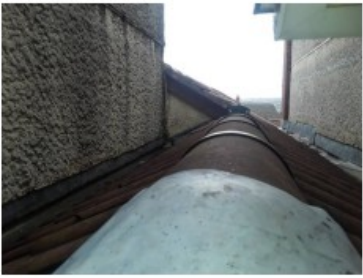
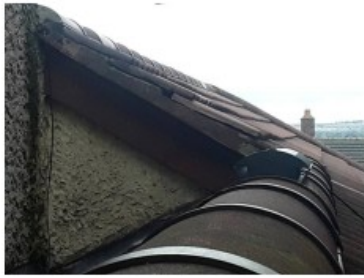
41	Presumed	Undercloak to small section of roof above reception corridor	External E/001	Very Low Risk – 12 monthly
Photo 1: Wide Angle			Photo 2: Close-up
