ASBESTOS SURVEY REPORT FOR WINCHESTER HOUSE, SUNDERLAND,
TYNE AND WEAR, SR5 4LW

Asbestos Register for

Winchester House, Sunderland, SR5 4LW

Date: 21 May 2025

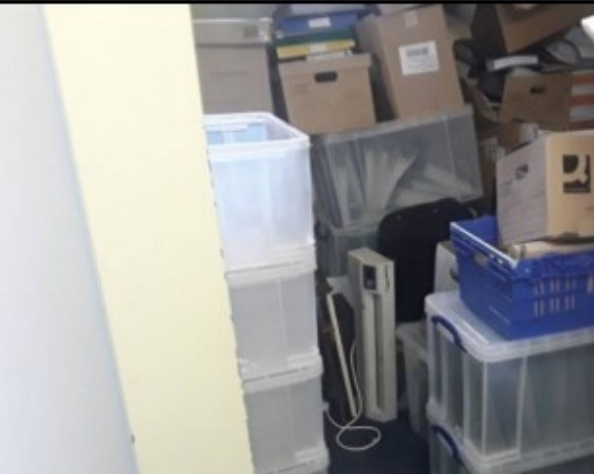
4	NZ001185	Floor tile with adhesive (under carpet)	Store Room G/021	No Risk

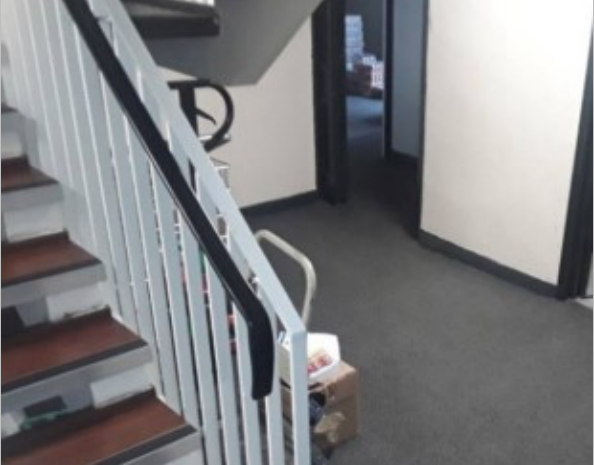
5	NZ001186	Floor covering under carpet running up skirting	Stairwell/Staircase G/026	No Risk

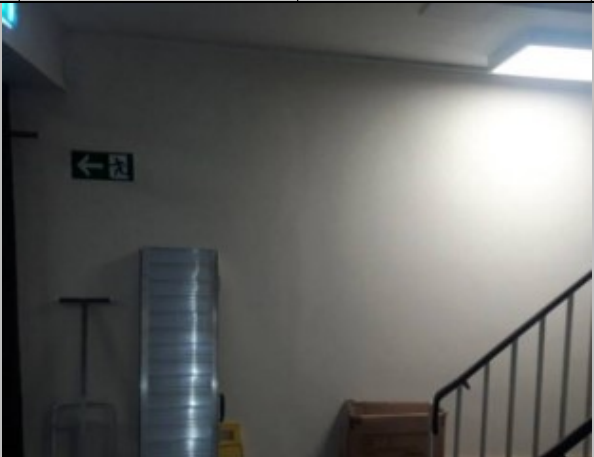
6	NZ001187	Wall coating	Stairwell/Staircase G/026	No Risk

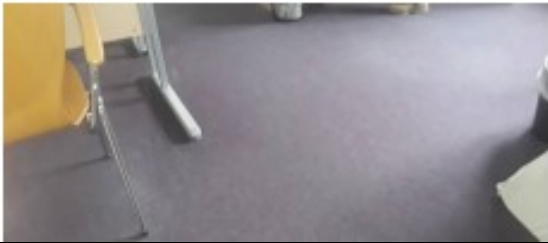
19	As NZ001191	Floor adhesive under carpet and modern screed	Office 1/019	Very Low Risk – 12 monthly
Photo 1: Wide Angle				Photo 2: Close

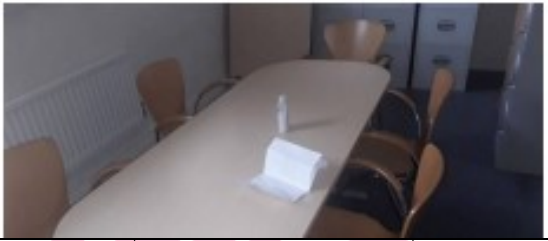
20	As NZ001191	Floor adhesive under carpet and modern screed	Office 1/020	Very Low Risk – 12 monthly
Photo 1: Wide Angle				Photo 2: Close

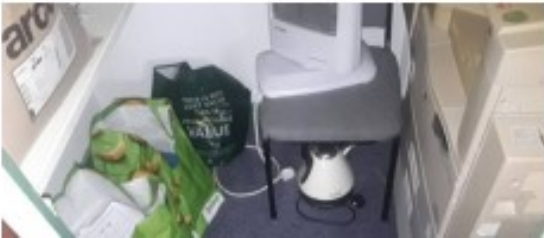
22	As NZ001191	Floor adhesive under carpet and modern screed	Cupboard 2 Office 1/022	Very Low Risk – 12 monthly
Photo 1: Wide Angle				Photo 2: Close

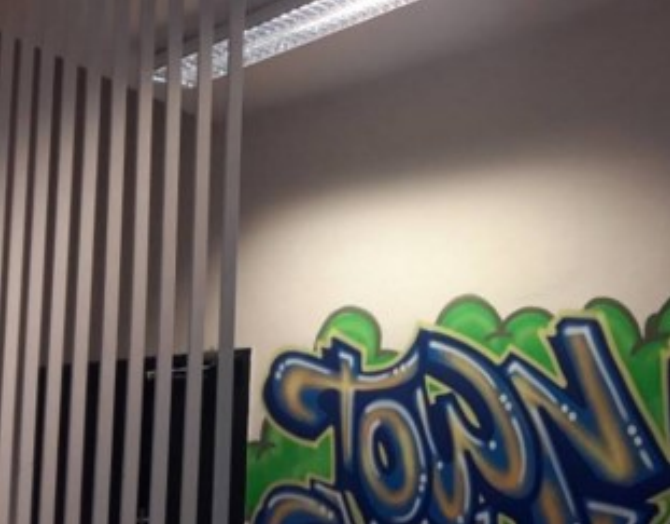
23	As NZ001190	Wall coating	Landing 2/001	No Risk

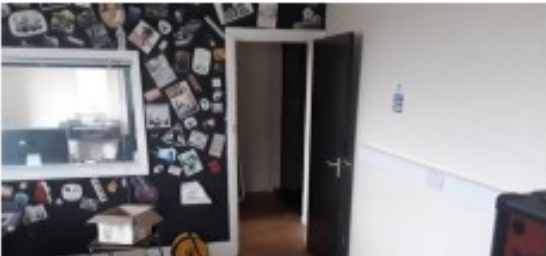
24	NZ001195	Floor adhesive under modern flooring	Corridor 2/002	Very Low Risk – 12 monthly
Photo 1: Wide Angle				Photo 2: Clos

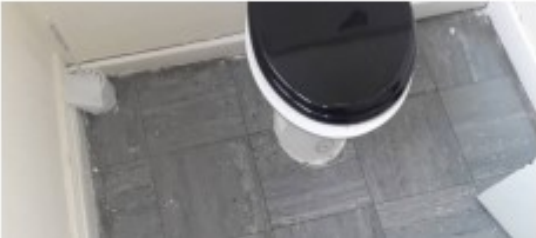
29	As NZ001196	Floor tile (with adhesive) with old adhesive on rear	Toilets Female 2/011	Very Low Risk – 12 monthly
Photo 1: Wide Angle				Photo 2: Close

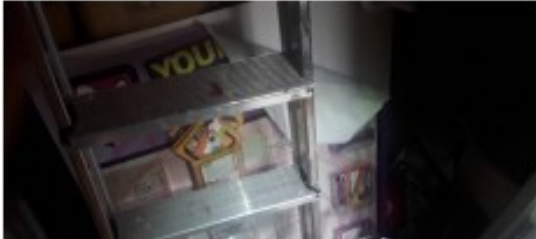
37	As NZ001196	Floor tile (with adhesive) with old adhesive on rear	Cupboard 2/020	Very Low Risk – 12 monthly
Photo 1: Wide Angle			Photo 2: Close-

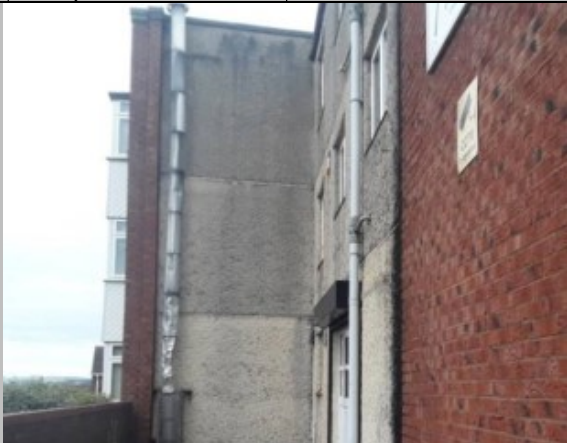
39	NZ001193	Wall jointing compound	External E/001	No Risk

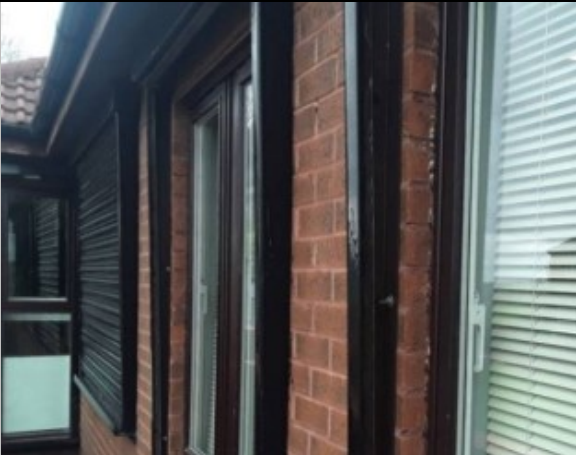
40	NZ001194	Window putty seal to frame wall door and windows. Timber frame to nursery extension	External E/001	No Risk

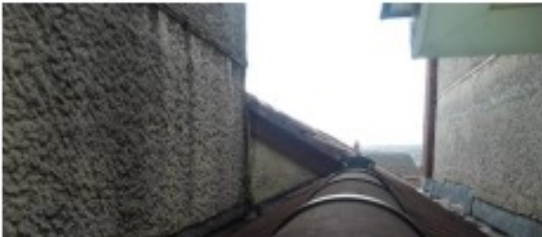
41	Presumed	Undercloak to small section of roof above reception corridor	External E/001	Very Low Risk – 12 monthly
Photo 1: Wide Angle				Photo 2: Close
