ASBESTOS SURVEY REPORT FOR PRUDHOE WEST ACADEMY, WEST ROAD, PRUDHOE, NORTHUMBERLAND, NE42 6HR

Asbestos Register for Prudhoe West Academy

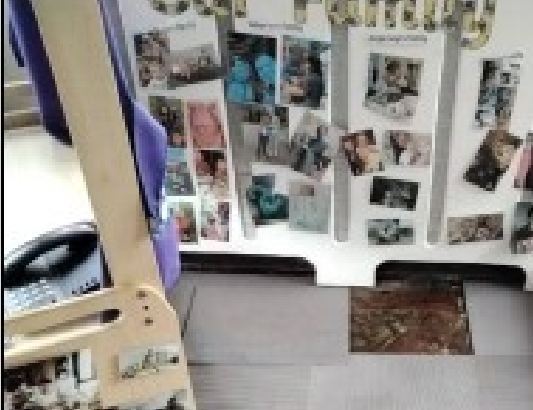
12	NG002175	Floor covering	Classroom G/036	No Risk
