ASBESTOS SURVEY REPORT FOR 12 – 14 BOROUGH ROAD,
SUNDERLAND, SR1 1EP

Asbestos Register for

12 – 14 Borough Road, SR1 1EP

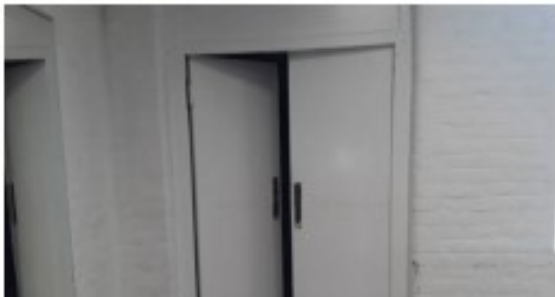
4	NZ001286	Door Protection Board	First Floor Room Dance Studio 1 (1/004)	Medium Risk – 3 monthly
Photo 1: Wide Angle			Photo 2: Close

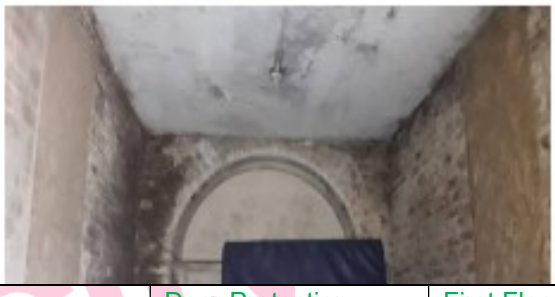
5	As NZ001285	Door Header Panel	First Floor Store room within Dance Studio 1 walkway between Buildings (1/005)	Very Low Risk – 12 monthly
Photo 1: Wide Angle			Photo 2: Close

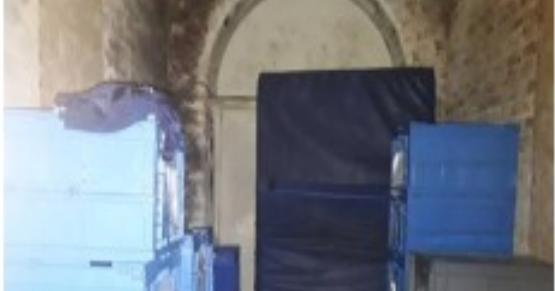
6	As NZ001286	Door Protection Board	First Floor Store room within Dance Studio 1 walkway between Buildings (1/005)	Medium Risk – 3 monthly
Photo 1: Wide Angle			Photo 2: Close

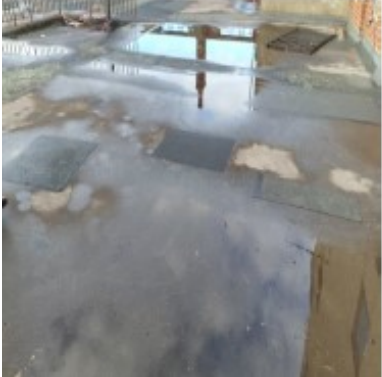
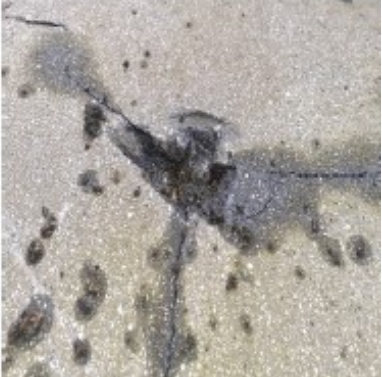
10	RT000685	Asphalt covering to concrete floor	External (E/01)	No Risk
