### **ASBESTOS SURVEY REPORT FOR PETER SMITH ANTIQUES, 12 – 14 BOROUGH ROAD**

## Asbestos Register for

**12 – 14 Borough Road, Sunderland**

**Date: 01 July 2025**

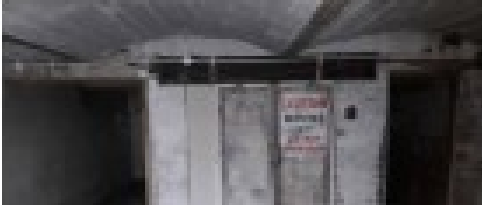
1	NZ001349	Wall (Insulating Board)	Large Room Z1/001	Low Risk – every 6 months
<b>Photo 1: Wide Angle</b>		<b>Photo 2: Close</b>

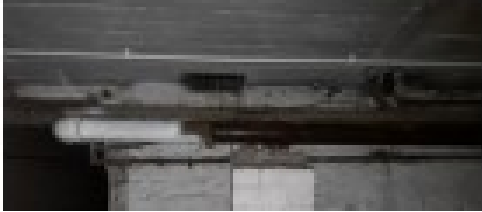
2	NZ001355	Debris/Residue To pipework and wall adjacent corridor (Thermal Insulation Lagging)	Large Room Z1/001	Low Risk – every 6 months
<b>Photo 1: Wide Angle</b>		<b>Photo 2: Close</b>

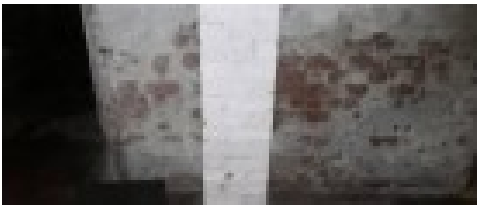
3	NZ001357	Debris/Residue To floor adjacent corridor (Thermal Insulation Lagging)	Large Room Z1/001	Removed Aug/Sept 24
<b>Photo 1: Wide Angle</b>		<b>Photo 2: Close</b>

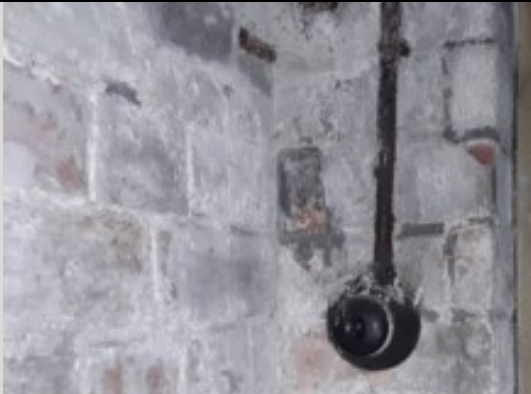
4	As NZ001333	Electrical Services Light switch (Composite Resinous/Reinforced Plastics)	Storage Z1/002	No Risk – N/A

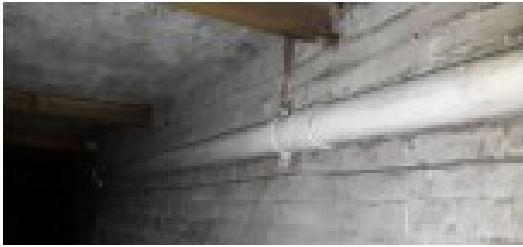
5	NZ001356	Debris/Residue To pipework and wall (Thermal Insulation Lagging)	Corridor Z1/003	Low Risk – every 6 months
<b>Photo 1: Wide Angle</b>		<b>Photo 2: Clo</b>

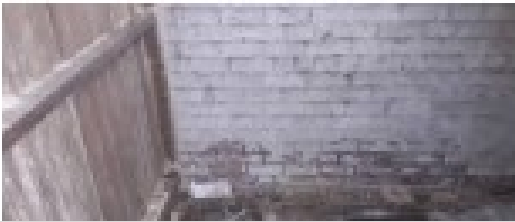
6	NZ001350	Debris/Residue To floor adjacent stairwell (Thermal Insulation Lagging)	Storage Area Z1/004	Removed Aug/Sept 24
<b>Photo 1: Wide Angle</b>		<b>Photo 2: Clos</b>

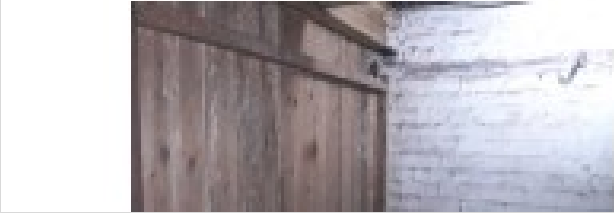
7	NZ001351	Debris/Residue To Timber wall adjacent stairwell (Thermal Insulation Lagging)	Storage Area Z1/004	Removed Aug/Sept 24
Photo 1: Wide Angle		Photo 2: Close Up

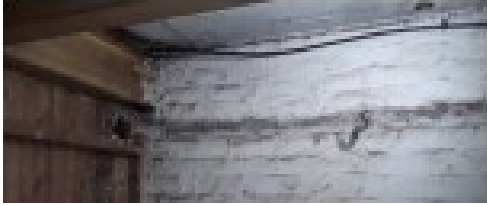
8	NZ001352	Debris/Residue To brick wall and pipework hangers adjacent stairwell (Thermal Insulation Lagging)	Storage Area Z1/004	Low Risk – every 6 months
Photo 1: Wide Angle		Photo 2: Close Up

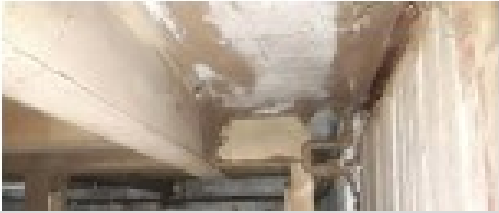
9	NZ001353	Debris/Residue To pipework adjacent Timber wall (Thermal Insulation Lagging)	Storage Area Z1/004	Removed Aug/Sept 24
Photo 1: Wide Angle		Photo 2: Close Up

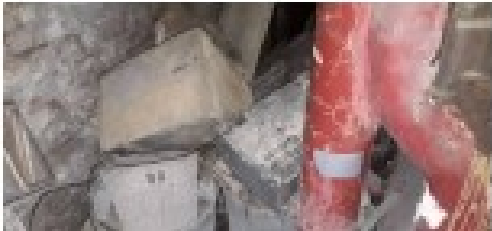
14	NZ001358	Debris/Residue To floor (Thermal Insulation Lagging)	Boiler Room (Restricted access due to contamination issues and storage) Z1/006	Low Risk – every 6 months
<b>Photo 1: Wide Angle</b>

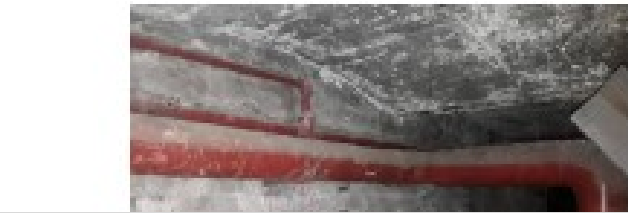
16	NZ001360	Pipework - Insulation To pipework L/H side of room (Thermal Insulation Lagging)	Boiler Room (Restricted access due to contamination issues and storage) Z1/006	Removed Aug/Sept 24
<b>Photo 1: Wide Angle</b>		<b>Photo 2: Clos</b>

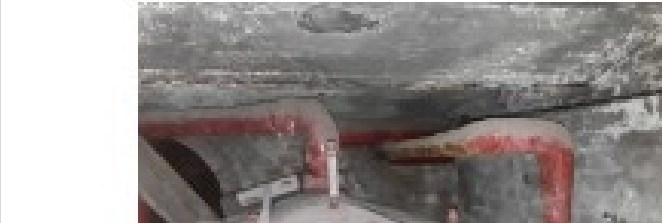
17	NZ001361	Pipework - Insulation To R/H side pipework (Thermal Insulation Lagging)	Boiler Room (Restricted access due to contamination issues and storage) Z1/006	Removed Aug/Sept 24
<b>Photo 1: Wide Angle</b>		<b>Photo 2: Clos</b>

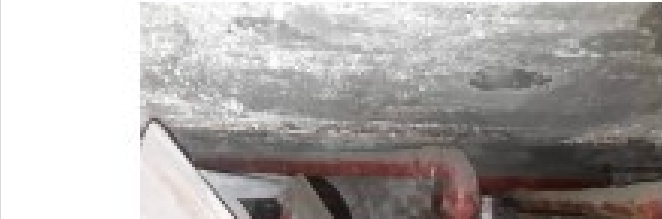
18	NZ001362	Pipework - Insulation To central pipework from boiler (Thermal Insulation Lagging)	Boiler Room (Restricted access due to contamination issues and storage) Z1/006	Removed Aug/Sept 24
<b>Photo 1: Wide Angle</b>		<b>Photo 2: Clos</b>

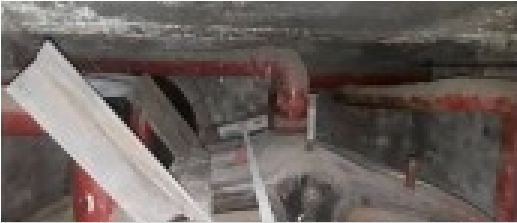
19	NZ001363	Boiler - Lining/Casing Covering full boiler (Thermal Insulation Lagging)	Boiler Room (Restricted access due to contamination issues and storage) Z1/006	Removed Aug/Sept 24
<b>Photo 1: Wide Angle</b>		<b>Photo 2: Clos</b>

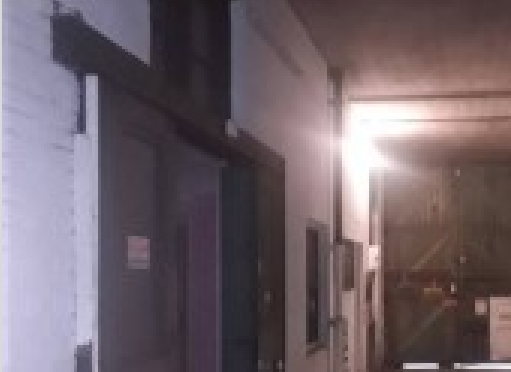
20	NZ001320	Window Putty/seal to glass windows and doors	Entrance Hall/Foyer/Lobby G/001	No Risk – N/A

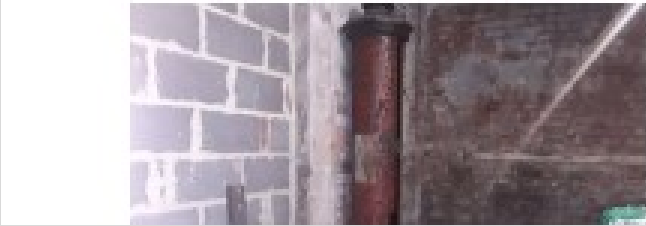
22	Presumed	Pipework Gasket(s) (Too deeply recessed to sample)	Room G/009	Removed Aug/Sept 24
<b>Photo 1: Wide Angle</b>		<b>Photo 2: Clos</b>

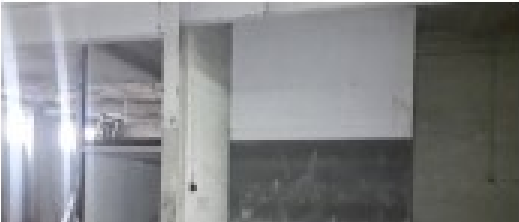
23	NZ001321	Wall To lift shaft and lift lobby also above lift lobby ceiling (Insulating Board)	Room – Large G/010	Low Risk – every 6 months
<b>Photo 1: Wide Angle</b>		<b>Photo 2: Clos</b>

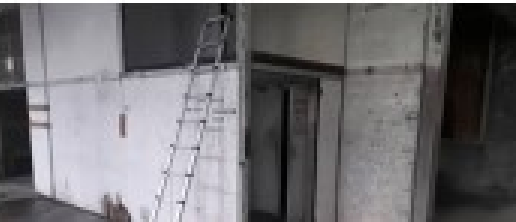
24	NZ001322	Debris/Residue To floor adjacent lift shaft and lift lobby from damaged panels (Insulating Board)	Room – Large G/010	Removed Aug/Sept 24
<b>Photo 1: Wide Angle</b>		<b>Photo 2: Clos</b>

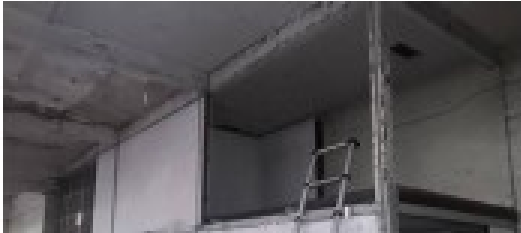
25	NZ001323	Debris/Residue To top of lift lobby (Insulating Board)	Room – Large G/010	Low Risk – every 6 months
<b>Photo 1: Wide Angle</b>		<b>Photo 2: Close</b>

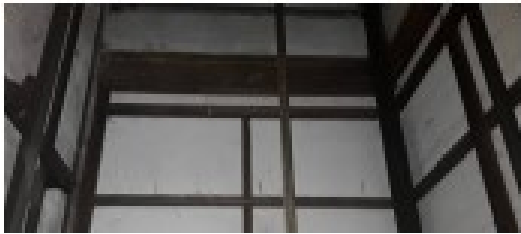
26	As NZ001321	Wall To lift shaft and lift lobby walls (Insulating Board)	Lift (Restricted access due to contamination issues) G/011	Low Risk – every 6 months
<b>Photo 1: Wide Angle</b>		<b>Photo 2: Close</b>

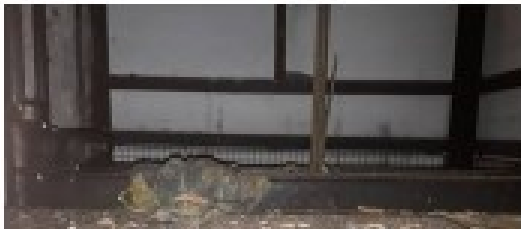
27	As NZ001322	Debris/Residue To floor, top of lift and around frame (Insulating Board)	Lift (Restricted access due to contamination issues) G/011	Low Risk – every 6 months
<b>Photo 1: Wide Angle</b>		<b>Photo 2: Close</b>

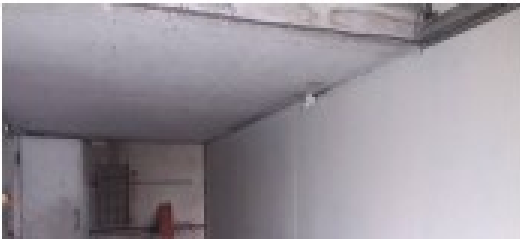
28	As NZ001321	Wall To lift shaft and lift lobby (Insulating Board)	Lift Lobby including staircase G/012	Low Risk – every 6 months
<b>Photo 1: Wide Angle</b>		<b>Photo 2: Close</b>

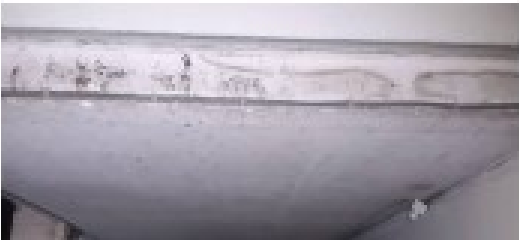
30	NZ001324	Ceiling To lift lobby (Insulating Board)	Lift Lobby including staircase G/012	Low Risk – every 6 months
<b>Photo 1: Wide Angle</b>		<b>Photo 2: Close</b>

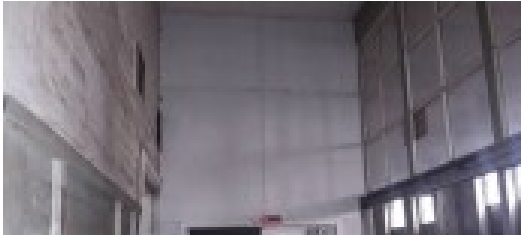
31	As NZ001321	Wall To lift lobby (Insulating Board)	Room G/013	Low Risk – every 6 months
<b>Photo 1: Wide Angle</b>		<b>Photo 2: Clos</b>

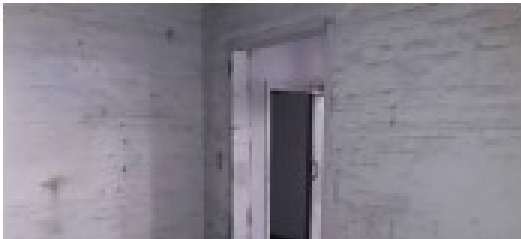
32	NZ001325	Door Beading to frame (Cement)	Plant Room G/014	Very Low Risk – every 12 months
<b>Photo 1: Wide Angle</b>		<b>Photo 2: Clos</b>

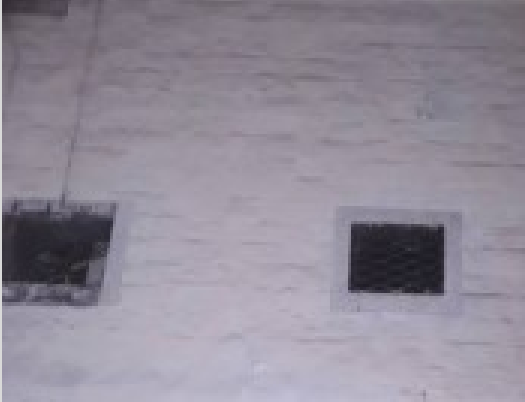
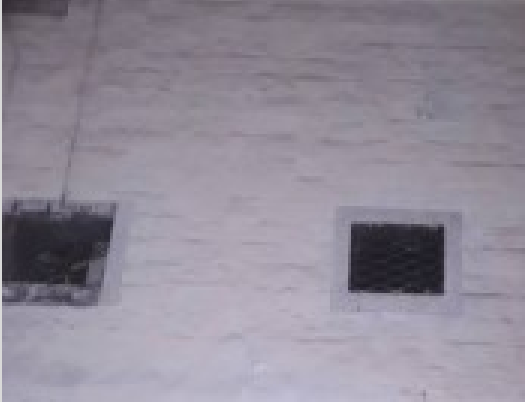
33	NZ001326	Wall - Vent Lining Panels to mesh (Cement)	Plant Room G/014	No Risk – N/A

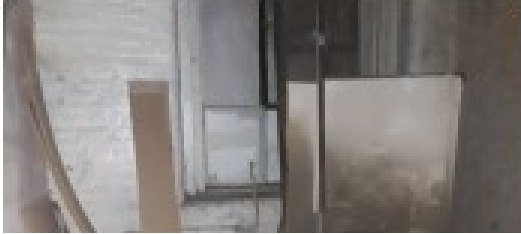
34	NZ001327	Debris/Residue To outer of Ductwork (Thermal Insulation Lagging)	Plant Room G/014	Low Risk – every 6 months
<b>Photo 1: Wide Angle</b>		<b>Photo 2: Clos</b>

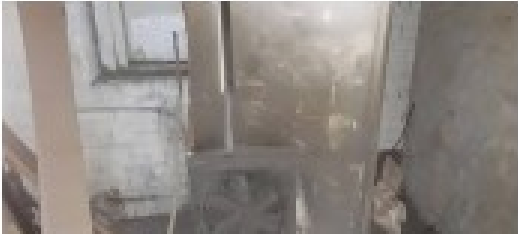
35	NZ001328	Debris/Residue To inner of Ductwork (Thermal Insulation Lagging)	Plant Room G/014	Low Risk – every 6 months
<b>Photo 1: Wide Angle</b>		<b>Photo 2: Clos</b>

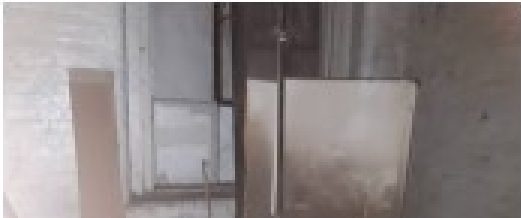
36	NZ001329	Debris/Residue To floor and window Sill around Ductwork (Cement)	Plant Room G/014	Low Risk – every 6 months
<b>Photo 1: Wide Angle</b>		<b>Photo 2: Clos</b>

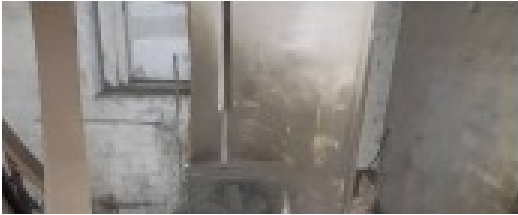
37	NZ001330	Debris To floor and window Sill next to Ductwork (Cement)	Plant Room G/014	Very Low Risk – every 12 months
<b>Photo 1: Wide Angle</b>		<b>Photo 2: Close</b>

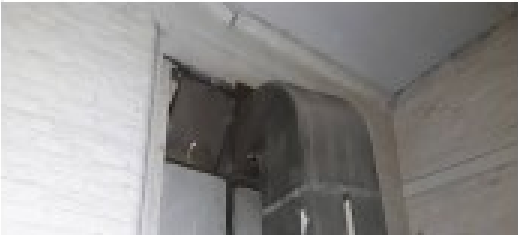
38	Presumed	Ductwork - Joint(s)	Plant Room G/014	Very Low Risk – every 12 months
<b>Photo 1: Wide Angle</b>		<b>Photo 2: Close</b>

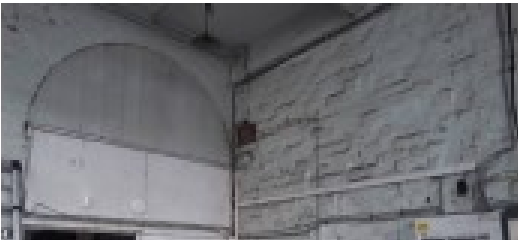
39	NZ001332	Door - Header Panel (Insulating Board)	Room – Large G/015	Low Risk – every 6 months
<b>Photo 1: Wide Angle</b>		<b>Photo 2: Close</b>

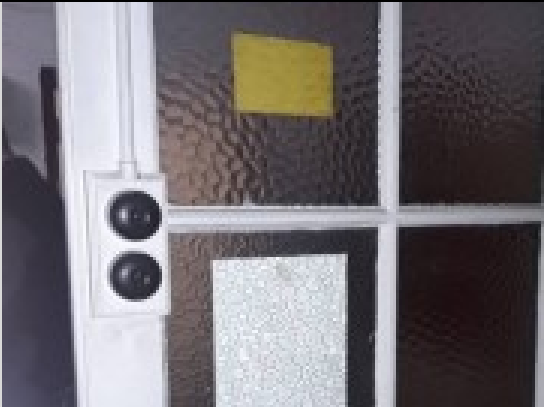
40	NZ001333	Electrical Services Light switch (Composite Resinous/Reinforced Plastics)	Office G/016	No Risk – N/A

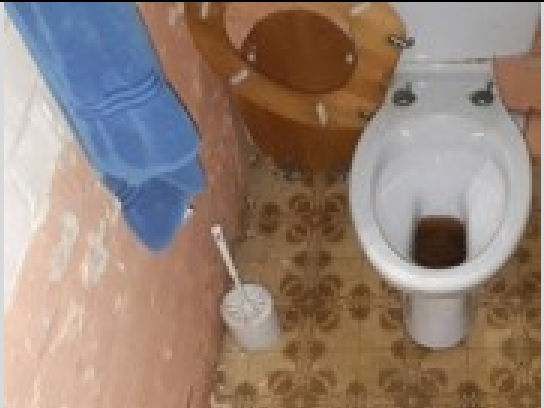
41	NZ001334	Floor – Covering (Paper/Card Products)	Toilets G/020	No Risk – N/A

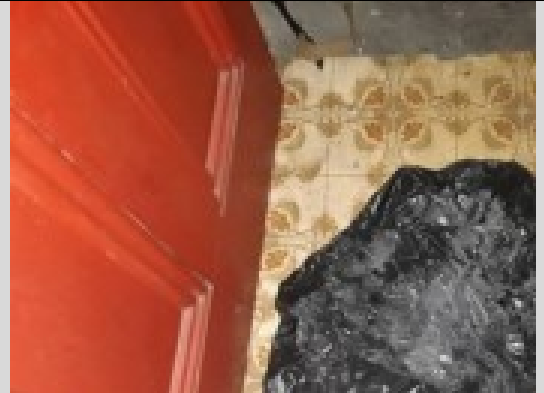
42	As NZ001334	Floor – Covering (Paper/Card Products)	Toilets Entrance G/021	No Risk – N/A

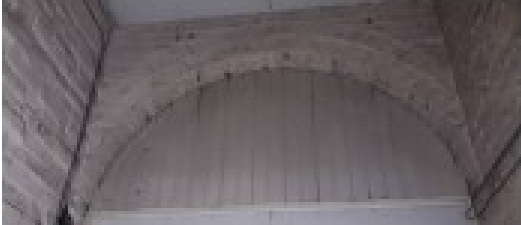
43	As NZ001332	Door - Header Panel (Insulating Board)	Staircase/Stairwell G/022	Low Risk – every 6 months
<b>Photo 1: Wide Angle</b>		<b>Photo 2: Close</b>

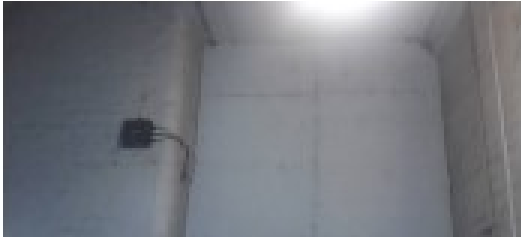
44	NZ001335	Wall (Insulating Board)	Landing Including staircase 1/001	Low Risk – every 6 months
<b>Photo 1: Wide Angle</b>		<b>Photo 2: Close</b>

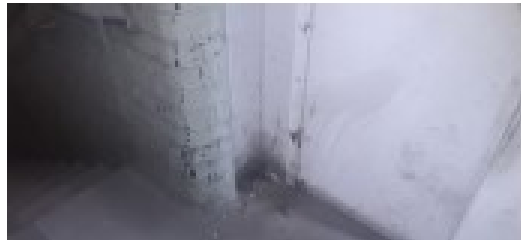
45	NZ001336	Debris/Residue To floor adjacent lift (Insulating Board)	Landing Including staircase 1/001	Removed Aug/Sept 24
<b>Photo 1: Wide Angle</b>		<b>Photo 2: Close</b>

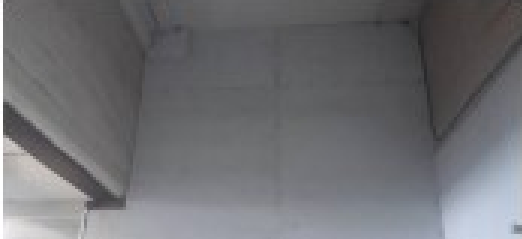
49	As NZ001335	Wall (Insulating Board)	Lift Lobby 1/002	Low Risk – every 6 months
<b>Photo 1: Wide Angle</b>		<b>Photo 2: Close</b>

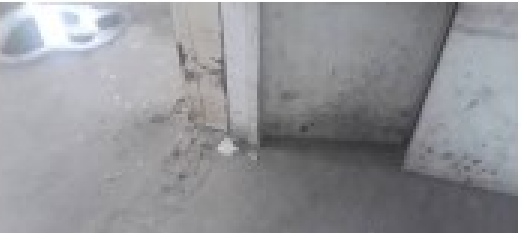
50	As NZ001336	Debris/Residue To floor next to door (Insulating Board)	Lift Lobby 1/002	Removed Aug/Sept 24
<b>Photo 1: Wide Angle</b>		<b>Photo 2: Close</b>

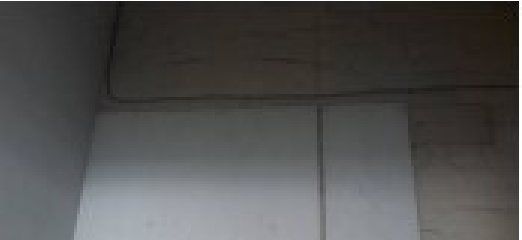
51	As NZ001338	Door - Header Panel to lift (Insulating Board)	Lift Lobby 1/002	Low Risk – every 6 months
<b>Photo 1: Wide Angle</b>		<b>Photo 2: Close</b>

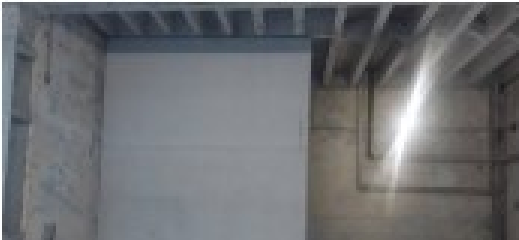
52	As NZ001335	Wall To lift shaft and door (Insulating Board)	Room – Large 1/003	Low Risk – every 6 months
<b>Photo 1: Wide Angle</b>		<b>Photo 2: Close</b>

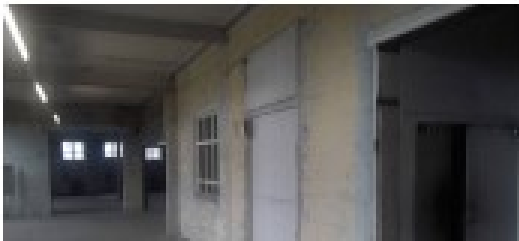
54	As NZ001337	Door - Frame Infill Panel (Insulating Board)	Room – Large 1/003	Low Risk – every 6 months
<b>Photo 1: Wide Angle</b>		<b>Photo 2: Close</b>

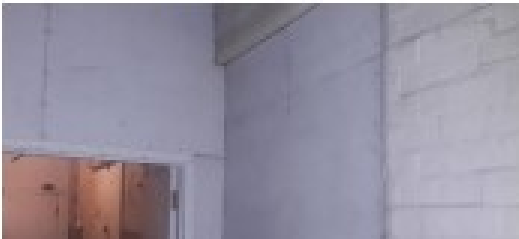
57	As NZ001339	Window - Infill Panel (Insulating Board)	Room – Large 1/003	Low Risk – every 6 months
<b>Photo 1: Wide Angle</b>		<b>Photo 2: Close</b>

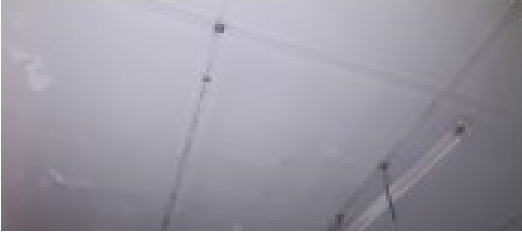
58	NZ001341	Ceiling (Cement)	Store Room 1/004	Very Low Risk – every 12 months
<b>Photo 1: Wide Angle</b>		<b>Photo 2: Close Up</b>

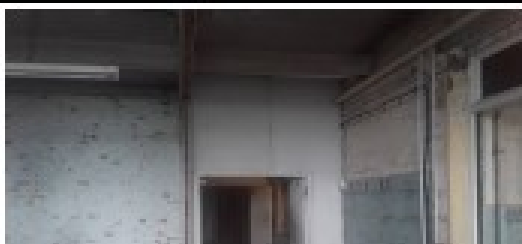
59	As NZ001335	Wall To doors to stairwell and side panels (Insulating Board)	Room – Large 1/005	Low Risk – every 6 months
<b>Photo 1: Wide Angle</b>		<b>Photo 2: Close Up</b>

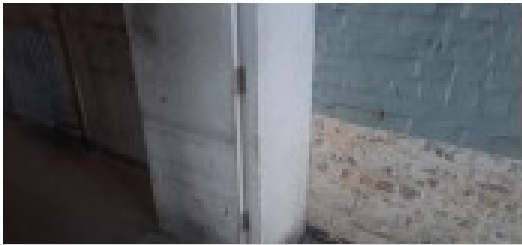
60	As NZ001336	Debris/Residue To floor adjacent door (Insulating Board)	Room – Large 1/005	Removed Aug/Sept 24
<b>Photo 1: Wide Angle</b>		<b>Photo 2: Close Up</b>

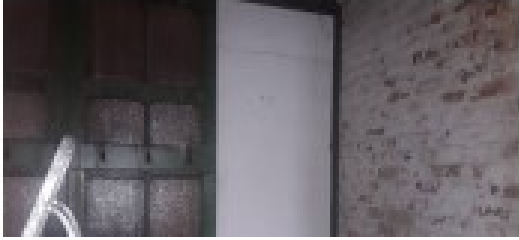
61	As NZ001337	Door - Frame Infill Panel (Insulating Board)	Room – Large 1/005	Low Risk – every 6 months
<b>Photo 1: Wide Angle</b>		<b>Photo 2: Close</b>

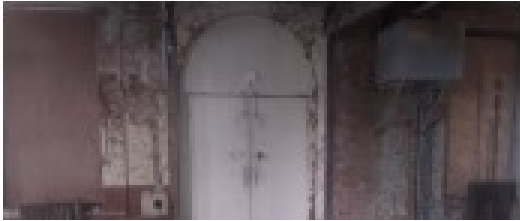
62	NZ001342	Door - Protection Board To doors on bridge to dance studio (Insulating Board)	Room – Large 1/005	Very Low Risk – 12 monthly
<b>Photo 1: Wide Angle</b>		<b>Photo 2: Close</b>

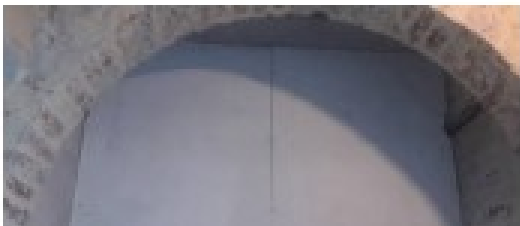
63	As NZ001335	Wall To doors (Insulating Board)	Hallway/passageway Including staircase to roof 1/006	Low Risk – every 6 months
<b>Photo 1: Wide Angle</b>		<b>Photo 2: Close</b>

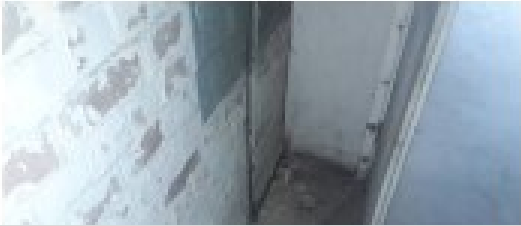
64	As NZ001336	Debris/Residue To floor next to door (Insulating Board)	Hallway/passageway Including staircase to roof 1/006	Removed Aug/Sept 24
<b>Photo 1: Wide Angle</b>		<b>Photo 2: Close</b>

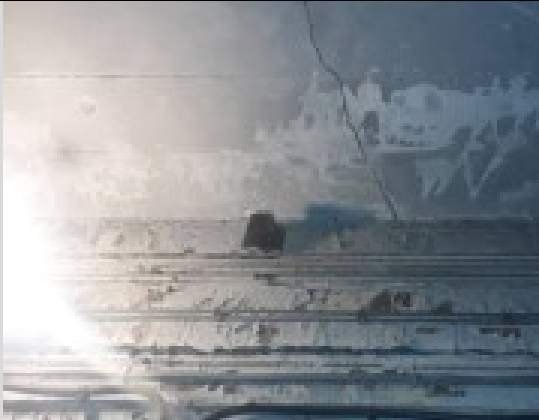
65	As NZ001333	Electrical Services Socket (Composite Resinous/Reinforced Plastics)	Hallway/passageway Including staircase to roof 1/006	No Risk – N/A

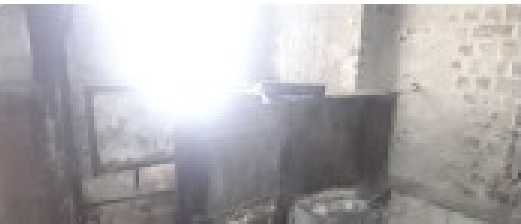
66	NZ001343	Machinery/Mechanical Services Insulation within framework (Insulating Board)	Plant Room 1/008	Low Risk – every 6 months
<b>Photo 1: Wide Angle</b>		<b>Photo 2: Close</b>

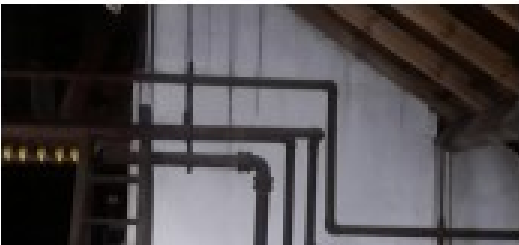
80	As NZ001320	Window Putty/seal To glass windows and doors	Workshop 2/005	No Risk – N/A
NO PHOTOGRAPHIC EVIDENCE				
81	As NZ001335	Wall To lift shaft (Insulating Board)	Room - Large Attic 3/001	Low Risk – every 6 months
<b>Photo 1:</b> Wide Angle		<b>Photo 2:</b> Close

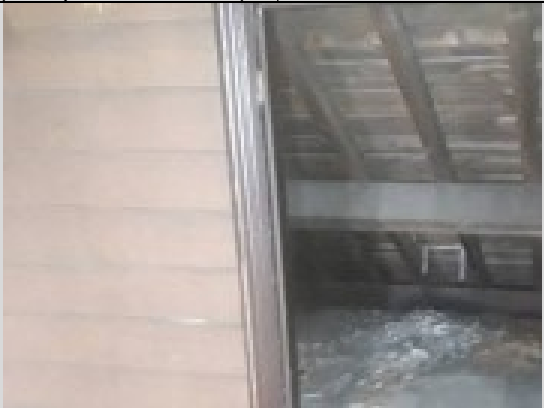
89	As NZ001347	Roof – Lining (Composite Bitumen)	Cupboard - Store Attic 3/006	No Risk – N/A

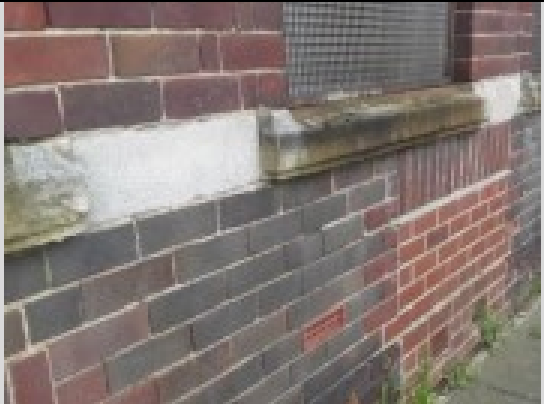
90	NZ001364	Damp Proof Course (Composite Bitumen)	External E/001	No Risk – N/A
