### ASBESTOS SURVEY REPORT FOR PETER SMITH ANTIQUES, 12 – 14 BOROUGH ROAD

## Asbestos Register for

**12 – 14 Borough Road, Sunderland**

**Date: 17 February 2026**

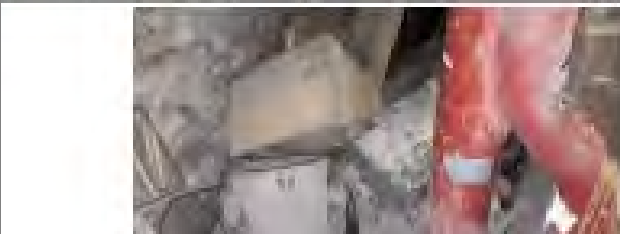
14	NZ001358	Debris/Residue To floor (Thermal Insulation Lagging)	Boiler Room (Restricted access due to contamination issues and storage) Z1/006	Removed – inspection survey J140747 Dec 2025
<b>Photo 1: Wide Angle</b>			<b>Photo 2: Close</b>

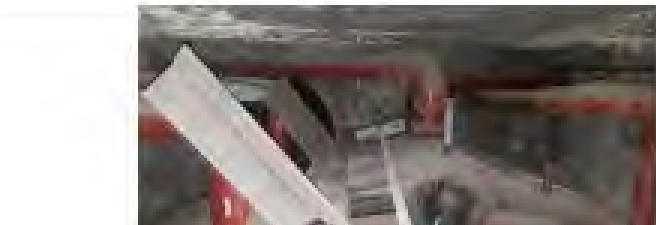
19	NZ001363	Boiler - Lining/Casing Covering full boiler (Thermal Insulation Lagging)	Boiler Room (Restricted access due to contamination issues and storage) Z1/006	Removed Aug/Sept 24
		<b>Photo 1: Wide Angle</b>		<b>Photo 2: Clos</b>

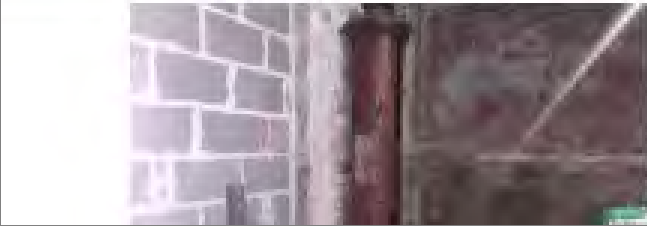
22	Presumed	Pipework Gasket(s) (Too deeply recessed to sample)	Room G/009	Removed Aug/Sept 24
<b>Photo 1: Wide Angle</b>		<b>Photo 2: Clos</b>

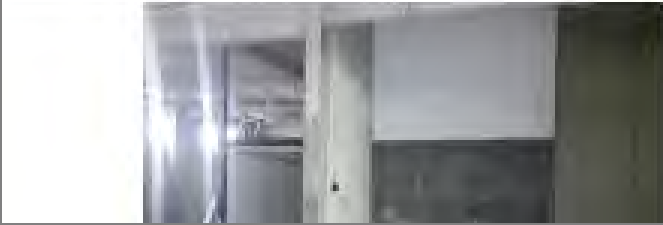
23	NZ001321	Wall To lift shaft and lift lobby also above lift lobby ceiling (Insulating Board)	Room – Large G/010	Removed – inspection survey J140747 Dec 2025
<b>Photo 1: Wide Angle</b>		<b>Photo 2: Clos</b>

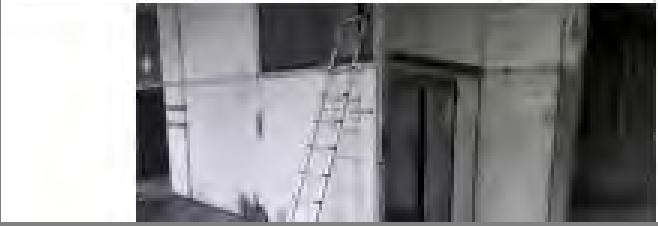
24	NZ001322	Debris/Residue To floor adjacent lift shaft and lift lobby from damaged panels (Insulating Board)	Room – Large G/010	Removed Aug/Sept 24
<b>Photo 1: Wide Angle</b>		<b>Photo 2: Clos</b>

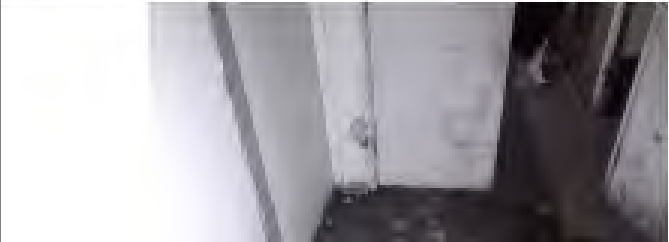
29	As NZ001322	Debris/Residue To floor (Insulating Board)	Lift Lobby including staircase G/012	Removed Aug/Sept 24
<b>Photo 1: Wide Angle</b>		<b>Photo 2: Close</b>

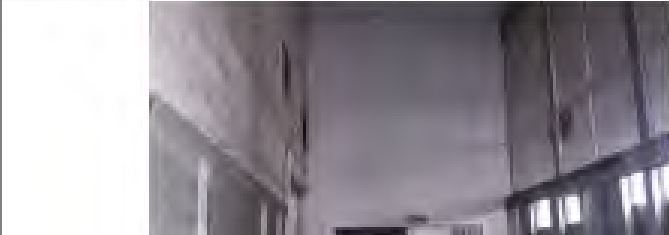
31	As NZ001321	Wall To lift lobby (Insulating Board)	Room G/013	Removed – inspection survey J140747 Dec 2025
<b>Photo 1: Wide Angle</b>		<b>Photo 2: Clos</b>

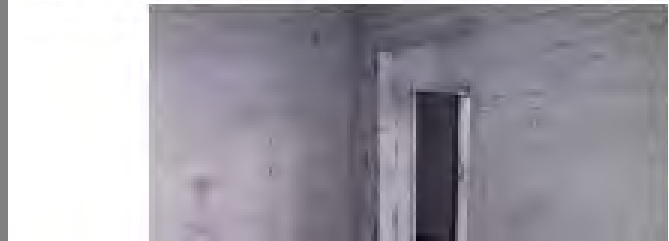
32	NZ001325	Door Beading to frame (Cement)	Plant Room G/014	Removed – inspection survey J140747 Dec 2025
<b>Photo 1: Wide Angle</b>		<b>Photo 2: Clos</b>

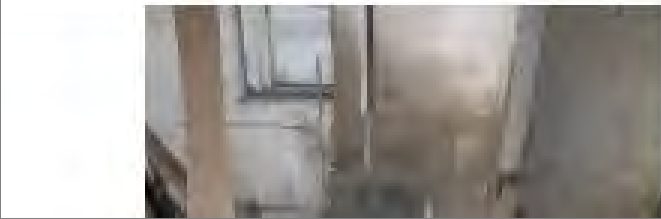
37	NZ001330	Debris To floor and window Sill next to Ductwork (Cement)	Plant Room G/014	Removed – inspection survey J140747 Dec 2025
<b>Photo 1: Wide Angle</b>		<b>Photo 2: Close</b>

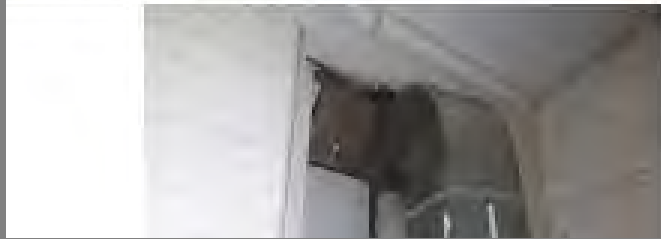
38	Presumed	Ductwork - Joint(s)	Plant Room G/014	Removed – inspection survey J140747 Dec 2025
<b>Photo 1: Wide Angle</b>		<b>Photo 2: Close</b>

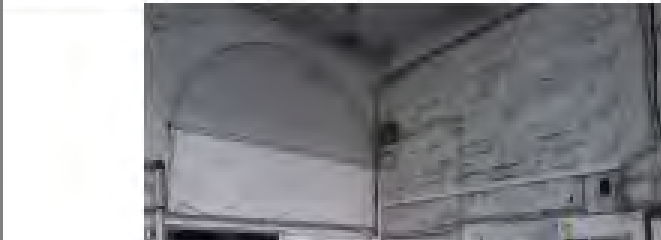
39	NZ001332	Door - Header Panel (Insulating Board)	Room – Large G/015	Removed – inspection survey J140747 Dec 2025
<b>Photo 1: Wide Angle</b>		<b>Photo 2: Close</b>

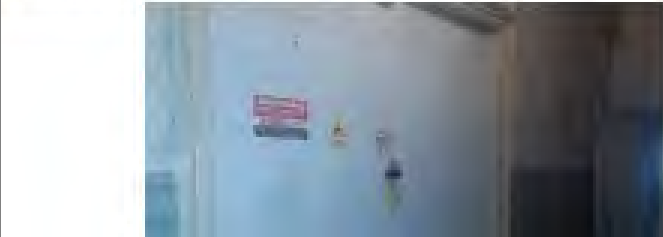
46	NZ001337	Door - Frame Infill Pane (Insulating Board)	Landing Including staircase 1/001	Removed – inspection survey J140747 Dec 2025
<b>Photo 1: Wide Angle</b>		<b>Photo 2: Close</b>

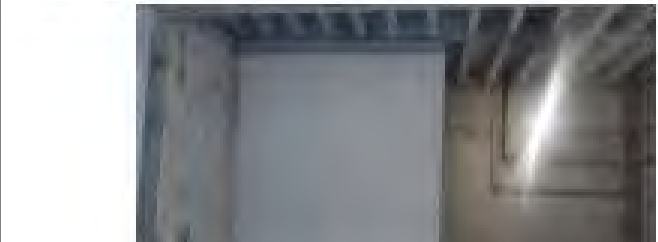
52	As NZ001335	Wall To lift shaft and door (Insulating Board)	Room – Large 1/003	Removed – inspection survey J140747 Dec 2025
<b>Photo 1: Wide Angle</b>		<b>Photo 2: Close</b>

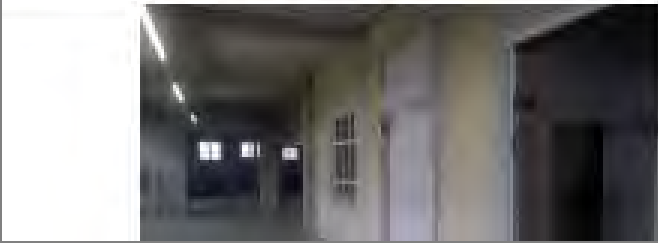
54	As NZ001337	Door - Frame Infill Panel (Insulating Board)	Room – Large 1/003	Removed – inspection survey J140747 Dec 2025
<b>Photo 1: Wide Angle</b>		<b>Photo 2: Close</b>

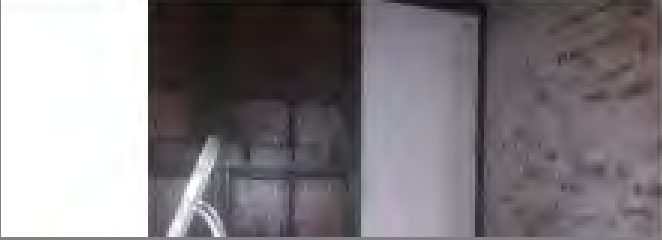
61	As NZ001337	Door - Frame Infill Panel (Insulating Board)	Room – Large 1/005	Removed – inspection survey J140747 Dec 2025
<b>Photo 1: Wide Angle</b>		<b>Photo 2: Close</b>

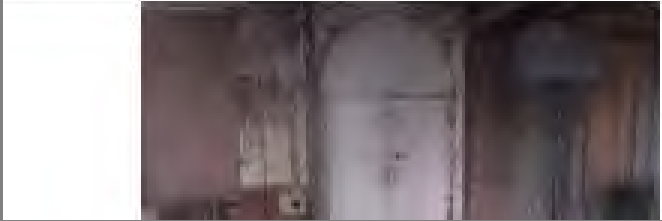
62	NZ001342	Door - Protection Board To doors on bridge to dance studio (Insulating Board)	Room – Large 1/005	Removed – inspection survey J140747 Dec 2025
<b>Photo 1: Wide Angle</b>		<b>Photo 2: Close</b>

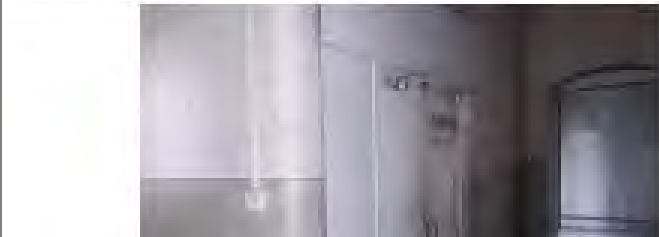
68	As NZ001335	Wall To lift shaft (Insulating Board)	Landing Including staircase 2/001	Removed – inspection survey J140747 Dec 2025
<b>Photo 1: Wide Angle</b>			<b>Photo 2: Close</b>

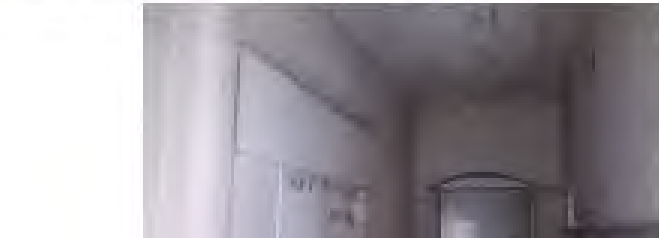
69	As NZ001338	Door - Header Panel (Insulating Board)	Landing Including staircase 2/001	Removed – inspection survey J140747 Dec 2025
<b>Photo 1: Wide Angle</b>			<b>Photo 2: Close</b>

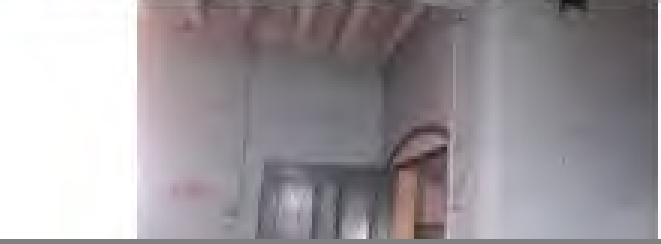
72	As NZ001338	Door - Header Panel (Insulating Board)	Room 2/002	Removed – inspection survey J140747 Dec 2025
<b>Photo 1: Wide Angle</b>			<b>Photo 2: Close</b>

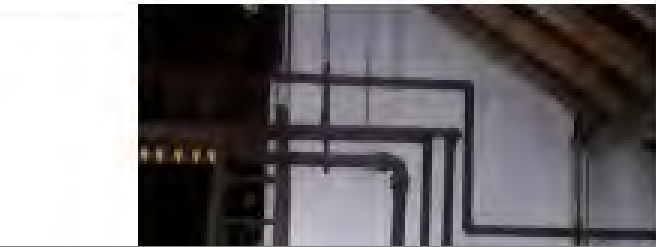
80	As NZ001320	Window Putty/seal To glass windows and doors	Workshop 2/005	No Risk – N/A
<b>NO PHOTOGRAPHIC EVIDENCE</b>				
81	As NZ001335	Wall To lift shaft (Insulating Board)	Room - Large Attic 3/001	Removed – inspection survey J140747 Dec 2025
<b>Photo 1: Wide Angle</b>			<b>Photo 2: Close</b>

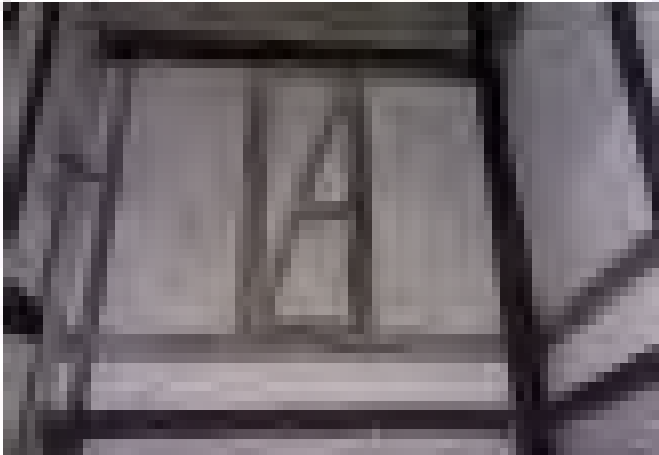
155	As PK002301	Board wall panels	Lift shaft /010	Removed – inspection survey J140747 Dec 2025
