### ASBESTOS SURVEY REPORT FOR CARETAKERS BUNGALOW, KEPIER SCHOOL, HOUGHTON

## **Asbestos Register for CARETAKERS BUNGALOW, KEPIER**

**UPRN: - AR/11/1201**

**Date: 23 April 2025**

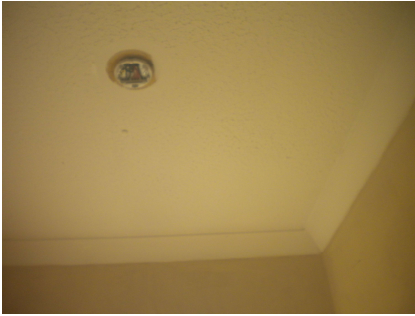
### **Item 1 Ref: BS/01**

The textured coating to the ceiling in the entrance hall does not contain asbestos.

Similar textured coating is also located on the ceiling in the hall, WC and hall cupboard 2

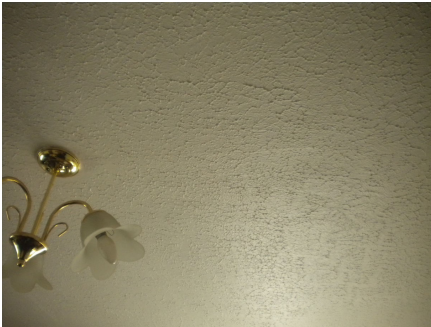
### **Item 3 - Ref: BS/02**

The textured coating to the ceiling in the living room does not contain asbestos.

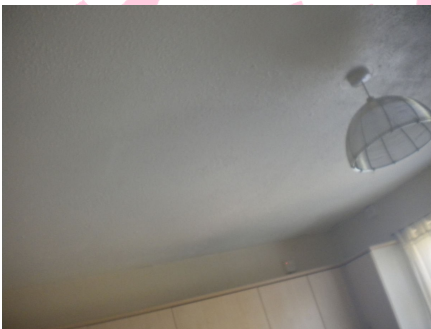
### **Item 4 - Ref: BS/03**

The textured coating to the ceiling in the kitchen does not contain asbestos.

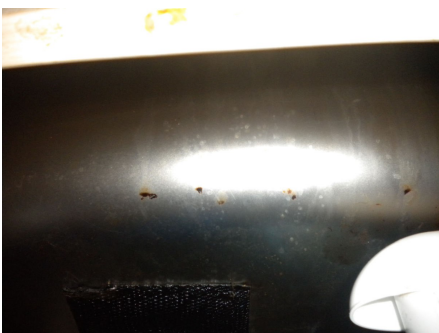
### **Item 5 - Ref: BS/04**

The sink pad to the sink in the kitchen does not contain asbestos.

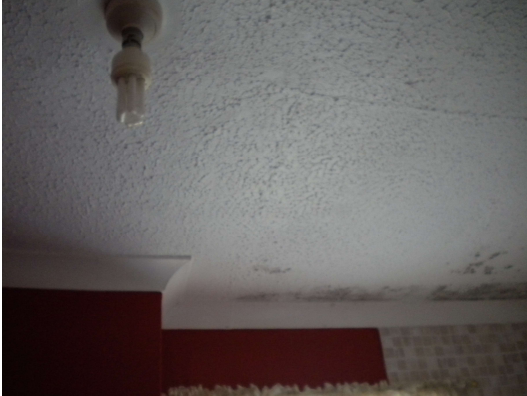
**Item 7 - Ref: BS/05**

The textured coating to the ceiling in the bathroom does not contain asbestos.

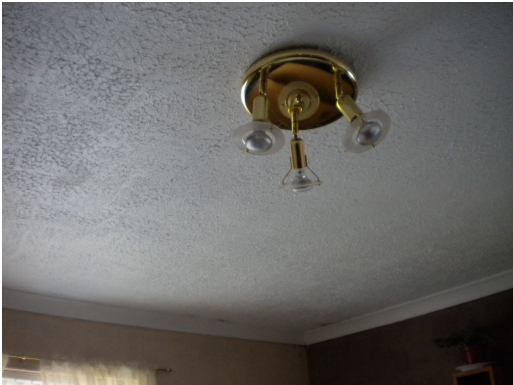
**Item 9 - Ref: BS/06**

The textured coating to the ceiling in bedroom 1 does not contain asbestos.

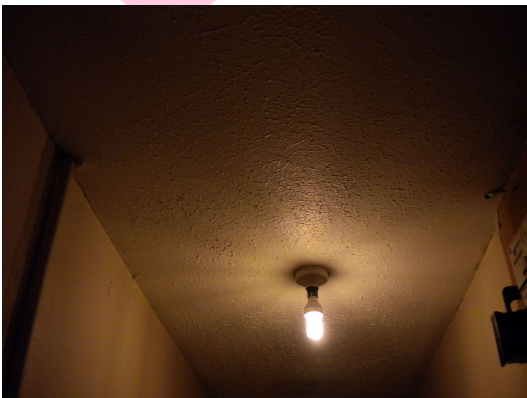
**Item 10 - Ref: BS/07**

The textured coating to the ceiling in the boiler cupboard does not contain asbestos.

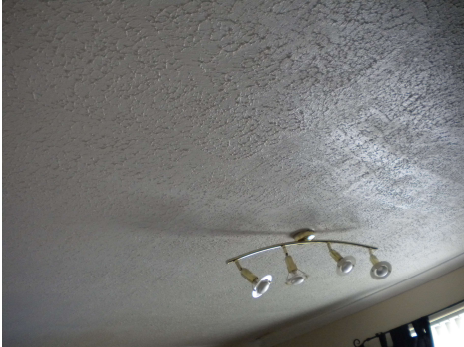
### **Item 11 - Ref: BS/08**

The textured coating to the ceiling in bedroom 2 does not contain asbestos.

Similar textured coating is located on the ceiling of bedroom 3.

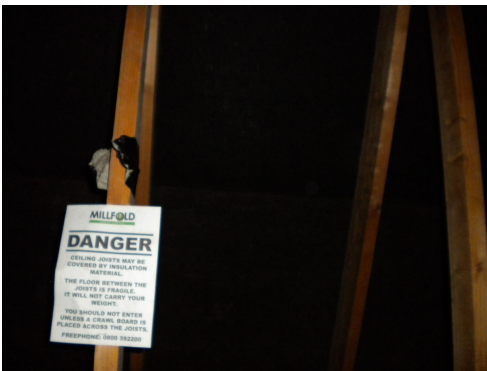
### **Item 12 - Ref: BS/09**

The roof felt to the loft does not contain asbestos.

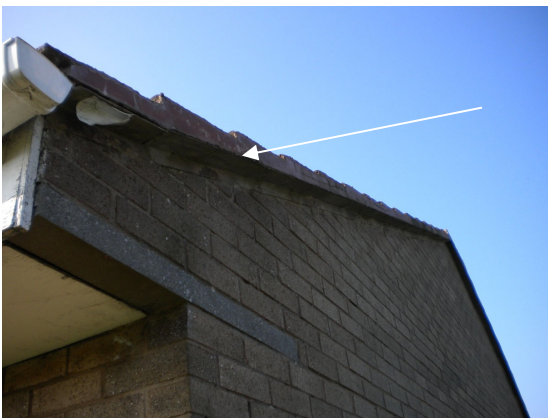
### **Item 13 - Ref: BS/10**

The cement verge board to the external of the property contains asbestos. Any change in its appearance should be noted and passed to Property Services.
