### ASBESTOS SURVEY REPORT FOR CARETAKERS BUNGALOW, KEPIER SCHOOL, HOUGHTON

## **Asbestos Register for CARETAKERS BUNGALOW, KEPIER**

**UPRN: - AR/11/1201**

## **Plan of Building and Samples Location – Caretakers House**

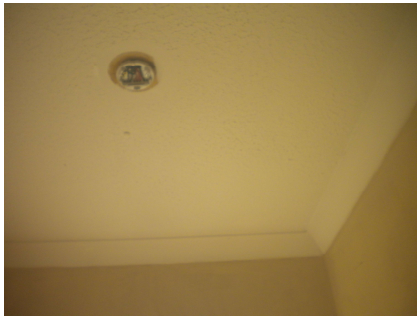
### **Item 1 Ref: BS/01**

The textured coating to the ceiling in the entrance hall does not contain asbestos.

Similar textured coating is also located on the ceiling in the hall, WC and hall cupboard 2

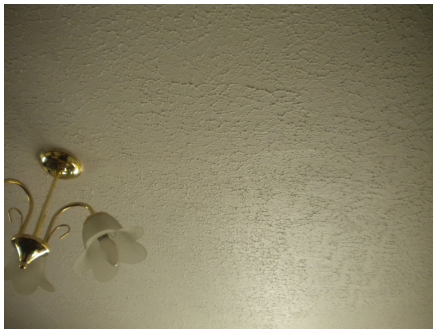
### **Item 3 - Ref: BS/02**

The textured coating to the ceiling in the living room does not contain asbestos.

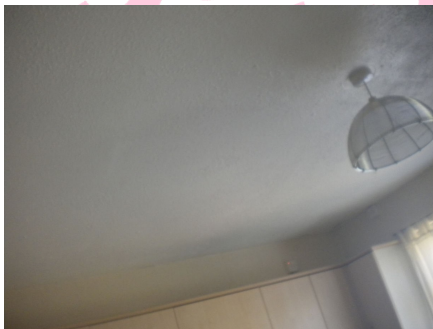
### **Item 4 - Ref: BS/03**

The textured coating to the ceiling in the kitchen does not contain asbestos.

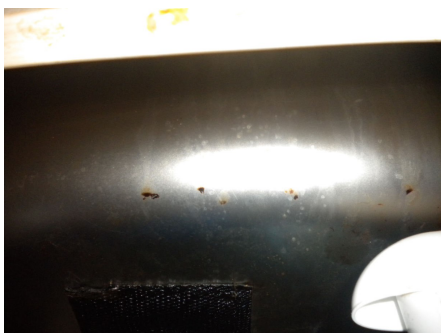
### **Item 5 - Ref: BS/04**

The sink pad to the sink in the kitchen does not contain asbestos.

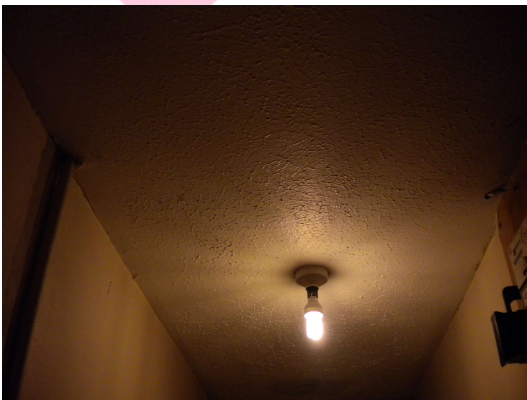
**Item 10 - Ref: BS/07**

The textured coating to the ceiling in the boiler cupboard does not contain asbestos.

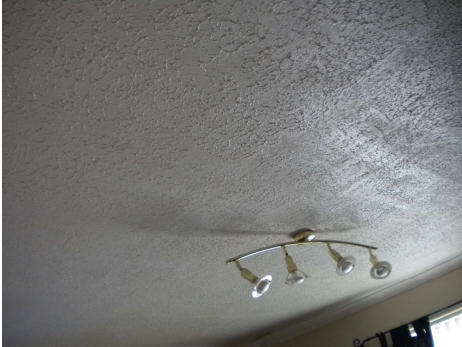
### **Item 11 - Ref: BS/08**

The textured coating to the ceiling in bedroom 2 does not contain asbestos.

Similar textured coating is located on the ceiling of bedroom 3.

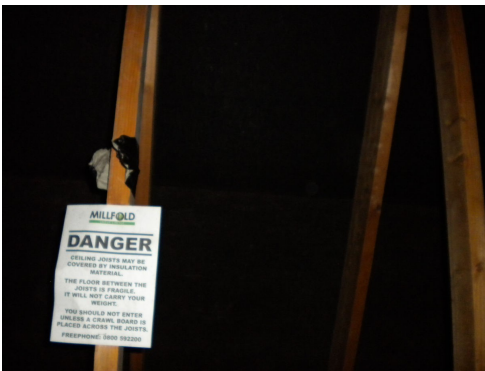
### **Item 12 - Ref: BS/09**

The roof felt to the loft does not contain asbestos.

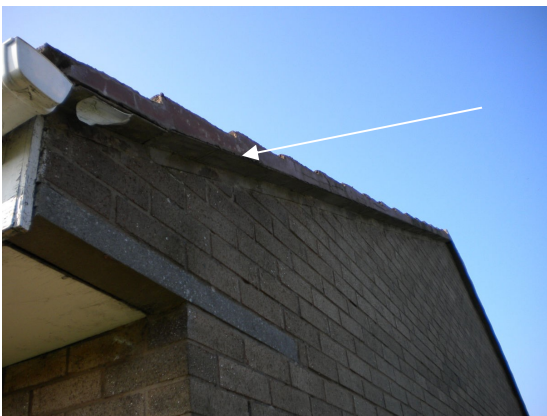
### **Item 13 - Ref: BS/10**

The cement verge board to the external of the property contains asbestos. Any change in its appearance should be noted and passed to Property Services.
