ASBESTOS SURVEY REPORT FOR SHAFTOE ACADEMY PRIMARY SCHOOL, HAYDON BRIDGE, HEXHAM, NE47 6BN.

## **Asbestos Register for Shaftoe Academy Primary School**

**UPRN: - J273378**

**Date: 22 May 2026**

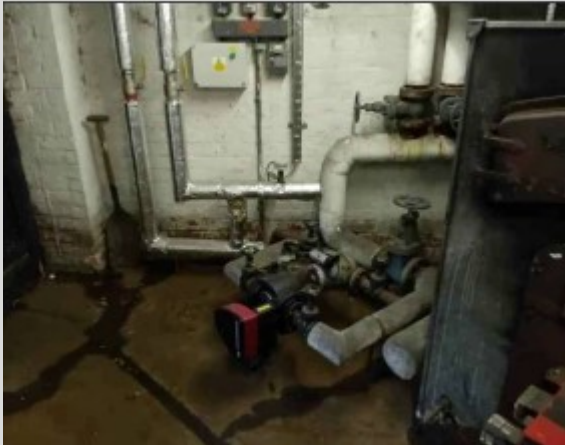
2	TL000318	Debris/Residue walls, composite sample from walls	Boiler Room Shaftoe Academy Z1/001	No Risk

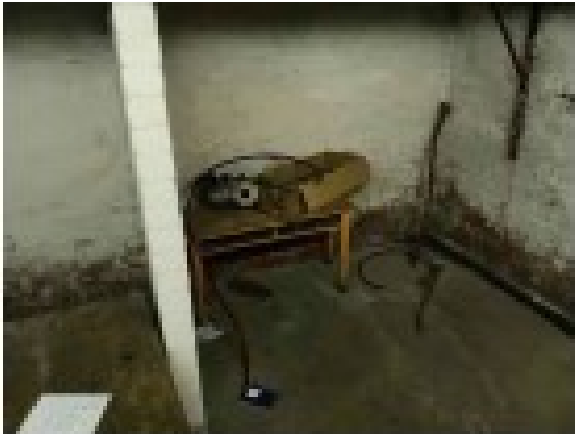
3	TL000319	Pipe Joints exposed flange on loose pipe	Boiler Room Shaftoe Academy Z1/001	Medium Risk – 3 monthly

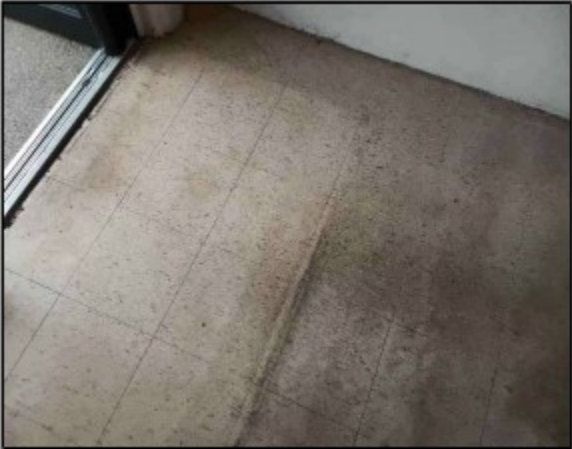
4	TL000310	Floor tile (with adhesive) Grey by main entrance	Entrance Hall/Foyer/Lobby Shaftoe Academy G/001	No Risk

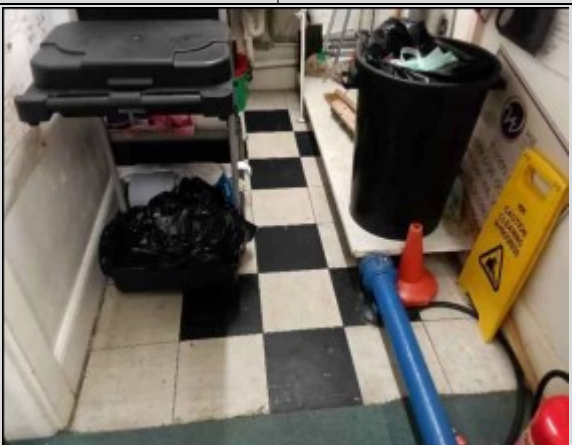
7	TL000311	Floor tile with adhesive Black and white	Store Room Shaftoe Academy G/009	No Risk

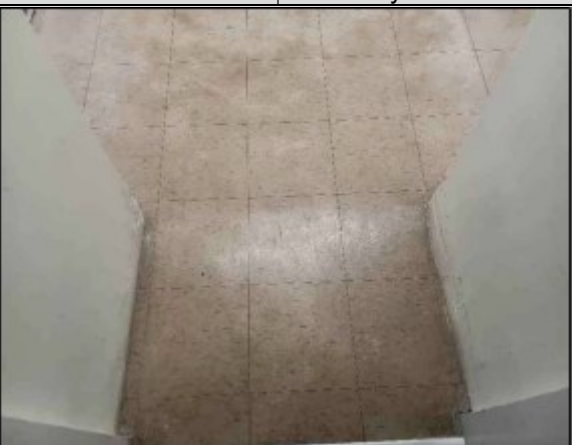
8	As TL000310	Floor tile (with adhesive) Grey beneath	Entrance Hall/Foyer/Lobby to stores Shaftoe Academy G/010	No Risk

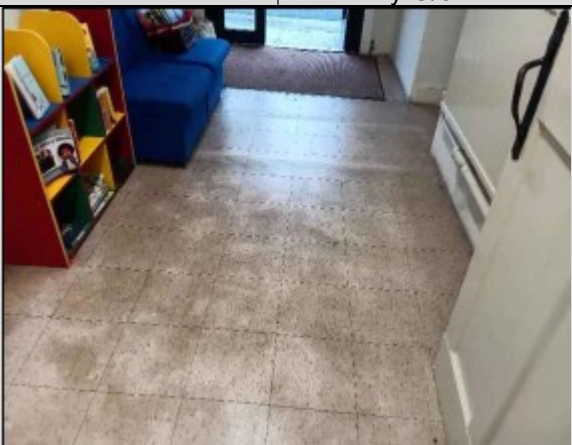
9	As TL000310	Floor tile (with adhesive) Grey	Entrance Hall/Foyer/Lobby to boys toilets Shaftoe Academy G/011	No Risk

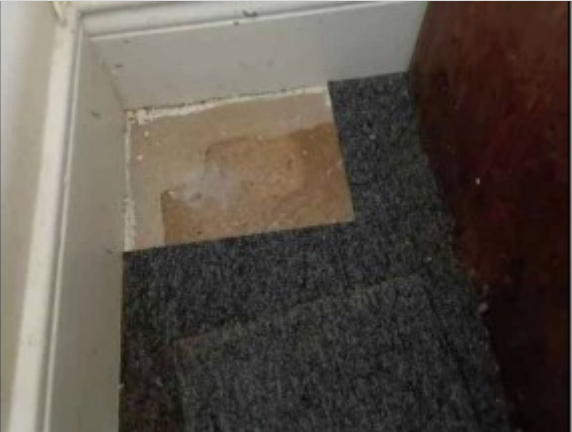
11	TL000313	Floor screed	Office Shaftoe Academy G/018	No Risk

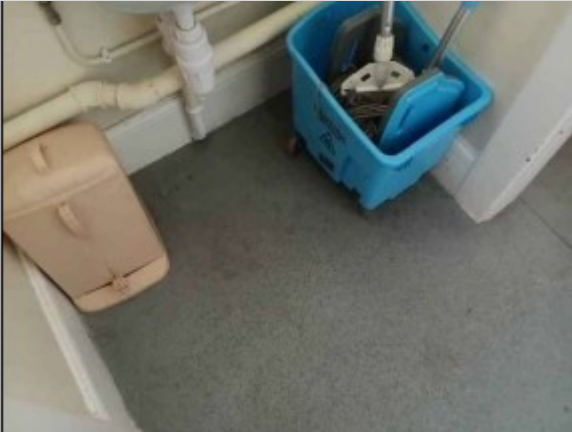
12	As TL000313	Floor screed	Entrance Hall/Foyer/Lobby Shaftoe Academy G/019	No Risk

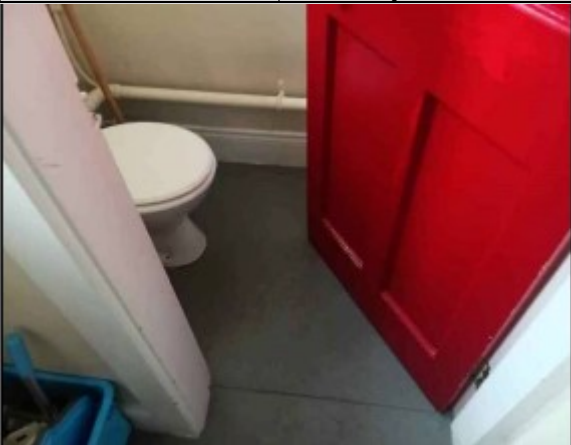
13	As TL000313	Floor screed	Toilet Shaftoe Academy G/20	No Risk

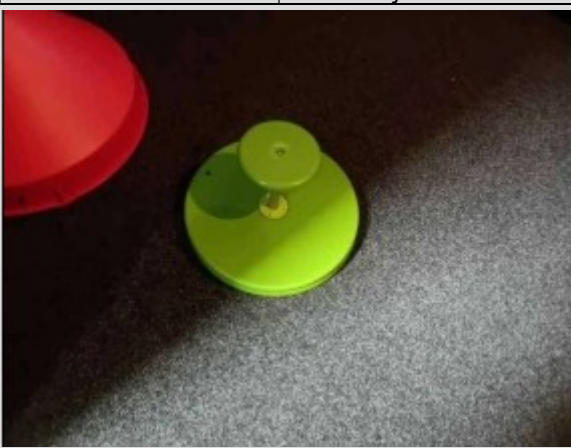
14	TL000314	Floor screed beneath carpet	Classroom The Newton Room Shaftoe Academy G/024	No Risk

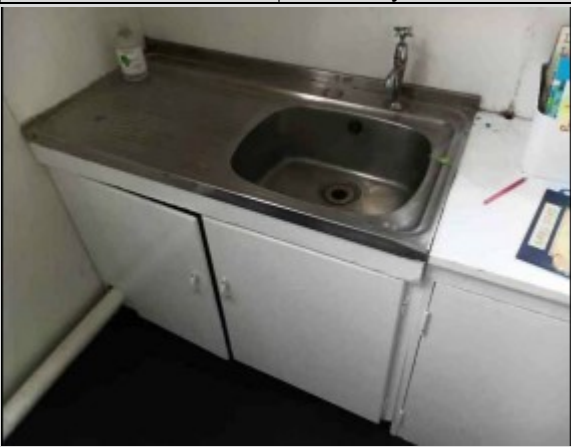
15	TL000315	Under sink mat	Classroom Shaftoe Academy G/025	No Risk

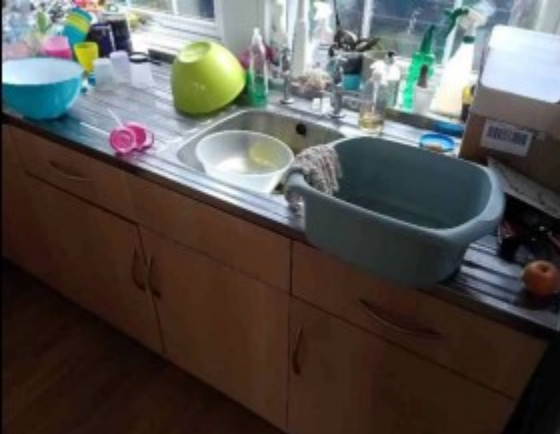
17	As TL000315	Under sink mat	Classroom Early Years Block G/010	No Risk

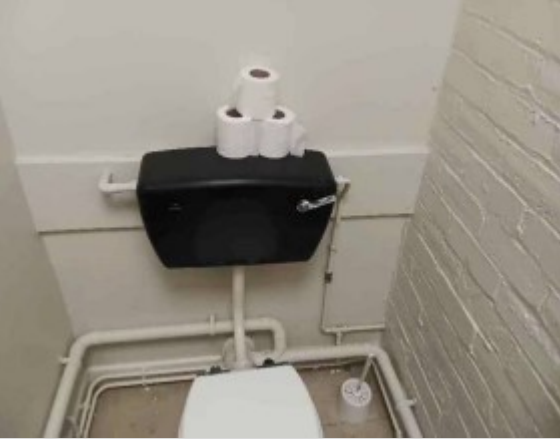
18	TL000321	Toilet cistern	Toilets Bamburgh Building G/003	No Risk

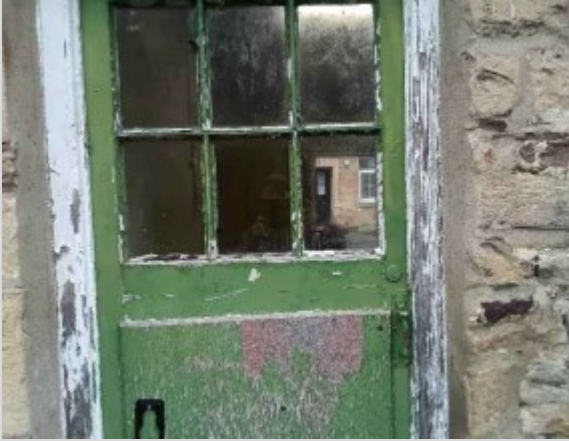
20	TL000323	Window putty seal to rear door	External Stores E/001	No Risk
