ASBESTOS SURVEY REPORT FOR MARINE PARK PRIMARY SCHOOL,
HATFIELD SQUARE, SOUTH SHIELDS, TYNE AND WEAR, NE33 2RD.

Asbestos Register for

Marine Park Primary School, Hatfield Square, NE33 2RD

Date: 26 January 2026

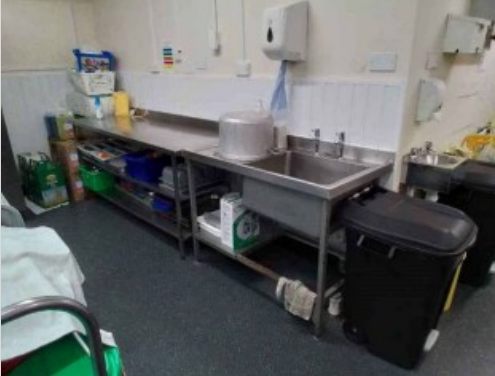
4	OQ002184	Under sink mat painted application	Kitchen G/011	No Risk

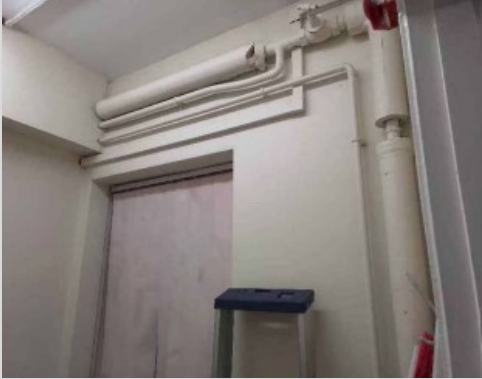
5	OQ002185	Pipework Insulation	Toilets G/015	No Risk

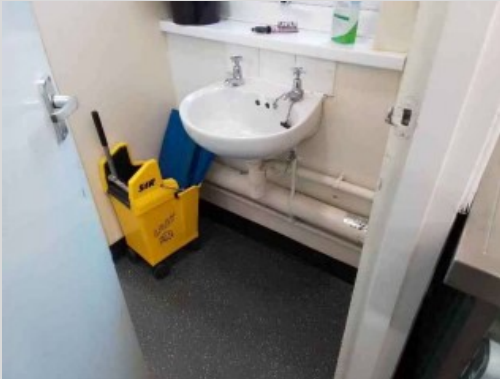
6	As OQ002185	Pipework Insulation	Washroom G/016	No Risk

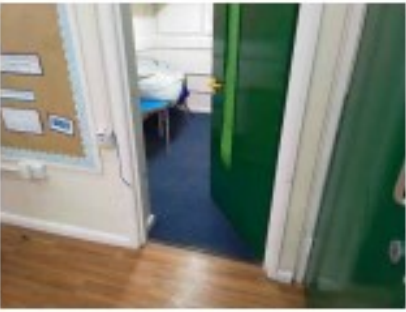
8	OQ002187	Floor tile orange	Classroom G/018	Very Low Risk – 12 Monthly
Photo 1: Wide Angle		Photo 2: Close-up

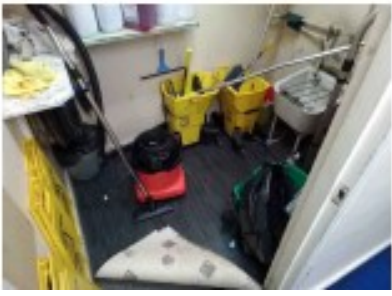
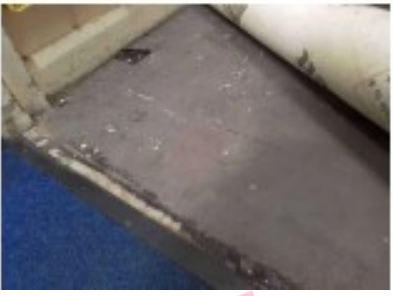
10	OQ002188	Floor tile grey	Cupboard Cleaners G/021	Very Low Risk – 12 Monthly
Photo 1: Wide Angle		Photo 2: Close-up

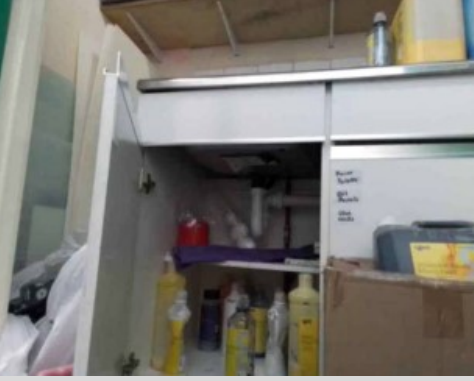
11	OQ002189	Under Sink Mat	Cupboard Store G/024	No Risk

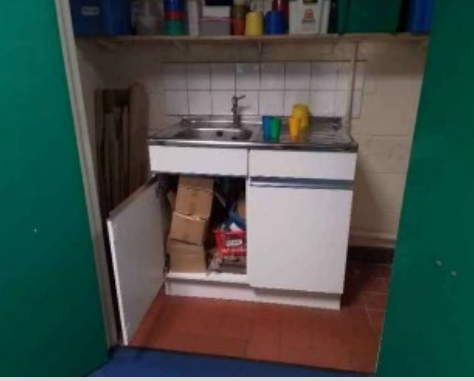
12	As OQ002189	Under Sink Mat	Cupboard G/027	No Risk

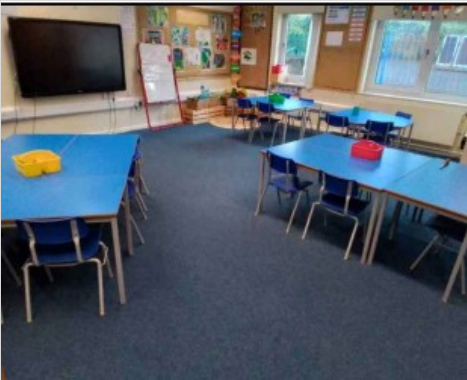
14	OQ002190	Floor tile Beige beneath screed	Classroom G/044	No Risk

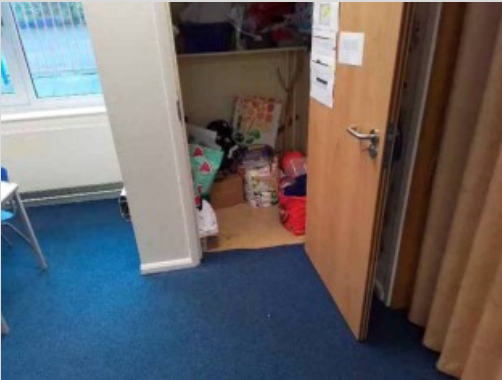
15	As OQ002190	Floor tile Beige beneath screed	Cupboard G/045	No Risk

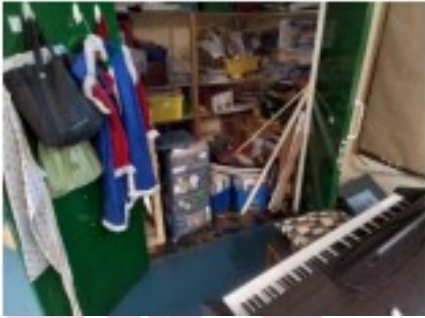
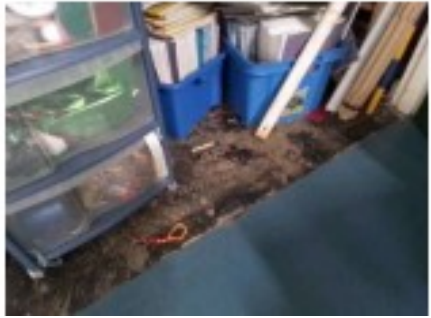
17	As OQ002191	Floor former tile adhesive under lino	Cupboard G/047	Very Low Risk – 12 Monthly
Photo 1: Wide Angle		Photo 2: Close-up

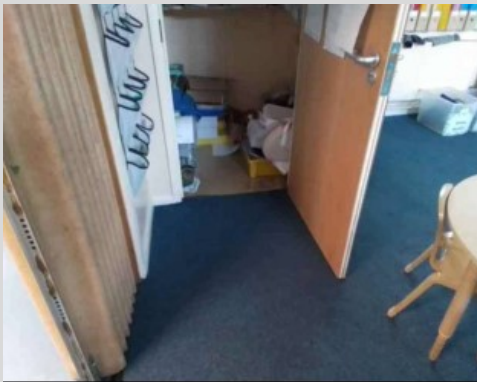
18	As OQ002190	Floor tile Beige beneath screed	Cupboard G/048	No Risk

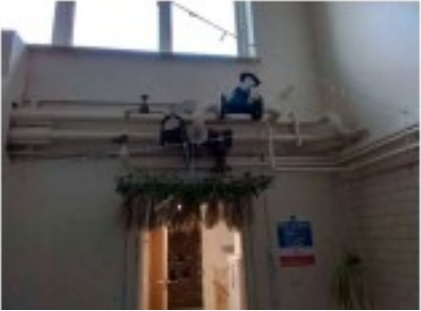
21	OQ002192	Pipework Gaskets	Classroom G/053	Very Low Risk – 12 Monthly
Photo 1: Wide Angle		Photo 2: Close-up

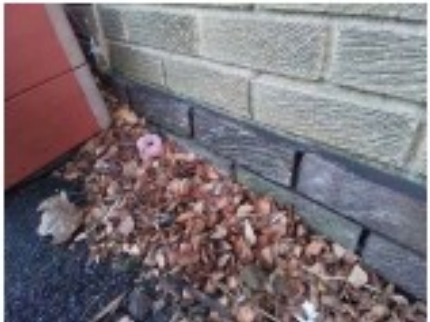
30	OQ002193	Damp proof course	External E/001	Very Low Risk – 12 Monthly
Photo 1: Wide Angle		Photo 2: Close-up

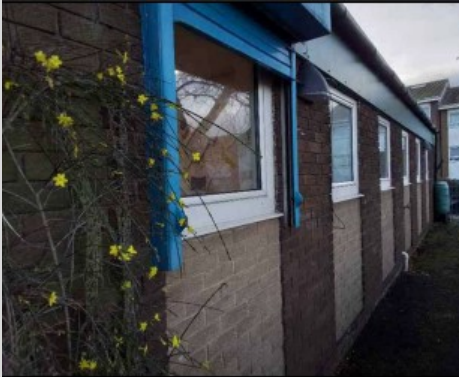
31	OQ002194	Window – remnants to sealant to wall	External E/001	No Risk

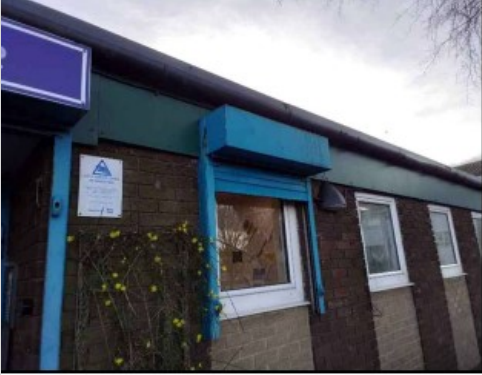
32	OQ002195	Fascias	External E/001	No Risk

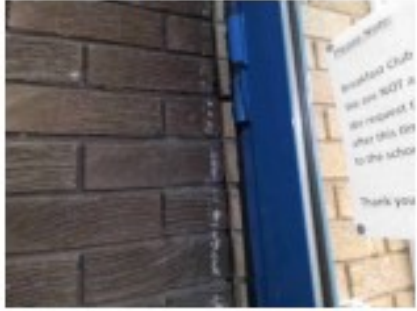
34	OQ002197	Damp proof course in brickwork cavity	External E/001	Very Low Risk – 12 Monthly
Photo 1: Wide Angle		Photo 2: Close-up

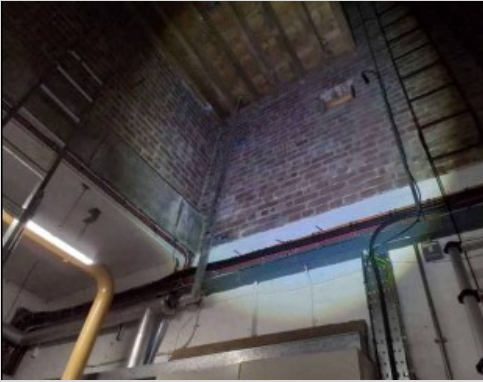
38	OQ002201	Debris/Residue to hardset to wall above electrics	External E/003	No Risk

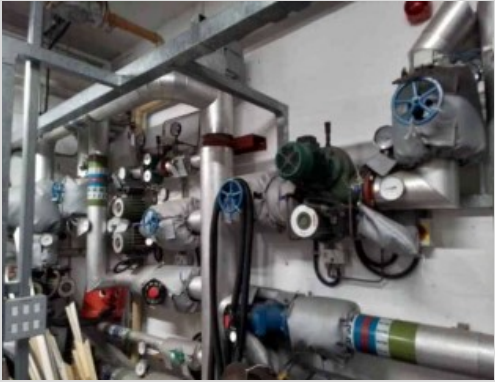
41	OQ002204	Debris/Residue to wall behind pumps	External E/002	No Risk

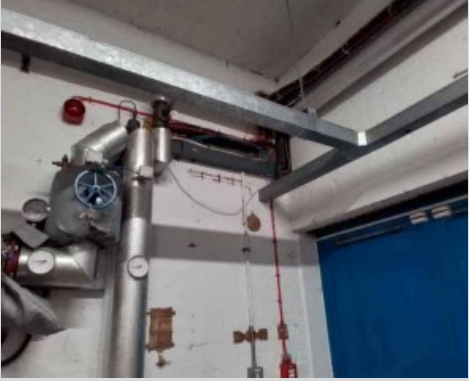
42	OQ002205	Debris/Residue inside conduit/cable tray	External E/003	No Risk
