ASBESTOS SURVEY REPORT FOR WHITBURN VILLAGE PRIMARY SCHOOL, CLEADON LANE, WHITBURN, SUNDERLAND, TYNE AND WEAR, SR6 7NS

**Whitburn Village Primary School, Cleadon Lane, Whitburn,
Sunderland, Tyne and Wear, SR6 7NS**

Date: 22 June 2026

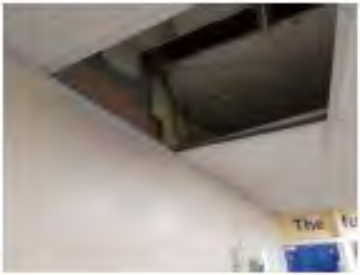
1	OQ002218	Wall - behind plasterboard, radiator and plastic, sampled in ceiling void	Ground Floor G/003 Hallway/passageway	Low Risk – Check every 6 months
Photo 1: Wide Angle		Photo 2: Close-up

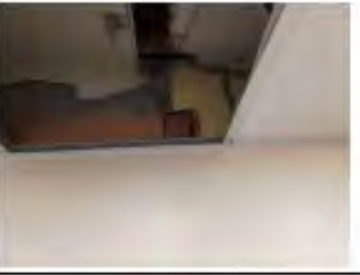
2	As OQ002218	Column Cladding - suspected behind wooden cladding	Ground Floor G/003 Hallway/passageway	Low Risk – Check every 6 months
Photo 1: Wide Angle		Photo 2: Close-up

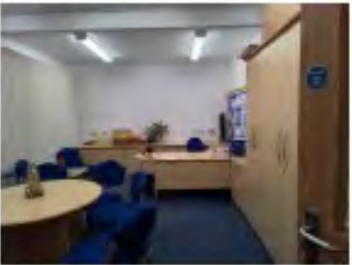
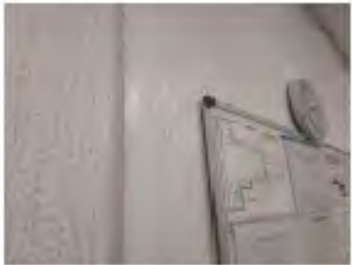
3	As OQ002218	Wall - covered in wallpaper	Ground Floor G/004 Office - Headteacher	Low Risk – Check every 6 months
Photo 1: Wide Angle		Photo 2: Close-up

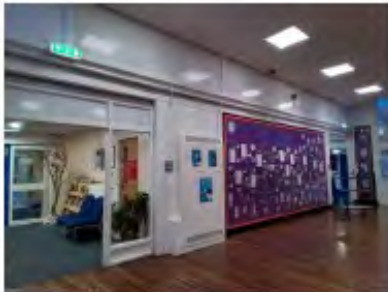
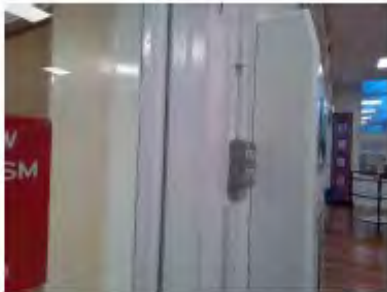
10	OQ002222	Wall - beneath plastic cladding	Ground Floor G/010 Dining Hall/area	Low Risk – Check every 6 months
Photo 1: Wide Angle		Photo 2: Close-up

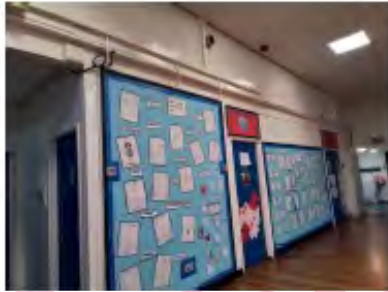
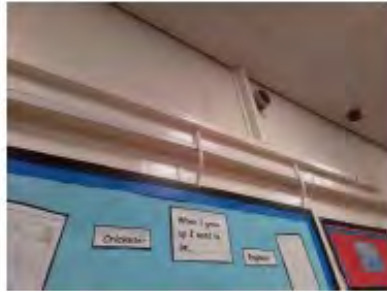
11	As OQ002222	Wall - beneath plastic cladding	Ground Floor G/011 Main Hall	Low Risk – Check every 6 months
Photo 1: Wide Angle		Photo 2: Close-up

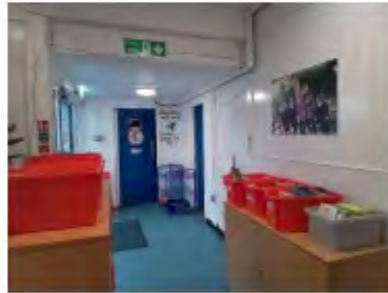
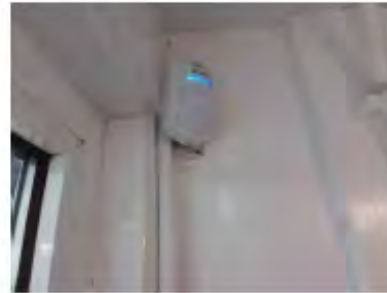
12	OQ002223	Wall - behind plastic cladding, visible at alarm sensor	Ground Floor G/012 Hallway/passageway	Low Risk – Check every 6 months
Photo 1: Wide Angle		Photo 2: Close-up

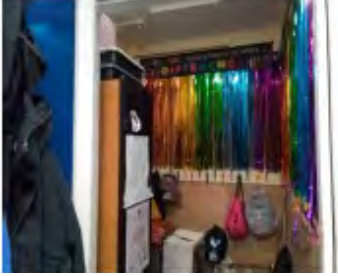
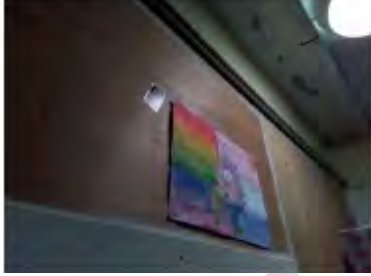
16	As OQ002223	Wall - all walls, protected by plywood	Ground Floor G/014 Cupboard - Store	Very Low Risk – Check every 12 months
Photo 1: Wide Angle		Photo 2: Close-up

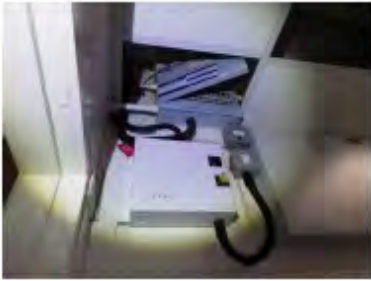
17	As OQ002223	Wall - all walls, beneath plastic cladding	Ground Floor G/015 Hallway/passageway /cloakroom	Low Risk – Check every 6 months
Photo 1: Wide Angle		Photo 2: Close-up

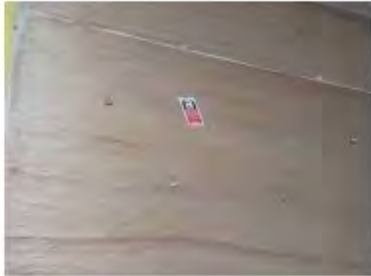
18	As OQ002223	Wall - all walls, protected by plywood	Ground Floor G/016 Cupboard - Store - Year 5 Classroom	Very Low Risk – Check every 12 months
Photo 1: Wide Angle		Photo 2: Close-up

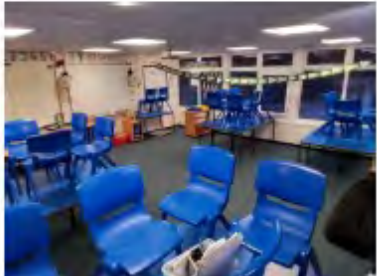
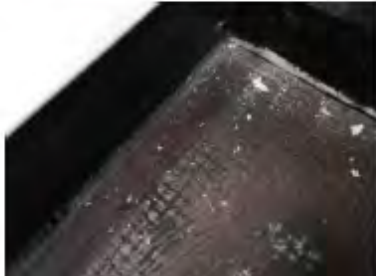
19	As OQ002220	Floor - former tile adhesive, beneath carpet	Ground Floor G/017 Classroom - Year 4	Very Low Risk – Check every 12 months
Photo 1: Wide Angle		Photo 2: Close-up

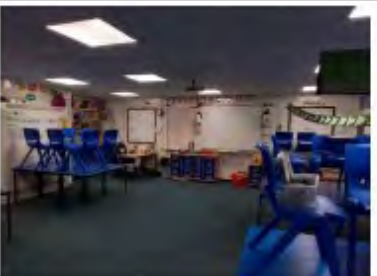
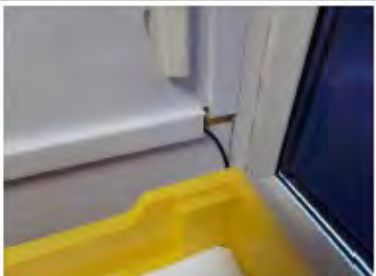
20	As OQ002223	Wall - behind plastic cladding and suspected behind window infill panels	Ground Floor G/017 Classroom - Year 4	Low Risk – Check every 6 months
Photo 1: Wide Angle		Photo 2: Close-up

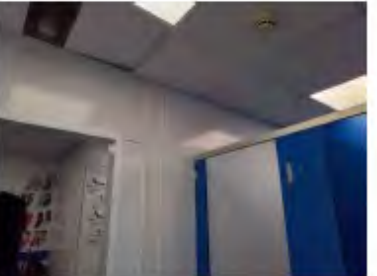
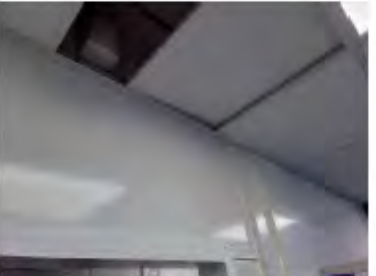
21	As OQ002223	Wall - all walls, beneath plastic cladding	Ground Floor G/018 Toilet(s)	Low Risk – Check every 6 months
Photo 1: Wide Angle		Photo 2: Close-up

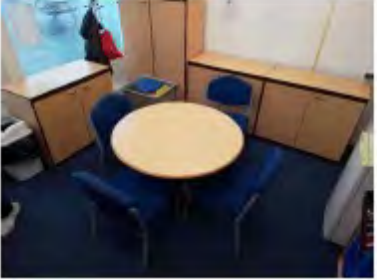
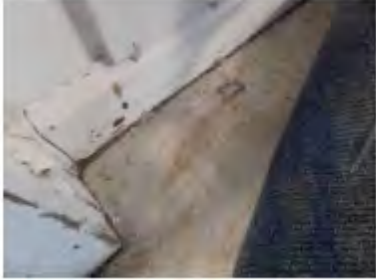
25	OQ002225	Floor - former tile adhesive, beneath carpet	Ground Floor G/023 Classroom - Breakfast	Very Low Risk – Check every 12 months
Photo 1: Wide Angle		Photo 2: Close-up

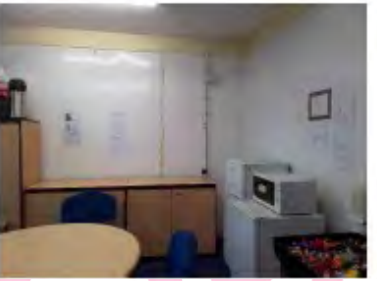
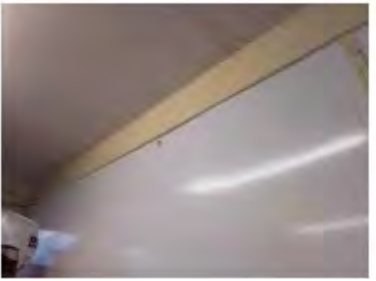
26	As OQ002223	Wall - behind plastic cladding and suspected behind window infill panels	Ground Floor G/023 Classroom - Breakfast	Low Risk – Check every 6 months
Photo 1: Wide Angle		Photo 2: Close-up

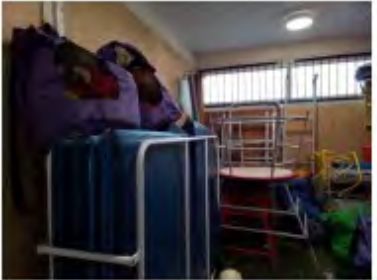
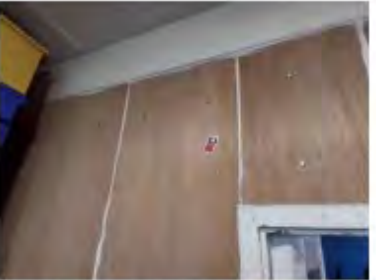
27	As OQ002219	Wall - all walls, protected by plywood	Ground Floor G/024 Cupboard - Store	Very Low Risk – Check every 12 months
Photo 1: Wide Angle		Photo 2: Close-up

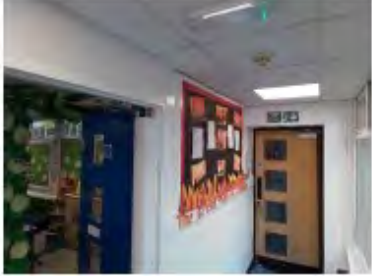
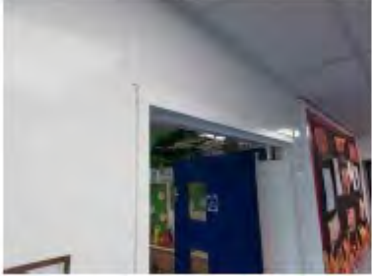
34	As OQ002226	Wall - all walls, beneath plastic cladding	Ground Floor G/030 Hallway/passageway	Low Risk – Check every 6 months
Photo 1: Wide Angle		Photo 2: Close-up

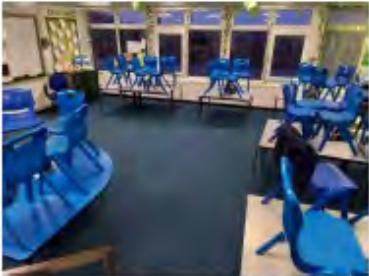
35	As OQ002225	Floor - former tile adhesive, beneath carpet	Ground Floor G/031 Classroom - Year 2	Very Low Risk – Check every 12 months
Photo 1: Wide Angle		Photo 2: Close-up

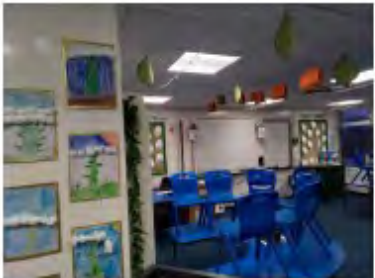
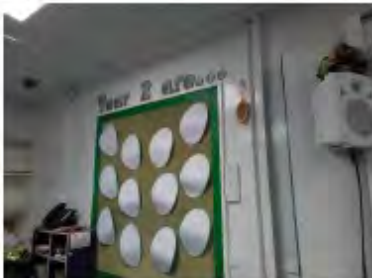
No Photographic Evidence Available		
36	As OQ002226	Wall - behind plastic cladding and suspected behind window infill panels	Ground Floor G/031 Classroom - Year 2	Low Risk – Check every 6 months
Photo 1: Wide Angle		Photo 2: Close-up

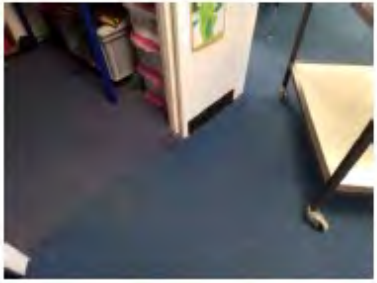
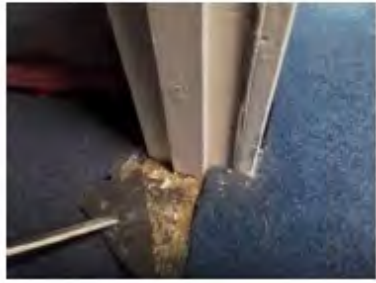
37	OQ002229	Floor - Tile - remnants to door frame	Ground Floor G/031 Classroom - Year 2	Very Low Risk – Check every 12 months
Photo 1: Wide Angle		Photo 2: Close-up

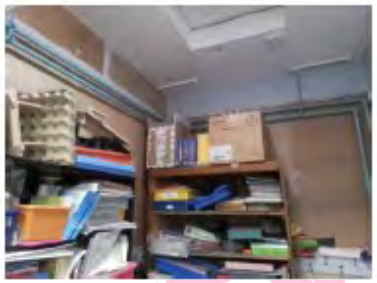
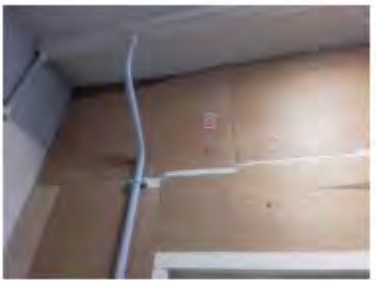
38	As OQ002226	Wall - all walls, protected by plywood	Ground Floor G/032 Cupboard - Store - Year 2 Classroom	Very Low Risk – Check every 12 months
Photo 1: Wide Angle		Photo 2: Close-up

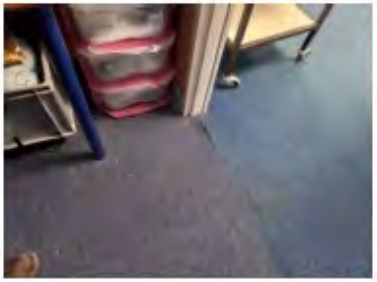
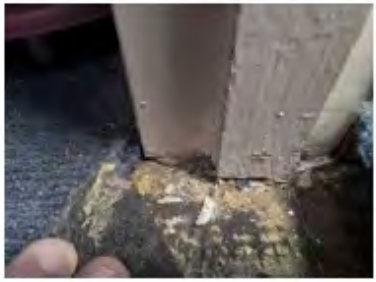
39	As OQ002229	Floor - Tile - remnants to door frame	Ground Floor G/032 Cupboard - Store - Year 2 Classroom	Very Low Risk – Check every 12 months
Photo 1: Wide Angle		Photo 2: Close-up

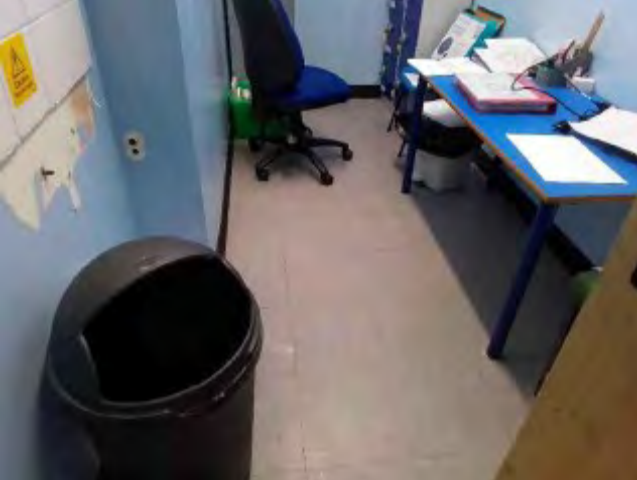
55	As OQ002235	Floor - Tile	Ground Floor G/062 Medical/First Aid Room	No Risk

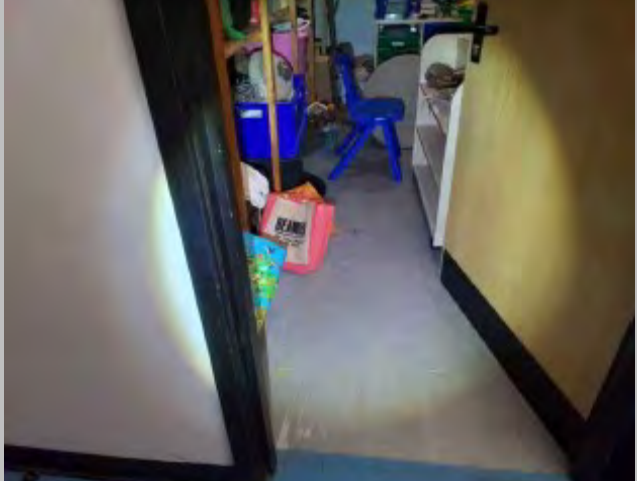
56	OQ002237	Floor - Tile - grey	Ground Floor G/063 Store Room	No Risk

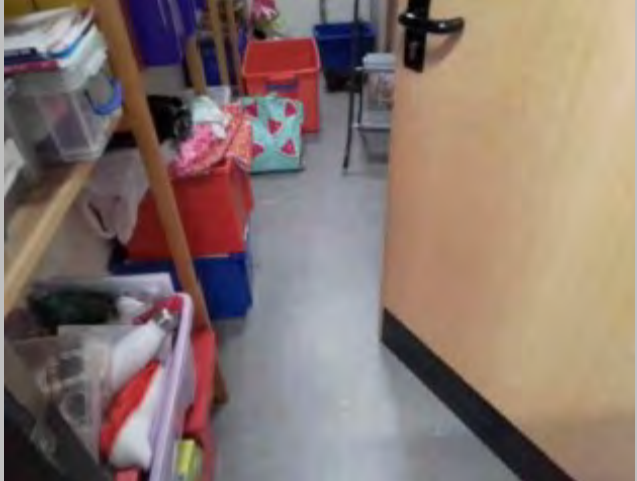
57	As OQ002237	Floor - Tile - grey	Ground Floor G/064 Store Room	No Risk

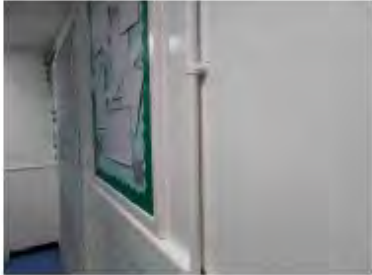
64	As OQ002242	Wall - behind plastic cladding	Ground Floor G/071 Hallway/passageway	Low Risk – Check every 6 months
Photo 1: Wide Angle		Photo 2: Close-up

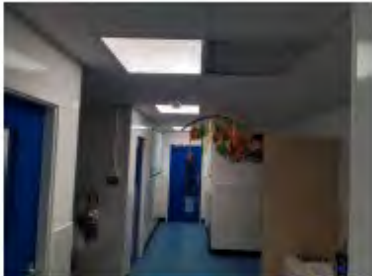
65	As OQ002242	Wall - all walls, beneath plastic and wood cladding	Ground Floor G/072 Hallway/passageway /cloakroom	Low Risk – Check every 6 months
Photo 1: Wide Angle		Photo 2: Close-up

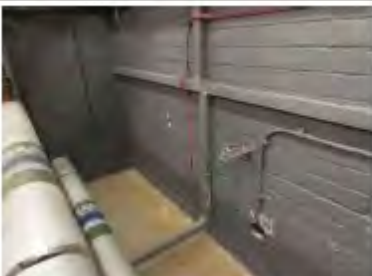
72	OQ002243	Debris/Residue - to rear wall	External E/001 Boiler Room	Low Risk – Check every 6 months
Photo 1: Wide Angle		Photo 2: Close-up

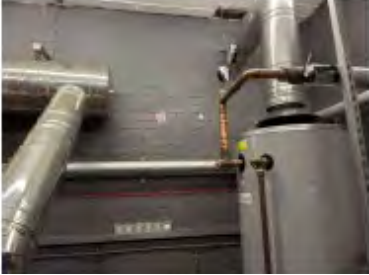
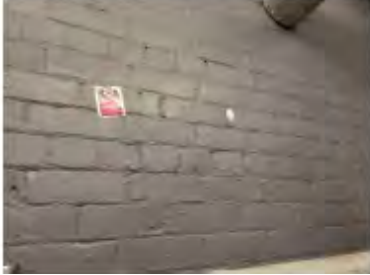
73	OQ002244	Debris/Residue - to rear wall. RHS	External E/001 Boiler Room	Low Risk – Check every 6 months
Photo 1: Wide Angle		Photo 2: Close-up

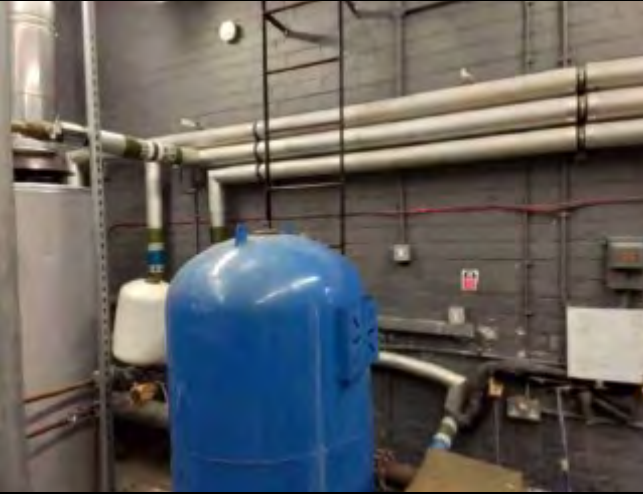
74	OQ002245	Debris/Residue - to RHS wall	External E/001 Boiler Room	No Risk

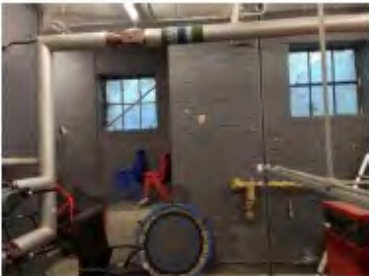
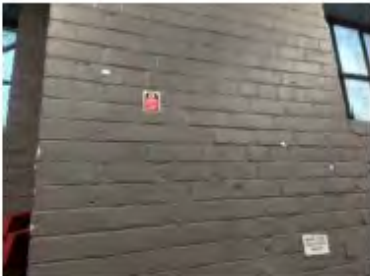
75	OQ002246	Debris/Residue - to RHS wall	External E/001 Boiler Room	Low Risk – Check every 6 months
Photo 1: Wide Angle		Photo 2: Close-up

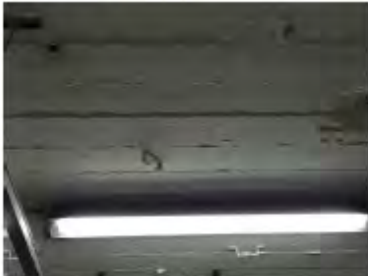
77	OQ002248	Debris/Residue - to ceiling	External E/001 Boiler Room	Low Risk – Check every 6 months
Photo 1: Wide Angle		Photo 2: Close-up

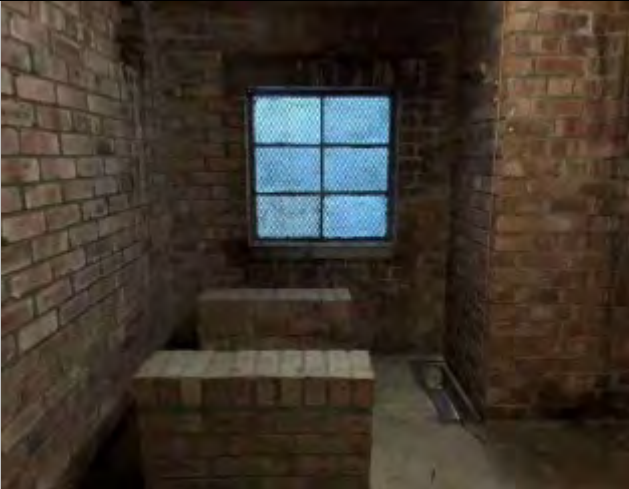
82	As OQ002251	Window Putty/seal	External E/002 Tank Room	No Risk

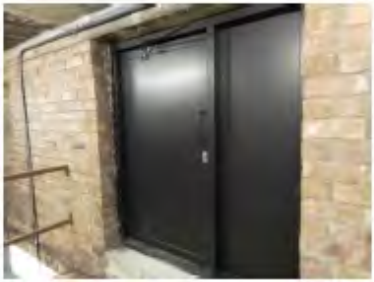
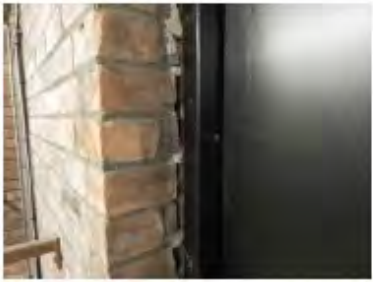
83	OQ002253	Wall - Lining - in wall cavity	External E/002 Tank Room	Very Low Risk – Check every 12 months
Photo 1: Wide Angle		Photo 2: Close-up

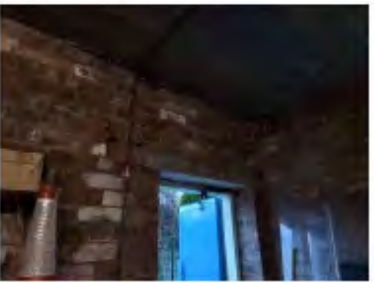
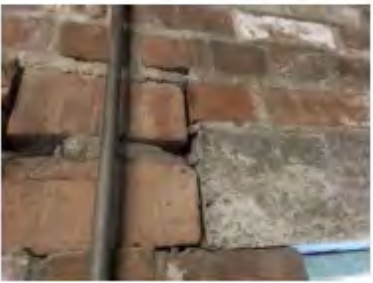
84	As OQ002253	Wall - Lining - in wall cavity	External E/003 Store Room	Very Low Risk – Check every 12 months
Photo 1: Wide Angle		Photo 2: Close-up

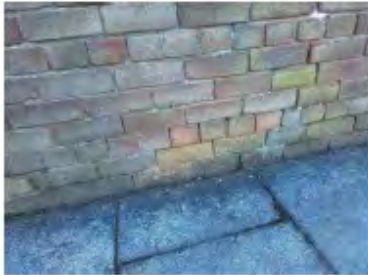
85	As OQ002253	Damp Proof Course - non visible	External E/004 Boiler Room	Very Low Risk – Check every 12 months
Photo 1: Wide Angle		Photo 2: Close-up

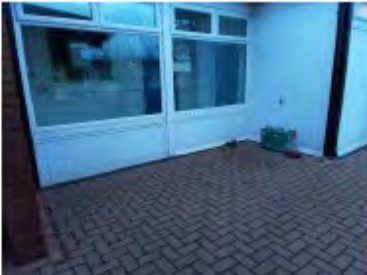
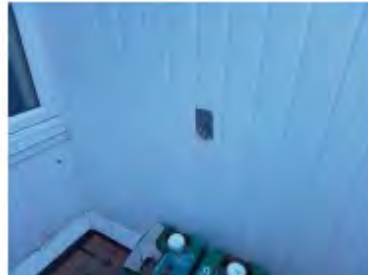
86	OQ002254	Wall - behind plastic cladding, inspected via pre-existing hole	External E/006 External	Low Risk – Check every 6 months
Photo 1: Wide Angle		Photo 2: Close-up

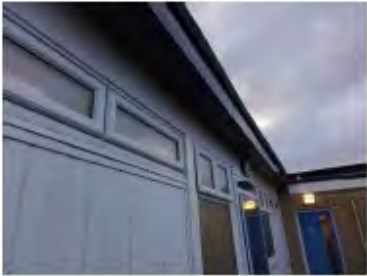
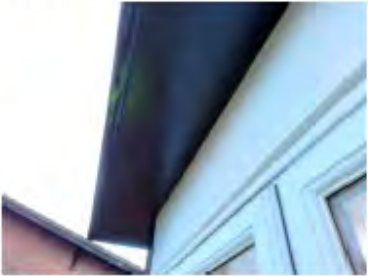
87	OQ002255	Soffits - throughout old block	External E/006 External	Very Low Risk – Check every 12 months
Photo 1: Wide Angle		Photo 2: Close-up

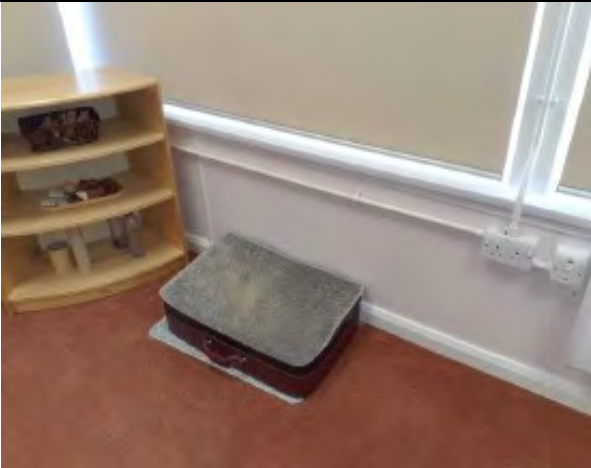
89	Presumed	Asbestos insulation board – low level walls behind wood	Daycare and Family Location 1/006 Family Room (G/01)	Low Risk – Check every 6 months

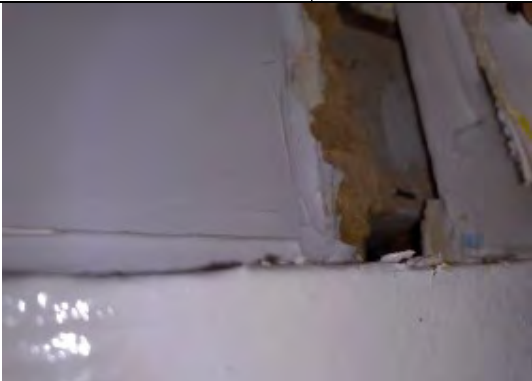
91	KG000830	Asbestos insulation board residue – in wall cavity above doorway to school	Daycare and Family Location 2/007 Daycare Room (G/03)	Medium Risk – check every 3 months

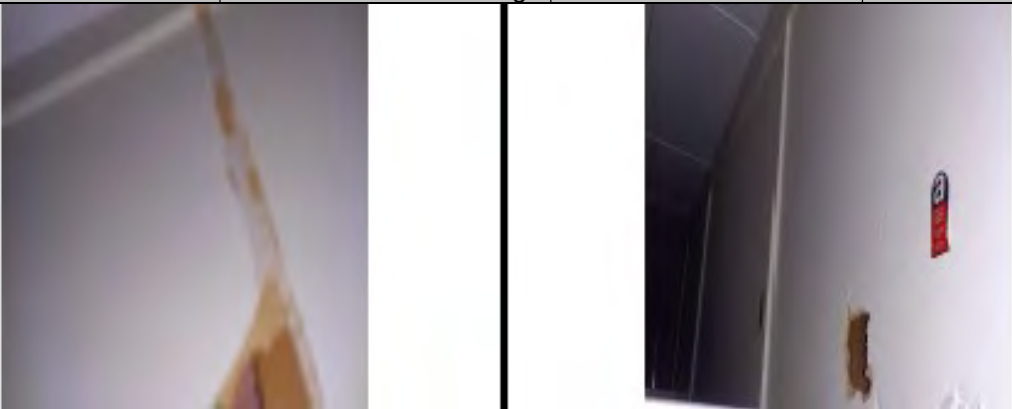
92	OU004369	Fibreboard wall in ceiling	Room G/10	No Risk

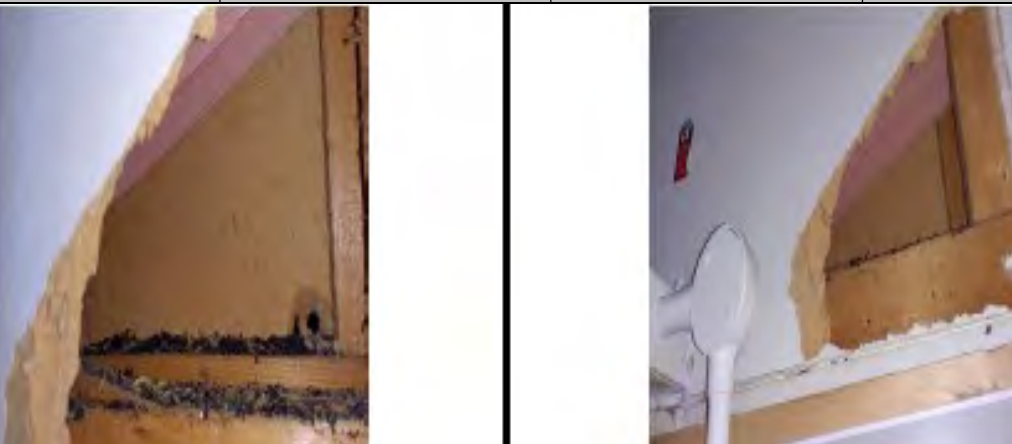
93	OU004370	Bitumen debris wall void	Room G/10	No Risk
