ASBESTOS SURVEY REPORT FOR WHITBURN VILLAGE PRIMARY SCHOOL, CLEADON LANE, WHITBURN, SUNDERLAND, TYNE AND WEAR, SR6 7NS

Asbestos Register for

**Whitburn Village Primary School, Cleadon Lane, Whitburn,
Sunderland, Tyne and Wear, SR6 7NS**

Date: 27 March 2026

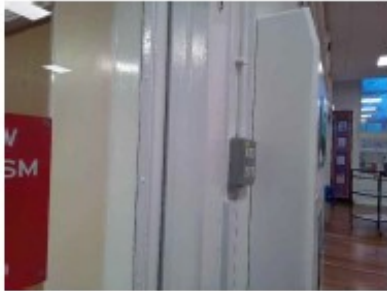
10	OQ002222	Wall - beneath plastic cladding	Ground Floor G/010 Dining Hall/area	Low Risk – Check every 6 months
Photo 1: Wide Angle		Photo 2: Close-up

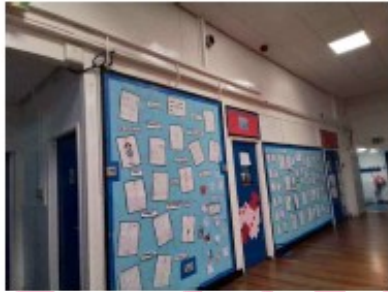
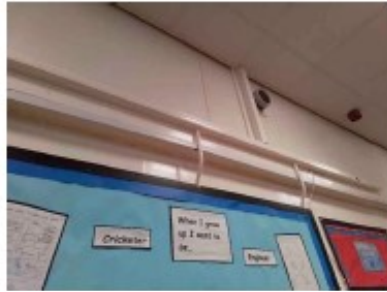
11	As OQ002222	Wall - beneath plastic cladding	Ground Floor G/011 Main Hall	Low Risk – Check every 6 months
Photo 1: Wide Angle		Photo 2: Close-up

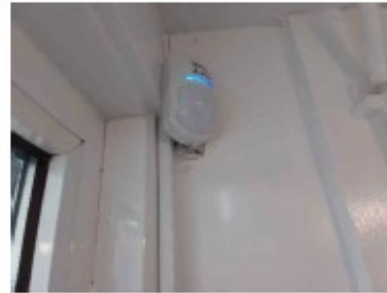
12	OQ002223	Wall - behind plastic cladding, visible at alarm sensor	Ground Floor G/012 Hallway/passageway	Low Risk – Check every 6 months
Photo 1: Wide Angle		Photo 2: Close-up

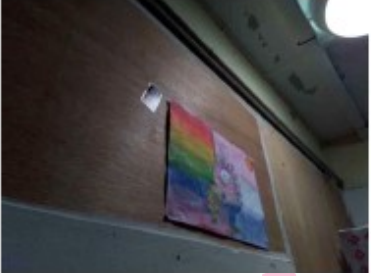
16	As OQ002223	Wall - all walls, protected by plywood	Ground Floor G/014 Cupboard - Store	Very Low Risk – Check every 12 months
Photo 1: Wide Angle		Photo 2: Close-up

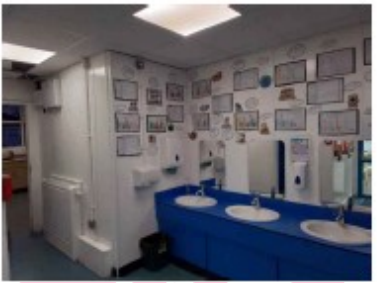
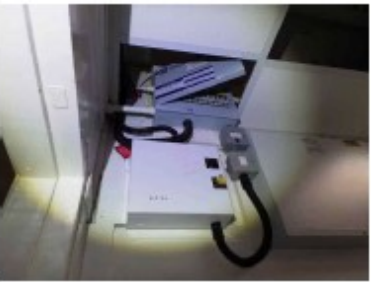
17	As OQ002223	Wall - all walls, beneath plastic cladding	Ground Floor G/015 Hallway/passageway /cloakroom	Low Risk – Check every 6 months
Photo 1: Wide Angle		Photo 2: Close-up

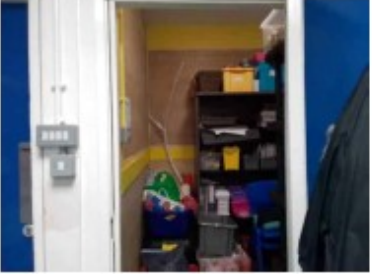
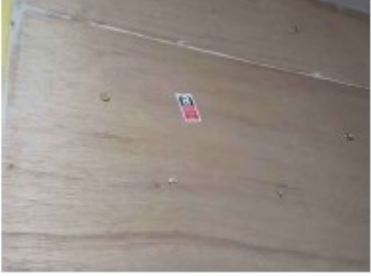
18	As OQ002223	Wall - all walls, protected by plywood	Ground Floor G/016 Cupboard - Store - Year 5 Classroom	Very Low Risk – Check every 12 months
Photo 1: Wide Angle		Photo 2: Close-up

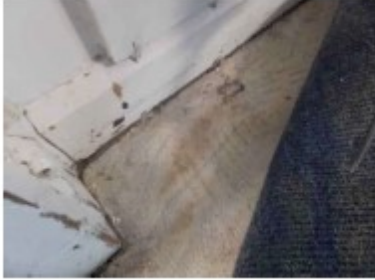
25	OQ002225	Floor - former tile adhesive, beneath carpet	Ground Floor G/023 Classroom - Breakfast	Very Low Risk – Check every 12 months
Photo 1: Wide Angle		Photo 2: Close-up

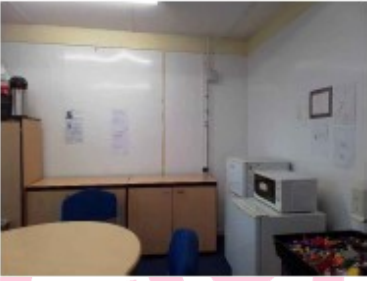
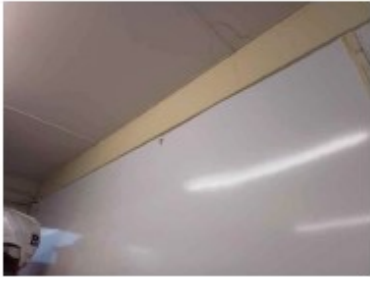
26	As OQ002223	Wall - behind plastic cladding and suspected behind window infill panels	Ground Floor G/023 Classroom - Breakfast	Low Risk – Check every 6 months
Photo 1: Wide Angle		Photo 2: Close-up

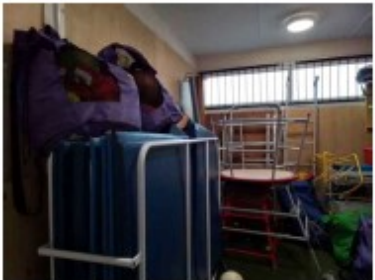
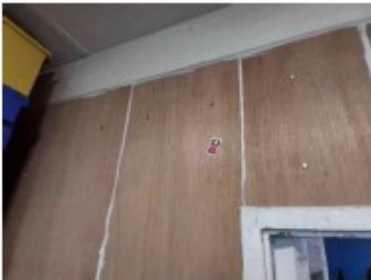
27	As OQ002219	Wall - all walls, protected by plywood	Ground Floor G/024 Cupboard - Store	Very Low Risk – Check every 12 months
Photo 1: Wide Angle		Photo 2: Close-up

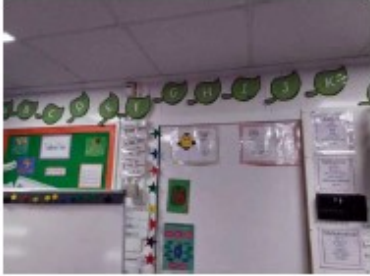
31	As OQ002226	Wall - behind plastic cladding and suspected behind window infill panels	Ground Floor G/027 Classroom - Year 3	Low Risk – Check every 6 months
Photo 1: Wide Angle		Photo 2: Close-up

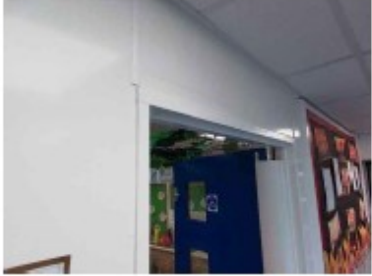
34	As OQ002226	Wall - all walls, beneath plastic cladding	Ground Floor G/030 Hallway/passageway	Low Risk – Check every 6 months
Photo 1: Wide Angle		Photo 2: Close-up

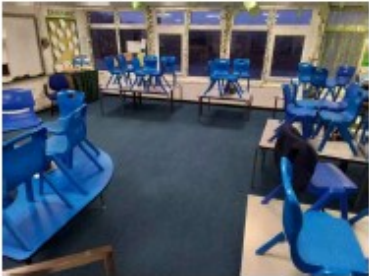
35	As OQ002225	Floor - former tile adhesive, beneath carpet	Ground Floor G/031 Classroom - Year 2	Very Low Risk – Check every 12 months
Photo 1: Wide Angle		Photo 2: Close-up

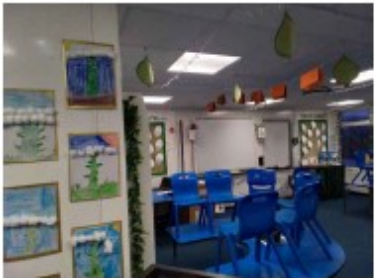
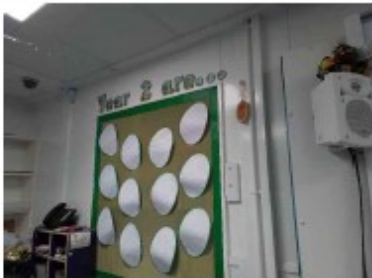
No Photographic Evidence Available		
36	As OQ002226	Wall - behind plastic cladding and suspected behind window infill panels	Ground Floor G/031 Classroom - Year 2	Low Risk – Check every 6 months
Photo 1: Wide Angle		Photo 2: Close-up

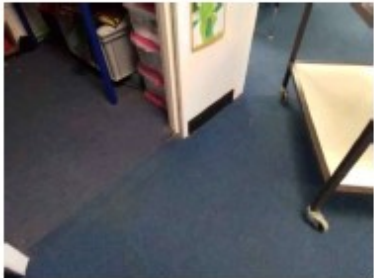
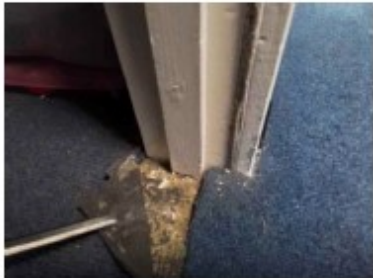
37	OQ002229	Floor - Tile - remnants to door frame	Ground Floor G/031 Classroom - Year 2	Very Low Risk – Check every 12 months
Photo 1: Wide Angle		Photo 2: Close-up

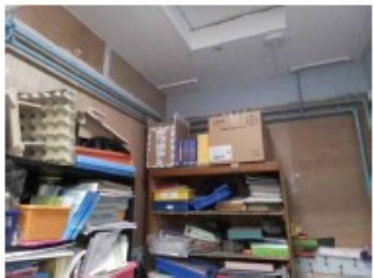
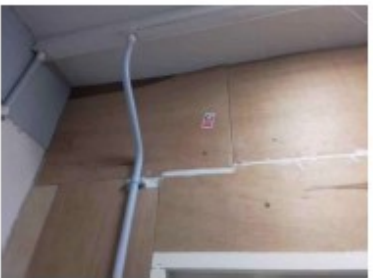
38	As OQ002226	Wall - all walls, protected by plywood	Ground Floor G/032 Cupboard - Store - Year 2 Classroom	Very Low Risk – Check every 12 months
Photo 1: Wide Angle		Photo 2: Close-up

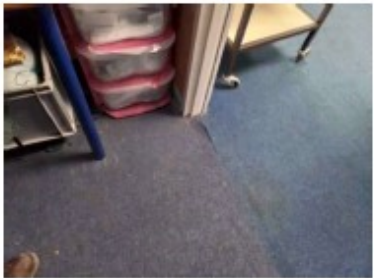
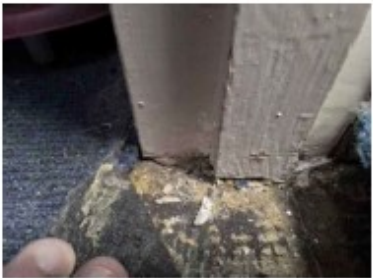
39	As OQ002229	Floor - Tile - remnants to door frame	Ground Floor G/032 Cupboard - Store - Year 2 Classroom	Very Low Risk – Check every 12 months
Photo 1: Wide Angle		Photo 2: Close-up

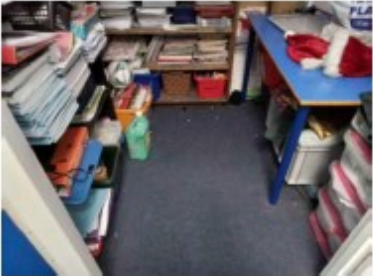
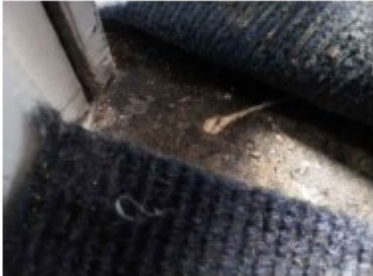
40	As OQ002225	Floor - former tile adhesive, beneath carpet	Ground Floor G/032 Cupboard - Store - Year 2 Classroom	Very Low Risk – Check every 12 months
Photo 1: Wide Angle		Photo 2: Close-up

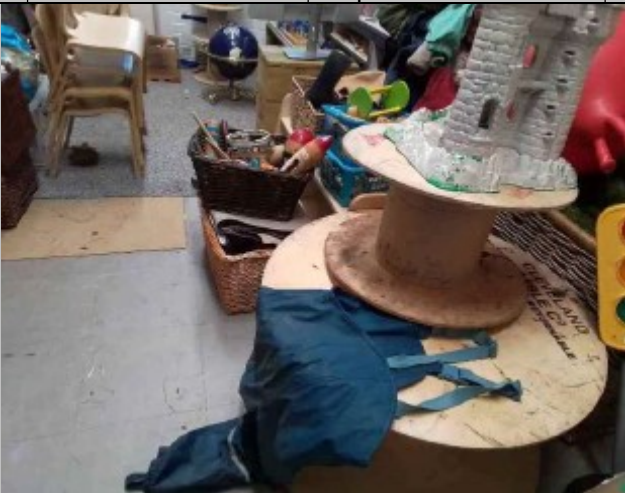
41	OQ002230	Floor - Tile - grey	Ground Floor G/038 Cupboard - Store	No Risk

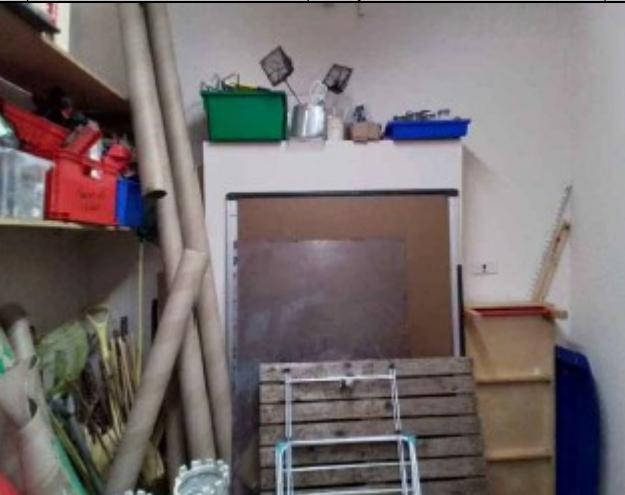
42	OQ002231	Heater - Casing	Ground Floor G/038 Cupboard - Store	No Risk

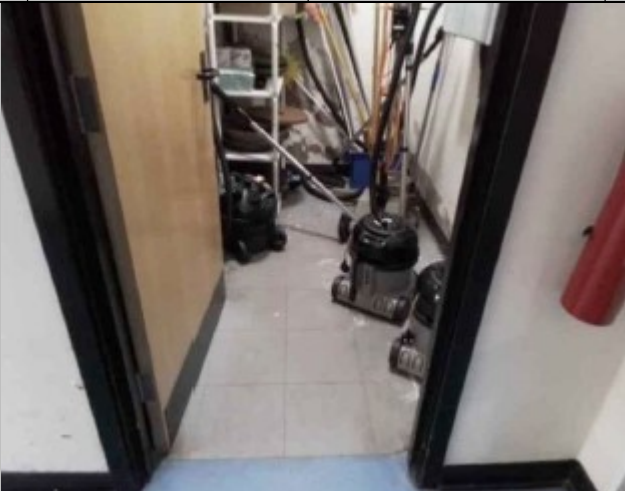
49	As OQ002235	Floor - Tile	Ground Floor G/051 Switch Room	No Risk

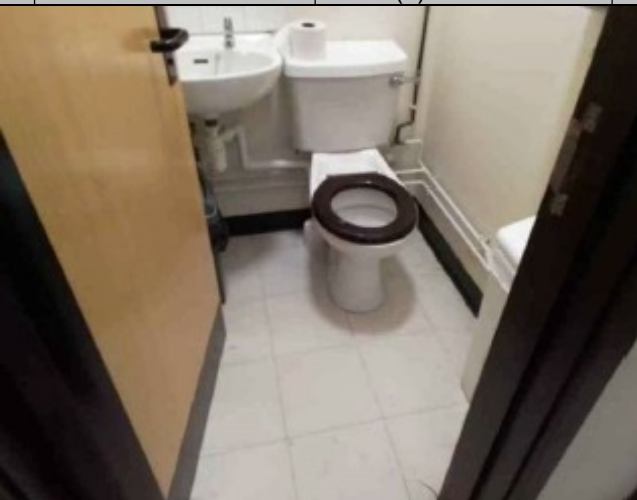
50	OQ002236	Floor - Tile - off white	Ground Floor G/052 Toilet(s) - Female	No Risk

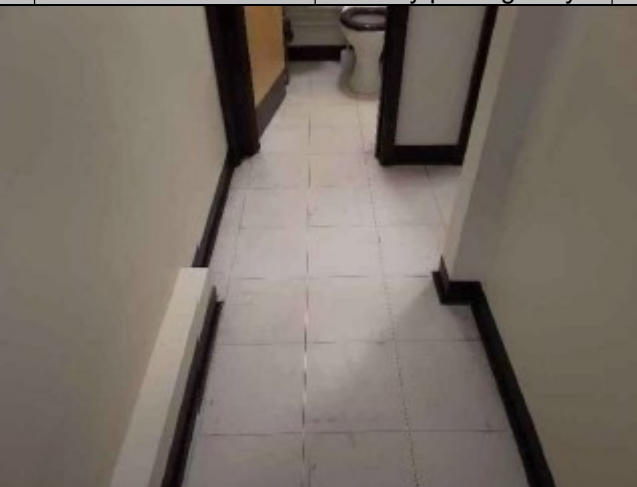
51	As OQ002236	Floor - Tile - off white	Ground Floor G/053 Hallway/passageway	No Risk

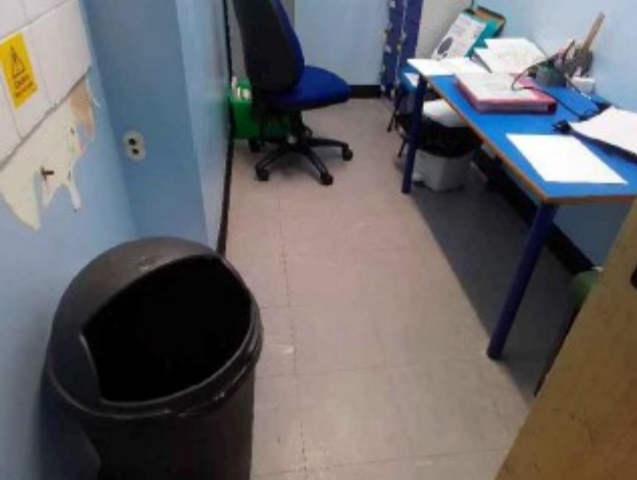
55	As OQ002235	Floor - Tile	Ground Floor G/062 Medical/First Aid Room	No Risk

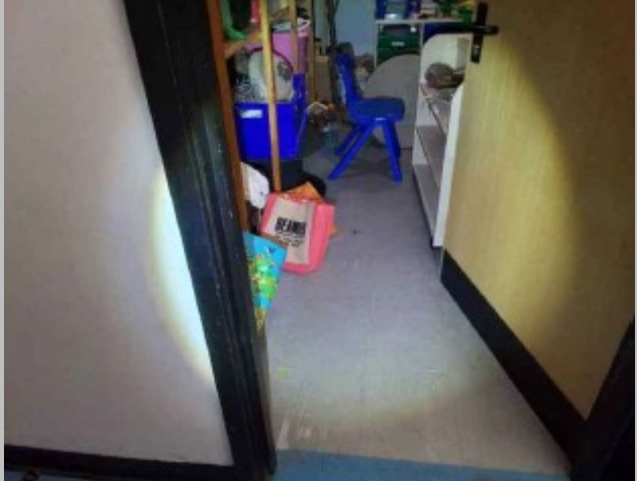
56	OQ002237	Floor - Tile - grey	Ground Floor G/063 Store Room	No Risk

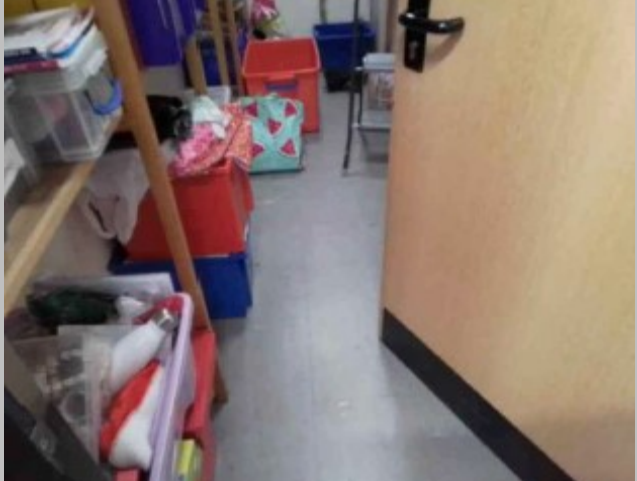
57	As OQ002237	Floor - Tile - grey	Ground Floor G/064 Store Room	No Risk

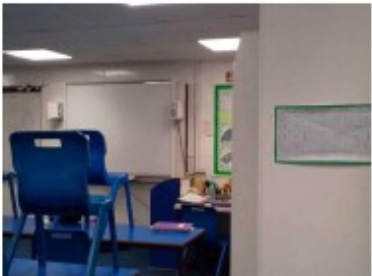
70	As OQ002242	Wall - behind plastic cladding and suspected behind window infill panels	Ground Floor G/076 Classroom - Year 6	Low Risk – Check every 6 months
Photo 1: Wide Angle		Photo 2: Close-up

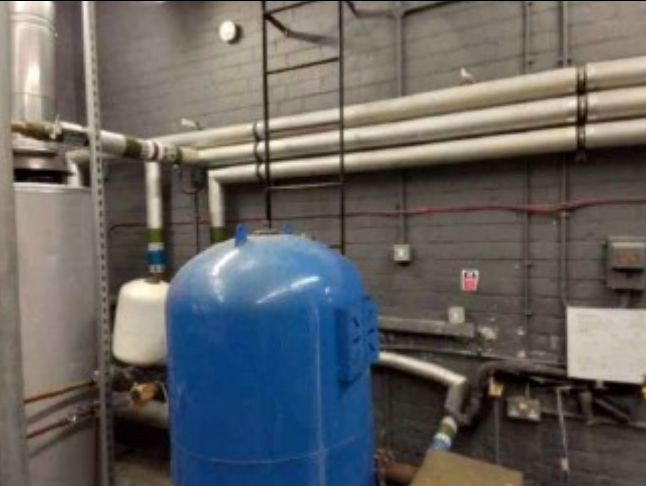
74	OQ002245	Debris/Residue - to RHS wall	External E/001 Boiler Room	No Risk

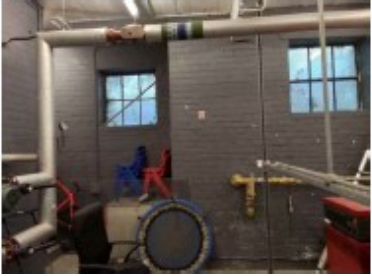
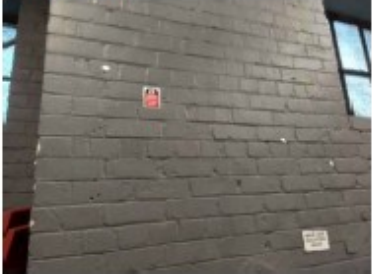
75	OQ002246	Debris/Residue - to RHS wall	External E/001 Boiler Room	Low Risk – Check every 6 months
Photo 1: Wide Angle		Photo 2: Close-up

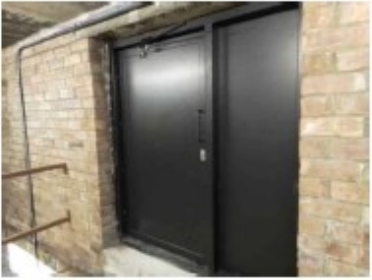
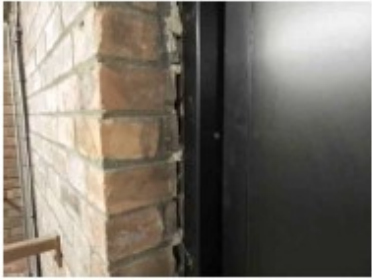
83	OQ002253	Wall - Lining - in wall cavity	External E/002 Tank Room	Very Low Risk – Check every 12 months
Photo 1: Wide Angle			Photo 2: Close-up

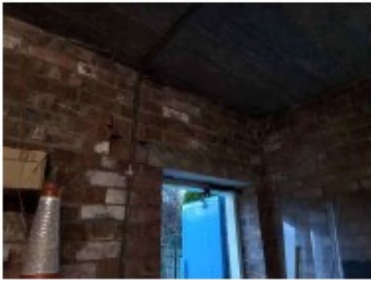
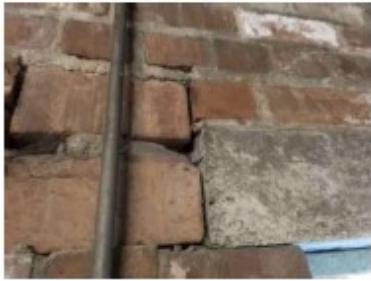
84	As OQ002253	Wall - Lining - in wall cavity	External E/003 Store Room	Very Low Risk – Check every 12 months
Photo 1: Wide Angle			Photo 2: Close-up

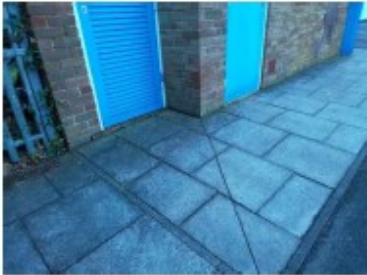
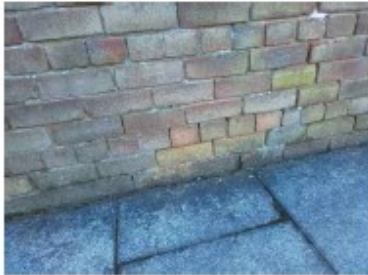
85	As OQ002253	Damp Proof Course - non visible	External E/004 Boiler Room	Very Low Risk – Check every 12 months
Photo 1: Wide Angle		Photo 2: Close-up

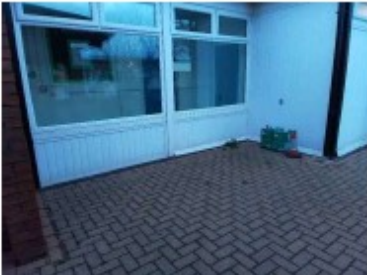
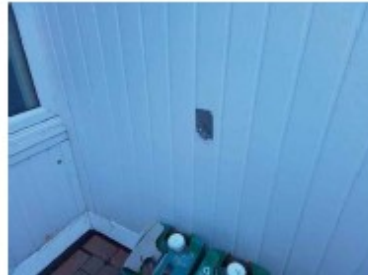
86	OQ002254	Wall - behind plastic cladding, inspected via pre-existing hole	External E/006 External	Low Risk – Check every 6 months
Photo 1: Wide Angle		Photo 2: Close-up

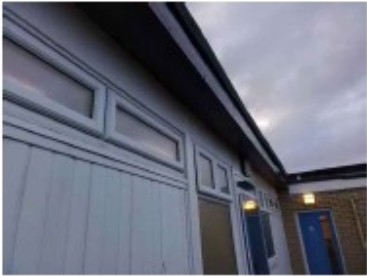
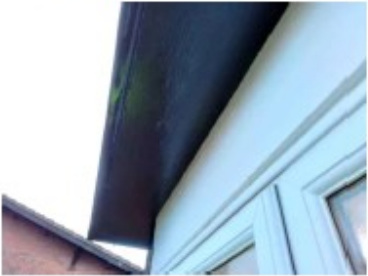
87	OQ002255	Soffits - throughout old block	External E/006 External	Very Low Risk – Check every 12 months
Photo 1: Wide Angle		Photo 2: Close-up

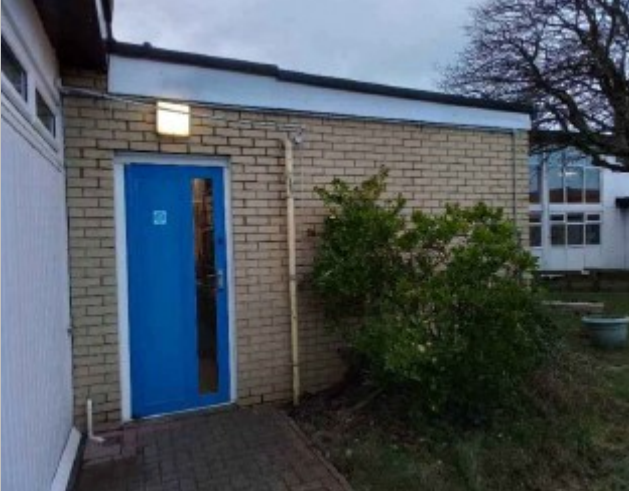
88	OQ002256	Wall - jointing compound, kitchen	External E/006 External	No Risk

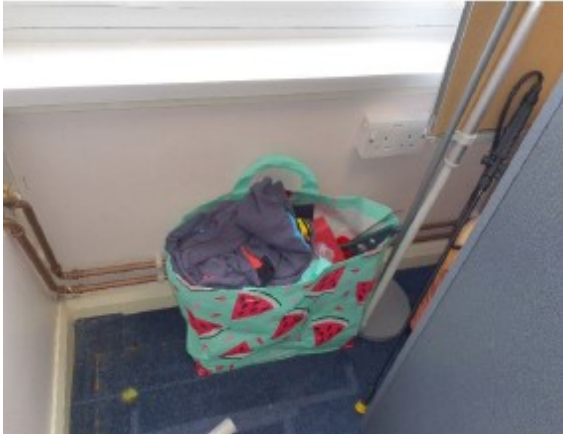
90	Presumed	Asbestos insulation board – low level walls behind wood	Daycare and Family Location 2/007 Store (G/02)	Low Risk – Check every 6 months

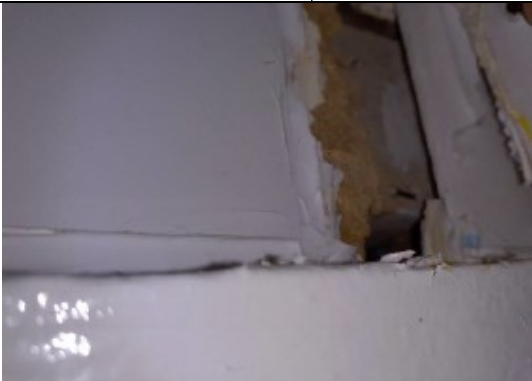
91	KG000830	Asbestos insulation board residue – in wall cavity above doorway to school	Daycare and Family Location 2/007 Daycare Room (G/03)	Medium Risk – check every 3 months

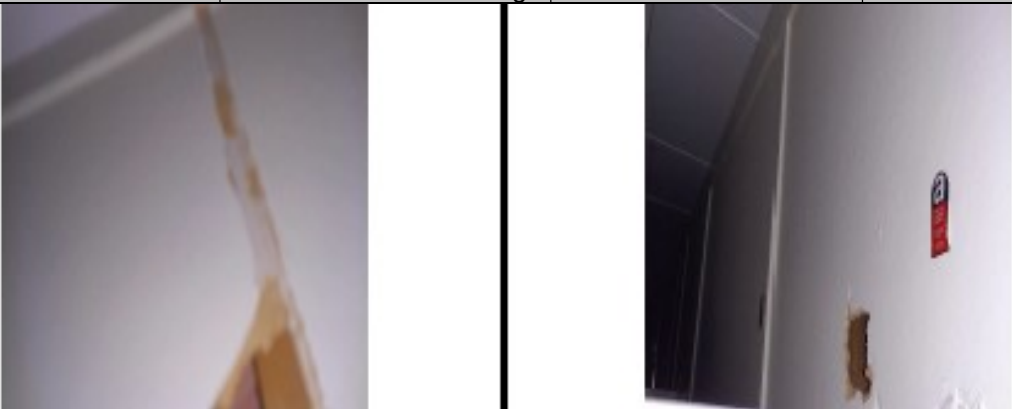
92	OU004369	Fibreboard wall in ceiling	Room G/10	No Risk

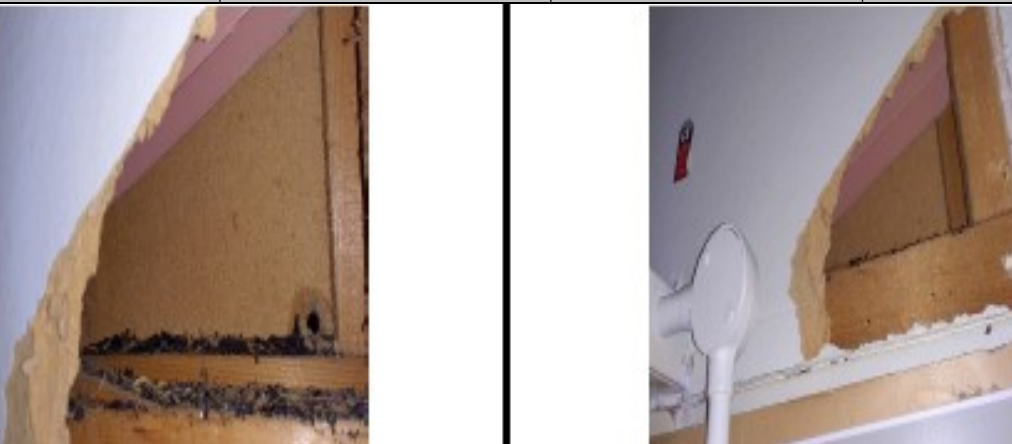
93	OU004370	Bitumen debris wall void	Room G/10	No Risk

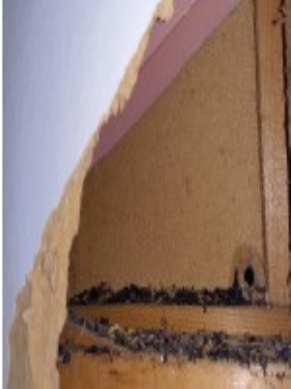
95	As OU004370	Bitumen debris wall void	Room G/11	No Risk
