ASBESTOS SURVEY REPORT FOR THORNEY CLOSE PRIMARY CARETAKERS HOUSE, SUNDERLAND

THORNEY CLOSE PRIMARY CARETAKERS HOUSE, SUNDERLAND

UPRN: - 203553

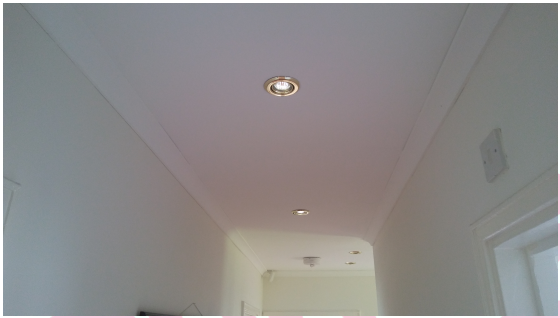
5	Presumed	Upper Ceiling	07/Hall Caretakers Bungalow	Very Low Risk - 12 monthly

<p>These areas were however inspected previously and asbestos identified, along with hall area, since then they have been over boarded. <i>(FP noted April 2026 that these might not be overboarded and just skimmed over – please take extra caution)</i></p> <p>Any change in its appearance should be recorded and passed to Property Services.</p>		
6	214430-1	Subfloor tile	Art Room – CT House	No Risk
<p>NO PHOTOGRAPH TAKEN</p>
