ASBESTOS SURVEY REPORT FOR CLAVERING PRIMARY SCHOOL,
CLAVERING ROAD, HARTLEPOOL, COUNTY DURHAM, TS27 3PN

Asbestos Register for Clavering Primary School, Hartlepool

Date: 24 November 2025

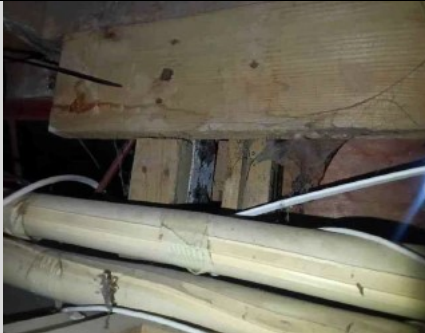
1	TL001061	Debris/Residue	Reception (Rm 0/47)	No Risk

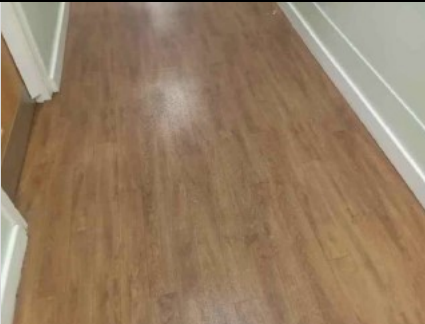
2	As TL001062	Flooring – covering beneath screed	Corridor (Rm 0/17)	No Risk

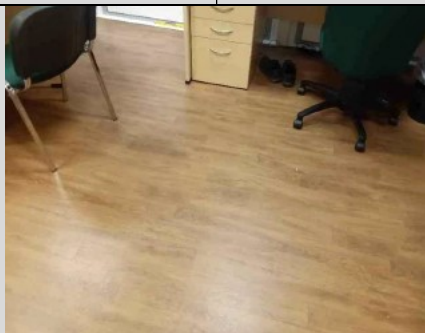
3	As TL001062	Flooring – covering beneath screed	Office (Rm 0/01a)	No Risk

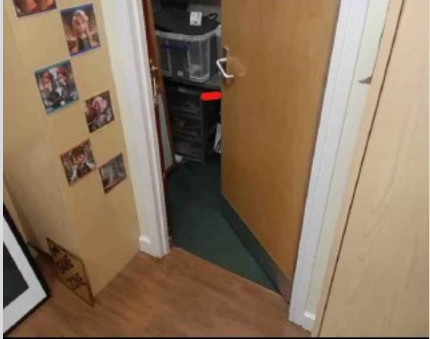
4	TL001062	Flooring – covering beneath screed	Store Room (Rm 0/01c)	No Risk

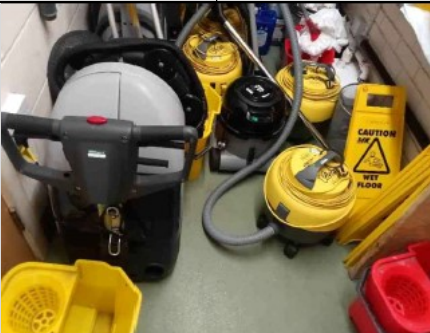
7	As TL001063	Flooring – covering beneath screed	Cupboard (Rm 0/65a)	No Risk

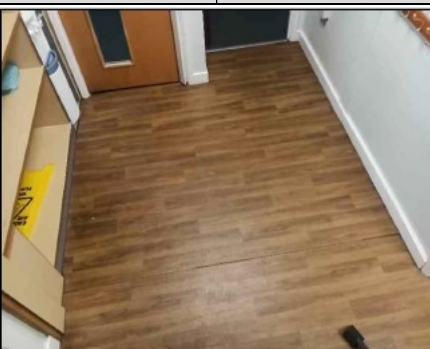
8	As TL001063	Flooring – covering beneath screed	Corridor (Rm 0/14)	No Risk

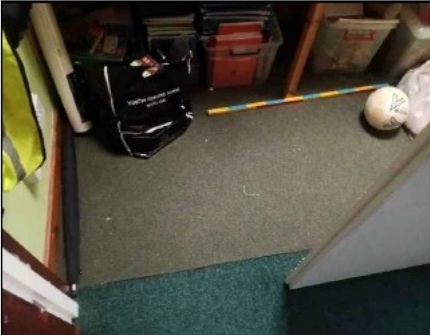
10	TL001064	Floor Covering	Store Room (Rm 0/02a)	No Risk

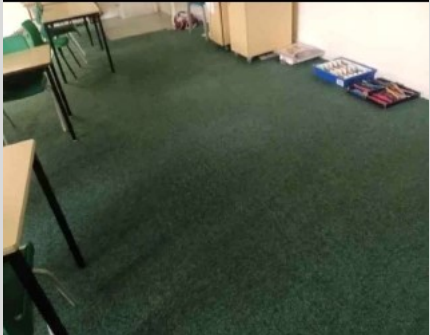
11	As TL001064	Floor Covering	Classroom (Rm 0/02)	No Risk

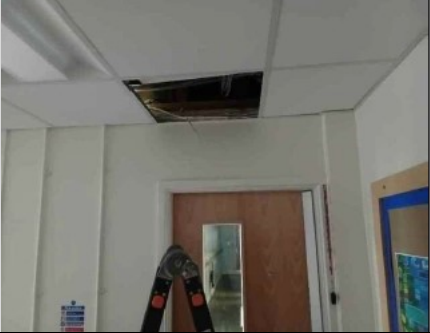
12	TL001065	Ceiling void paper covering above walls	Classroom (Rm 0/02)	No Risk

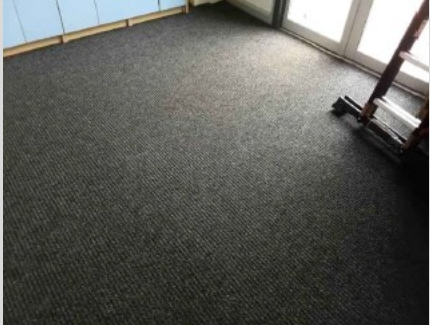
13	As TL001063	Flooring – covering beneath screed	Corridor (Rm 0/64)	No Risk

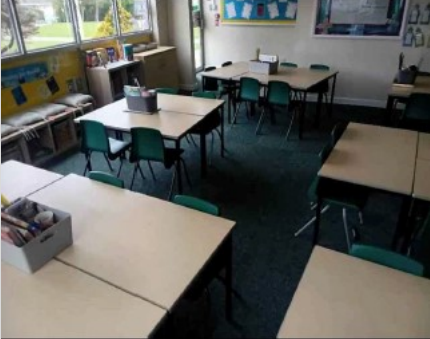
14	As TL001063	Flooring – covering beneath screed	Classroom (Rm 0/62)	No Risk

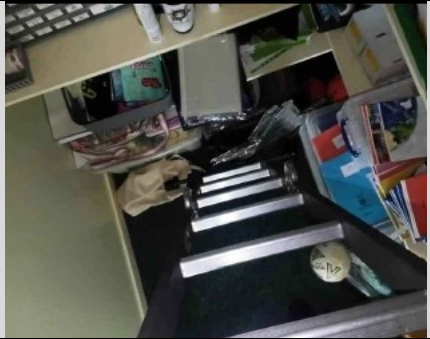
15	As TL001063	Flooring – covering beneath screed	Store Room inc Ceiling void (Rm 0/62a)	No Risk

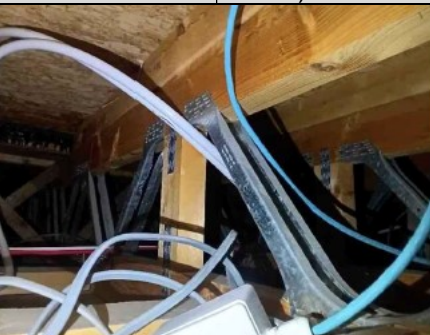
16	As TL001061	Ceiling void	Store Room inc Ceiling void (Rm 0/62a)	No Risk

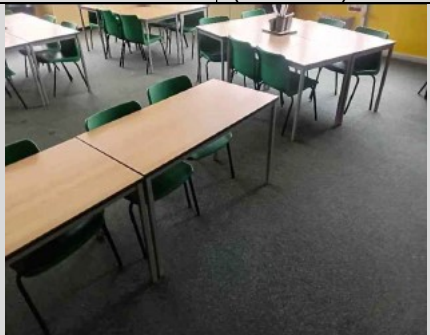
17	As TL001063	Flooring – covering beneath screed	Classroom inc Ceiling void limited inspection of void from hatch (Rm 0/63)	No Risk

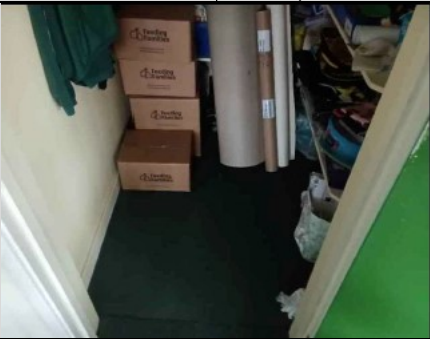
18	As TL001063	Flooring – covering beneath screed	Store Room (Rm 0/63a)	No Risk

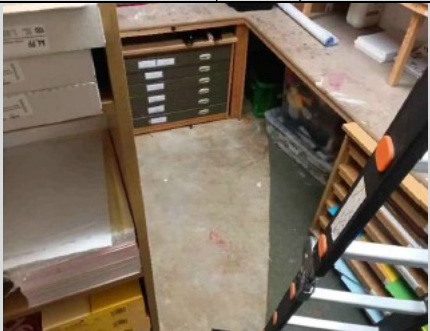
19	As TL001063	Flooring – covering beneath screed	Store Room (Rm 0/05a)	No Risk

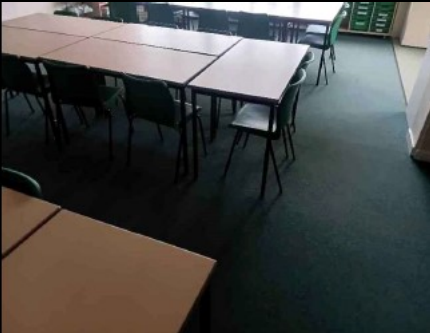
20	As TL001063	Flooring – covering beneath screed	Classroom (Rm 0/06)	No Risk

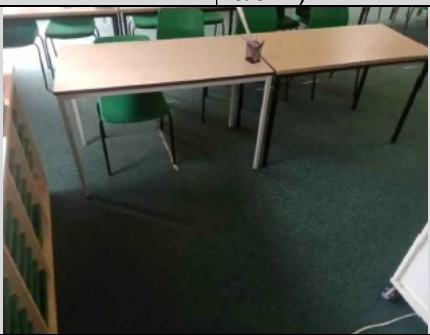
21	As TL001063	Flooring – covering beneath screed	Classroom (Rm 0/07a)	No Risk

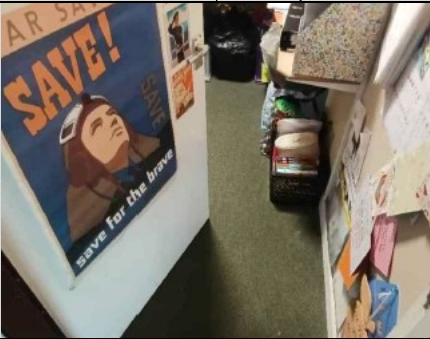
22	As TL001063	Flooring – covering beneath screed	Store Room (Rm 0/06a)	No Risk

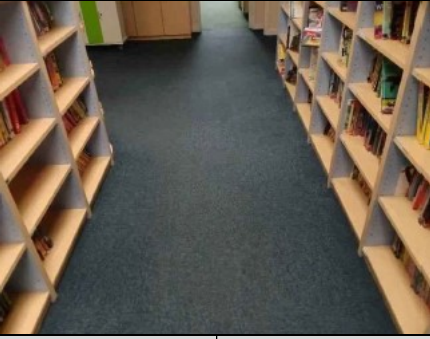
23	As TL001063	Flooring – covering beneath screed	Library (Rm 0/07)	No Risk

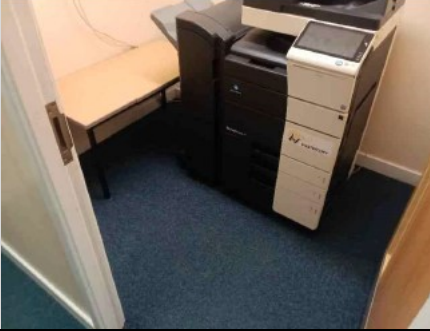
24	As TL001063	Flooring – covering beneath screed	Photocopy Room (Rm 0/07c)	No Risk

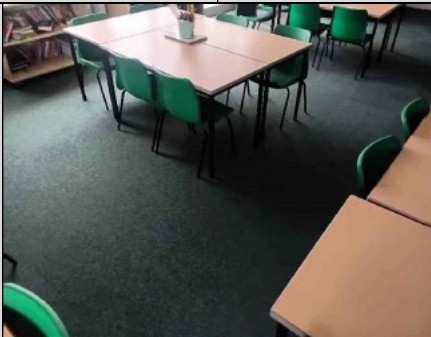
25	As TL001063	Flooring – covering beneath screed	Classroom (Rm 0/08)	No Risk

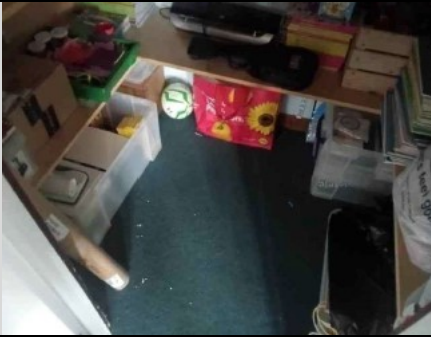
26	As TL001063	Flooring – covering beneath screed	Store Room (Rm 0/11a)	No Risk

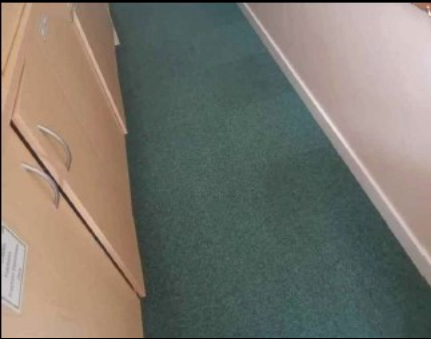
27	As TL001063	Flooring – covering beneath screed	Resources (Rm 0/11)	No Risk

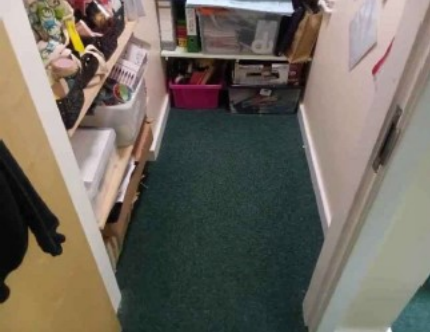
29	As TL001063	Flooring – covering beneath screed	Store Room (Rm 0/13b)	No Risk

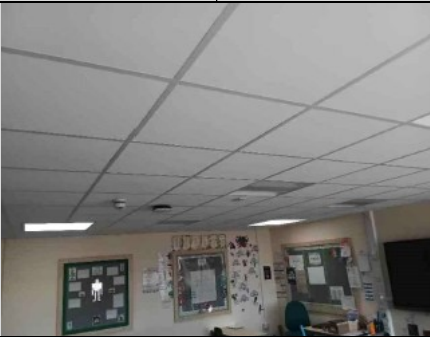
31	As TL001061	Ceiling void to central beams	Classroom (Rm 0/12)	No Risk

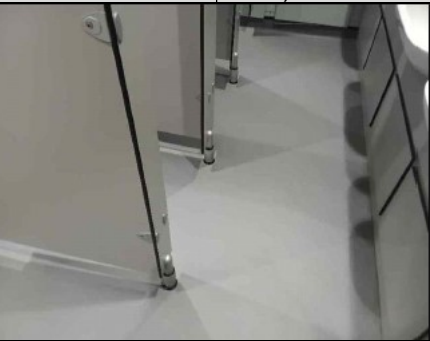
33	As TL001063	Flooring – covering beneath screed	Toilets Male (Rm 0/04)	No Risk

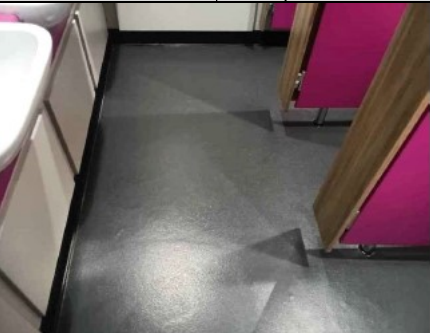
34	As TL001063	Flooring – covering beneath screed	Toilets Female (Rm 0/05)	No Risk

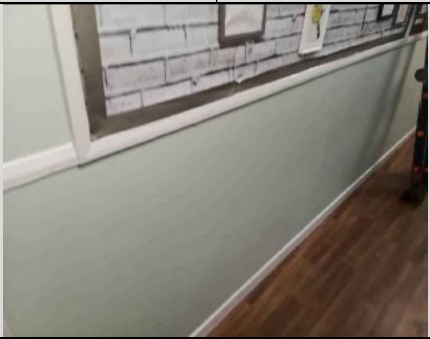
35	As TL001063	Flooring – covering beneath screed	Services (Rm 0/04a	No Risk

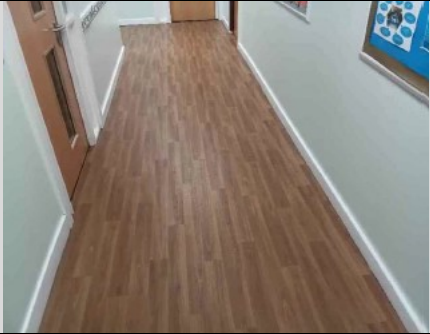
36	As TL001063	Flooring – covering beneath screed	Corridor (Rm 0/30)	No Risk

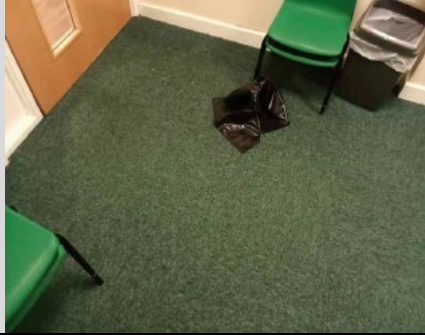
37	As TL001063	Flooring – covering beneath screed	Classroom (Rm 0/19b)	No Risk

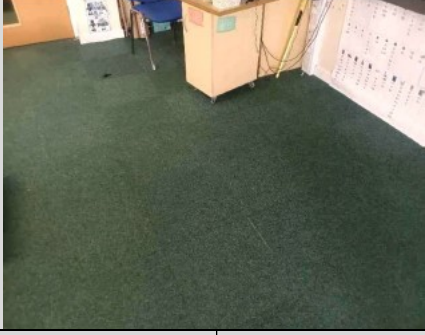
38	As TL001063	Flooring – covering beneath screed	Classroom (Rm 0/19a)	No Risk

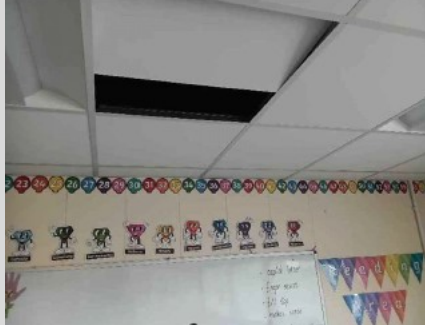
39	TL001067	Ceiling Void – Ceiling above	Classroom (Rm 0/19a)	No Risk

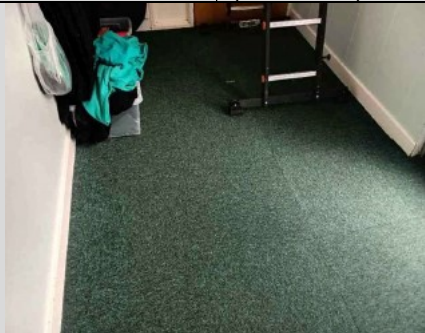
40	As TL001063	Flooring – covering beneath screed	Entrance Hall/Foyer (Rm 0/20a)	No Risk

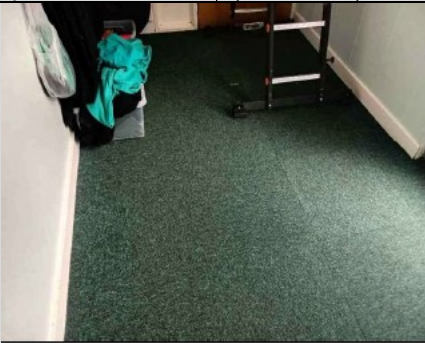
41	As TL001068	Ceiling void bitumen to paper	Entrance Hall/Foyer (Rm 0/20a)	No Risk

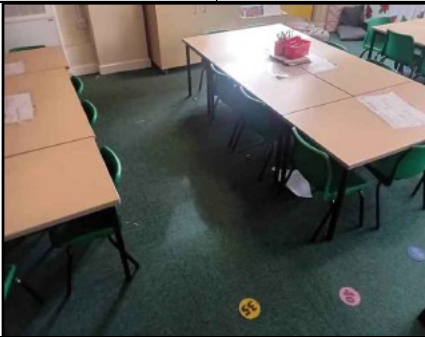
42	As TL001063	Flooring – covering beneath screed	Classroom (Rm 0/19)	No Risk

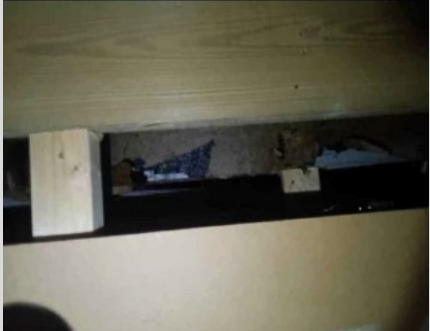
43	TL001068	Ceiling void bitumen to paper	Classroom (Rm 0/19)	No Risk

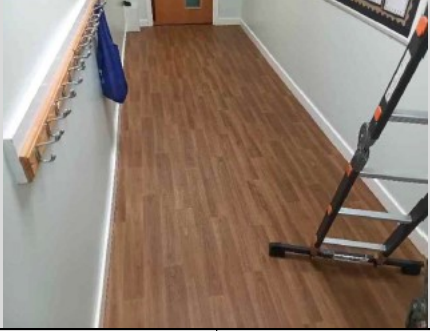
44	As TL001063	Flooring – covering beneath screed	Corridor (Rm 0/26)	No Risk

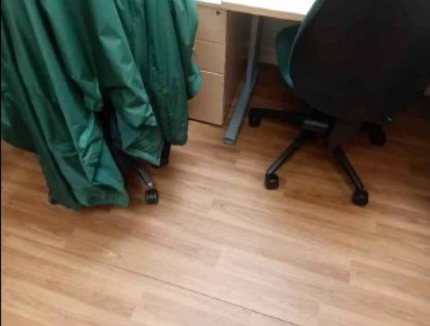
45	As TL001063	Flooring – covering beneath screed	Office (Rm 0/20)	No Risk

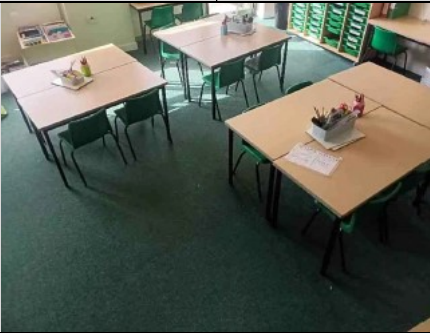
46	As TL001063	Flooring – covering beneath screed	Classroom (Rm 0/24)	No Risk

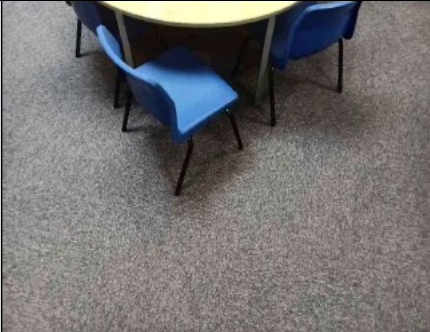
48	As TL001063	Flooring – covering beneath screed	Classroom (Rm 0/25)	No Risk

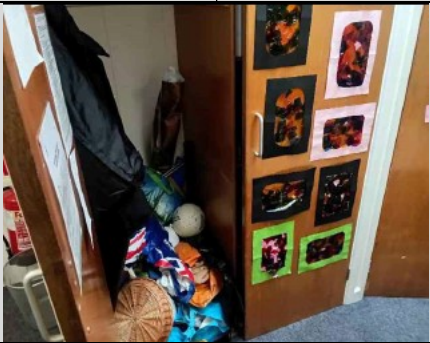
49	As TL001063	Flooring – covering beneath screed	Cupboard (Rm 0/25e)	No Risk

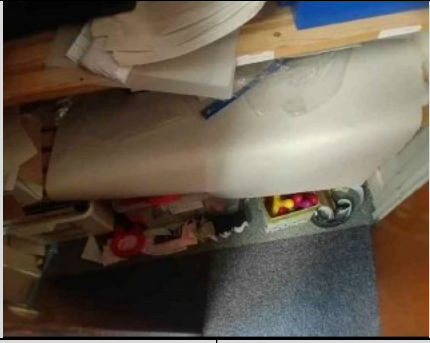
50	As TL001063	Flooring – covering beneath screed	Cupboard (Rm 0/25f)	No Risk

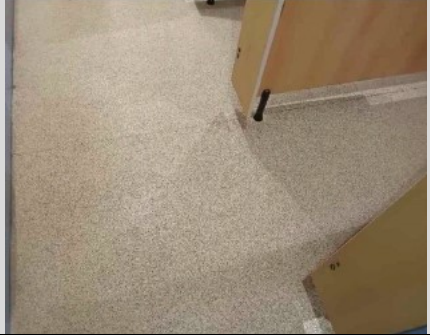
51	As TL001063	Flooring – covering beneath screed	Toilets (Rm 0/25b)	No Risk

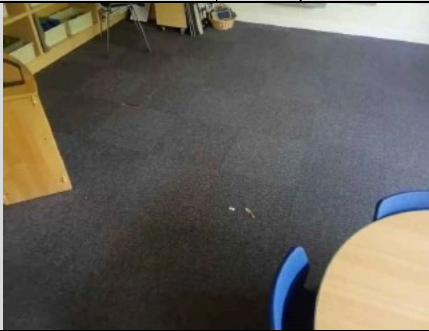
52	As TL001063	Flooring – covering beneath screed	Classroom (Rm 0/24a)	No Risk

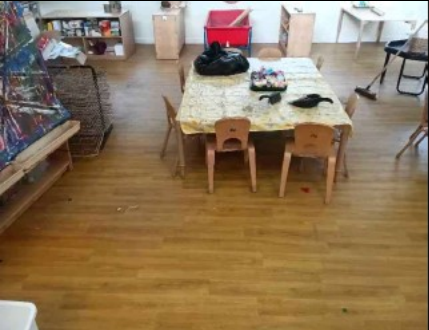
53	As TL001063	Flooring – covering beneath screed	Classroom (Rm 0/25c)	No Risk

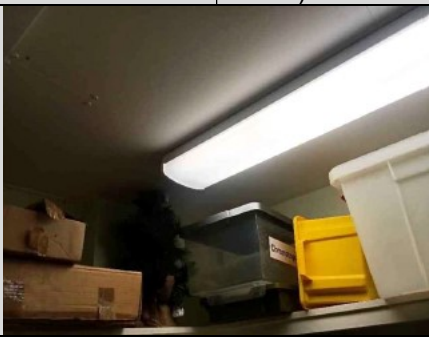
54	TL001069	Ceiling	Store Room (Rm 0/33a)	No Risk

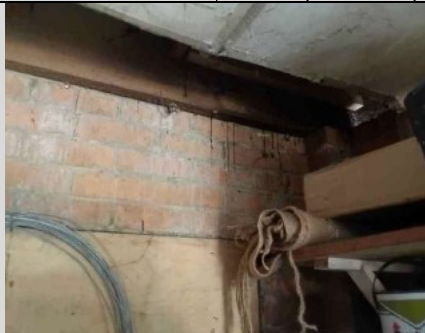
58	TL001076	Ceiling void residue	Externally Accessed Store (Rm 0/48)	No Risk

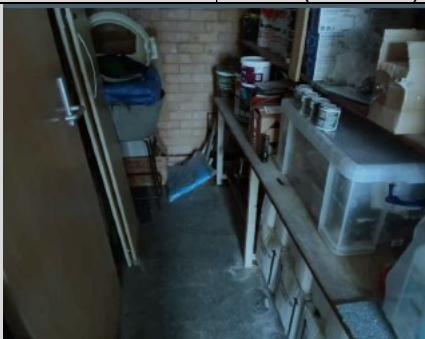
59	TL001077	Damp Proof Course	Externally Accessed Store (Rm 0/48)	No Risk

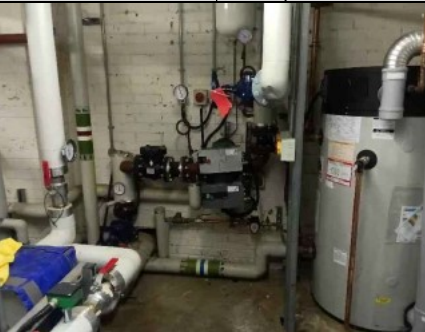
60	TL001078	Pipework Gaskets	Boiler Room (Rm 0/49)	No Risk

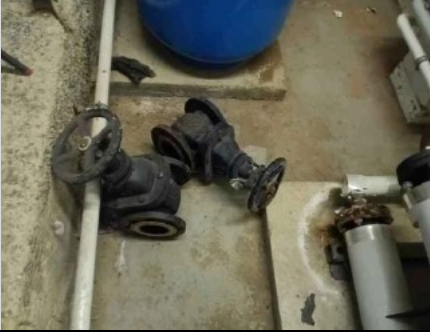
61	TL001079	Pipework Gaskets residue to exposed flange	Boiler Room (Rm 0/49)	No Risk

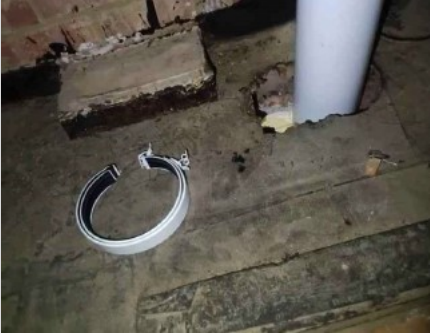
62	TL001080	Floor covering to upper level floor	Boiler Room (Rm 0/49)	No Risk

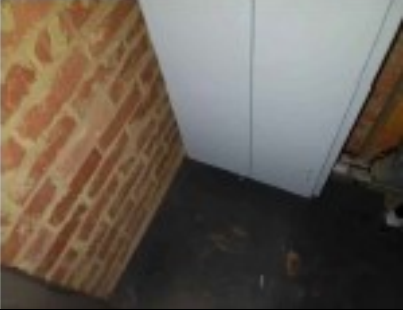
63	TL001075	Damp Proof Course	Cupboard – Meter (Rm 0/50)	Very Low Risk

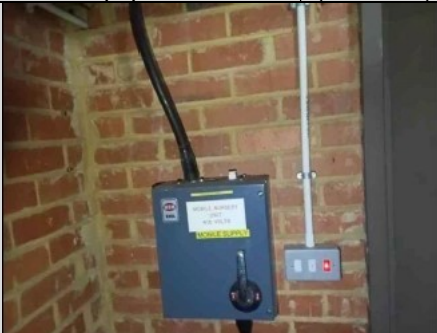
64	TL001082	Debris/Residue to electrical equipment	Cupboard – Meter (Rm 0/50)	No Risk

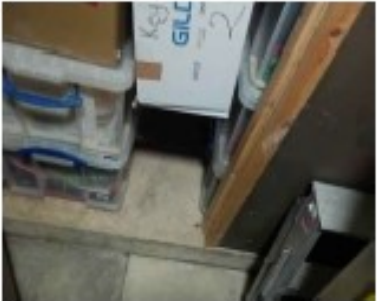
65	As TL001075	Damp Proof Course	Store Room (Rm 0/50a)	Very Low Risk

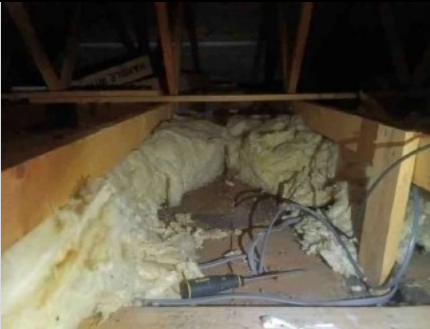
71	TL001071	Debris	Loft Space L/01 Breakfast and after schools club	No Risk

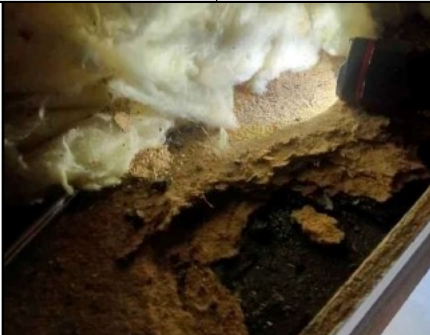
72	As TL001071	Floor covering backing to fibreboard floor	Loft Space L/01 Breakfast and after schools club	No Risk

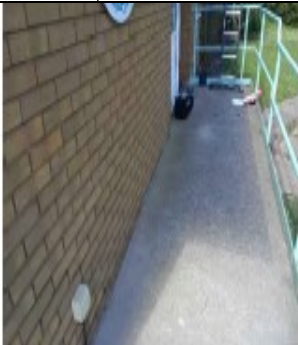
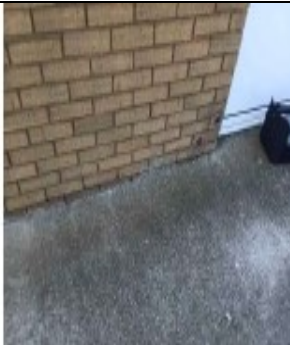
73	TL001074	Damp proof course	External E/01 Breakfast and after schools club	Low Risk

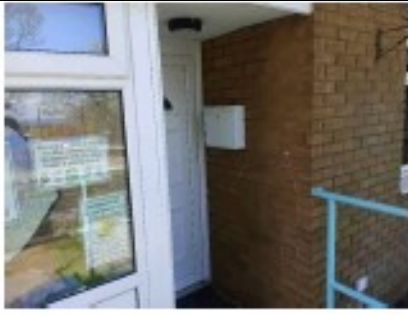
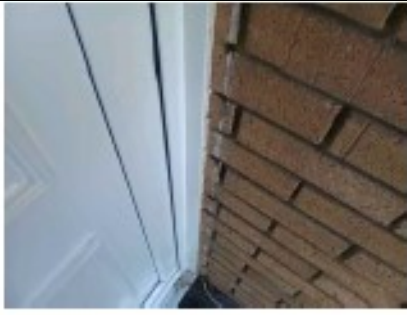
74	As TL001073	Wall behind modern silicone sealant	External E/01 Breakfast and after schools club	Very Low Risk

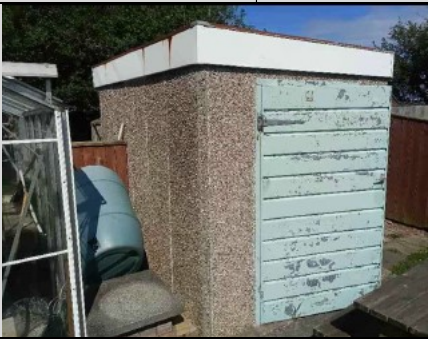
75	TL001075	Wall jointing compound	External E/01 Caretaker's Store	No Risk
