ASBESTOS SURVEY REPORT FOR CLAVERING PRIMARY SCHOOL,  
CLAVERING ROAD, HARTLEPOOL, COUNTY DURHAM, TS27 3PN

## **Asbestos Register for Clavering Primary School, Hartlepool**

**Date: 20 May 2025**

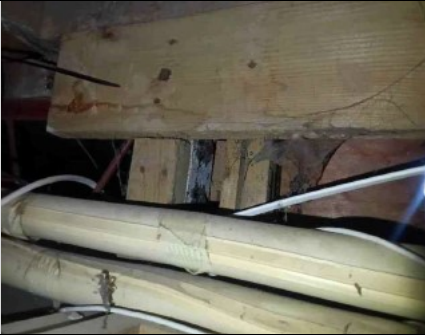
1	TL001061	Debris/Residue	Reception (Rm 0/47)	No Risk

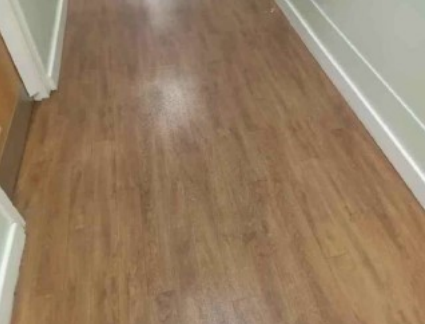
2	As TL001062	Flooring – covering beneath screed	Corridor (Rm 0/17)	No Risk

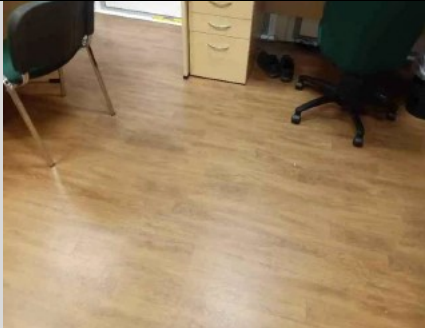
3	As TL001062	Flooring – covering beneath screed	Office (Rm 0/01a)	No Risk

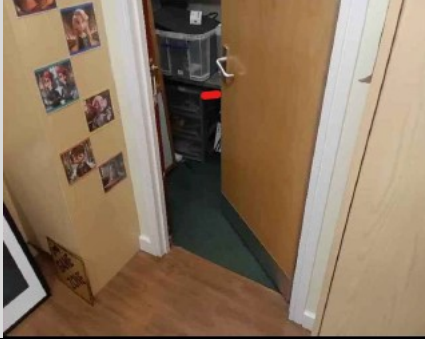
4	TL001062	Flooring – covering beneath screed	Store Room (Rm 0/01c)	No Risk

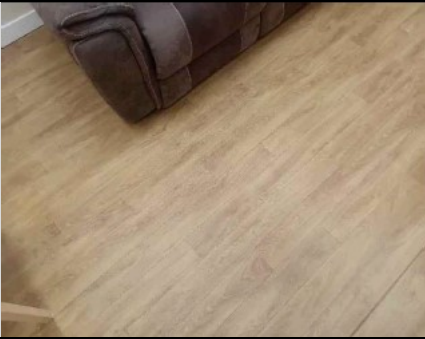
5	As TL001062	Flooring – covering beneath screed	PPA (Rm 0/01b)	No Risk

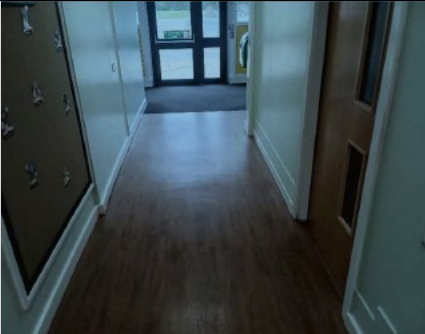
6	TL001063	Flooring – covering beneath screed	Corridor (Rm 0/65)	No Risk

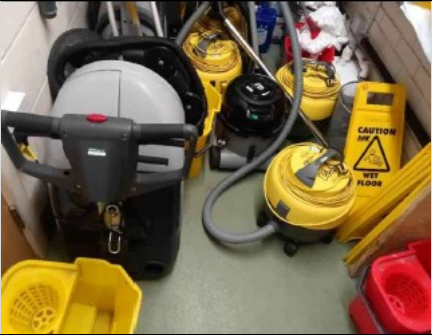
7	As TL001063	Flooring – covering beneath screed	Cupboard (Rm 0/65a)	No Risk

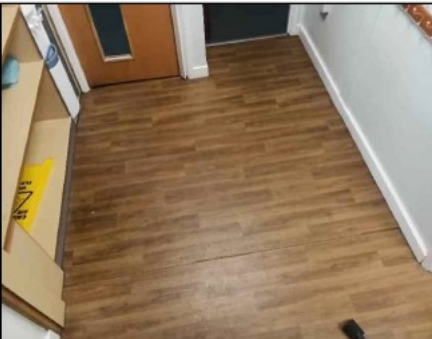
8	As TL001063	Flooring – covering beneath screed	Corridor (Rm 0/14)	No Risk

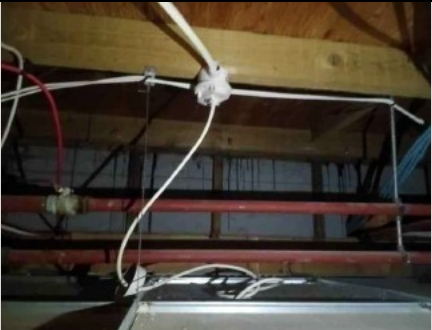
9	As TL001061	Debris/Residue in void above double door to 065	Corridor (Rm 0/14)	No Risk

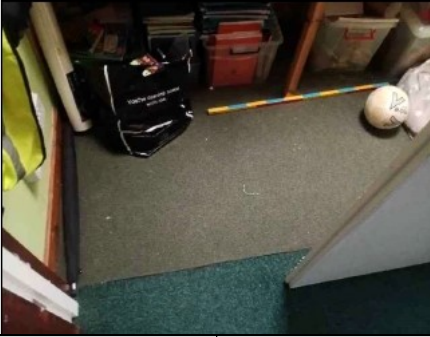
10	TL001064	Floor Covering	Store Room (Rm 0/02a)	No Risk

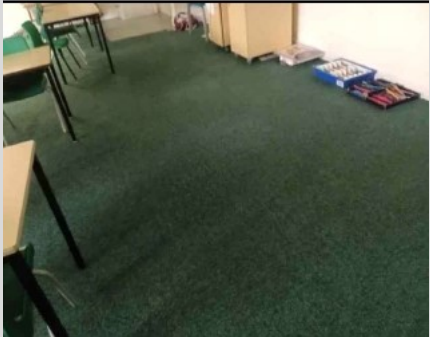
11	As TL001064	Floor Covering	Classroom (Rm 0/02)	No Risk

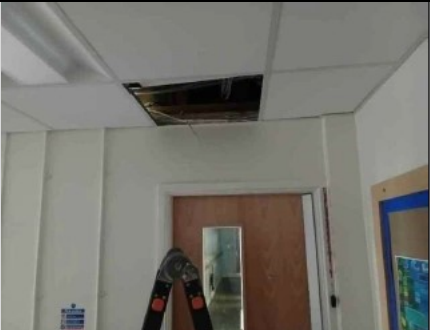
12	TL001065	Ceiling void paper covering above walls	Classroom (Rm 0/02)	No Risk

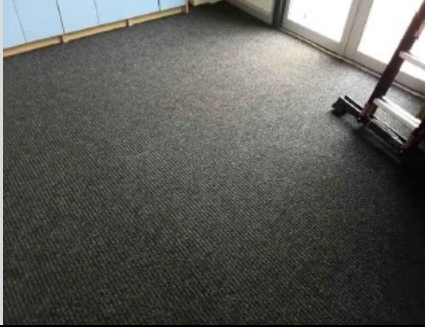
13	As TL001063	Flooring – covering beneath screed	Corridor (Rm 0/64)	No Risk

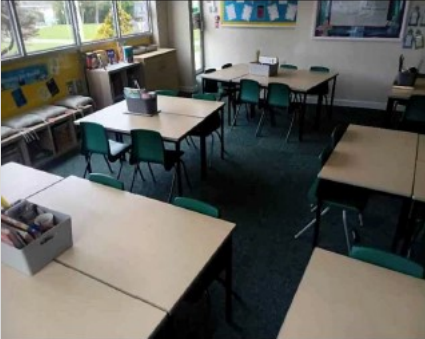
14	As TL001063	Flooring – covering beneath screed	Classroom (Rm 0/62)	No Risk

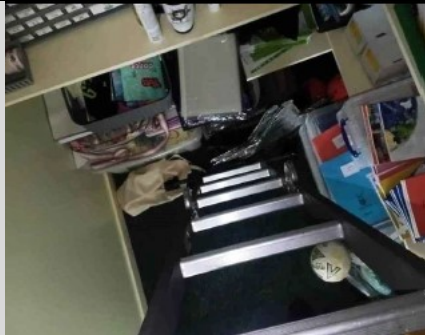
15	As TL001063	Flooring – covering beneath screed	Store Room inc Ceiling void (Rm 0/62a)	No Risk

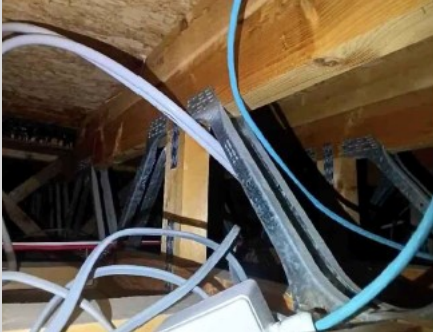
16	As TL001061	Ceiling void	Store Room inc Ceiling void (Rm 0/62a)	No Risk

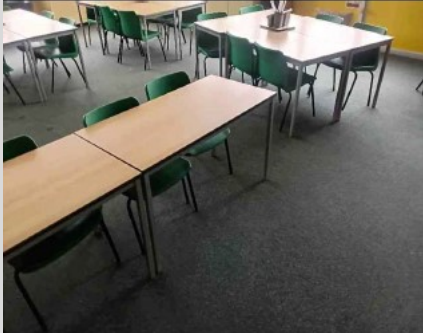
17	As TL001063	Flooring – covering beneath screed	Classroom inc Ceiling void limited inspection of void from hatch (Rm 0/63)	No Risk

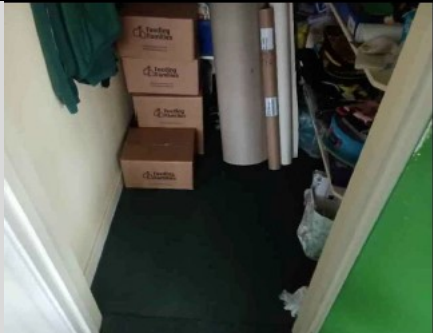
18	As TL001063	Flooring – covering beneath screed	Store Room (Rm 0/63a)	No Risk

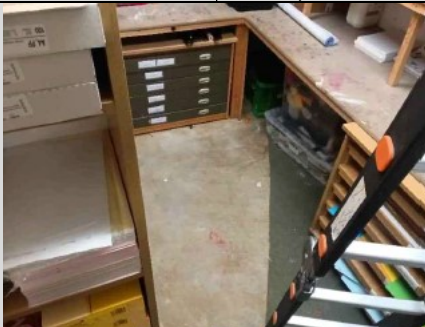
19	As TL001063	Flooring – covering beneath screed	Store Room (Rm 0/05a)	No Risk

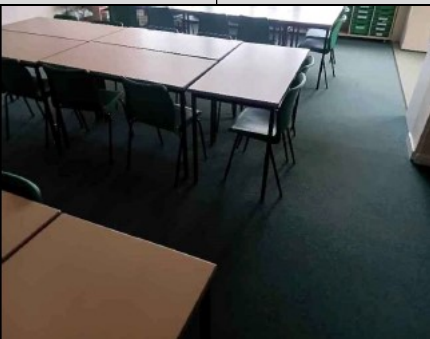
20	As TL001063	Flooring – covering beneath screed	Classroom (Rm 0/06)	No Risk

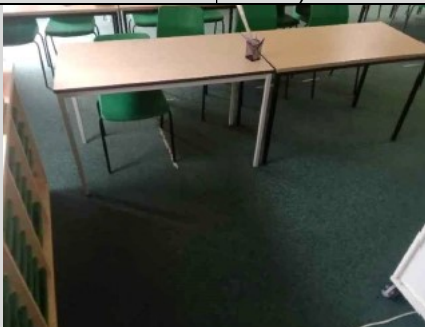
21	As TL001063	Flooring – covering beneath screed	Classroom (Rm 0/07a)	No Risk

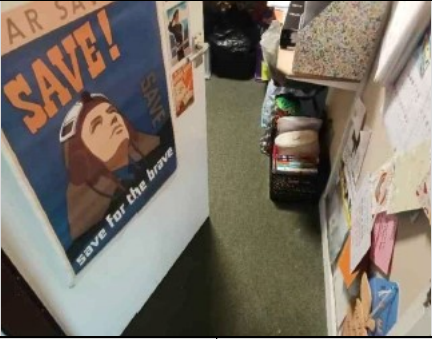
22	As TL001063	Flooring – covering beneath screed	Store Room (Rm 0/06a)	No Risk

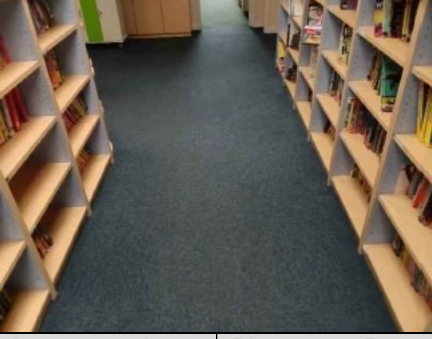
23	As TL001063	Flooring – covering beneath screed	Library (Rm 0/07)	No Risk

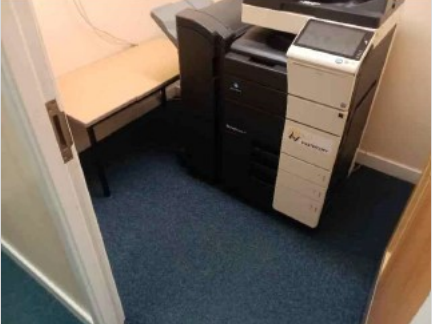
24	As TL001063	Flooring – covering beneath screed	Photocopy Room (Rm 0/07c)	No Risk

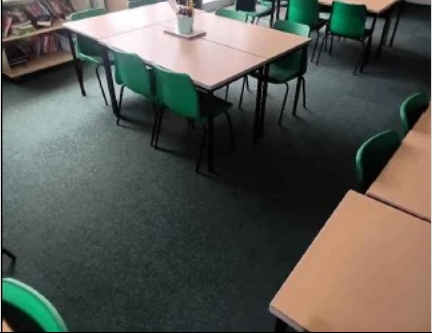
25	As TL001063	Flooring – covering beneath screed	Classroom (Rm 0/08)	No Risk

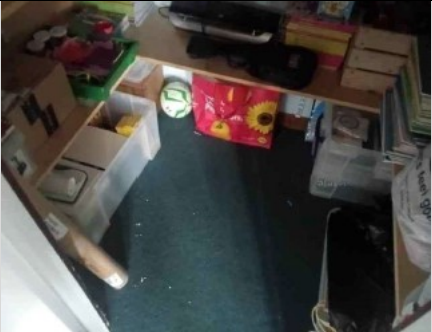
26	As TL001063	Flooring – covering beneath screed	Store Room (Rm 0/11a)	No Risk

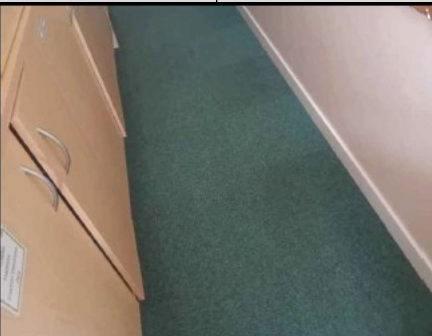
27	As TL001063	Flooring – covering beneath screed	Resources (Rm 0/11)	No Risk

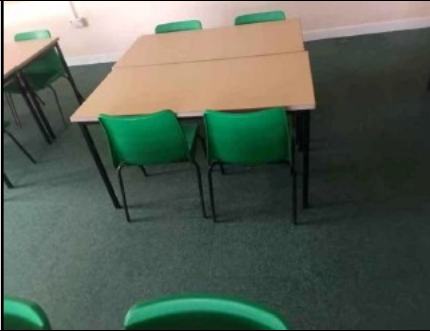
28	As TL001063	Flooring – covering beneath screed	Classroom (Rm 0/13)	No Risk

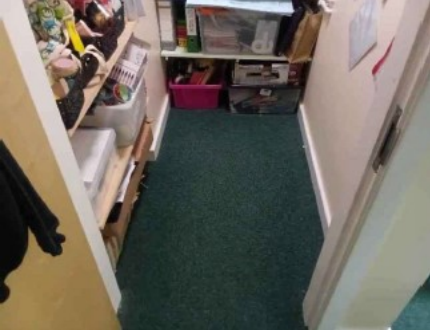
29	As TL001063	Flooring – covering beneath screed	Store Room (Rm 0/13b)	No Risk

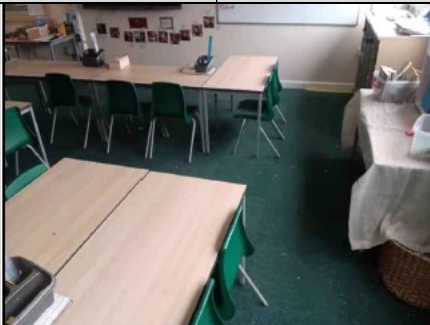
30	TL001066	Flooring – covering beneath screed	Classroom (Rm 0/12)	No Risk

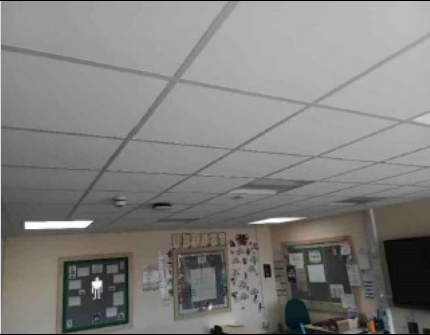
31	As TL001061	Ceiling void to central beams	Classroom (Rm 0/12)	No Risk

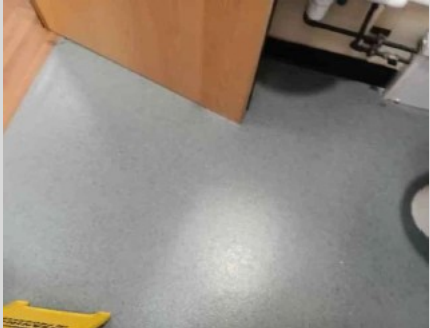
32	As TL001063	Flooring – covering beneath screed	Toilets (Rm 0/07d)	No Risk

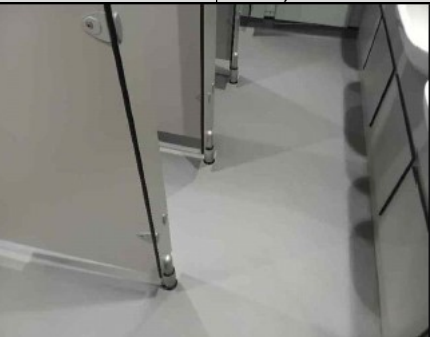
33	As TL001063	Flooring – covering beneath screed	Toilets Male (Rm 0/04)	No Risk

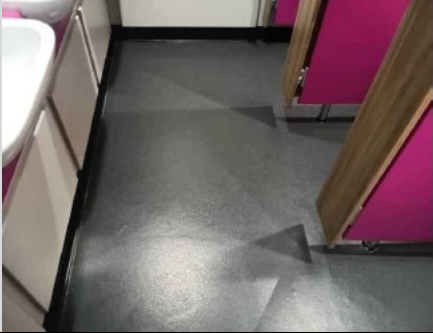
34	As TL001063	Flooring – covering beneath screed	Toilets Female (Rm 0/05)	No Risk

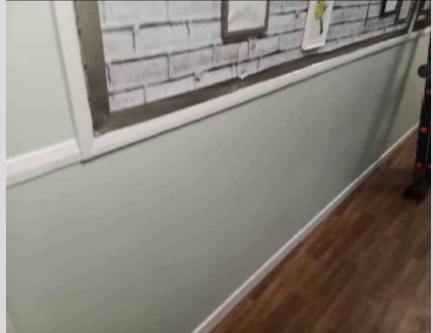
35	As TL001063	Flooring – covering beneath screed	Services (Rm 0/04a)	No Risk

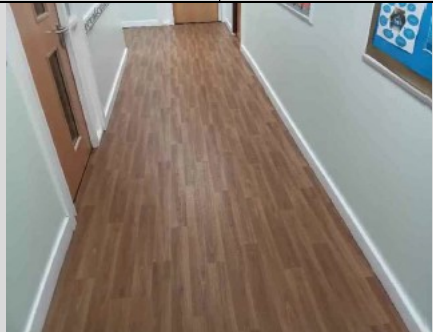
36	As TL001063	Flooring – covering beneath screed	Corridor (Rm 0/30)	No Risk

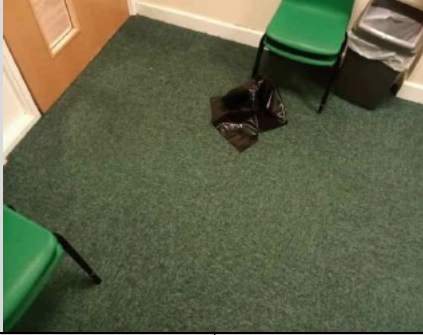
37	As TL001063	Flooring – covering beneath screed	Classroom (Rm 0/19b)	No Risk

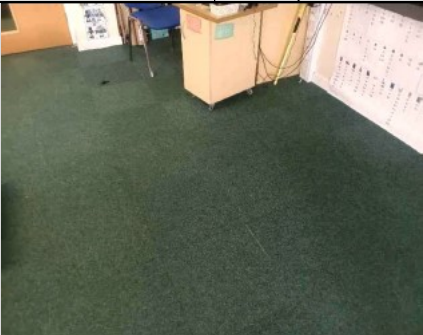
38	As TL001063	Flooring – covering beneath screed	Classroom (Rm 0/19a)	No Risk

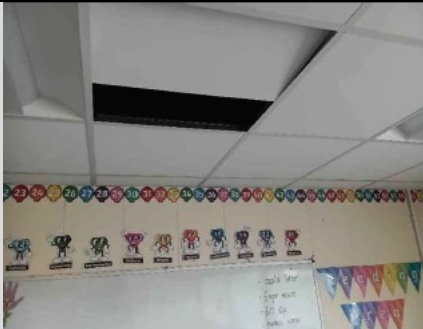
39	TL001067	Ceiling Void – Ceiling above	Classroom (Rm 0/19a)	No Risk

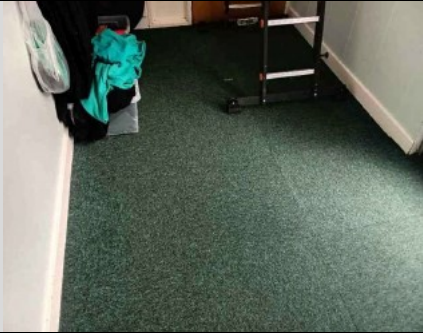
40	As TL001063	Flooring – covering beneath screed	Entrance Hall/Foyer (Rm 0/20a)	No Risk

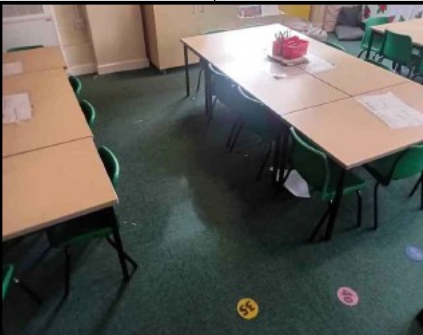
42	As TL001063	Flooring – covering beneath screed	Classroom (Rm 0/19)	No Risk

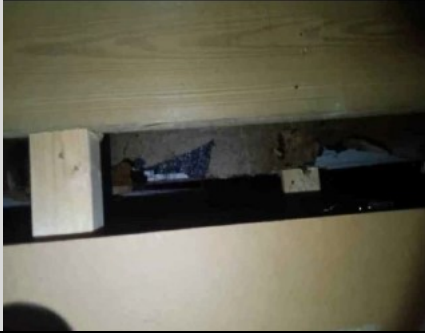
43	TL001068	Ceiling void bitumen to paper	Classroom (Rm 0/19)	No Risk

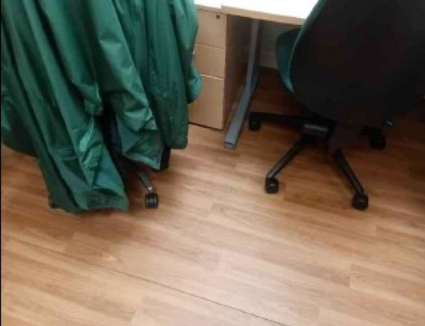
45	As TL001063	Flooring – covering beneath screed	Office (Rm 0/20)	No Risk

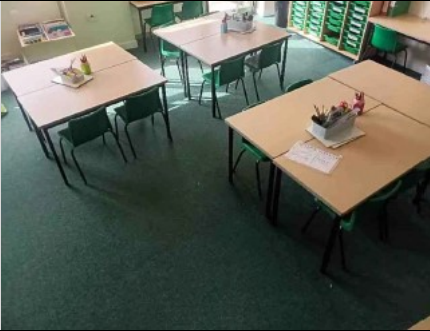
46	As TL001063	Flooring – covering beneath screed	Classroom (Rm 0/24)	No Risk

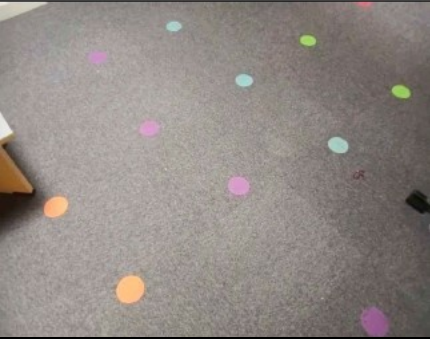
47	As TL001063	Flooring – covering beneath screed	Classroom (Rm 0/25a)	No Risk

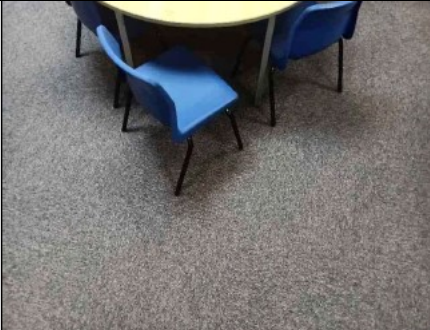
48	As TL001063	Flooring – covering beneath screed	Classroom (Rm 0/25)	No Risk

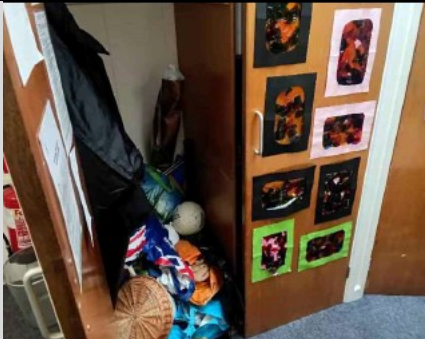
49	As TL001063	Flooring – covering beneath screed	Cupboard (Rm 0/25e)	No Risk

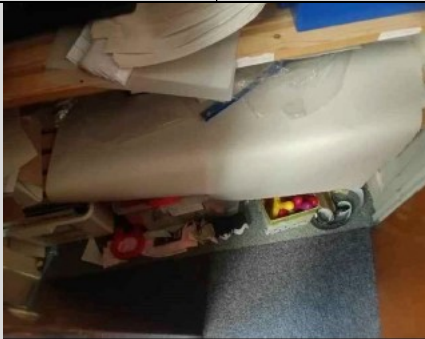
50	As TL001063	Flooring – covering beneath screed	Cupboard (Rm 0/25f)	No Risk

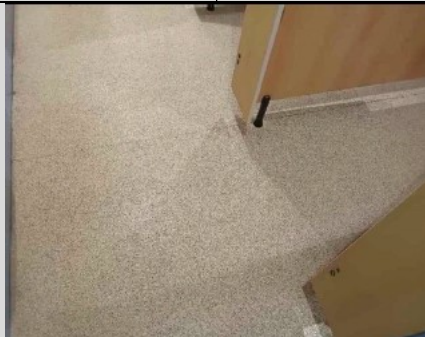
51	As TL001063	Flooring – covering beneath screed	Toilets (Rm 0/25b)	No Risk

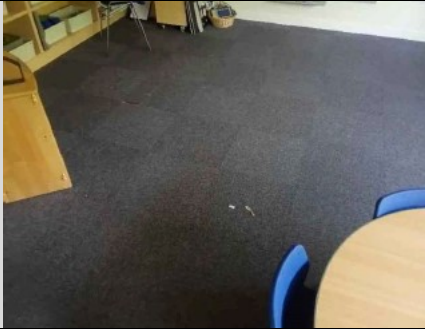
52	As TL001063	Flooring – covering beneath screed	Classroom (Rm 0/24a)	No Risk

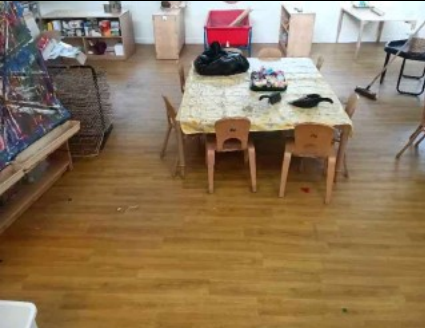
53	As TL001063	Flooring – covering beneath screed	Classroom (Rm 0/25c)	No Risk

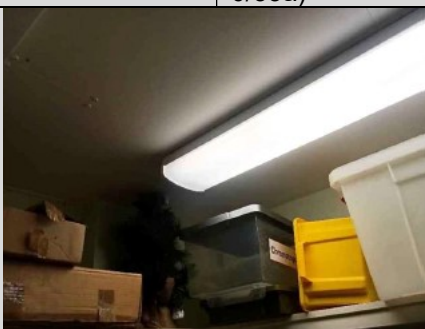
54	TL001069	Ceiling	Store Room (Rm 0/33a)	No Risk

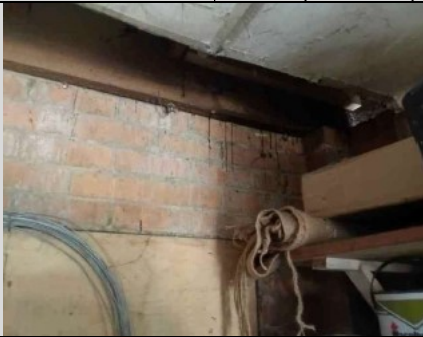
58	TL001076	Ceiling void residue	Externally Accessed Store (Rm 0/48)	No Risk

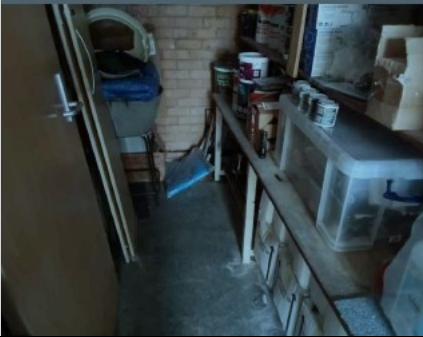
59	TL001077	Damp Proof Course	Externally Accessed Store (Rm 0/48)	No Risk

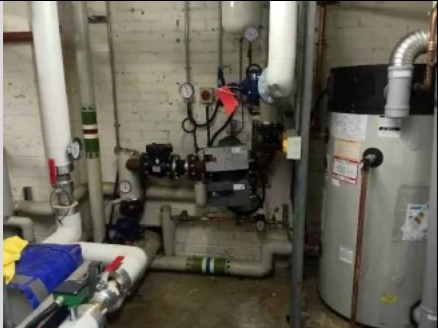
60	TL001078	Pipework Gaskets	Boiler Room (Rm 0/49)	No Risk

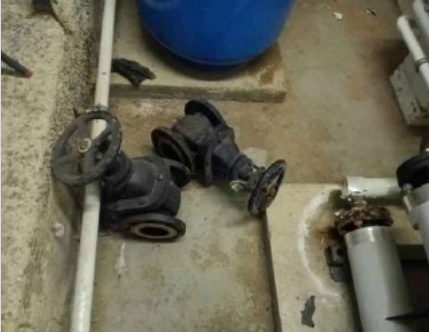
61	TL001079	Pipework Gaskets residue to exposed flange	Boiler Room (Rm 0/49)	No Risk

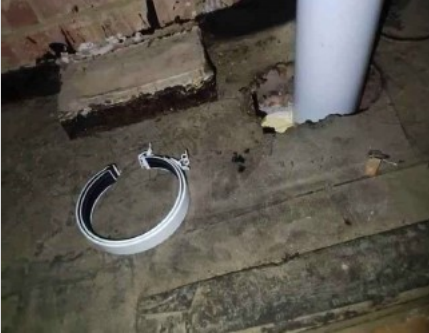
62	TL001080	Floor covering to upper level floor	Boiler Room (Rm 0/49)	No Risk

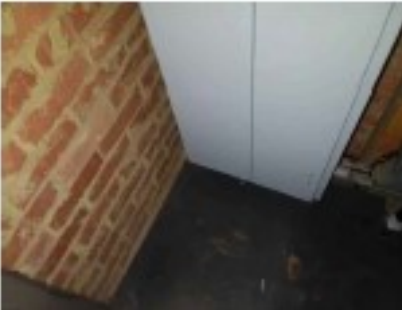
63	TL001075	Damp Proof Course	Cupboard – Meter (Rm 0/50)	Very Low Risk

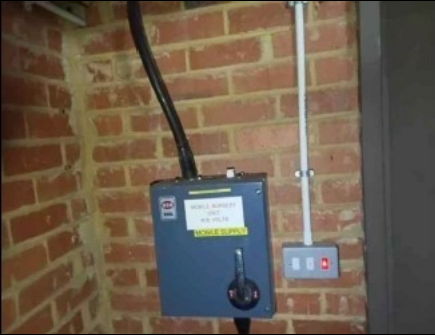
64	TL001082	Debris/Residue to electrical equipment	Cupboard – Meter (Rm 0/50)	No Risk

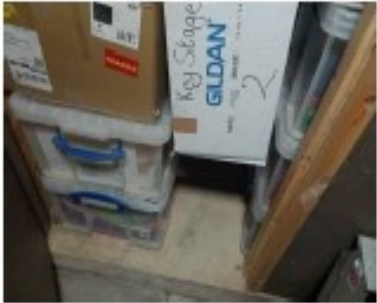
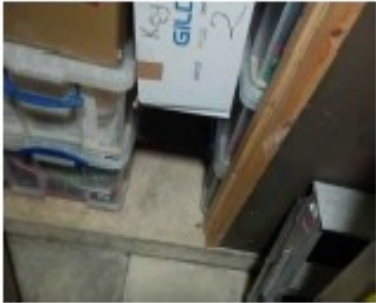
65	As TL001075	Damp Proof Course	Store Room (Rm 0/50a)	Very Low Risk

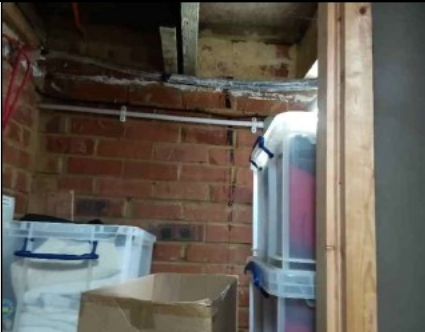
66	As TL001076	Wall Residue	Store Room (Rm 0/50a)	No Risk

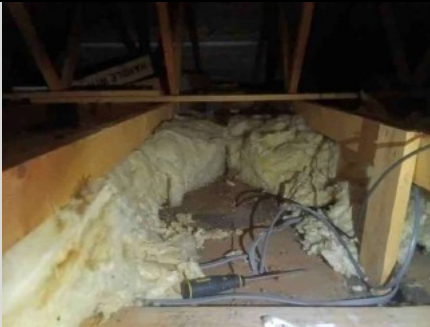
71	TL001071	Debris	Loft Space L/01 Breakfast and after schools club	No Risk

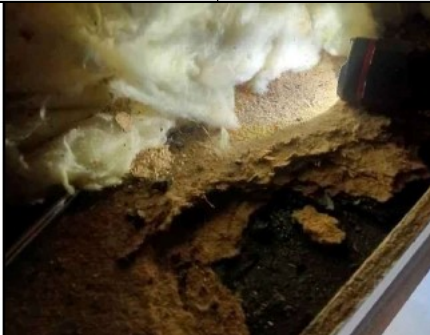
72	As TL001071	Floor covering backing to fibreboard floor	Loft Space L/01 Breakfast and after schools club	No Risk

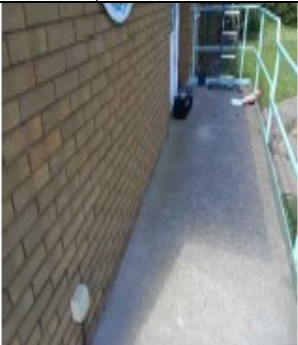
73	TL001074	Damp proof course	External E/01 Breakfast and after schools club	Low Risk

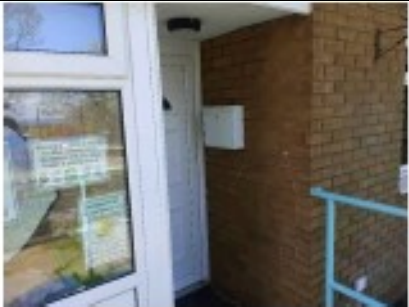
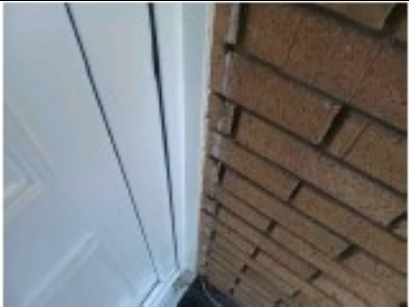
74	As TL001073	Wall behind modern silicone sealant	External E/01 Breakfast and after schools club	Very Low Risk

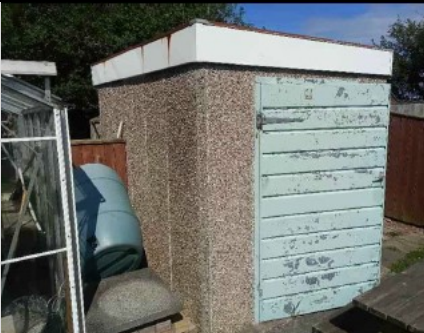
75	TL001075	Wall jointing compound	External E/01 Caretaker's Store	No Risk
