ASBESTOS SURVEY REPORT FOR GREENFIELDS NURSERY AND PRE SCHOOL, TAYLOR AVENUE, WIDEOPEN, NEWCASTLE, NE13 6NB.

## **Asbestos Register for Greenfield Nursery and Pre School**

**Date: 24 June 2025**

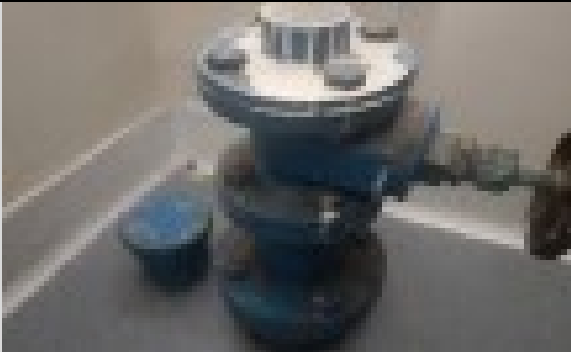
5	RC000235	Gaskets – Pipe flanges	Store G/007	No Risk

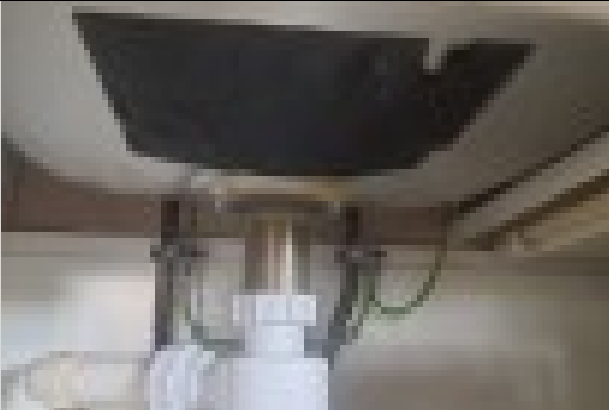
9	RC000238	Sink pad	Staff Room 1/001	No Risk

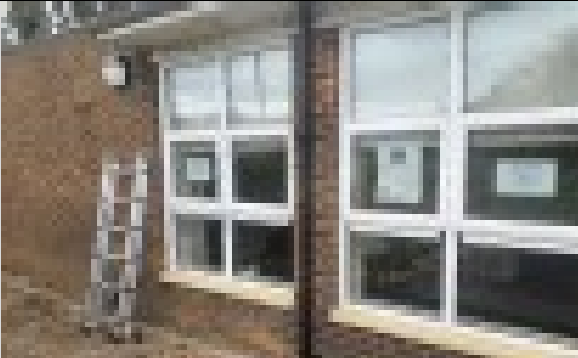
13	RC000241	Mastic to downpipe collars front of main building	External E/001	No Risk

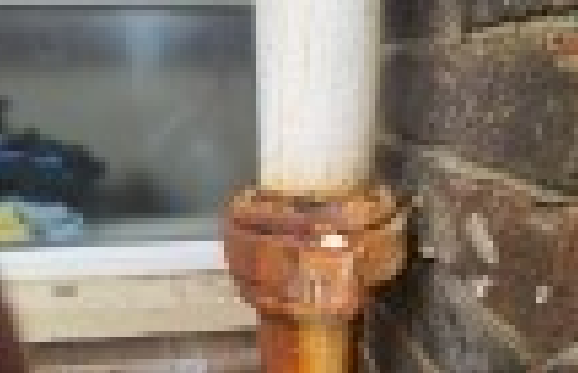
14	RC000242	Mastic to downpipe collars rear of main building	External E/001	No Risk

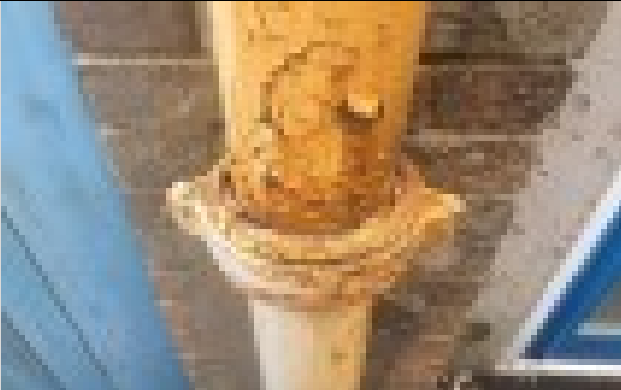
15	RC000243	Mastic to downpipe collars to front and rear of building near extension	External E/001	No Risk

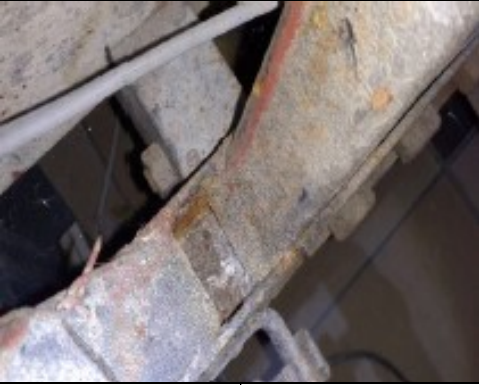
19	OU002881	Thermal insulation debris – between metal supporting beams	Loft R/01	Medium Risk – 3 monthly (advise to have inspected and removed)

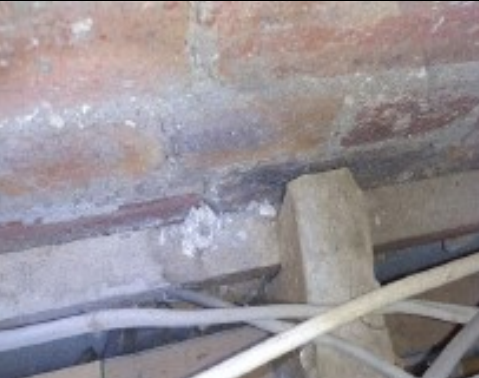
20	OU002882	Thermal insulation debris – between metal supporting beams	Loft R/01	Medium Risk – 3 monthly (advise to have inspected and removed)

20	Thermal insulation debris – between metal supporting beams	Loft R/01	Medium Risk – 3 monthly (advise to have inspected and removed)	21/05/2026	Analytical contractor only		Recommend analytical contractor reinspection annually until environmental clean carried out.
