ASBESTOS SURVEY REPORT FOR GREENFIELDS NURSERY AND PRE SCHOOL, TAYLOR AVENUE, WIDEPEN, NEWCASTLE, NE13 6NB.

Asbestos Register for Greenfield Nursery and Pre School

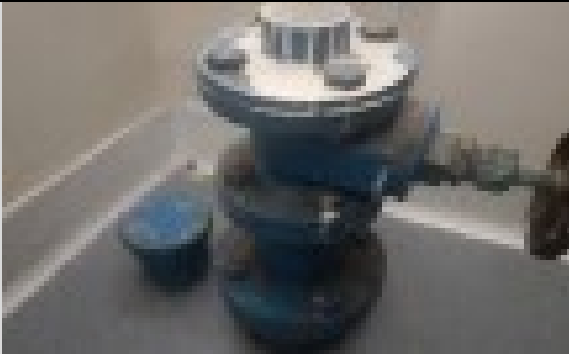
5	RC000235	Gaskets – Pipe flanges	Store G/007	No Risk

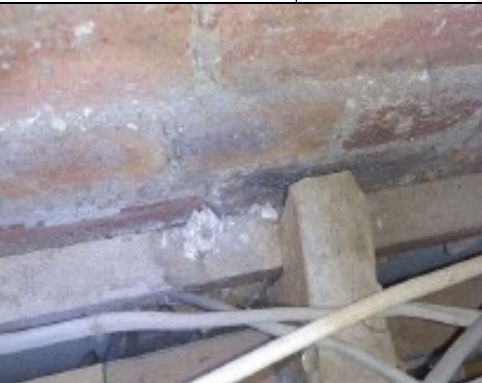
20	OU002882	Thermal insulation debris – between metal supporting beams	Loft R/01	Medium Risk – 3 monthly (advise to have inspected and removed)

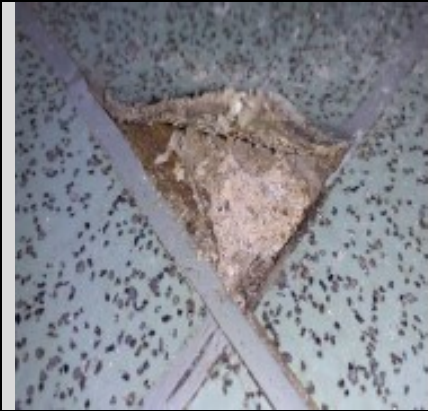
21	PK003398	Screed – floor below carpet and modern lino	Day care room G/01	No Risk
