ASBESTOS SURVEY REPORT FOR FELLGATE PRIMARY SCHOOL,  
JARROW, TYNE AND WEAR, NE32 4XA.

### **Fellgate Primary School, Jarrow**

**Date: 27 May 2025**

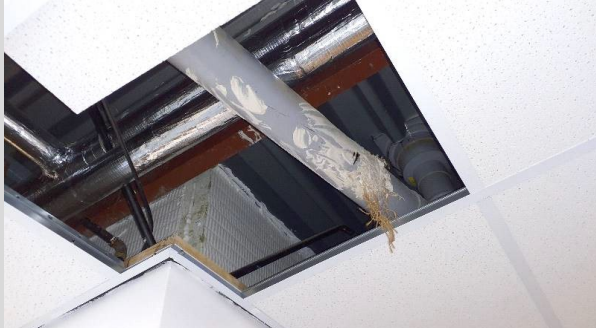
4	OU002382	String to clasp columns and pipework	Corridor 1 G/005	Does not contain asbestos.

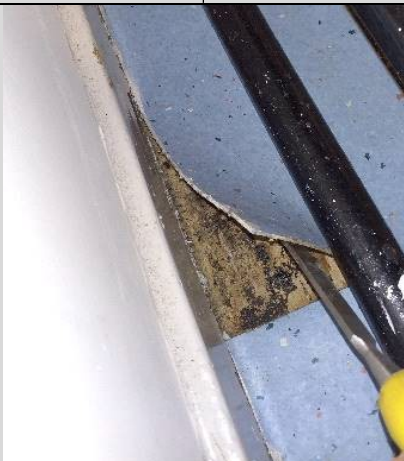
5	OU002383	Residual adhesive beneath modern vinyl tiles	Corridor 1 G/005	Does not contain asbestos.

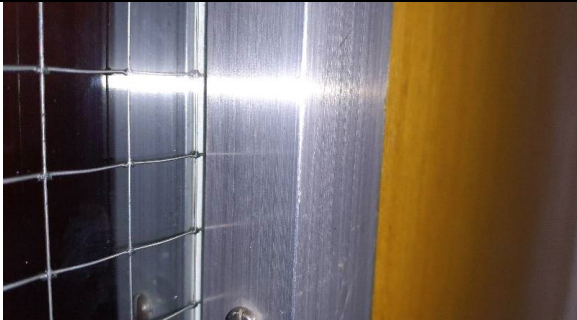
6	As OU002385	Insulating board – beading to timber door's beneath metal trim	Corridor 1 G/005	Low Risk – to be checked every 6 months.  Any change in appearance should be recorded and passed to Property Services.

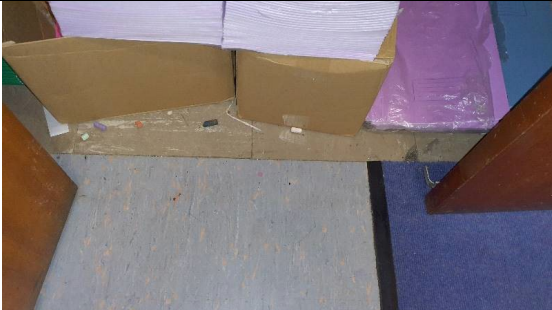
16	As OU002389	Tiles – floor	Corridor Cupboard 2 G/015	Very Low Risk – to be checked every 12 months.  Any change in appearance should be recorded and passed to Property Services.

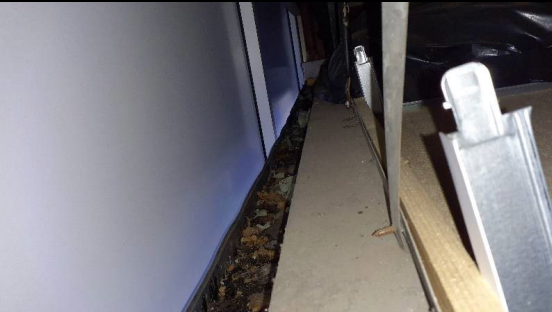
17	As OU002381	Debris above windows in ceiling void	The Tree House G/016	Does not contain asbestos.

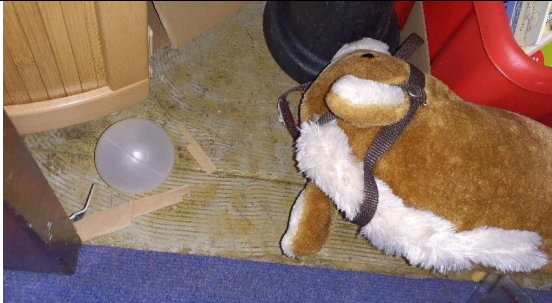
18	As OU002387	Tiles – floor	The Tree House Cupboard G/017	Very Low Risk – to be checked every 12 months.  Any change in appearance should be recorded and passed to Property Services.

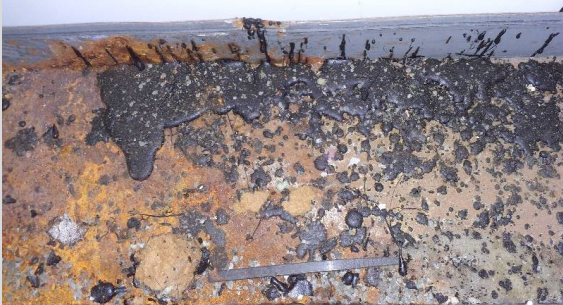
19	As OU002381	Debris above windows in ceiling void	ICT Suite G/018	Does not contain asbestos.

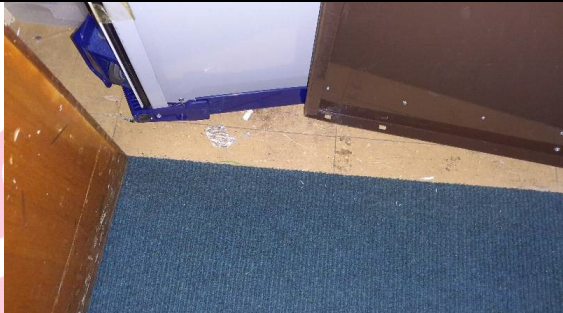
20	As OU002387	Tiles – floor	ICT Suite Cupboard G/019	Very Low Risk – to be checked every 12 months.  Any change in appearance should be recorded and passed to Property Services.

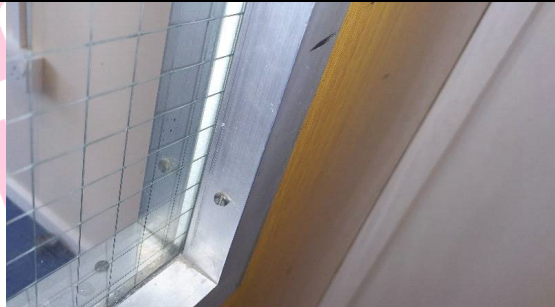
23	As OU002385	Insulating board – beading to timber door's behind metal trim	Corridor 3 G/022	Low Risk – to be checked every 6 months.  Any change in appearance should be recorded and passed to Property Services.

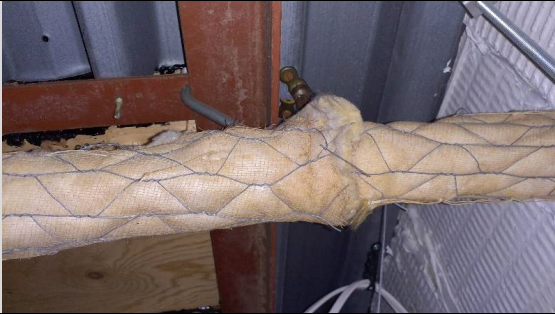
31	OU002392	String – around pipework	Corridor 4 G/031	Does not contain asbestos.

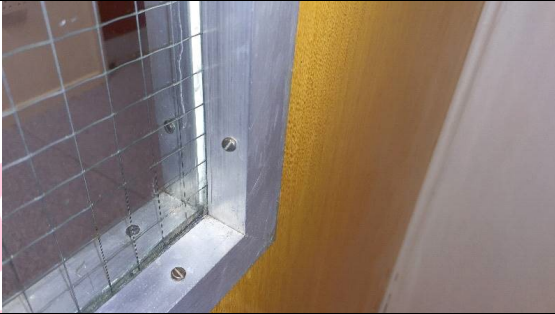
32	As OU002385	Insulating board – beading to timber door's behind metal trim	Corridor 4 G/031	Low Risk – to be checked every 6 months.  Any change in appearance should be recorded and passed to Property Services.

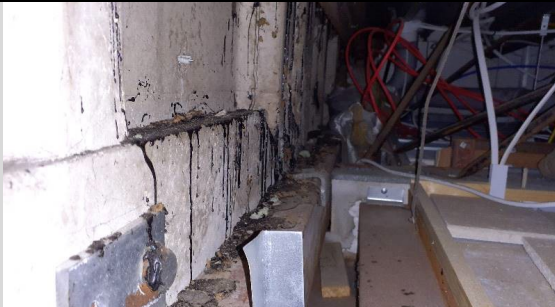
33	As OU002381	Debris above door	Corridor 4 G/031	Does not contain asbestos.

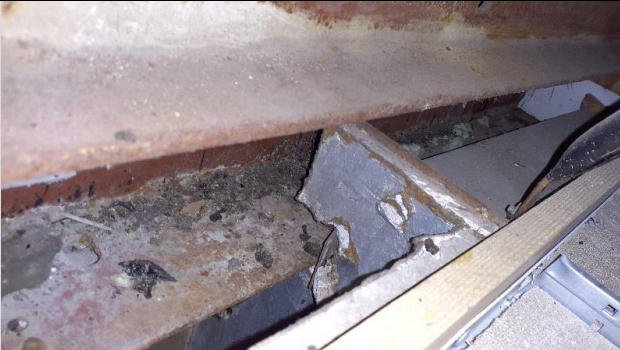
34	As OU002381	Debris above windows	Boy's WC G/032	Does not contain asbestos.

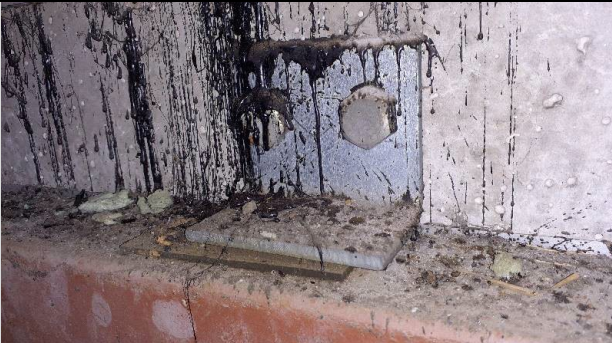
35	As OU002381	Debris above windows	Girl's WC G/033	Does not contain asbestos.

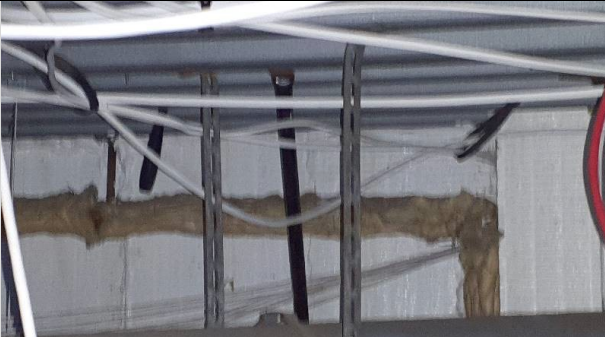
36	As OU002392	String – around pipework	Girl's WC G/033	Does not contain asbestos.

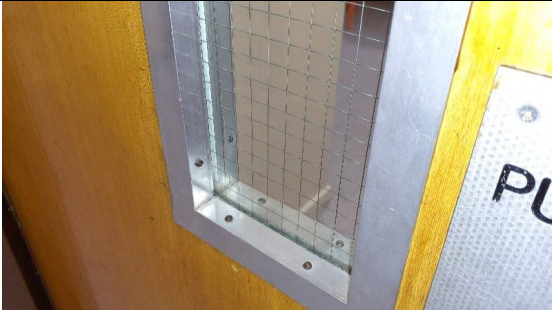
37	As OU002385	Insulating board – beading to timber door's behind metal trim	Corridor 5 G/034	Low Risk – to be checked every 6 months.  Any change in appearance should be recorded and passed to Property Services.

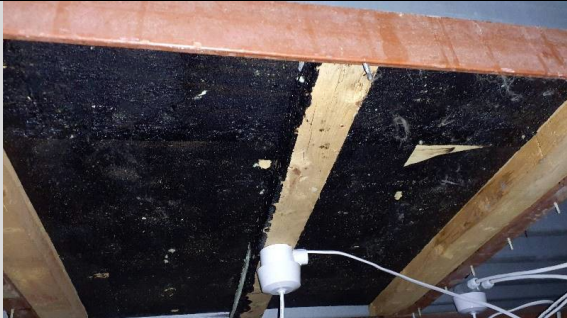
38	OU002393	Bitumen to ceiling within ceiling void	Corridor 5 G/034	Does not contain asbestos.

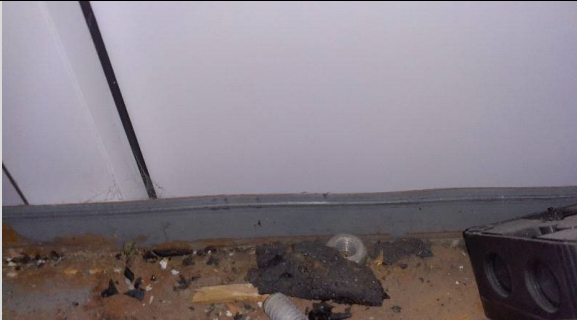
39	As OU002381	Debris above windows	Elms Class G/035	Does not contain asbestos.

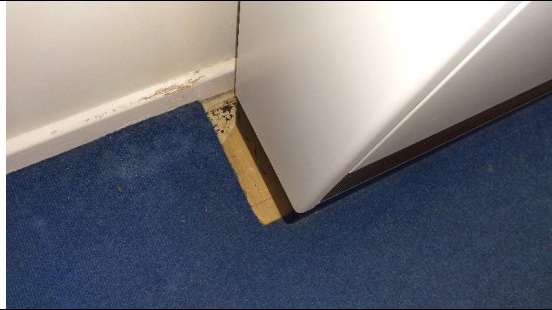
40	OU002394	Tiles – beneath electric wall heater	Elms Class G/035	<p>Very Low Risk – to be checked every 12 months.</p> <p>Any change in appearance should be recorded and passed to Property Services.</p>

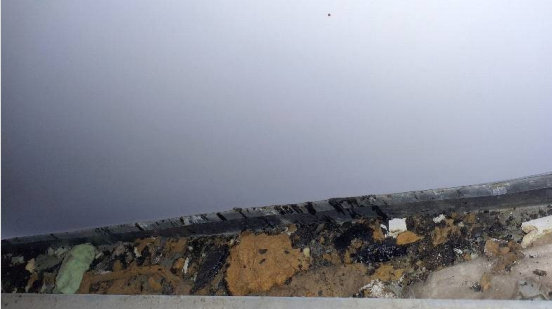
41	As OU002381	Debris above windows	Sycamores Class G/037	Does not contain asbestos.

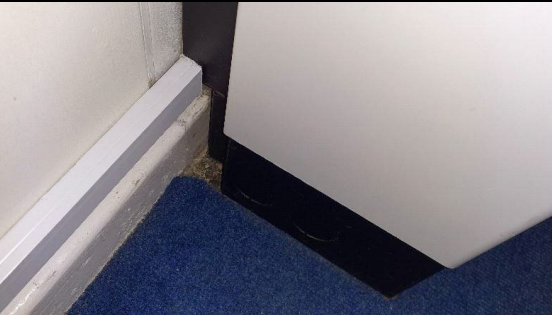
42	OU002395	Tiles – beneath electric wall heater	Sycamores Class G/037	<p>Very Low Risk – to be checked every 12 months.</p> <p>Any change in appearance should be recorded and passed to Property Services.</p>

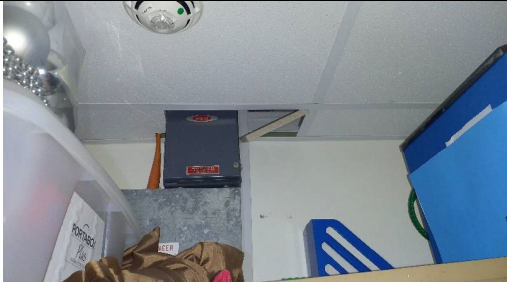
46	Presumed	Flash guards – fuse box	Oaks Class Cupboard G/040	<p>Low Risk – to be checked every 6 months.</p> <p>Any change in appearance should be recorded and passed to Property Services.</p>

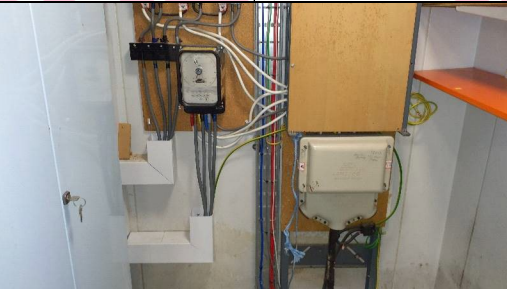
47	Presumed	Flash guards – live electrics	Electric Cupboard G/041	<p>Low Risk – to be checked every 6 months.</p> <p>Any change in appearance should be recorded and passed to Property Services.</p>

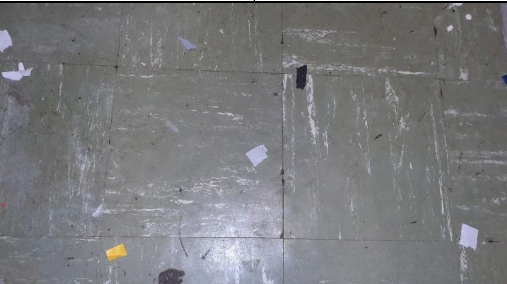
48	OU002415	Tile – floor	Electric Cupboard G/041	<p>Very Low Risk – to be checked every 12 months.</p> <p>Any change in appearance should be recorded and passed to Property Services.</p>

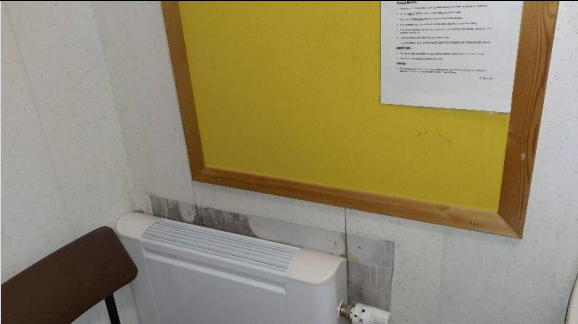
52	OU002398	Fibreboard – pin board	Kitchen WC G/046	Does not contain asbestos.

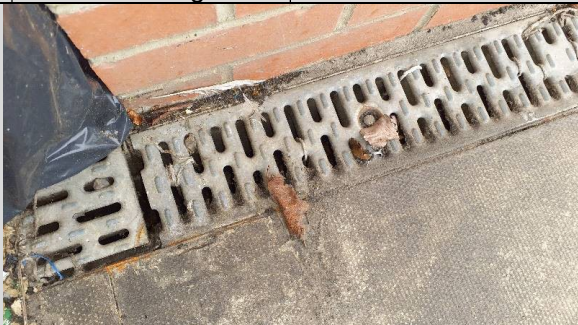
53	OU002402	String debris – around drainage	External E/001	Does not contain asbestos.

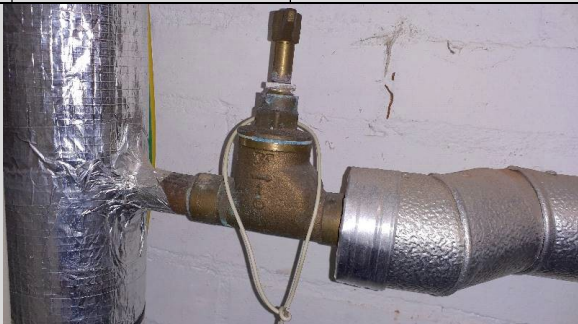
54	OU002399	Gasket – stop tap	Boiler Room E/003	Does not contain asbestos.

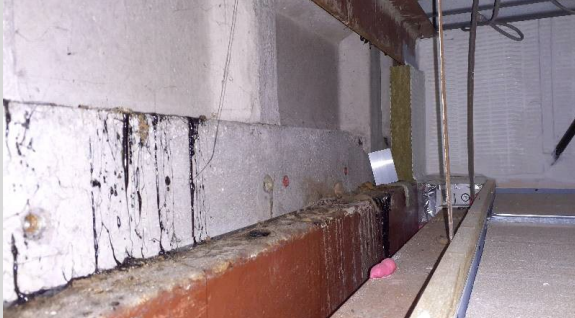
58	OU002403	Debris above windows	Lobby G/001 (Penshaw)	Does not contain asbestos.

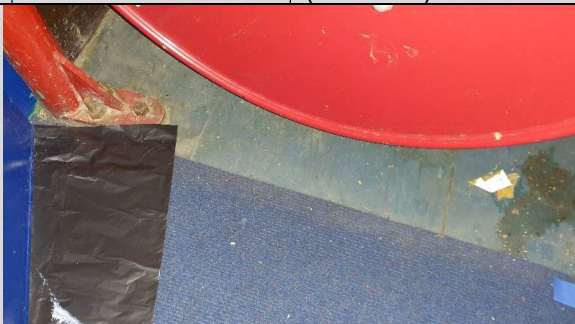
59	OU002404	Tiles beneath fire hose	Lobby G/001 (Penshaw)	Does not contain asbestos.

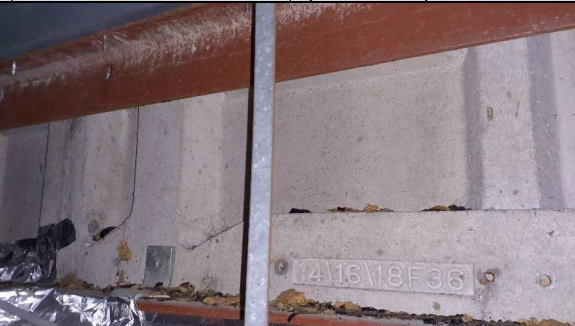
60	As OU002403	Debris above windows	Corridor 1 G/003 (Penshaw)	Does not contain asbestos.

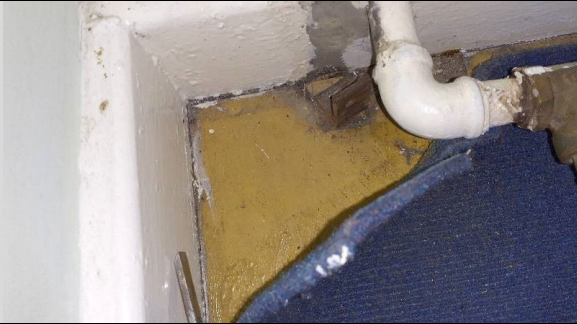
61	OU002405	Tiles beneath carpet	Corridor 1 G/003 (Penshaw)	Does not contain asbestos.

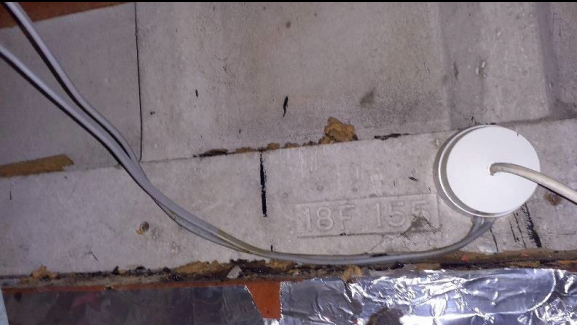
62	As OU002403	Debris above windows	Boys WC G/004 (Penshaw)	Does not contain asbestos.

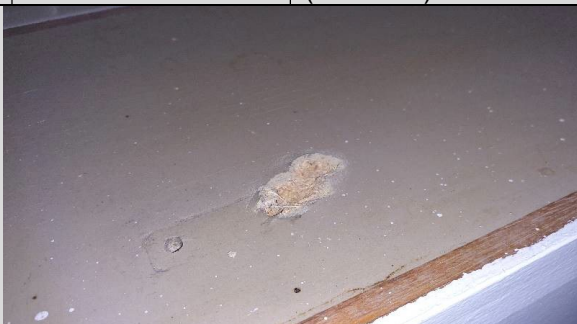
63	OU002406	Textile – window sill	Boys WC G/004 (Penshaw)	Does not contain asbestos.

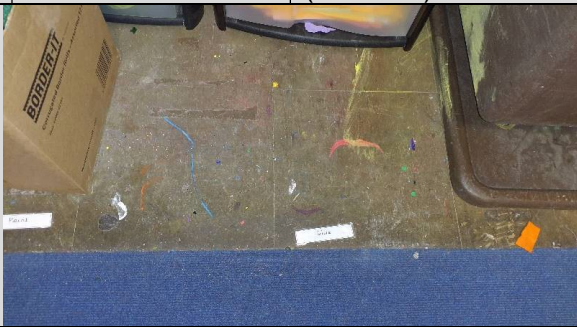
64	OU002407	Tiles Floor	Corridor 2 Cupboard 1 G/007 (Penshaw)	Does not contain asbestos.

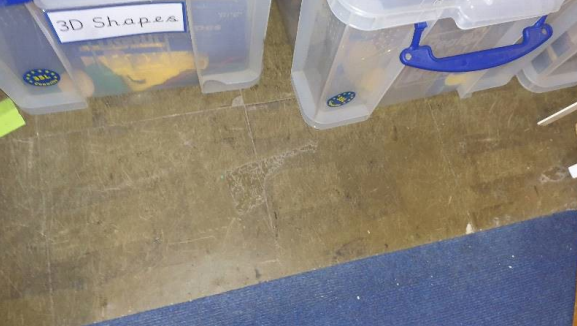
65	As OU002407	Tiles Floor	Corridor 2 Cupboard 2 G/008 (Penshaw)	Does not contain asbestos.

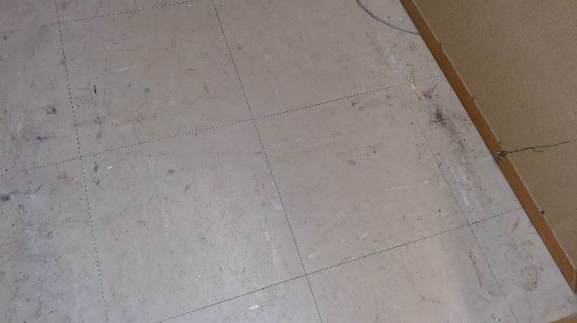
66	OU002408	Tiles Floor	Curriculum Resources Cupboard G/029 (Penshaw)	Does not contain asbestos.

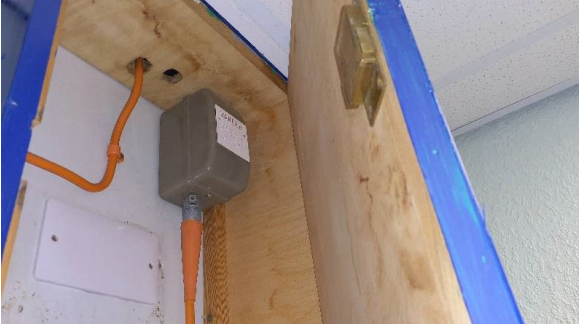
67	Presumed	Flash guards – fuse box live	Corridor 6 G/032 (Penshaw)	Low Risk – to be checked every 6 months.  Any change in appearance should be recorded and passed to Property Services.

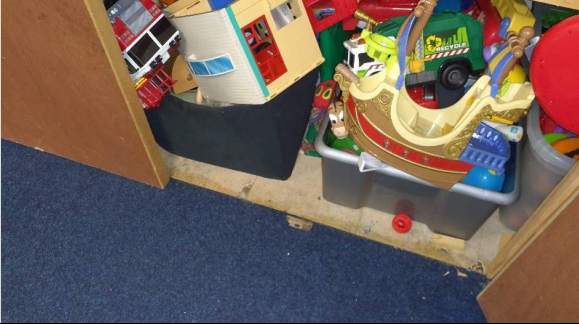
68	OU002409	Tiles Floor	KSI Cupboard G/033 (Penshaw)	Does not contain asbestos.

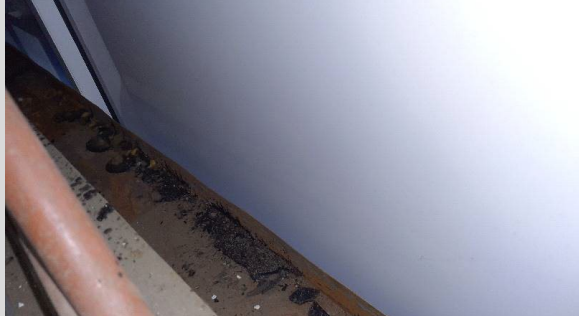
69	As OU002403	Debris above windows	Classroom 5 G/034 (Penshaw)	Does not contain asbestos.

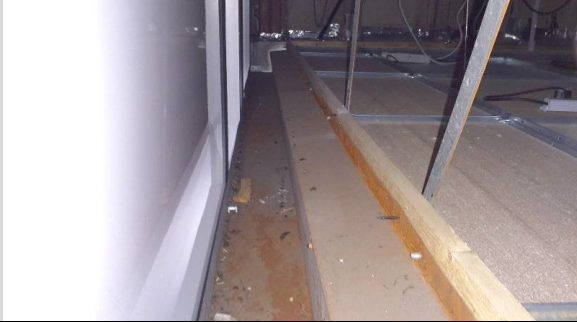
70	As OU002403	Debris above windows	Classroom 5 Quite Room G/035 (Penshaw)	Does not contain asbestos.

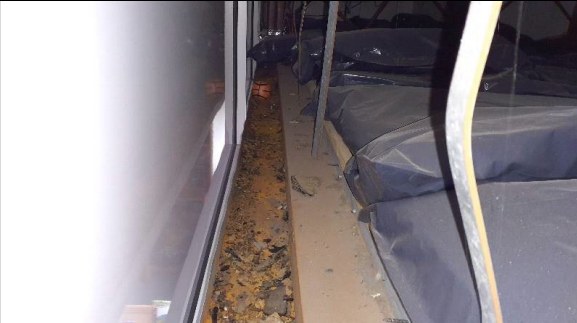
71	As OU002403	Debris above windows	Classroom 6 G/037 (Penshaw)	Does not contain asbestos.

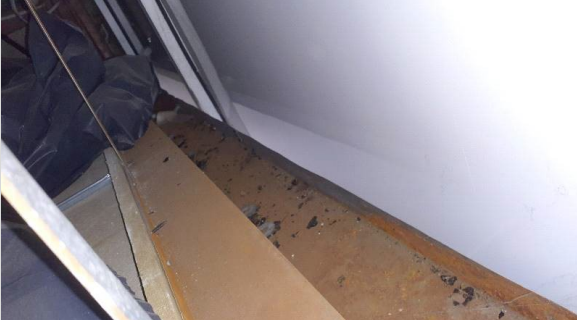
72	As OU002403	Debris above windows	Classroom 6 Quite Room G/038 (Penshaw)	Does not contain asbestos.

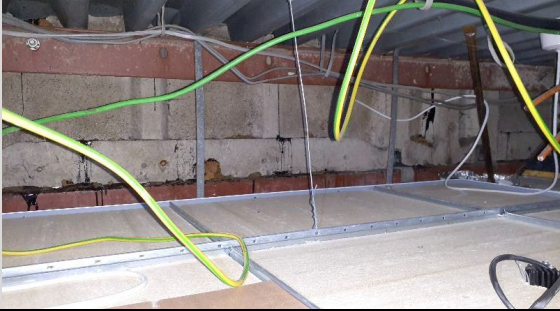
73	As OU002403	Debris above windows	Electric Cupboard G/040 (Penshaw)	Does not contain asbestos.

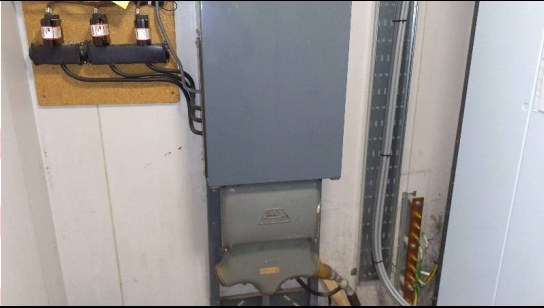
74	Presumed	Flash guards - Live electrics	Electric Cupboard G/040 (Penshaw)	Low Risk – to be checked every 6 months.  Any change in appearance should be recorded and passed to Property Services.

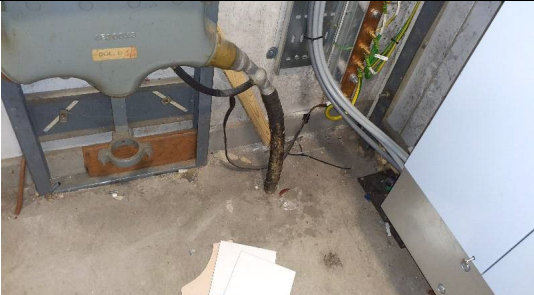
75	Presumed	Bitumen Cable wrap	Electric Cupboard G/040 (Penshaw)	Low Risk – to be checked every 6 months.  Any change in appearance should be recorded and passed to Property Services.

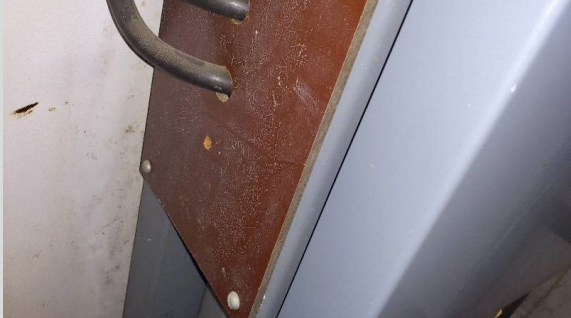
76	OU002410	Composite panel to side of fuse box	Electric Cupboard G/040 (Penshaw)	Does not contain asbestos.

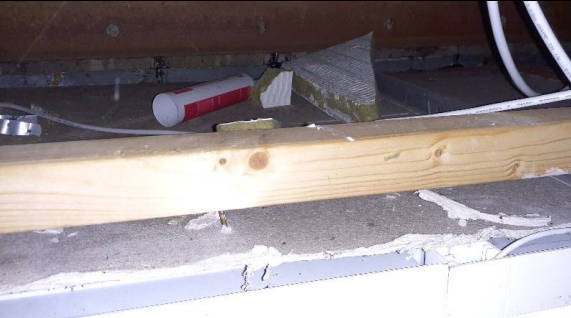
77	OU002411	Insulating board – ceiling void	Entrance G/042 (Penshaw)	Does not contain asbestos.

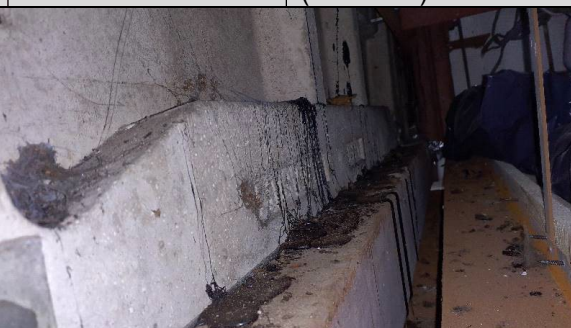
78	As OU002403	Debris above windows	WC 1 G/043 (Penshaw)	Does not contain asbestos.

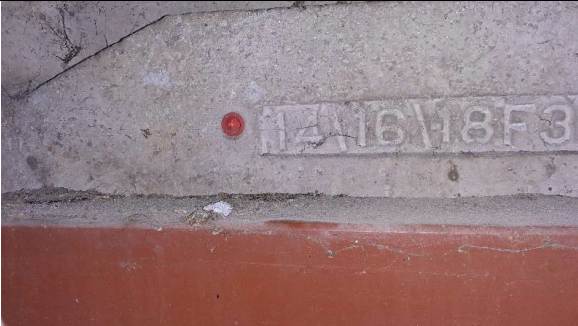
82	As OU002413	Debris insulating board	Storage Cupboard G/047 (Penshaw)	Medium Risk – to be checked every 3 months.  Any change in appearance should be recorded and passed to Property Services.

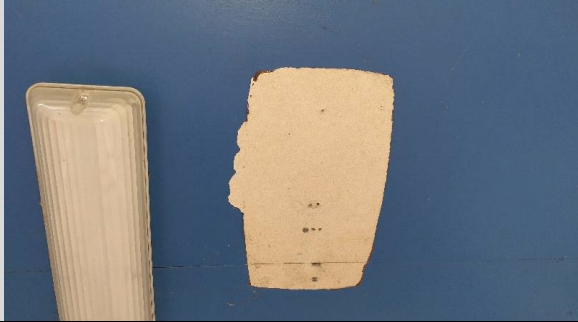
83	As OU002411	Insulating board – ceiling void	External E/001 (Penshaw)	Does not contain asbestos.

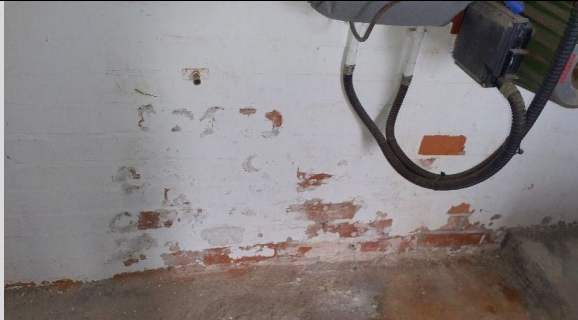
84	OU002414	Insulation residue - walls	External E/001 (Penshaw)	Does not contain asbestos.
