ASBESTOS SURVEY REPORT FOR FELLGATE PRIMARY SCHOOL,
JARROW, TYNE AND WEAR, NE32 4XA.

Fellgate Primary School, Jarrow

Date: 01 December 2025

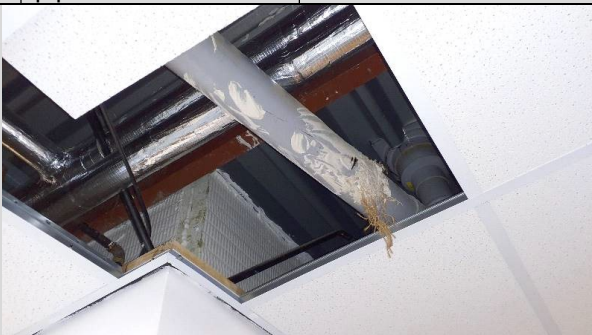
4	OU002382	String to clasp columns and pipework	Corridor 1 G/005	Does not contain asbestos.

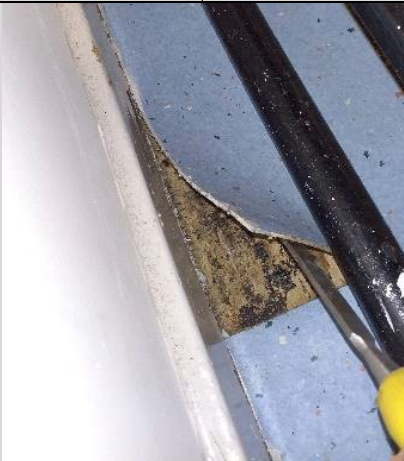
5	OU002383	Residual adhesive beneath modern vinyl tiles	Corridor 1 G/005	Does not contain asbestos.

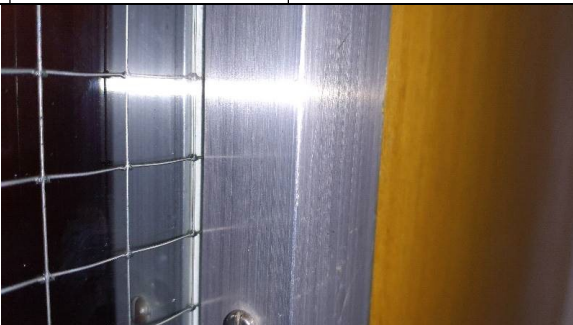
6	As OU002385	Insulating board – beading to timber door's beneath metal trim	Corridor 1 G/005	<p>Low Risk – to be checked every 6 months.</p> <p>Any change in appearance should be recorded and passed to Property Services.</p>

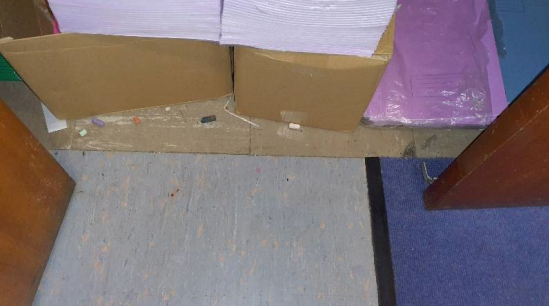
16	As OU002389	Tiles – floor	Corridor Cupboard 2 G/015	Very Low Risk – to be checked every 12 months. Any change in appearance should be recorded and passed to Property Services.

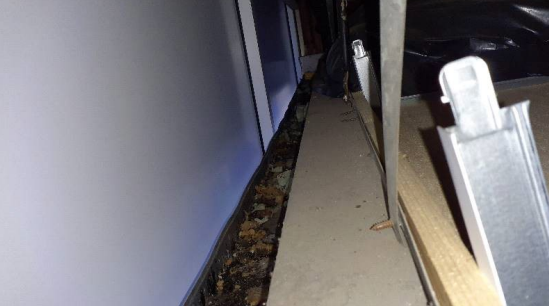
17	As OU002381	Debris above windows in ceiling void	The Tree House G/016	Does not contain asbestos.

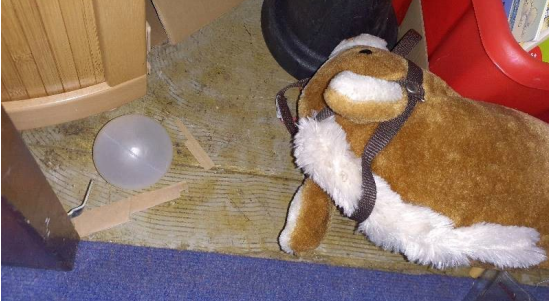
18	As OU002387	Tiles – floor	The Tree House Cupboard G/017	Very Low Risk – to be checked every 12 months. Any change in appearance should be recorded and passed to Property Services.

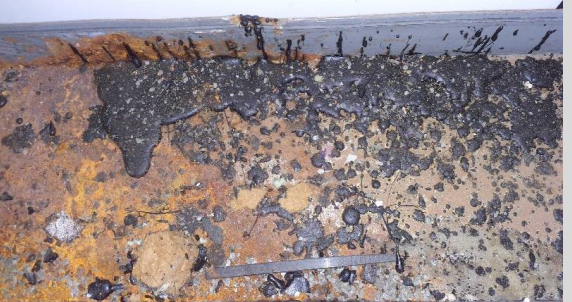
19	As OU002381	Debris above windows in ceiling void	ICT Suite G/018	Does not contain asbestos.

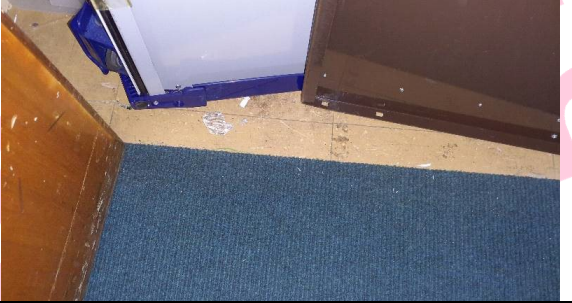
20	As OU002387	Tiles – floor	ICT Suite Cupboard G/019	Very Low Risk – to be checked every 12 months. Any change in appearance should be recorded and passed to Property Services.

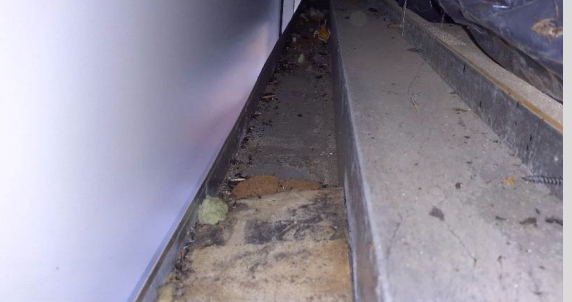
21	As OU002381	Debris above windows in ceiling void	Headteachers Office G/020	Does not contain asbestos.

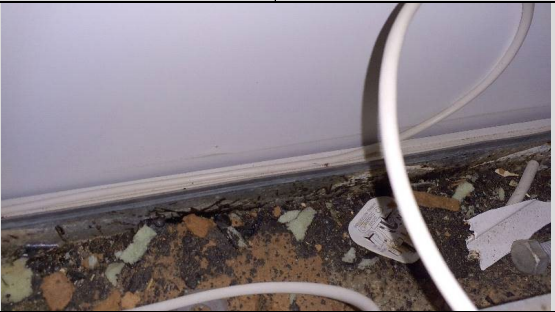
25	As OU002381	Debris above windows	Meeting Room 1 G/024	Does not contain asbestos.

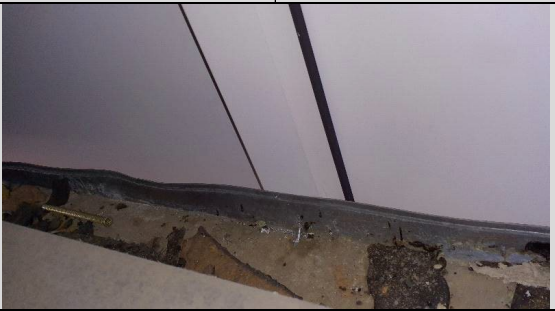
26	As OU002381	Debris above windows	Staff Room G/025	Does not contain asbestos.

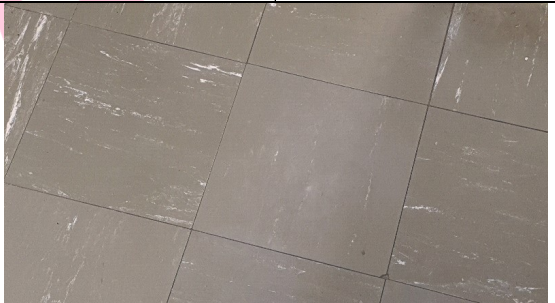
27	OU002391	Tiles – Floor	Men's WC G/026	<p>Very Low Risk – to be checked every 12 months.</p> <p>Any change in appearance should be recorded and passed to Property Services.</p>

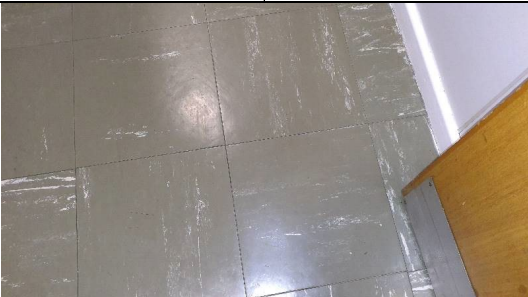
28	As OU002391	Tiles – Floor	Women’s WC G/027	<p>Very Low Risk – to be checked every 12 months.</p> <p>Any change in appearance should be recorded and passed to Property Services.</p>

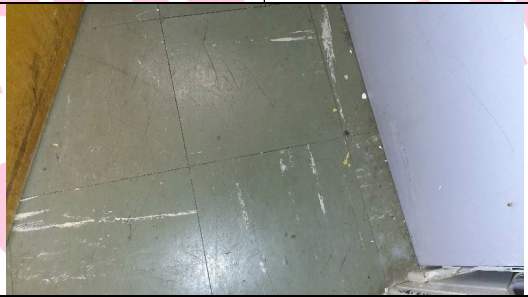
29	As OU002391	Tiles – Floor	Cleaners Cupboard G/028	<p>Very Low Risk – to be checked every 12 months.</p> <p>Any change in appearance should be recorded and passed to Property Services.</p>

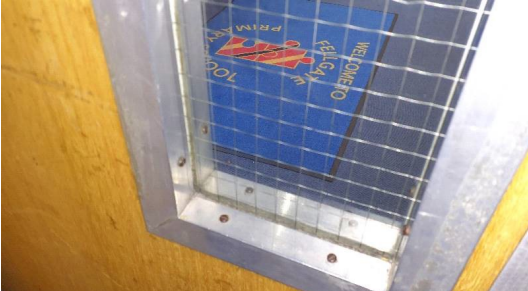
30	As OU002385	Insulating board – beading to timber door’s behind metal trim	Main Hall G/029	<p>Low Risk – to be checked every 6 months.</p> <p>Any change in appearance should be recorded and passed to Property Services.</p>

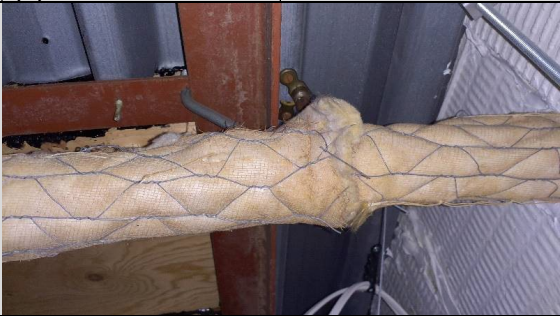
31	OU002392	String – around pipework	Corridor 4 G/031	Does not contain asbestos.

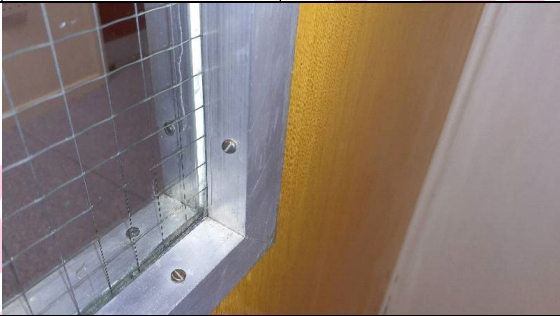
32	As OU002385	Insulating board – beading to timber door's behind metal trim	Corridor 4 G/031	<p>Low Risk – to be checked every 6 months.</p> <p>Any change in appearance should be recorded and passed to Property Services.</p>

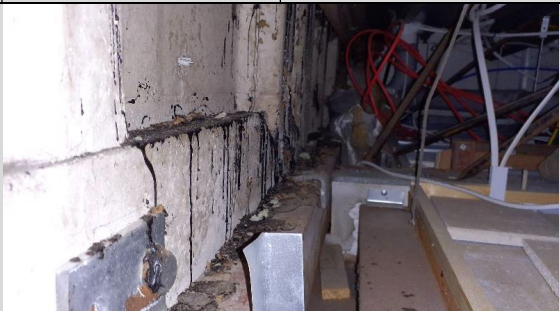
33	As OU002381	Debris above door	Corridor 4 G/031	Does not contain asbestos.

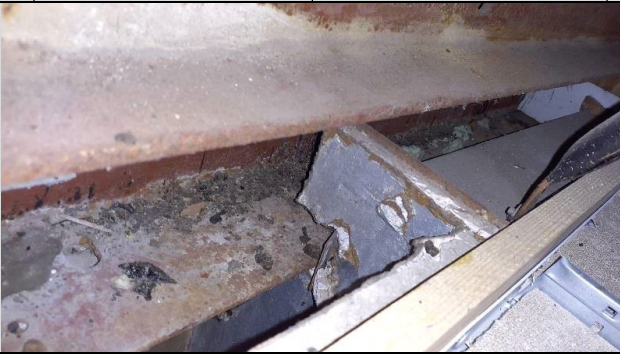
34	As OU002381	Debris above windows	Boy's WC G/032	Does not contain asbestos.

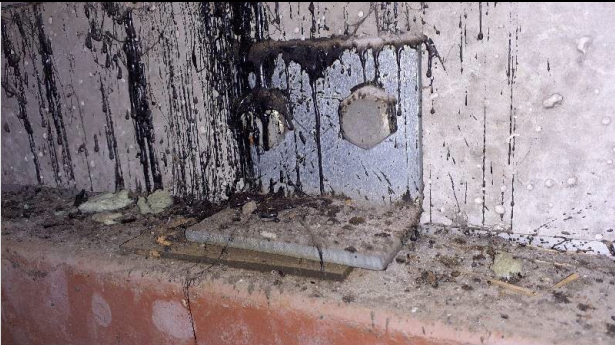
35	As OU002381	Debris above windows	Girl's WC G/033	Does not contain asbestos.

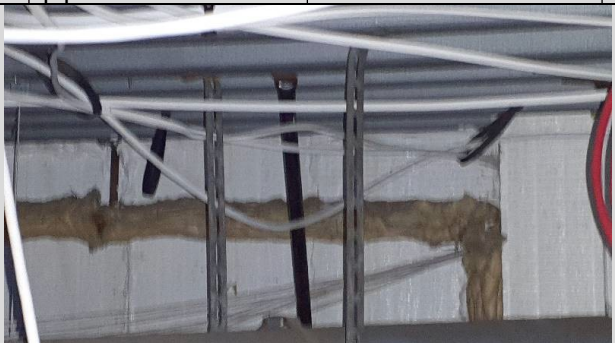
36	As OU002392	String – around pipework	Girl's WC G/033	Does not contain asbestos.

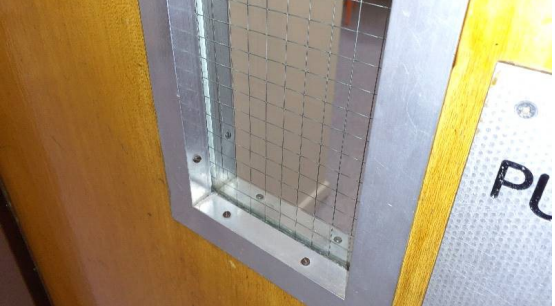
37	As OU002385	Insulating board – beading to timber door's behind metal trim	Corridor 5 G/034	Low Risk – to be checked every 6 months. Any change in appearance should be recorded and passed to Property Services.

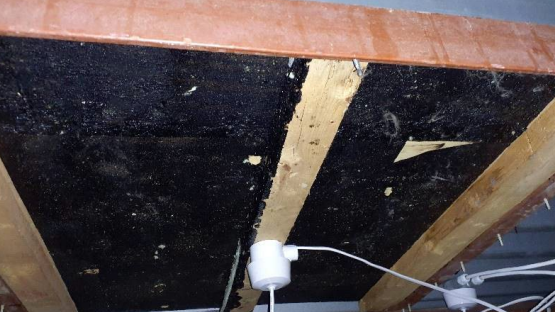
38	OU002393	Bitumen to ceiling within ceiling void	Corridor 5 G/034	Does not contain asbestos.

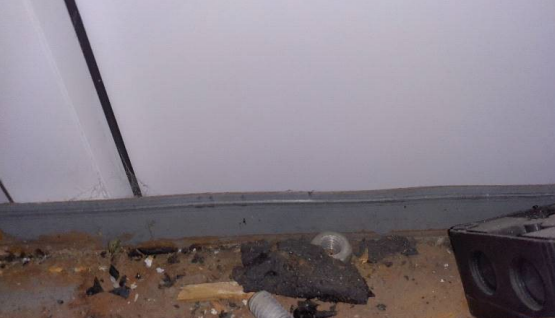
39	As OU002381	Debris above windows	Elms Class G/035	Does not contain asbestos.

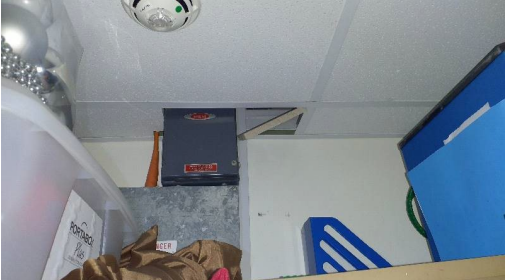
46	Presumed	Flash guards – fuse box	Oaks Class Cupboard G/040	<p>Low Risk – to be checked every 6 months.</p> <p>Any change in appearance should be recorded and passed to Property Services.</p>

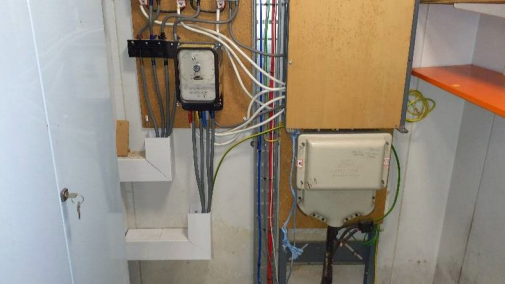
47	Presumed	Flash guards – live electrics	Electric Cupboard G/041	<p>Low Risk – to be checked every 6 months.</p> <p>Any change in appearance should be recorded and passed to Property Services.</p>

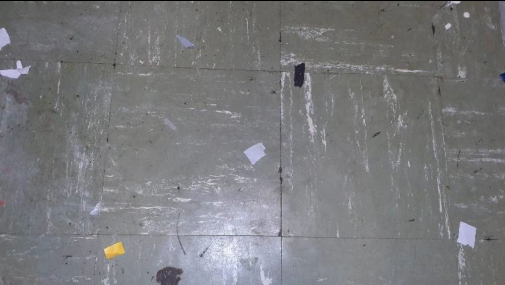
48	OU002415	Tile – floor	Electric Cupboard G/041	<p>Very Low Risk – to be checked every 12 months.</p> <p>Any change in appearance should be recorded and passed to Property Services.</p>

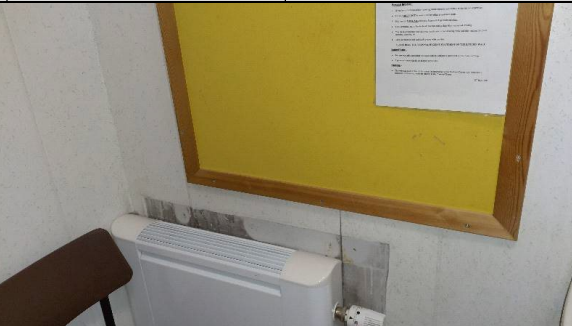
52	OU002398	Fibreboard – pin board	Kitchen WC G/046	Does not contain asbestos.

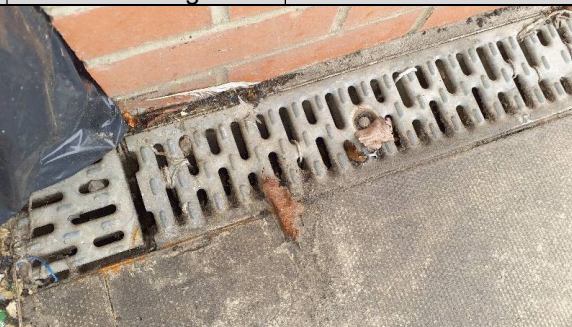
53	OU002402	String debris – around drainage	External E/001	Does not contain asbestos.

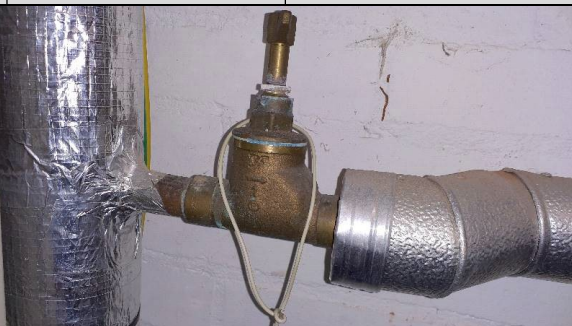
54	OU002399	Gasket – stop tap	Boiler Room E/003	Does not contain asbestos.

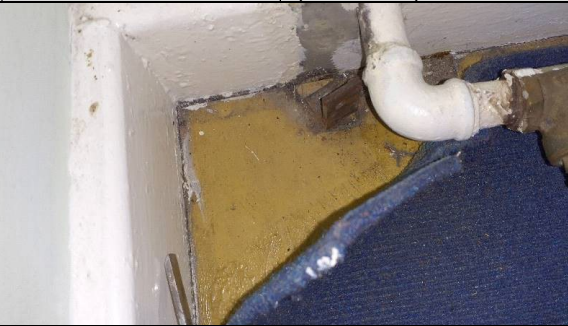
61	OU002405	Tiles beneath carpet	Corridor 1 G/003 (Penshaw)	Does not contain asbestos.

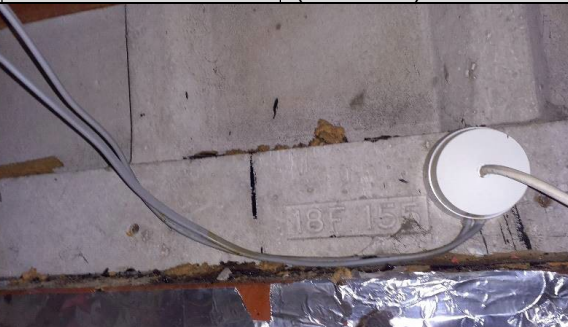
62	As OU002403	Debris above windows	Boys WC G/004 (Penshaw)	Does not contain asbestos.

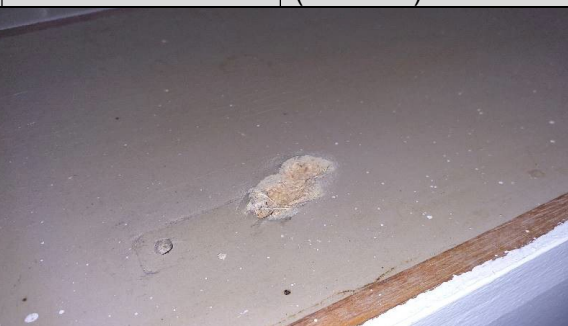
63	OU002406	Textile – window sill	Boys WC G/004 (Penshaw)	Does not contain asbestos.

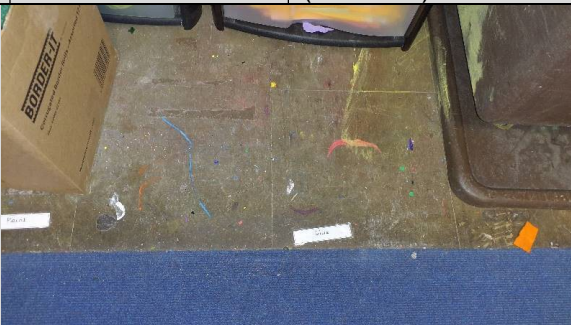
64	OU002407	Tiles Floor	Corridor 2 Cupboard 1 G/007 (Penshaw)	Does not contain asbestos.

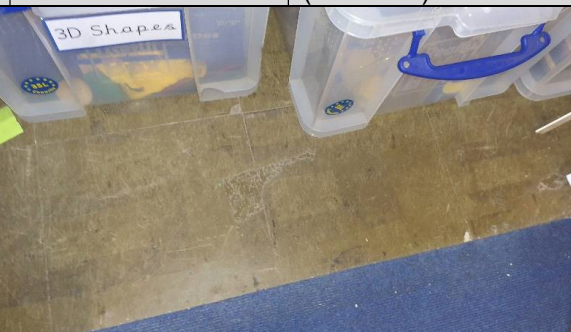
65	As OU002407	Tiles Floor	Corridor 2 Cupboard 2 G/008 (Penshaw)	Does not contain asbestos.

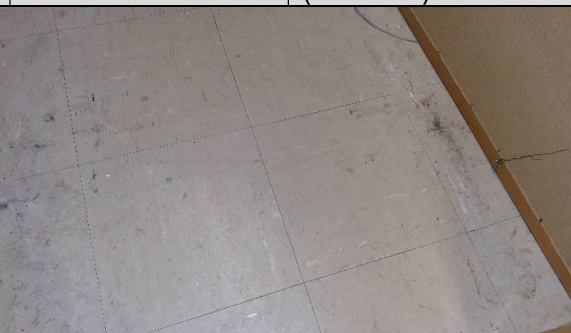
66	OU002408	Tiles Floor	Curriculum Resources Cupboard G/029 (Penshaw)	Does not contain asbestos.

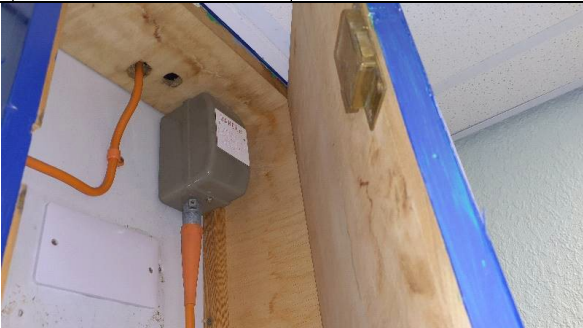
67	Presumed	Flash guards – fuse box live	Corridor 6 G/032 (Penshaw)	<p>Low Risk – to be checked every 6 months.</p> <p>Any change in appearance should be recorded and passed to Property Services.</p>

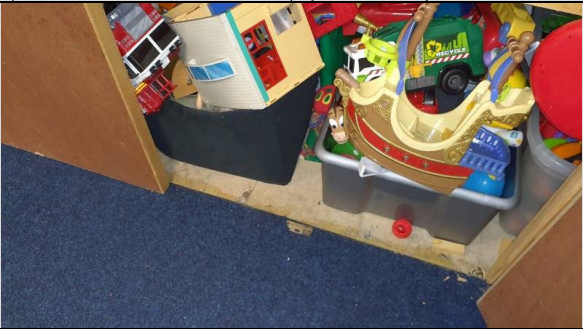
68	OU002409	Tiles Floor	KSI Cupboard G/033 (Penshaw)	Does not contain asbestos.

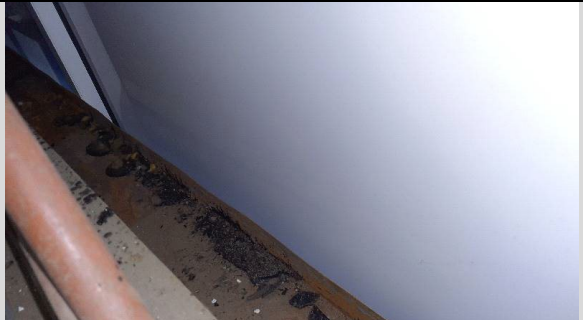
69	As OU002403	Debris above windows	Classroom 5 G/034 (Penshaw)	Does not contain asbestos.

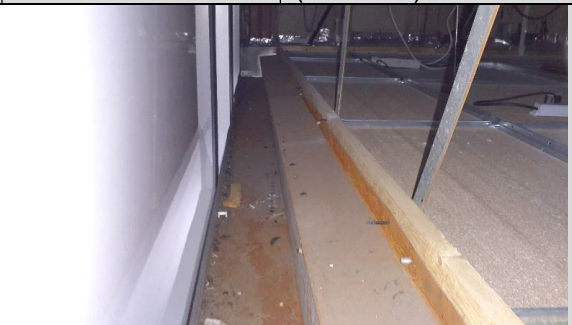
70	As OU002403	Debris above windows	Classroom 5 Quite Room G/035 (Penshaw)	Does not contain asbestos.

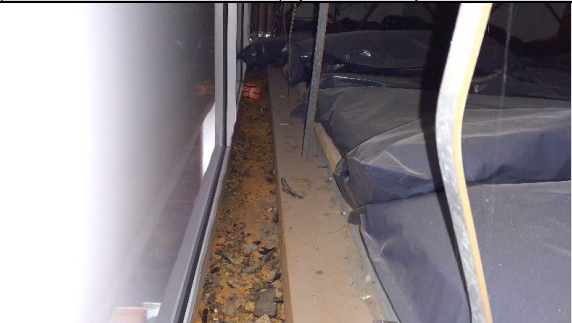
71	As OU002403	Debris above windows	Classroom 6 G/037 (Penshaw)	Does not contain asbestos.

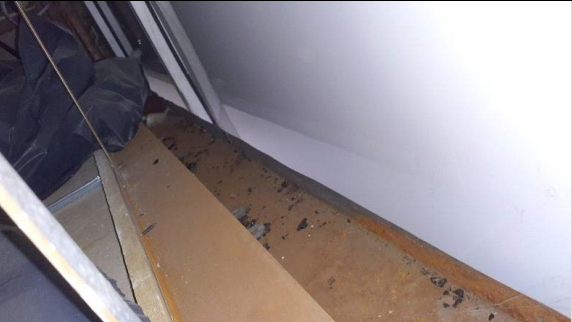
72	As OU002403	Debris above windows	Classroom 6 Quite Room G/038 (Penshaw)	Does not contain asbestos.

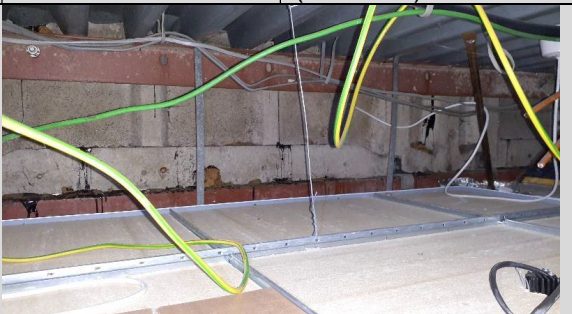
73	As OU002403	Debris above windows	Electric Cupboard G/040 (Penshaw)	Does not contain asbestos.

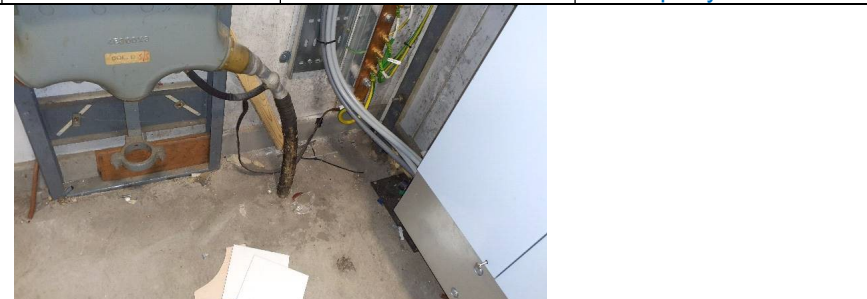
74	Presumed	Flash guards - Live electrics	Electric Cupboard G/040 (Penshaw)	<p>Low Risk – to be checked every 6 months.</p> <p>Any change in appearance should be recorded and passed to Property Services.</p>

75	Presumed	Bitumen Cable wrap	Electric Cupboard G/040 (Penshaw)	<p>Low Risk – to be checked every 6 months.</p> <p>Any change in appearance should be recorded and passed to Property Services.</p>

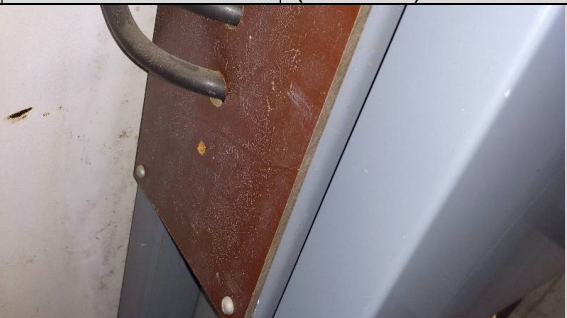
76	OU002410	Composite panel to side of fuse box	Electric Cupboard G/040 (Penshaw)	Does not contain asbestos.

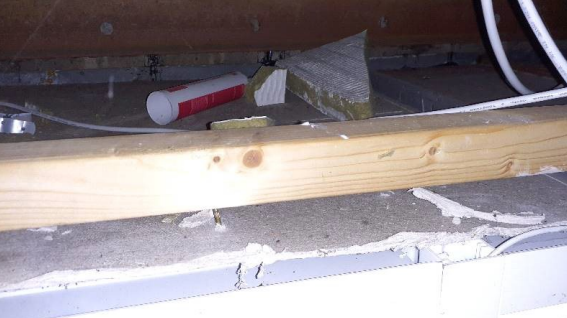
77	OU002411	Insulating board – ceiling void	Entrance G/042 (Penshaw)	Does not contain asbestos.

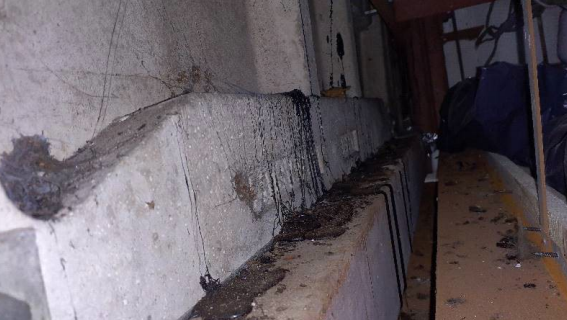
78	As OU002403	Debris above windows	WC 1 G/043 (Penshaw)	Does not contain asbestos.

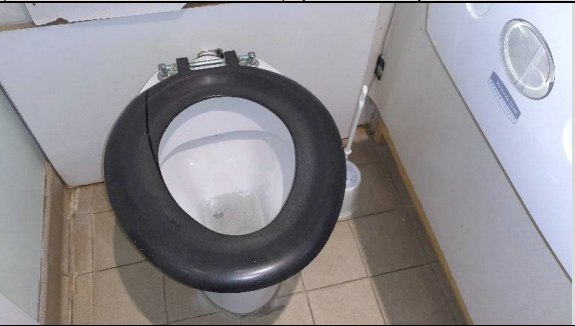
79	OU002412	Composite toilet seat	WC 1 G/043 (Penshaw)	Does not contain asbestos.

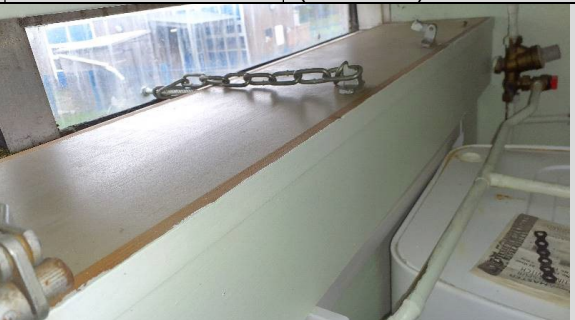
80	A OU002406	Textile – window sill	WC 1 G/043 (Penshaw)	Does not contain asbestos.

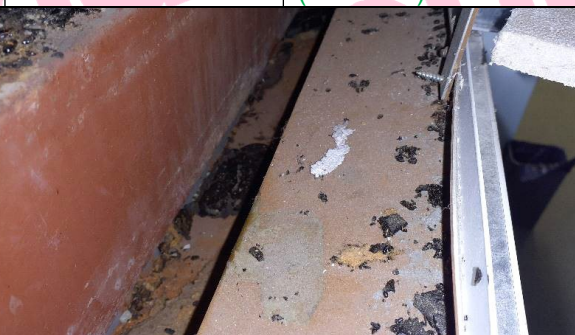
81	OU002413	Debris insulating board	Life skills flat G/046 (Penshaw)	Removed July 2025
