ASBESTOS SURVEY REPORT FOR GREENFIELDS COMMUNITY PRIMARY SCHOOL, WIDEPEN, NEWCASTLE, NE13 6NB.

Asbestos Register for Greenfields Community Primary School

UPRN: - J116857

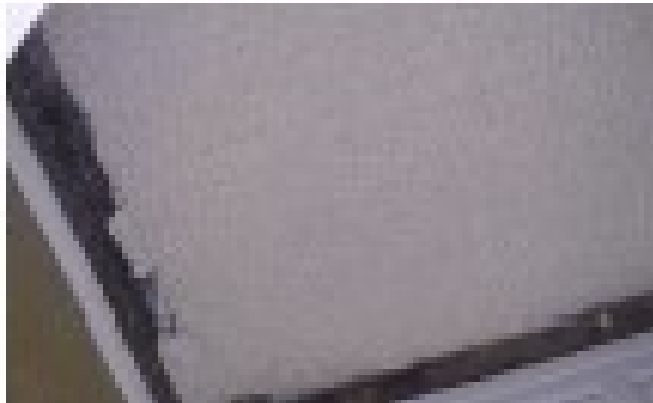
10	PK001265	Coating – upper ceiling above suspended tiles	Main Kitchen G/009	No Risk - Does not contain asbestos.

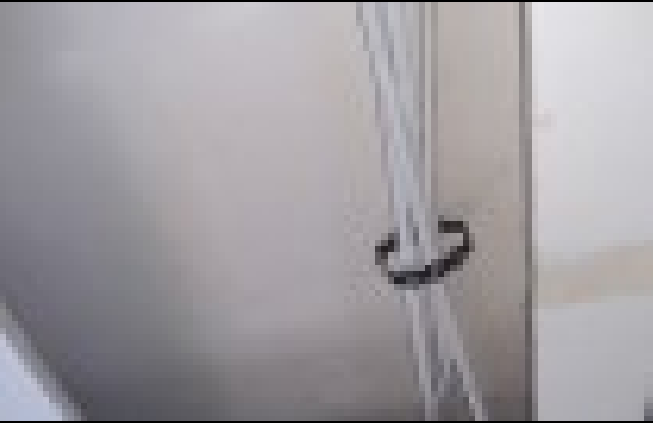
11	PK001266	Fire protection – metal beams and upper ceiling above suspended tiles	Main Kitchen G/009	Low Risk – 6 monthly

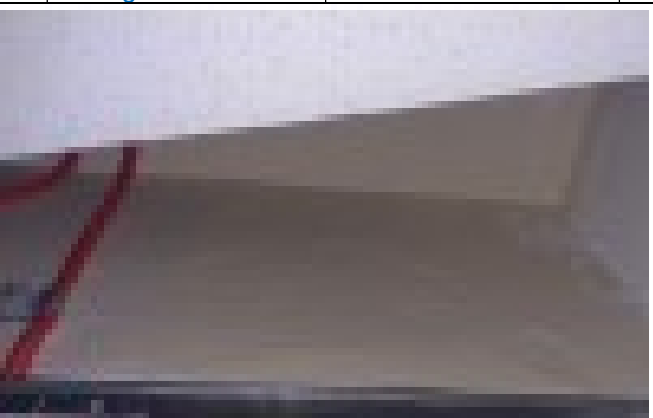
12	As PK001266	Fire protection – beams and upper ceiling	Main Kitchen G/010	Low Risk – 6 monthly

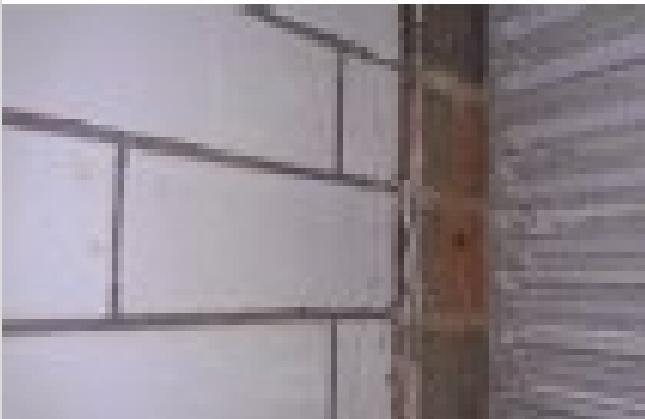
46	PK001283	Mastic residue – brick workaround wall vent	Boiler Room G/077	No Risk - Does not contain asbestos.

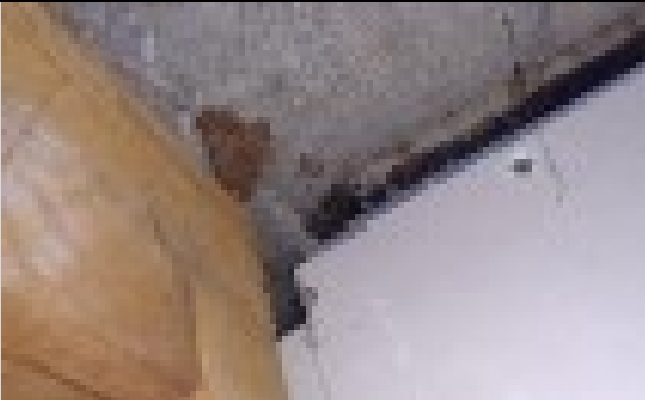
47	PK001284	Felt – metal structure and wall above windows within ceiling void	Early Years classroom 1 G/079	No Risk - Does not contain asbestos.

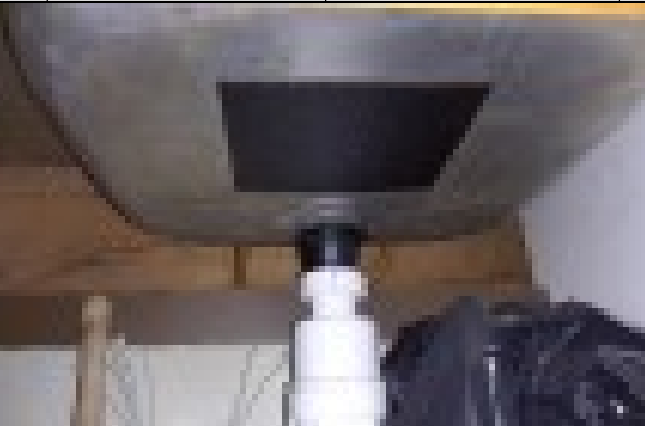
48	PK001285	Sink Pad	Early Years classroom 2 G/080	No Risk - Does not contain asbestos.

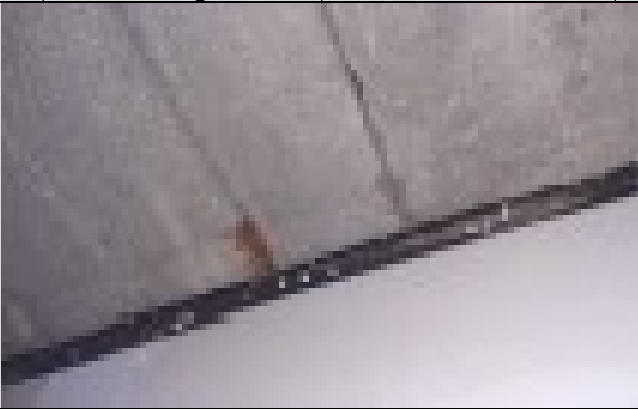
52	As PK001284	Felt – metal structure and wall above windows within ceiling void	Early years classroom 2 toilets G/083	No Risk - Does not contain asbestos.

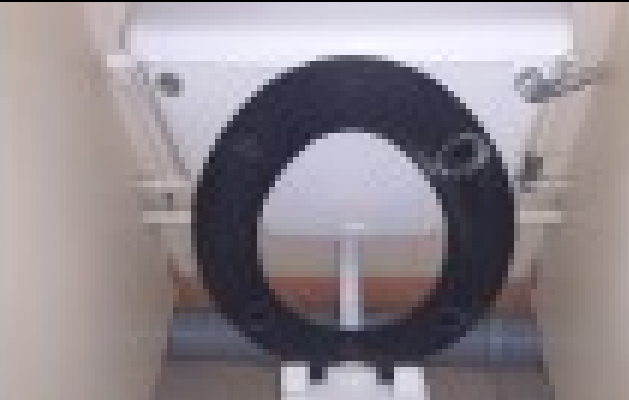
53	As PK001278	Composite toilet seat	Early years classroom 1 toilets G/085	No Risk - Does not contain asbestos.

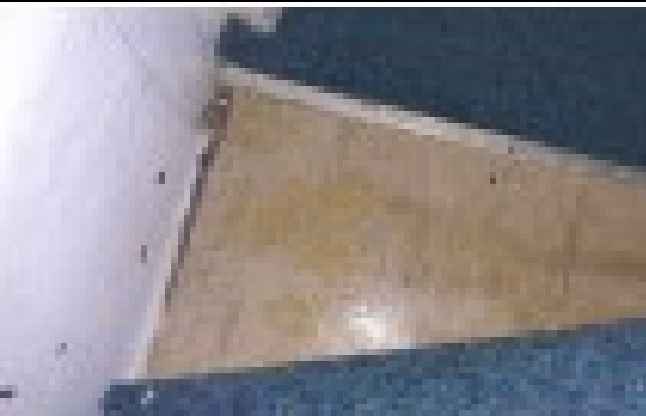
54	As PK001281	Vinyl floor tiles and adhesive – floor below carpet	Early years sensory room G/086	No Risk - Does not contain asbestos.

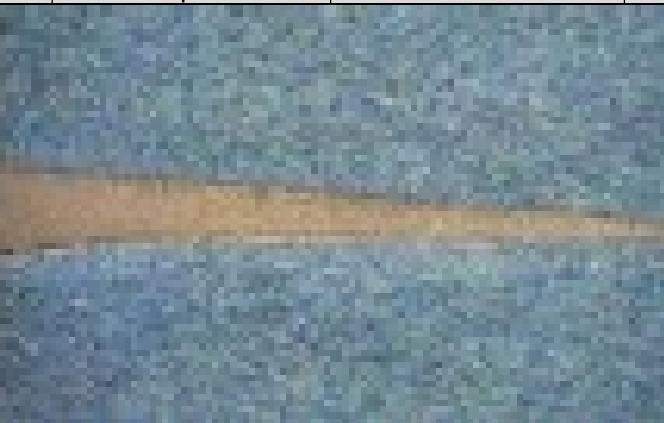
58	As PK001287	Vinyl floor tiles and adhesive – floor below carpet	Corridor G/094	No Risk - Does not contain asbestos.

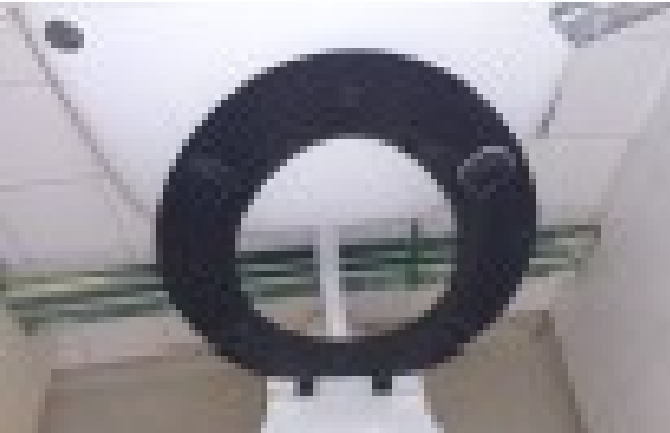
59	As PK001278	Composite toilet seat	Boys toilet G/098	No Risk - Does not contain asbestos.

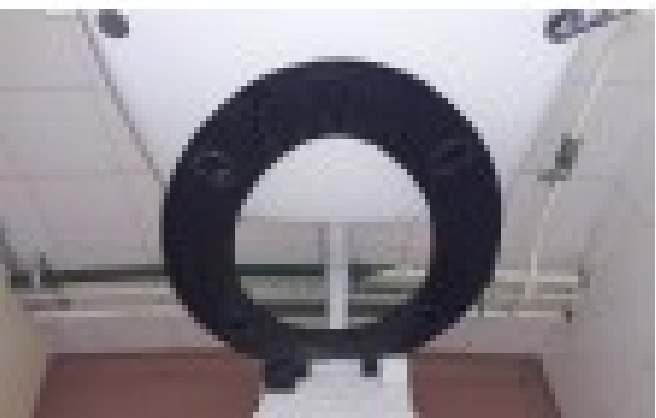
60	As PK001278	Composite toilet seat	Girls toilet G/099	No Risk - Does not contain asbestos.

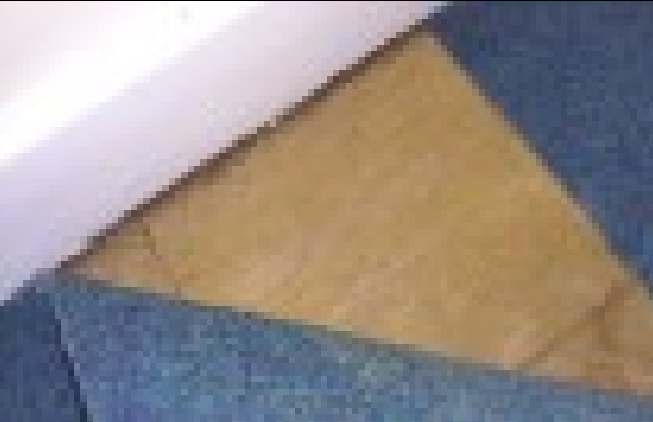
75	As PK001289	Floor tiles – floor below carpet	Stairwell 1/013	No Risk - Does not contain asbestos.

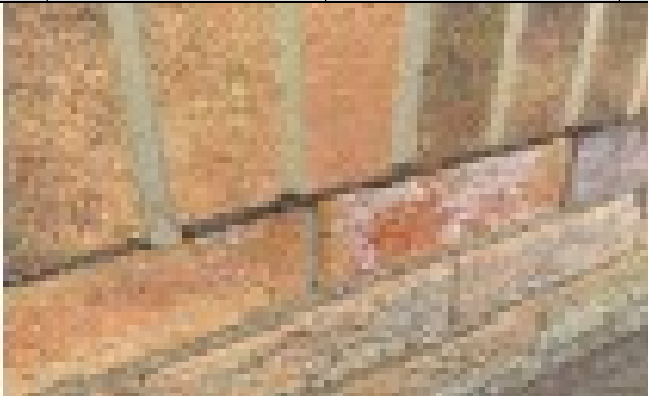
97	PK001294	Damp proof course - Walls	External	No Risk - Does not contain asbestos.

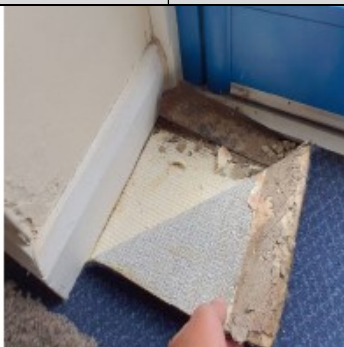
98	RO000383	Bitumen strip – floor	Toddles Room G/16 G/01	No Risk - Does not contain asbestos.

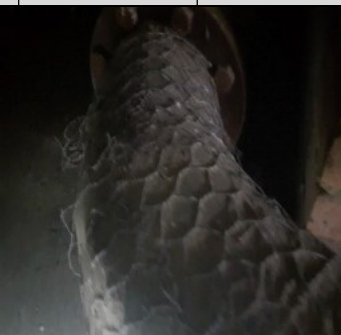
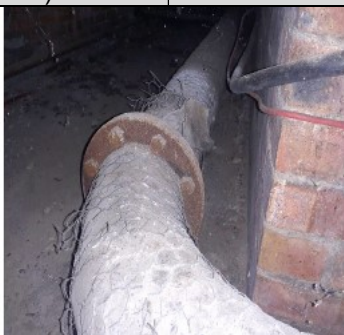
99	OU003090	Insulation - Pipework	Undercroft G/01 (Boiler Room)	No Risk - Does not contain asbestos.

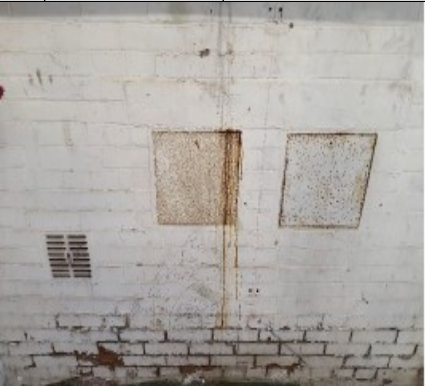
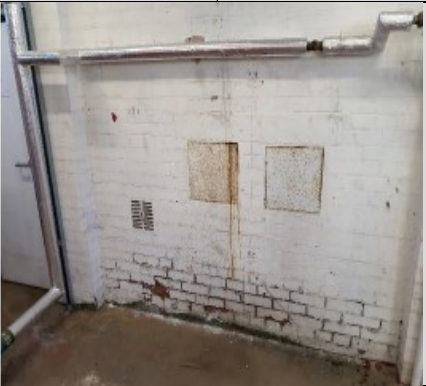
103	RO001630	Insulation residue to wall	Boiler Room G/01	No Risk - Does not contain asbestos.

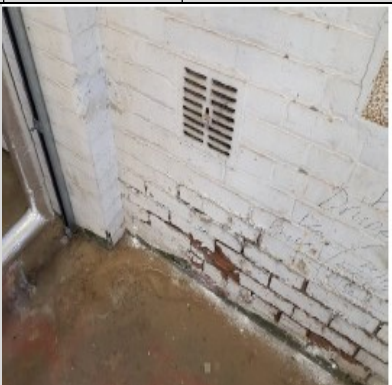
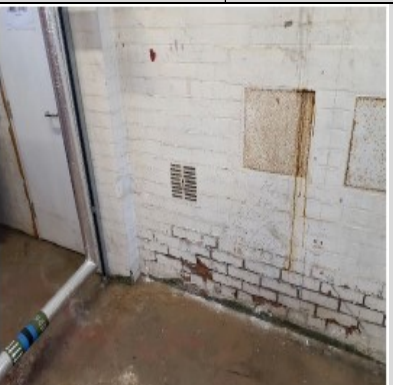
104	RO001631	Insulation residue to wall	Boiler Room G/01	No Risk - Does not contain asbestos.

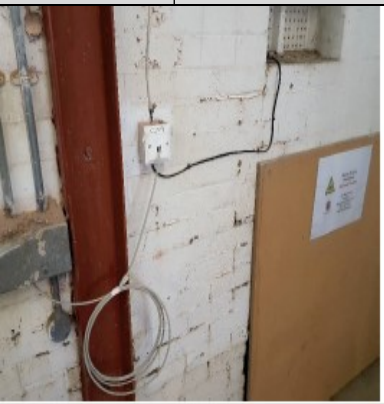
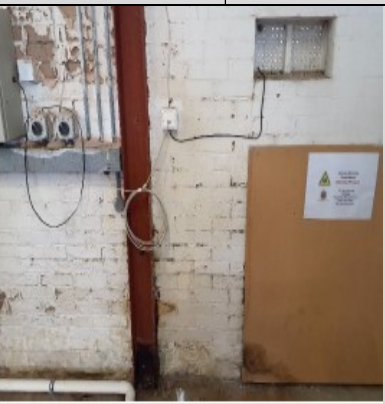
105	RO001632	Insulation residue to wall	Boiler Room G/01	No Risk - Does not contain asbestos.

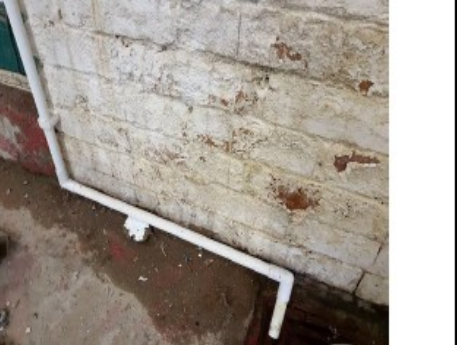
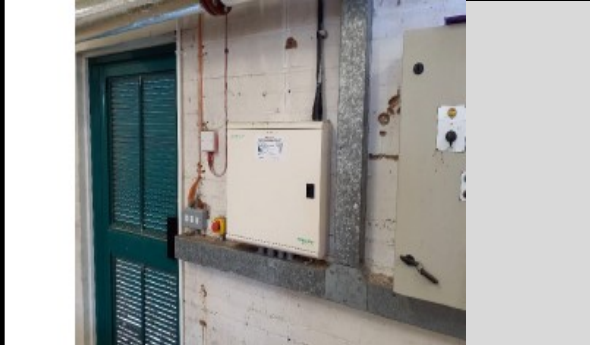
109	RO001636	Insulation residue to wall	Boiler Room G/01	No Risk - Does not contain asbestos.

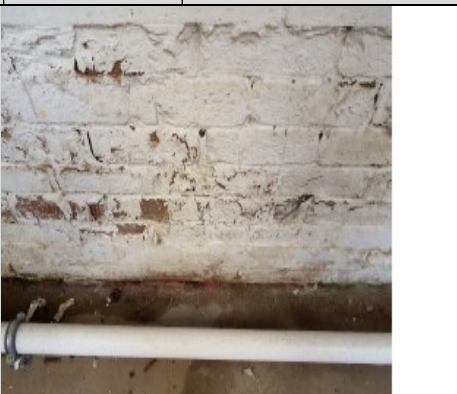
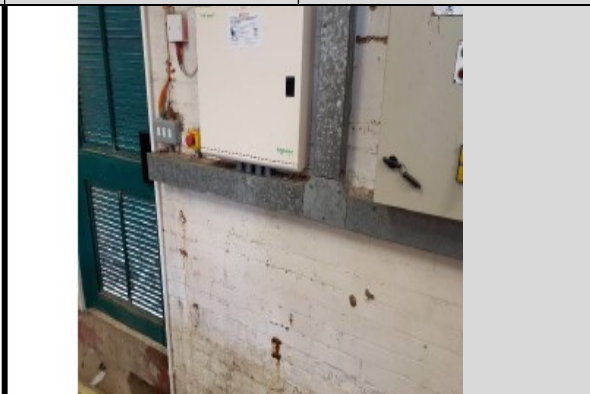
110	RO001637	Insulation debris to wall	Boiler Room G/01	No Risk - Does not contain asbestos.

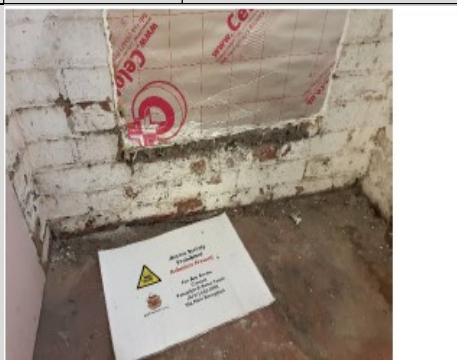
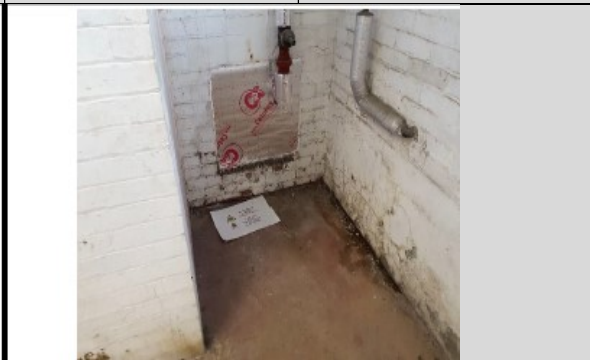
111	RO001638	Insulation residue to wall	Boiler Room G/01	No Risk - Does not contain asbestos.
