ASBESTOS SURVEY REPORT FOR GREENFIELDS COMMUNITY PRIMARY SCHOOL, WIDEOPEN, NEWCASTLE, NE13 6NB.

Asbestos Register for Greenfields Community Primary School

Date: 08 July 2025

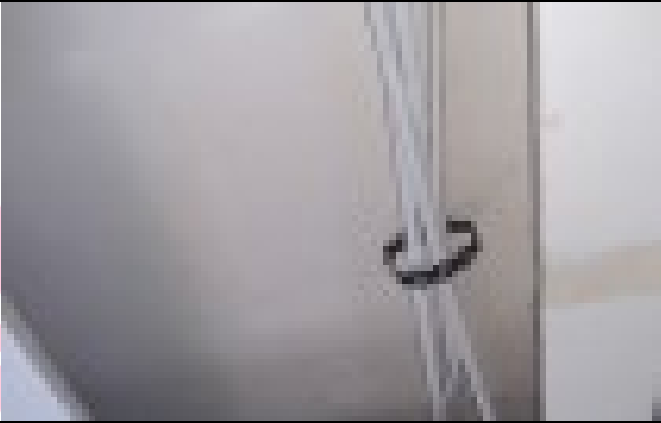
11	PK001266	Fire protection – metal beams and upper ceiling above suspended tiles	Main Kitchen G/009	Low Risk – 6 monthly

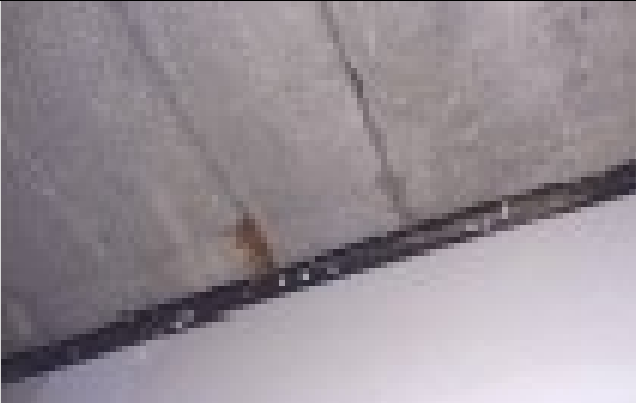
52	As PK001284	Felt – metal structure and wall above windows within ceiling void	Early years classroom 2 toilets G/083	No Risk - Does not contain asbestos.

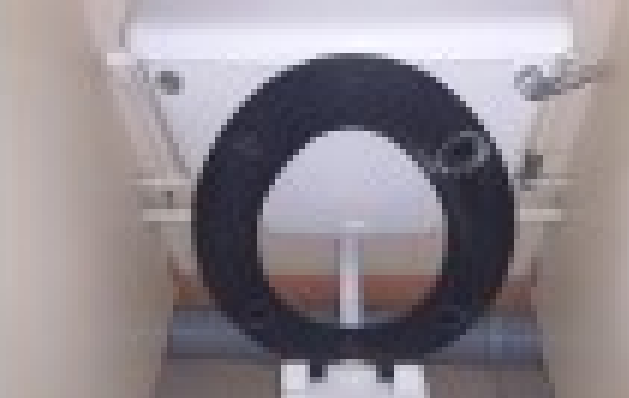
53	As PK001278	Composite toilet seat	Early years classroom 1 toilets G/085	No Risk - Does not contain asbestos.

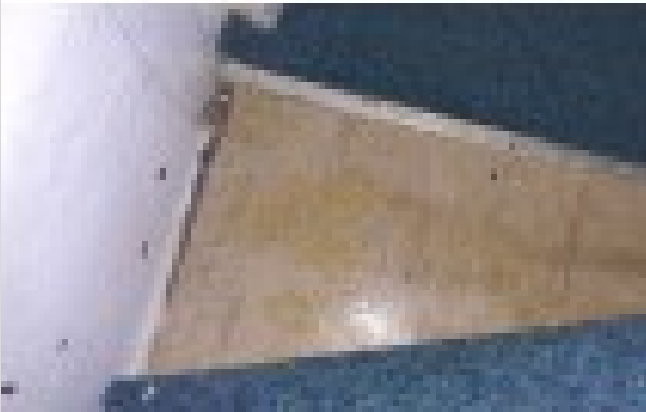
54	As PK001281	Vinyl floor tiles and adhesive – floor below carpet	Early years sensory room G/086	No Risk - Does not contain asbestos.

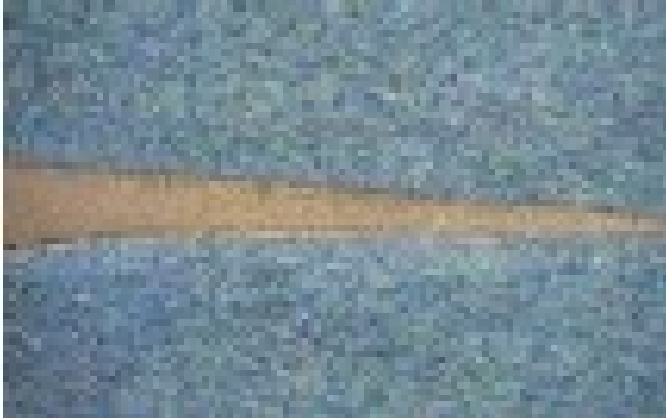
58	As PK001287	Vinyl floor tiles and adhesive – floor below carpet	Corridor G/094	No Risk - Does not contain asbestos.

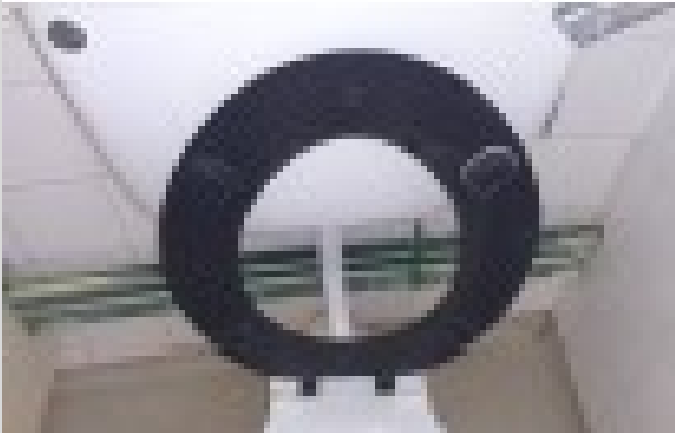
59	As PK001278	Composite toilet seat	Boys toilet G/098	No Risk - Does not contain asbestos.

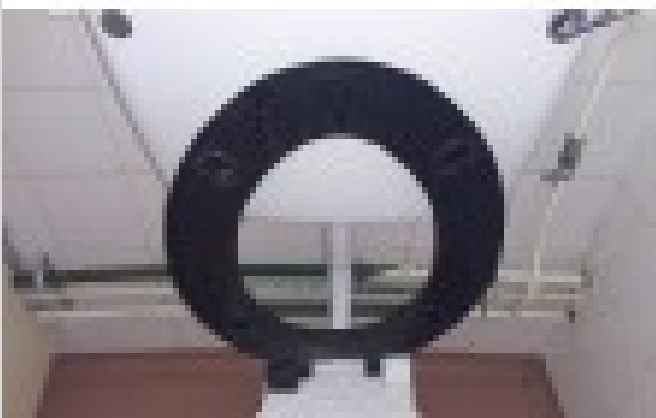
60	As PK001278	Composite toilet seat	Girls toilet G/099	No Risk - Does not contain asbestos.

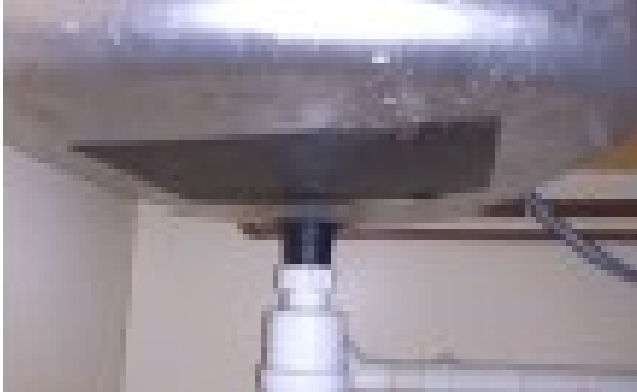
70	PK001291	Sink pad	Staffroom room 6 1/003	No Risk - Does not contain asbestos.

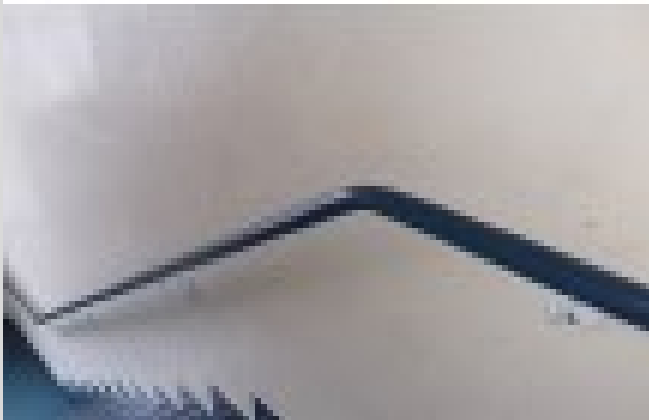
73	As PK001271	Coating – walls to stairs	Stairwell 1/013	No Risk - Does not contain asbestos.

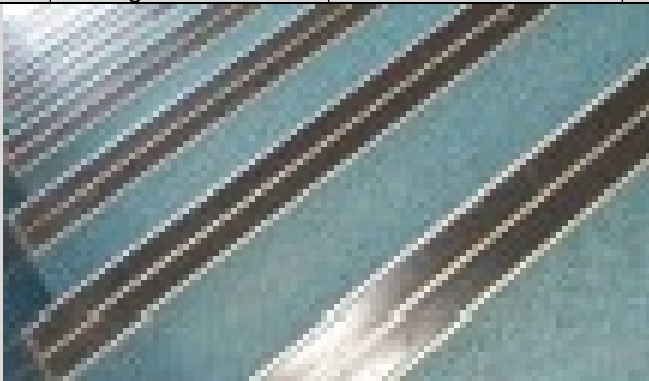
74	As PK001282	Composite – stair nosing	Stairwell 1/013	No Risk - Does not contain asbestos.

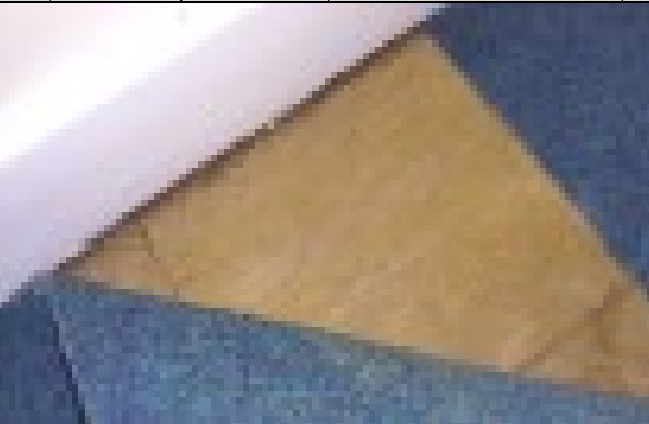
75	As PK001289	Floor tiles – floor below carpet	Stairwell 1/013	No Risk - Does not contain asbestos.

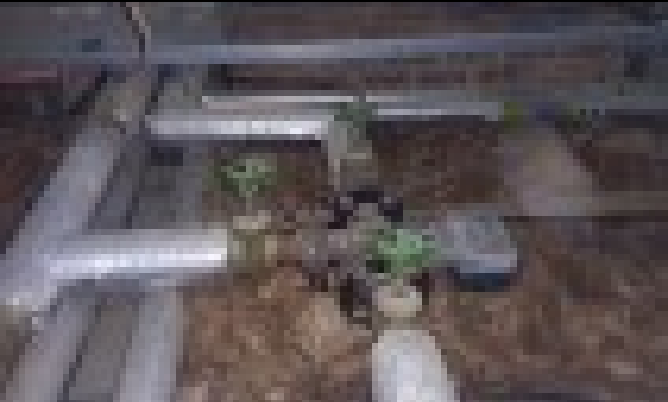
93	Presumed	Gaskets – pipework	Roof void 3 R/003	Very Low Risk – 12 monthly

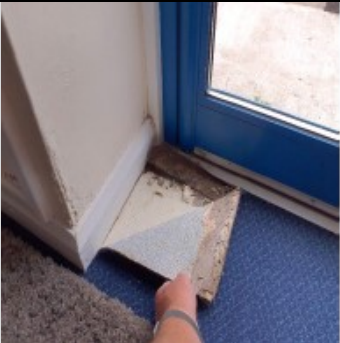
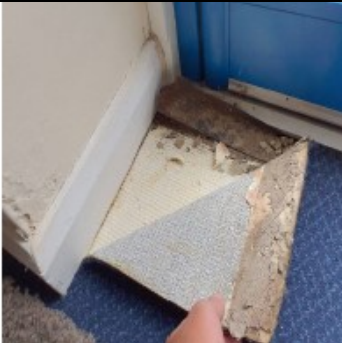
98	RO000383	Bitumen strip – floor	Toddles Room G/16 G/01	No Risk - Does not contain asbestos.

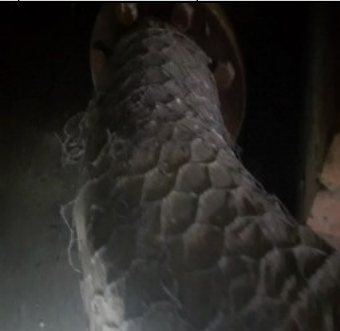
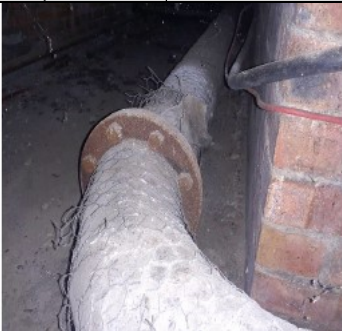
99	OU003090	Insulation - Pipework	Undercroft G/01 (Boiler Room)	No Risk - Does not contain asbestos.

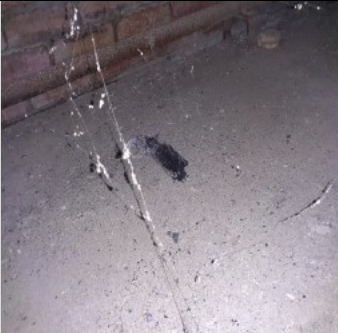
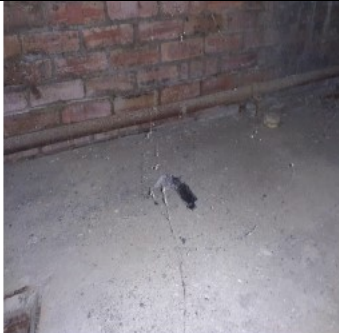
100	OU003091	Debris - Floor	Undercroft G/01 (Boiler Room)	No Risk - Does not contain asbestos.
